U.S. House of Representatives
Subcommittee on Oversight and Investigations
of the
Committee on Energy and Commerce
Washington, DC 20515-6116

March 21, 1994

TITLE (4)
Automatic Reactor Shutdown Following Failure of the Main Turbine

SUBJECT: FERMII 2 CATASTROPHIC
TURBINE-GENERATOR FAILURE

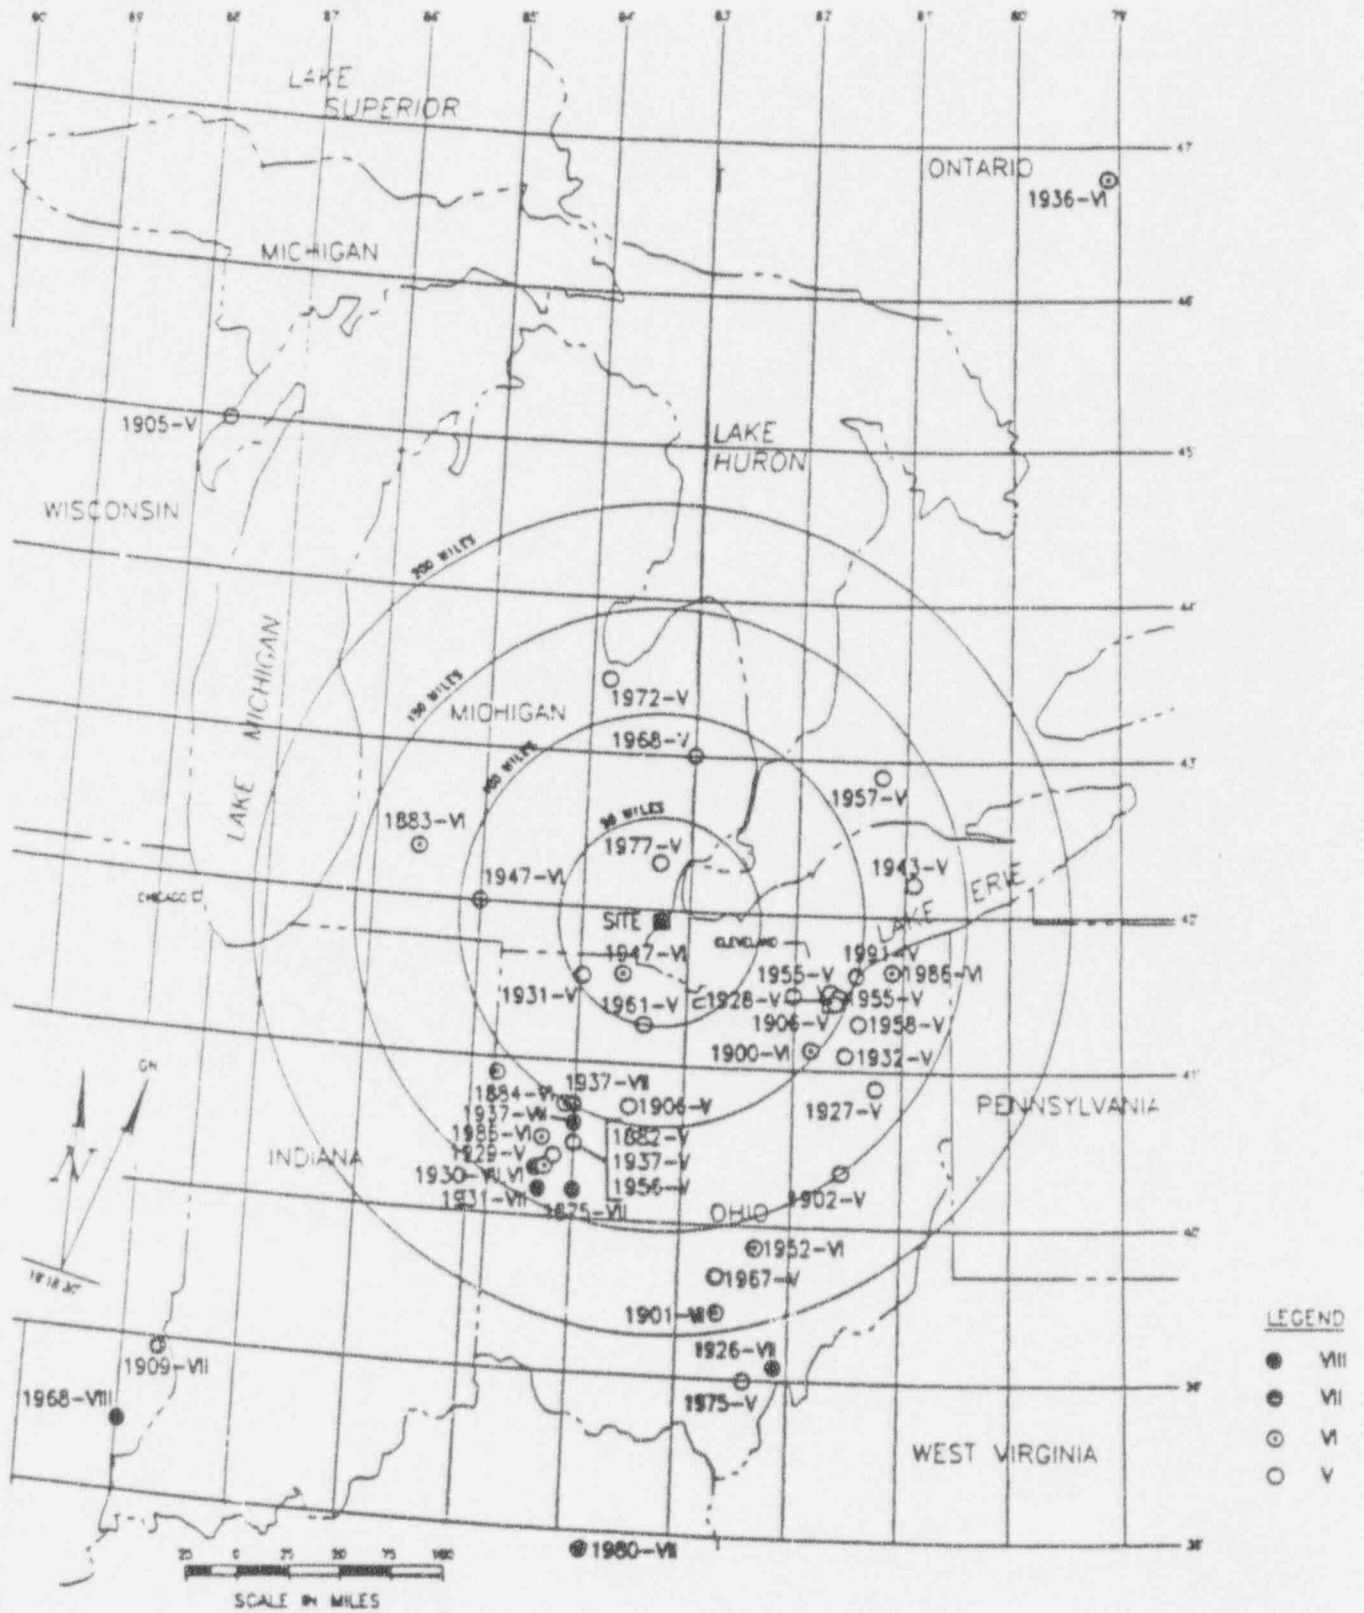
Figure 2.1.1.1

Fermi 2 is located in a relatively seismic stable area. Approximately fifteen intensity VI (Modified Mercalli Scale) or greater earthquakes have occurred within a two hundred mile radius in the last two hundred years (Figure 2.1.1.1). Additionally, nine earthquakes of intensity V or less have occurred within a fifty mile radius of the facility (Figure 2.1.1.2). Although the Fermi 2 OBE is associated with an intensity VI seismic event, it is unlikely the facility will experience such an earthquake within its lifetime.

Epicenter Map, Detroit Area, intensity V or Greater, 200 Mile Radius

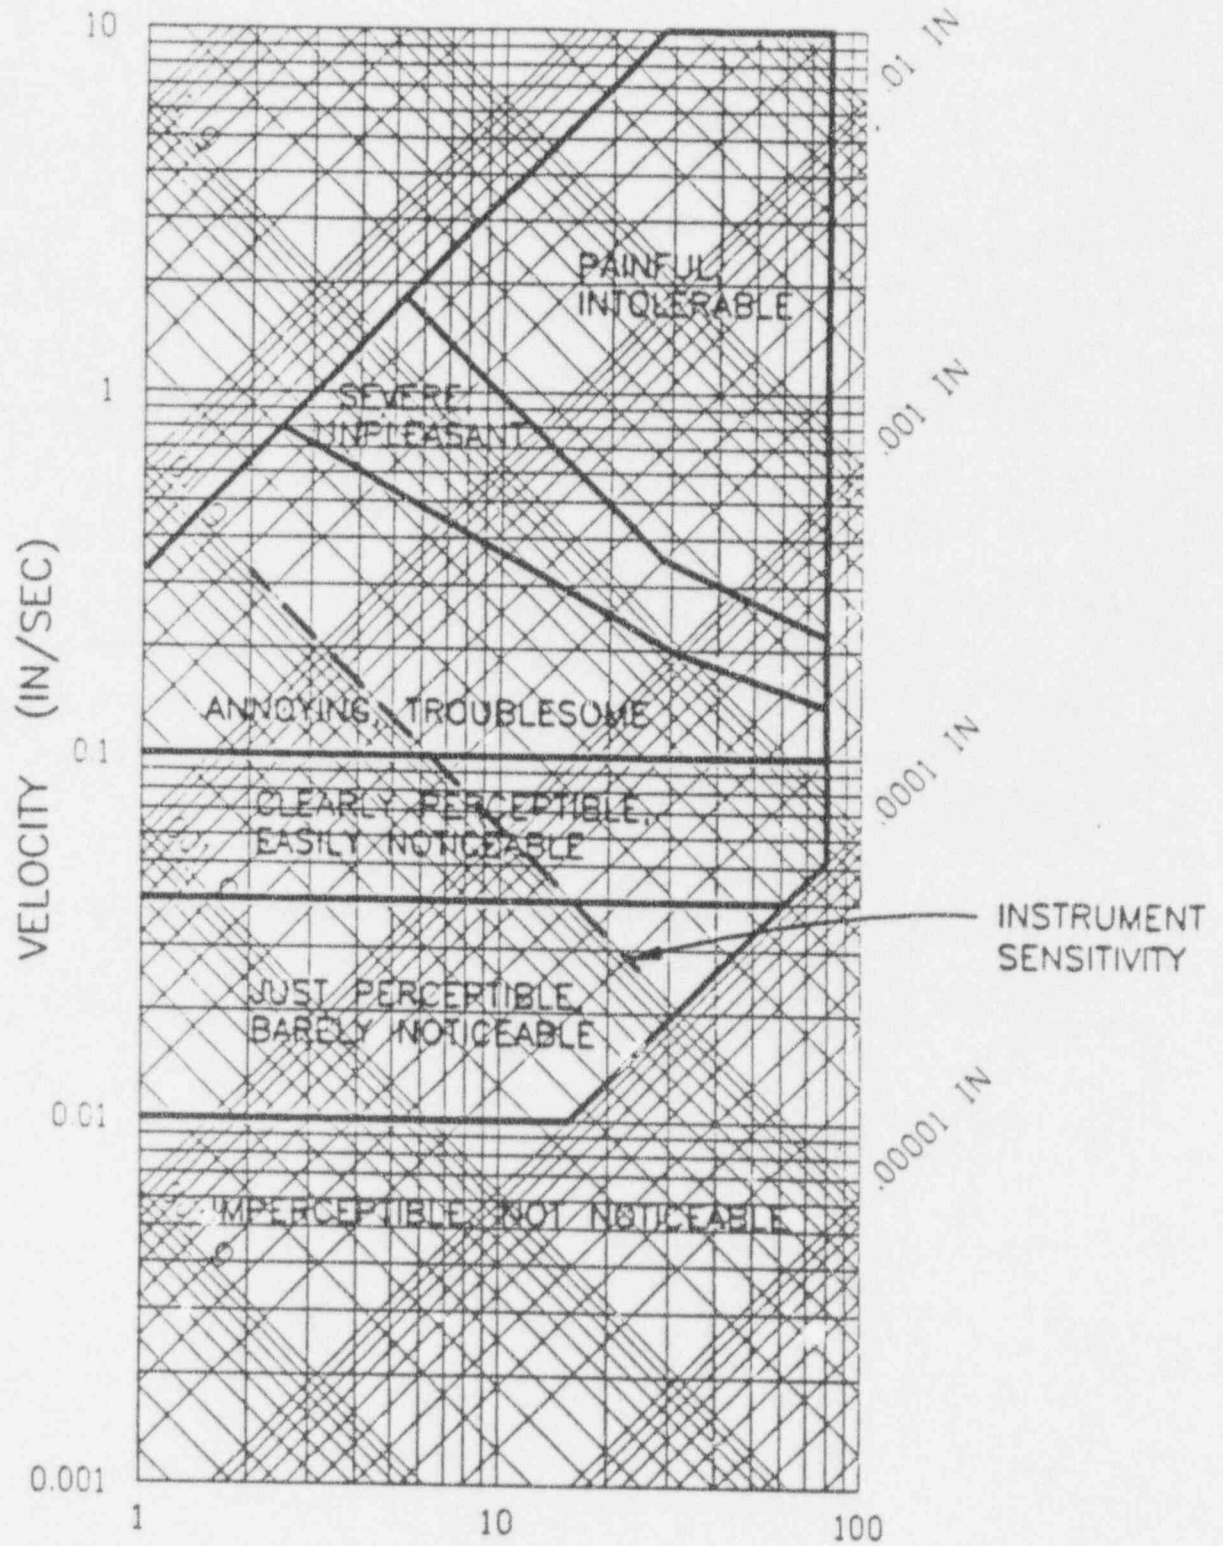
Figure 2.2.4.1

Work conducted by numerous researchers have established physiological limits of human perceptibility to vibration. The studies demonstrate humans can detect vibrations well below the current instrument sensitivity at Fermi 2 (Figure 2.2.4.1).

FREQUENCY (HERTZ)
Human Vibration Sensitivity

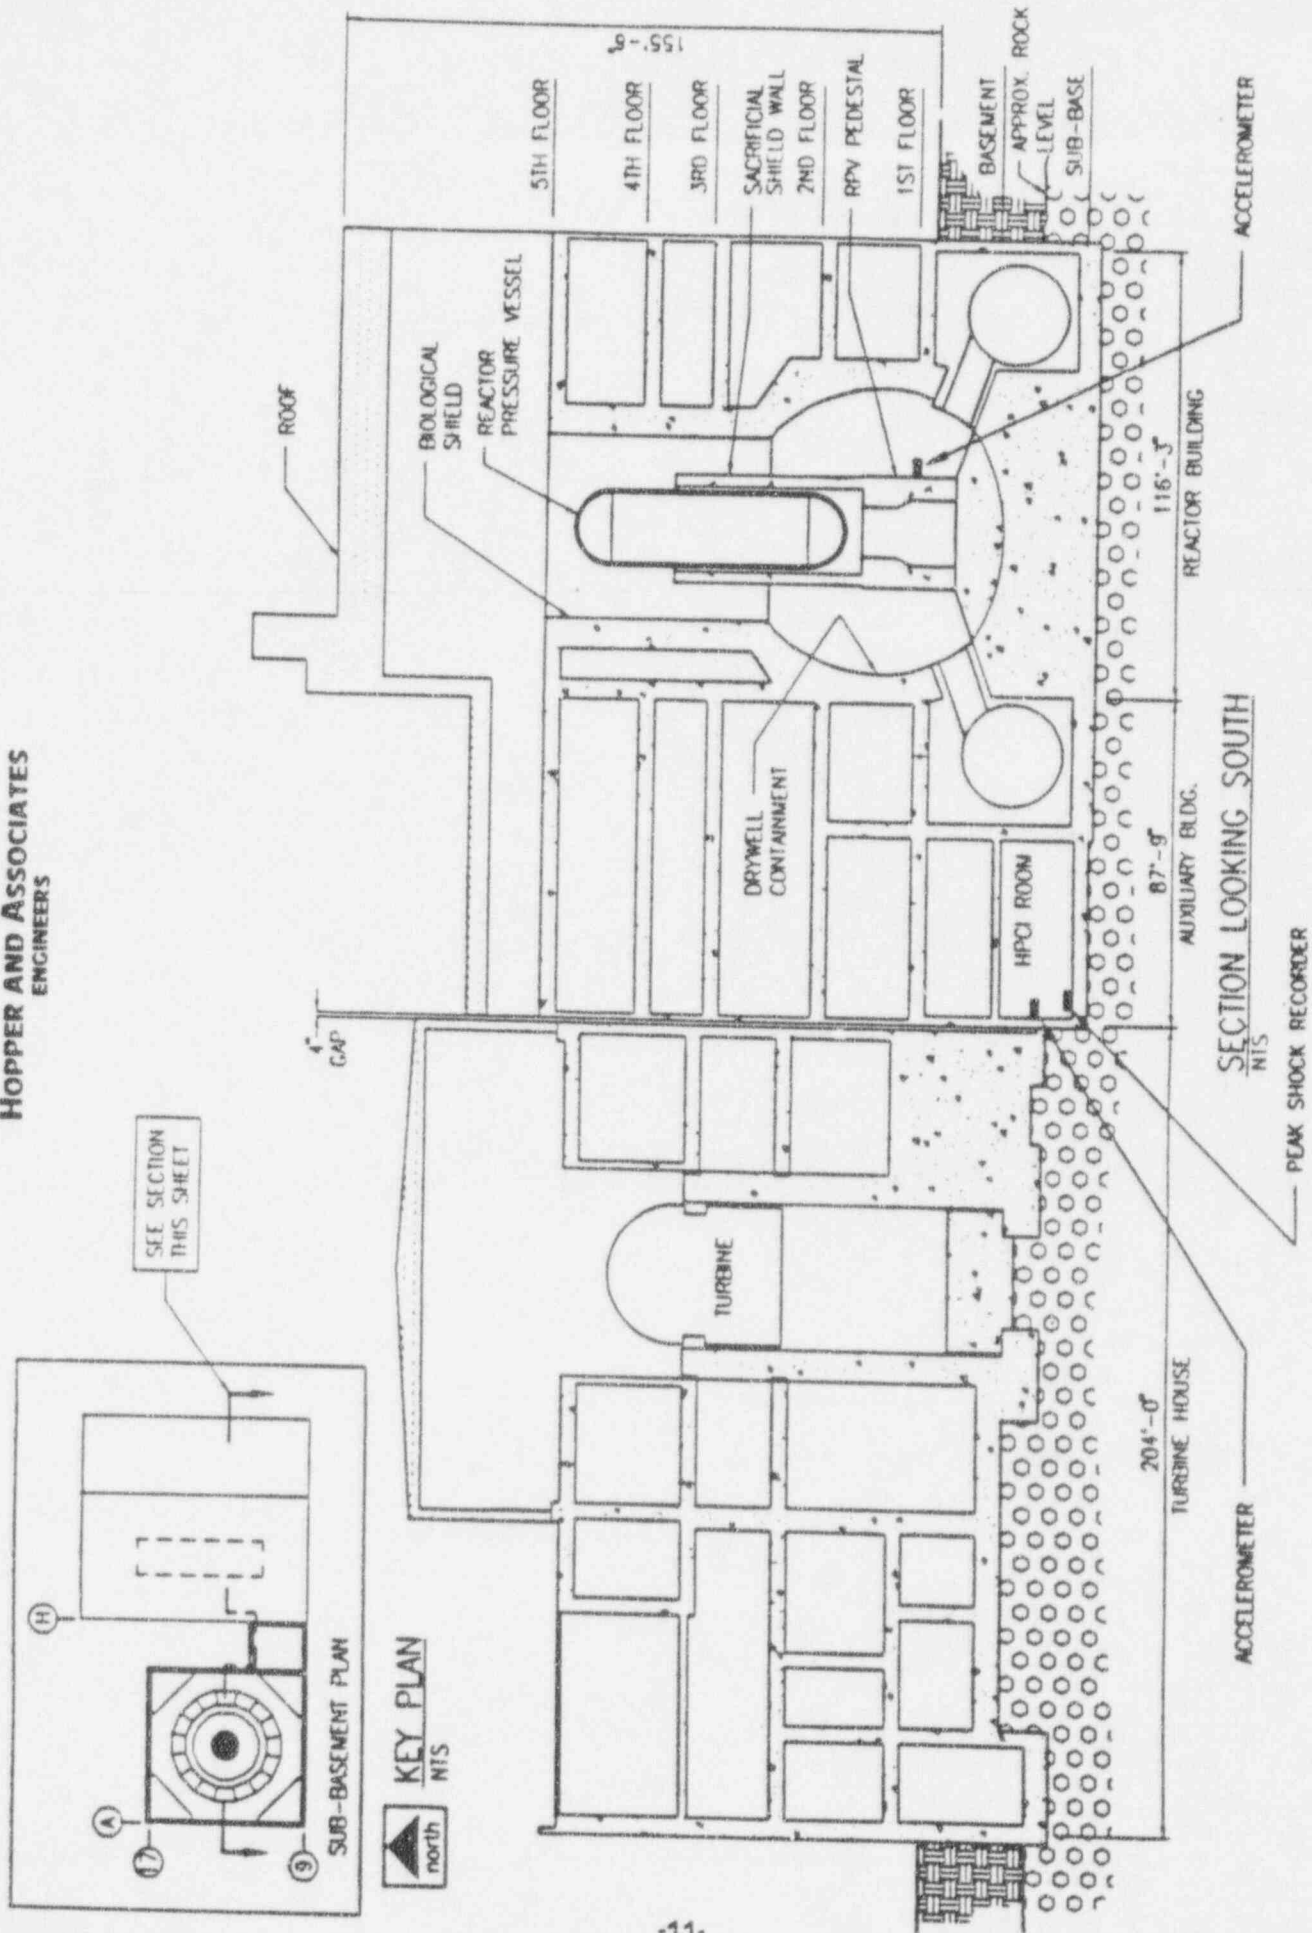
Passive and Active Instrumentation Location at HPCI Room and RPV Pedestal
Figure 3.1.1.1

Two Teledyne/Geotech accelerometers are located in the Reactor/Auxiliary building, in the HPCI room sub-basement and at the RPV pedestal (Figure 3.1.1.1). The accelerometers measure longitudinal, transverse, and vertical acceleration, which correspond to the vertical, north/south, and east/west directions of the passive recorders.

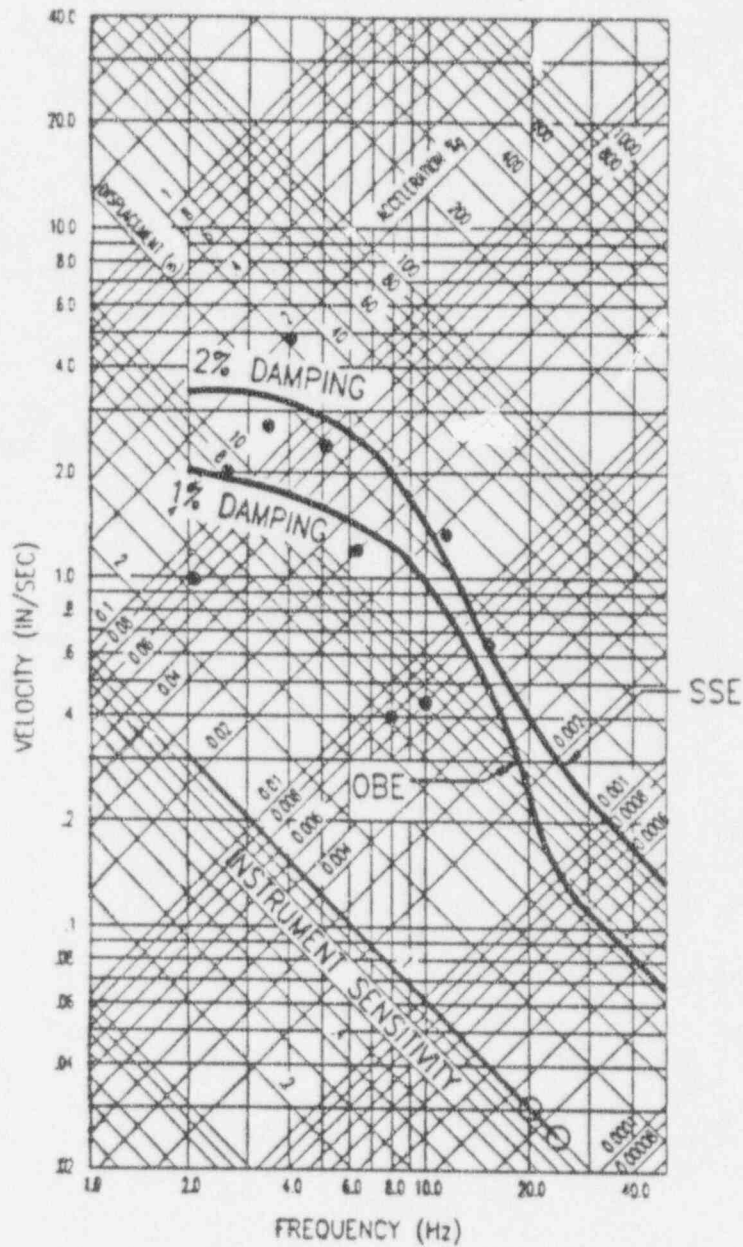
Figure 3.2.1.1

D30-N005 Passive Instrumentation, Vertical Response Spectra - HPCI Room

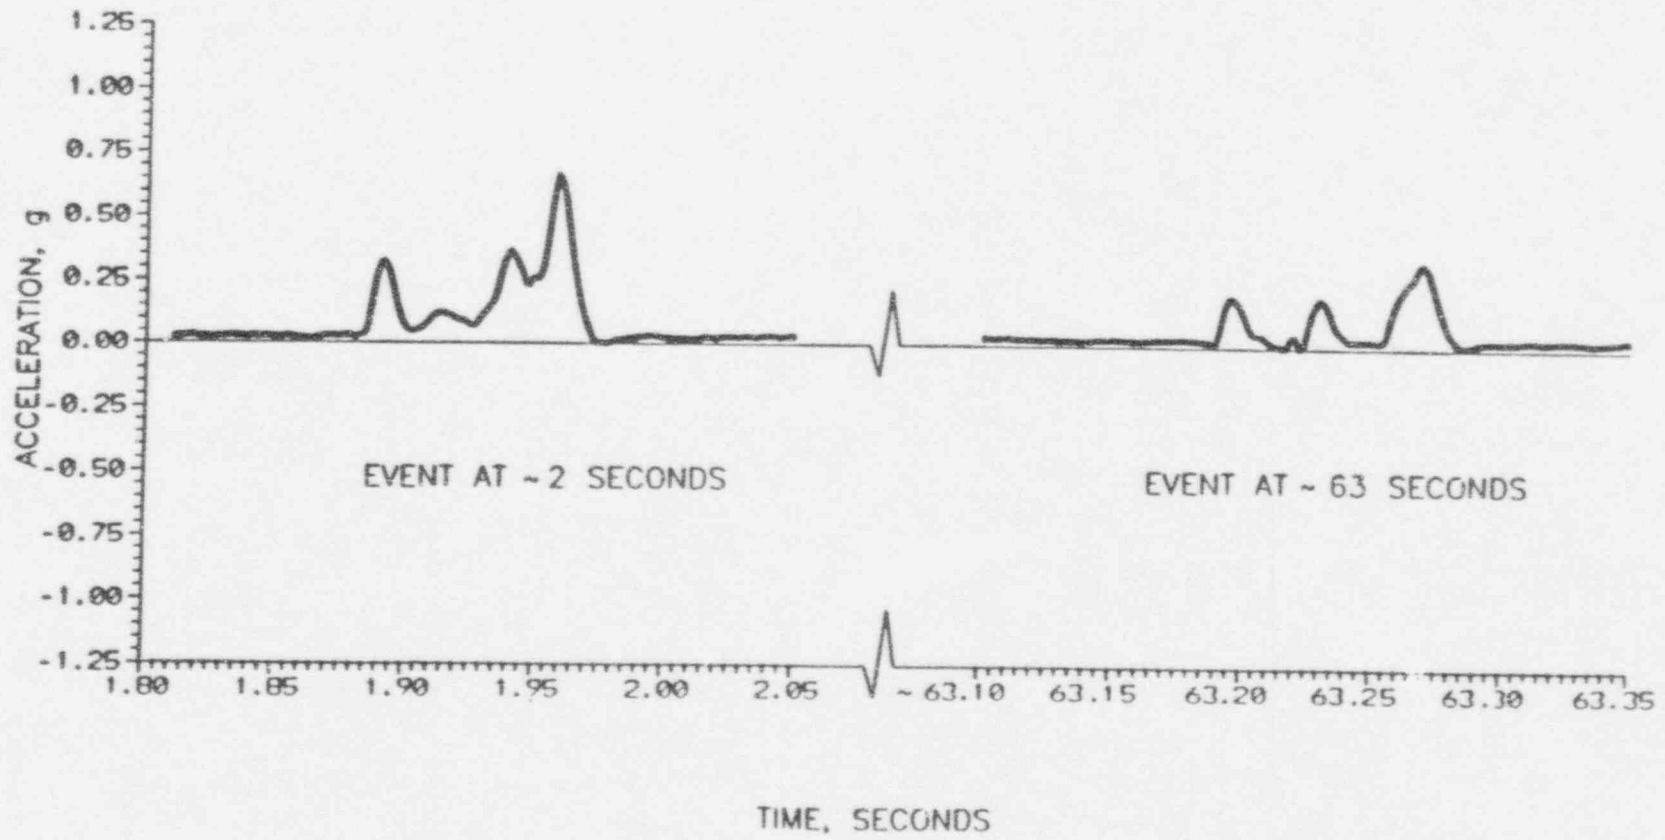
Figure 3.2.2.1

D30-N003 Accelerometer, Vertical Direction Time History - HPCI Room
