Subj: Comments On Draft NRC Bulletin On Loss Of Fill-Oil In
Rosemount Transmitters

PRESENTATION TO CPGR ON
PROPOSED GENERIC LETTER ON
DEFICIENCY IN BWR THERMAL LIMITS
CALCULATIONS CAUSED BY CHANNEL BOX BOW

SUBJECT: CORRECTION OF DEFICIENCY IN BWR CRITICAL POWER RATIO CALCULATION
DUE TO CHANNEL BOX BOW

NRC INFORMATION NOTICE NO. 89-69: LOSS OF THERMAL MARGIN CAUSED BY
CHANNEL BOX BOW

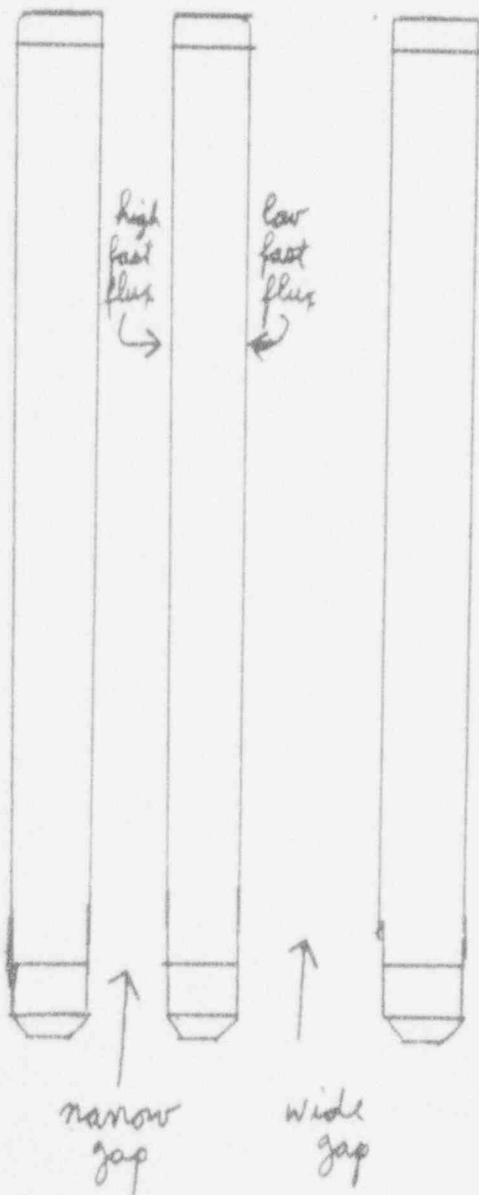
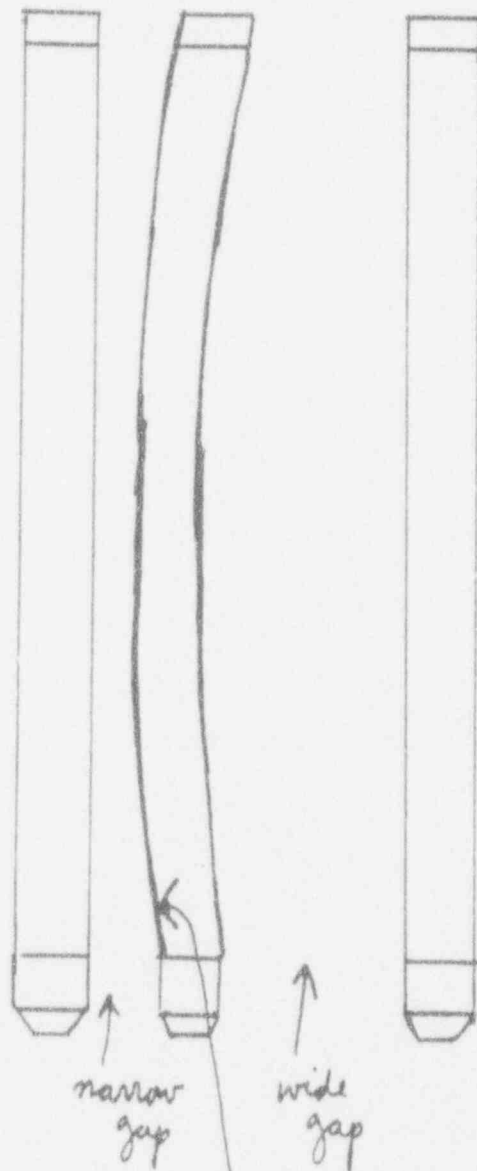
Figure 1
Channel Bow

axial Representation of Channel Bow

channel Before Exposure

channel after Exposure

This side sees a higher differential growth

The failed fuel rods were located symmetrically in the core. The fuel assemblies containing the rods that had failed were located adjacent to once-burned fuel assemblies with highly exposed fuel channels (see Figure 1). These fuel channels were in their second bundle lifetime and had excessive channel bowing. In each assembly with failed fuel, the corner rod facing the adjacent control rod was heavily oxidized and the cladding was penetrated just below the top spacer grid. In addition, each of the four failed rods had typical secondary internal hydriding damage near the bottom of the fuel rods, resulting in loss of fuel material.
