UNITED STATES  
NUCLEAR REGULATORY COMMISSION  
WASHINGTON, D. C. 20555

Docket No. 50-306

FACILITY: Prairie Island Unit 2 (PI-2)

SUBJECT: SUMMARY OF MEETING ON OCTOBER 29, 1981 - REACTOR COOLANT PUMP SHAFT  
CRACK

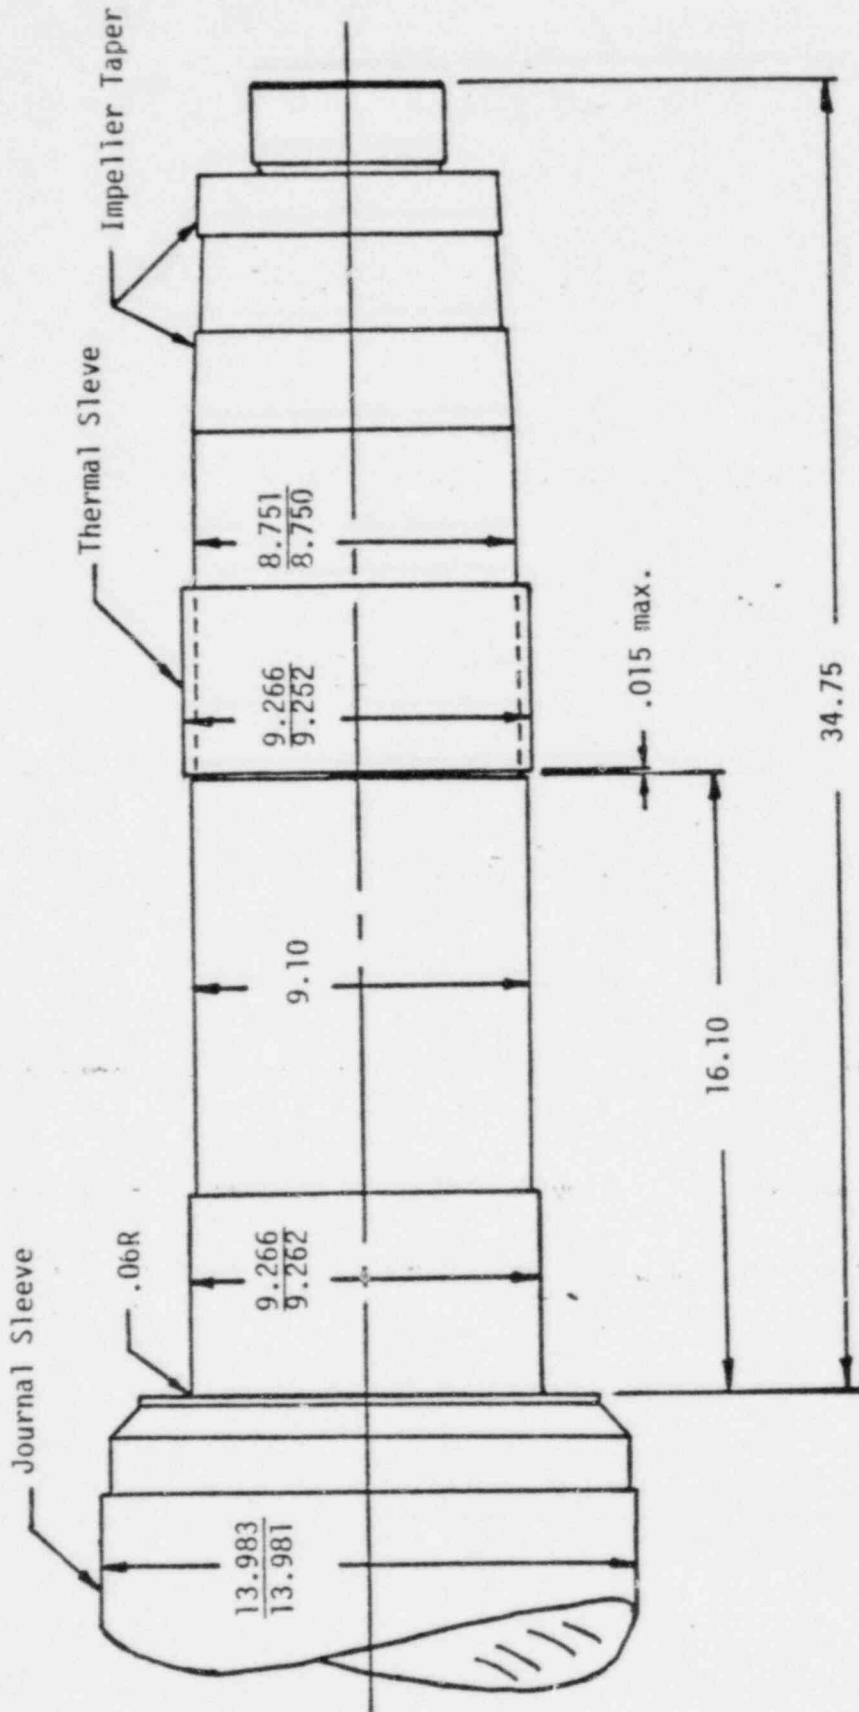
LOWER SHAFT DIMENSIONS

NRP PIN DIMENSIONS  
(CRACKED PIN HOLE)

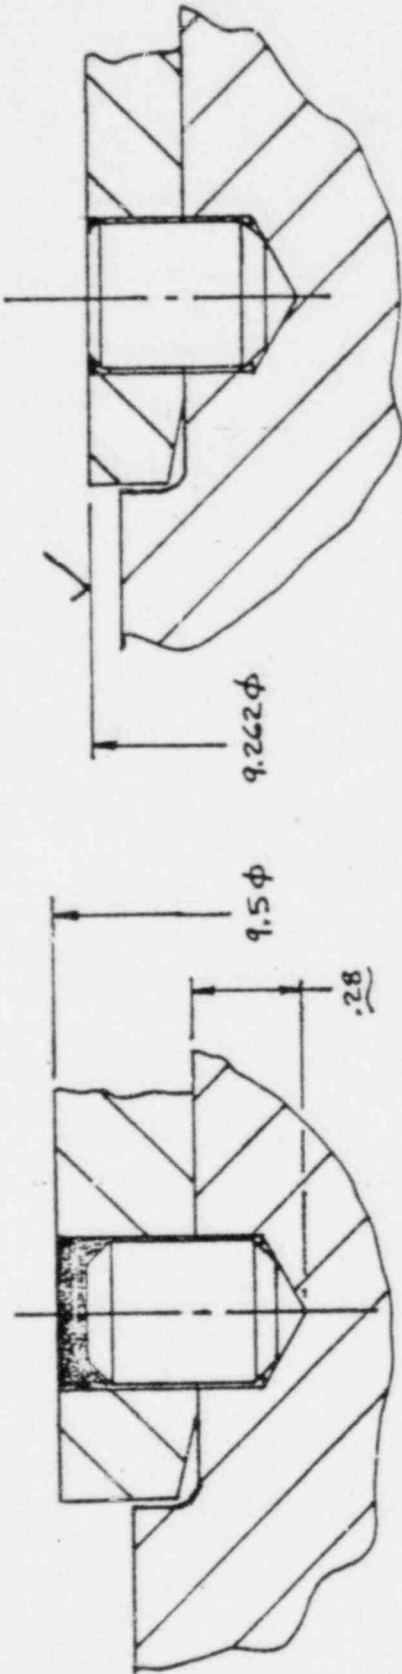
SLEEVE MACHINING  
REMOVED WELD

1ST PIN  
INSTALLATION

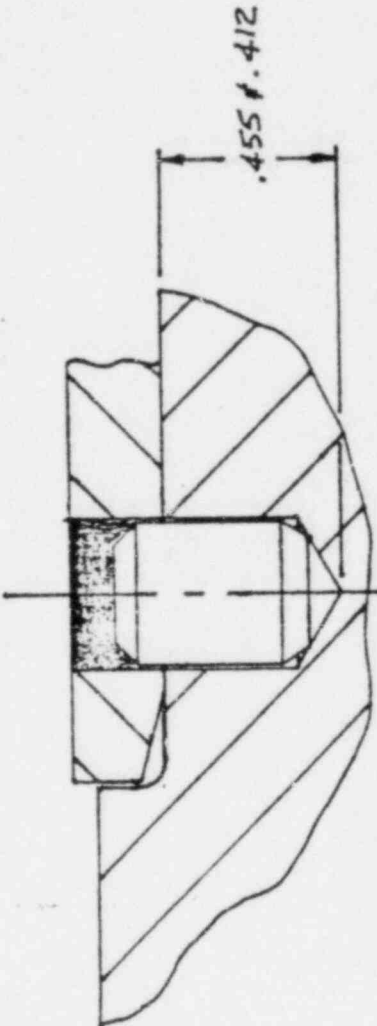
2ND PIN  
INSTALLATION

- . HIGH LOCALIZED TENSILE RESIDUAL STRESS AT PIN WELDS PROVIDED SITES OF PRIMARY CRACK INITIATION

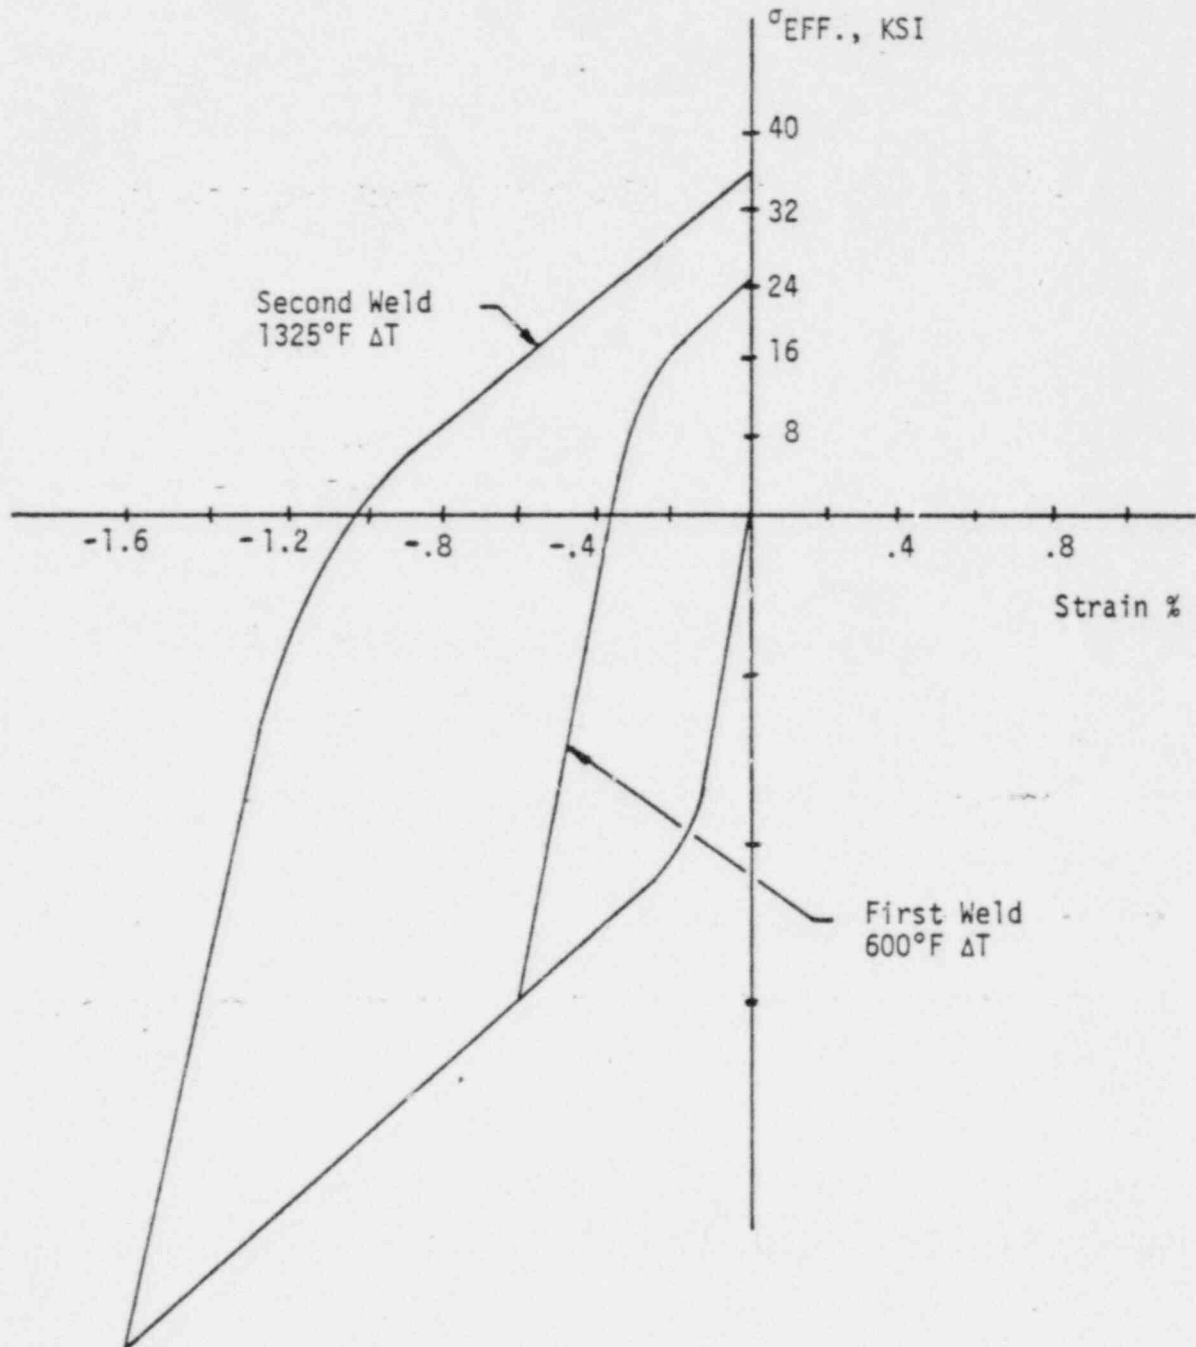
ALTERNATING STRESS REQUIRED TO PROPAGATE A SMALL CRACK

- LOCALIZED HIGH STRESS DUE TO WELDING AT PIN HOLE - NO CRACK.
- PIN FRETTING PRODUCES ADDITIONAL HIGH LOCAL STRESS WHICH INITIATES AND PROPAGATES SMALL CRACK WITHIN HIGH CONTACT STRESS FIELD. CRACK ARRESTS AS IT LEAVES HIGH CONTACT STRESS FIELD (0.1 IN.).
- NO KNOWN LOADS OF MAGNITUDE REQUIRED TO PROPAGATE CRACK TO FAILURE.

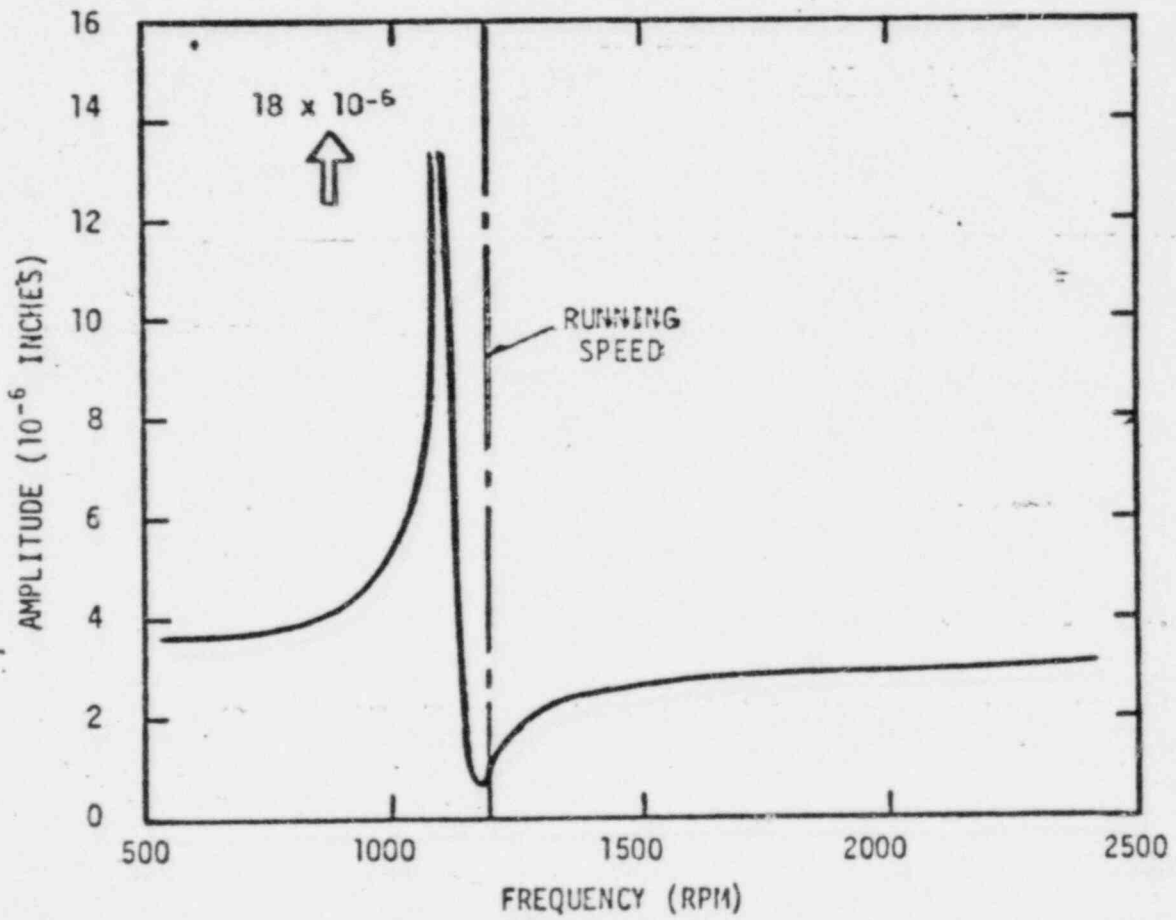
AXIAL RESPONSE  
RELATIVE DISPLACEMENTS IN VICINITY OF CRACK

- AXIAL AND TORSIONAL MODES DO NOT APPEAR TO BE POTENTIAL SOURCES OF THE PROBLEM
- THE LATERAL MODE WHICH PRODUCES THE HIGHEST RELATIVE VIBRATION RESPONSE IS THE 7.9 HZ BENDING MODE
- THE ALTERNATING STRESSES ASSOCIATED WITH THIS MODE ARE SMALL
- THERE IS ALSO NO EVIDENCE OF LARGE DEFLECTIONS ASSOCIATED WITH THIS MODE IN PUMPS WHICH ARE IN NORMAL CONDITION

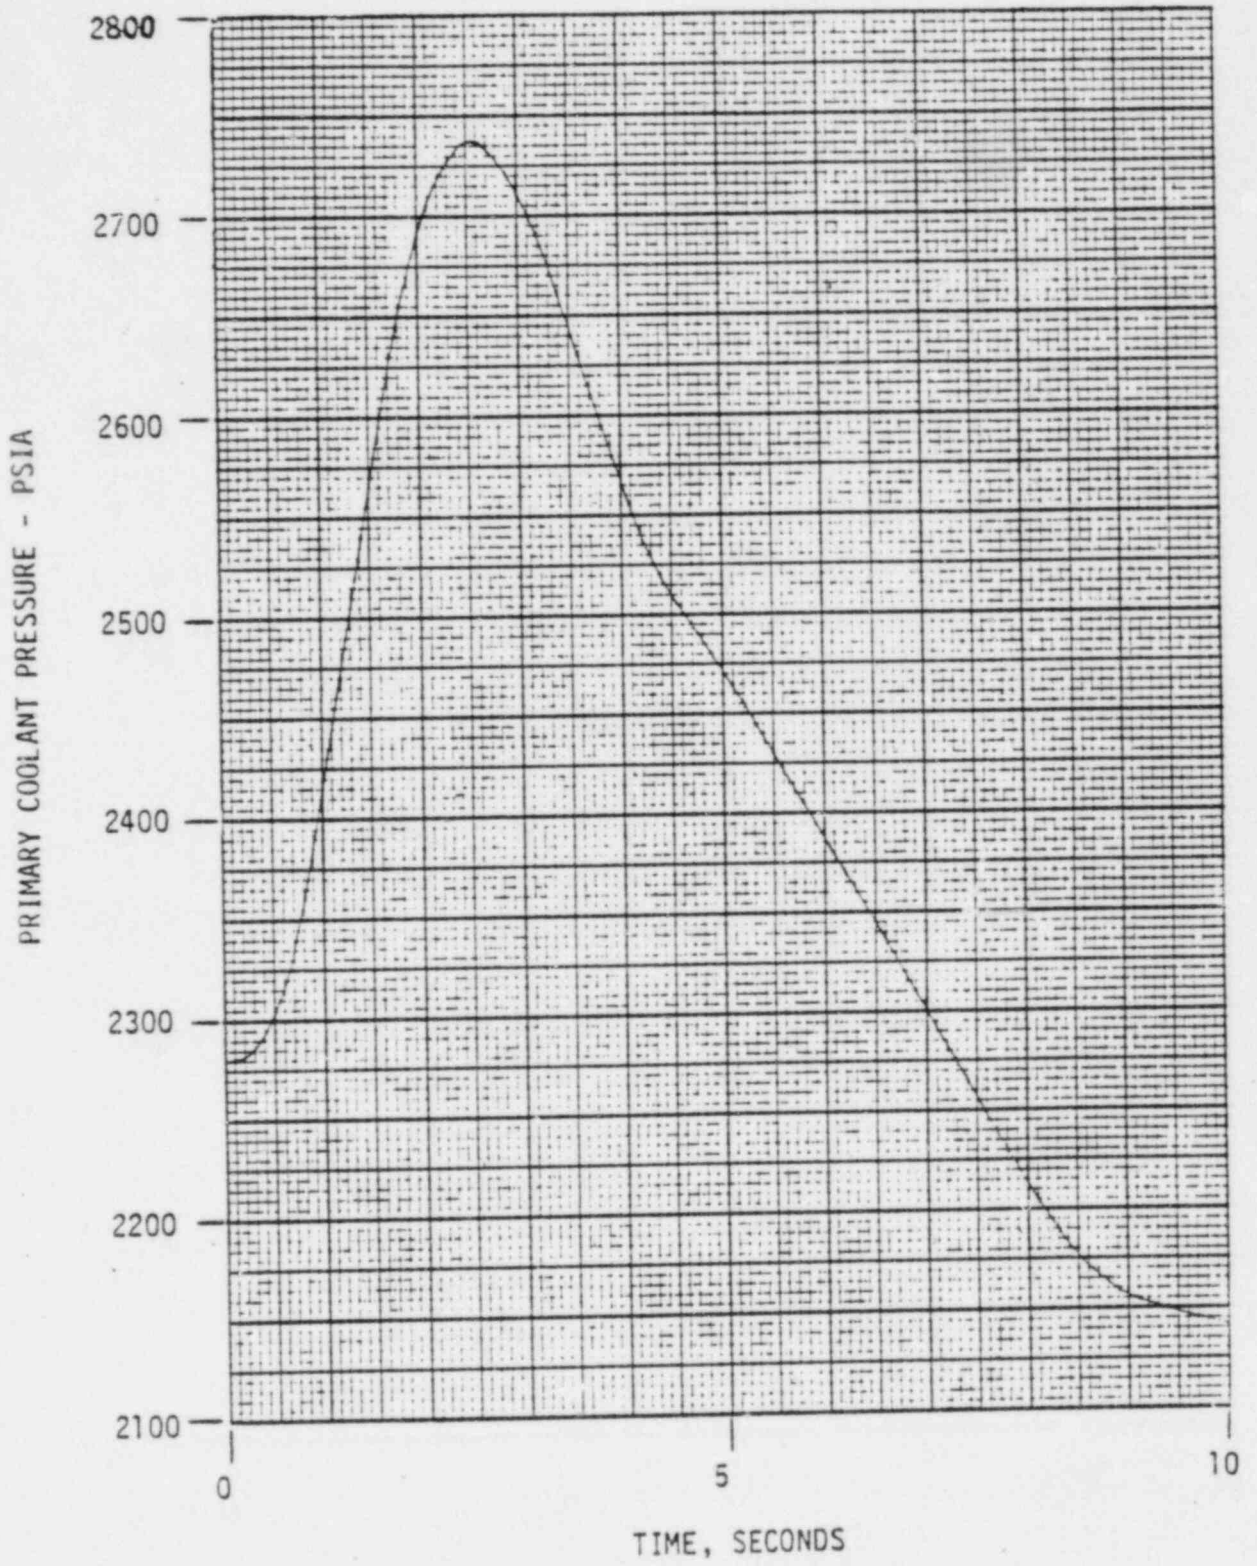
A HIGH-PRESSURE "SPIKE" OCCURS IN A FEW SECONDS, THEN DECAYS AWAY.

FOR NORTHERN STATES POWER, THE PEAK RCS PRESSURE CALCULATED FOR A LOCKED ROTOR TRANSIENT WAS 2737 PSIA (FSAR). IN SUPPORT OF THE EPRI VALVE PROGRAM, THE PEAK PRESSURE CALCULATED (2-LOOP REFERENCE PLANT) WAS 2745 PSIA.
