Subject: Crystal River Unit 3  
Docket No. 50-302  
Operating License No. DPR-72  
Licensee Event Report No. 89-039-01

**LICENSEE EVENT REPORT (LER)**

TITLE (4) **Personnel Error Results in Operation Outside the 10 CFR 50 Appendix R Separation Design Basis**

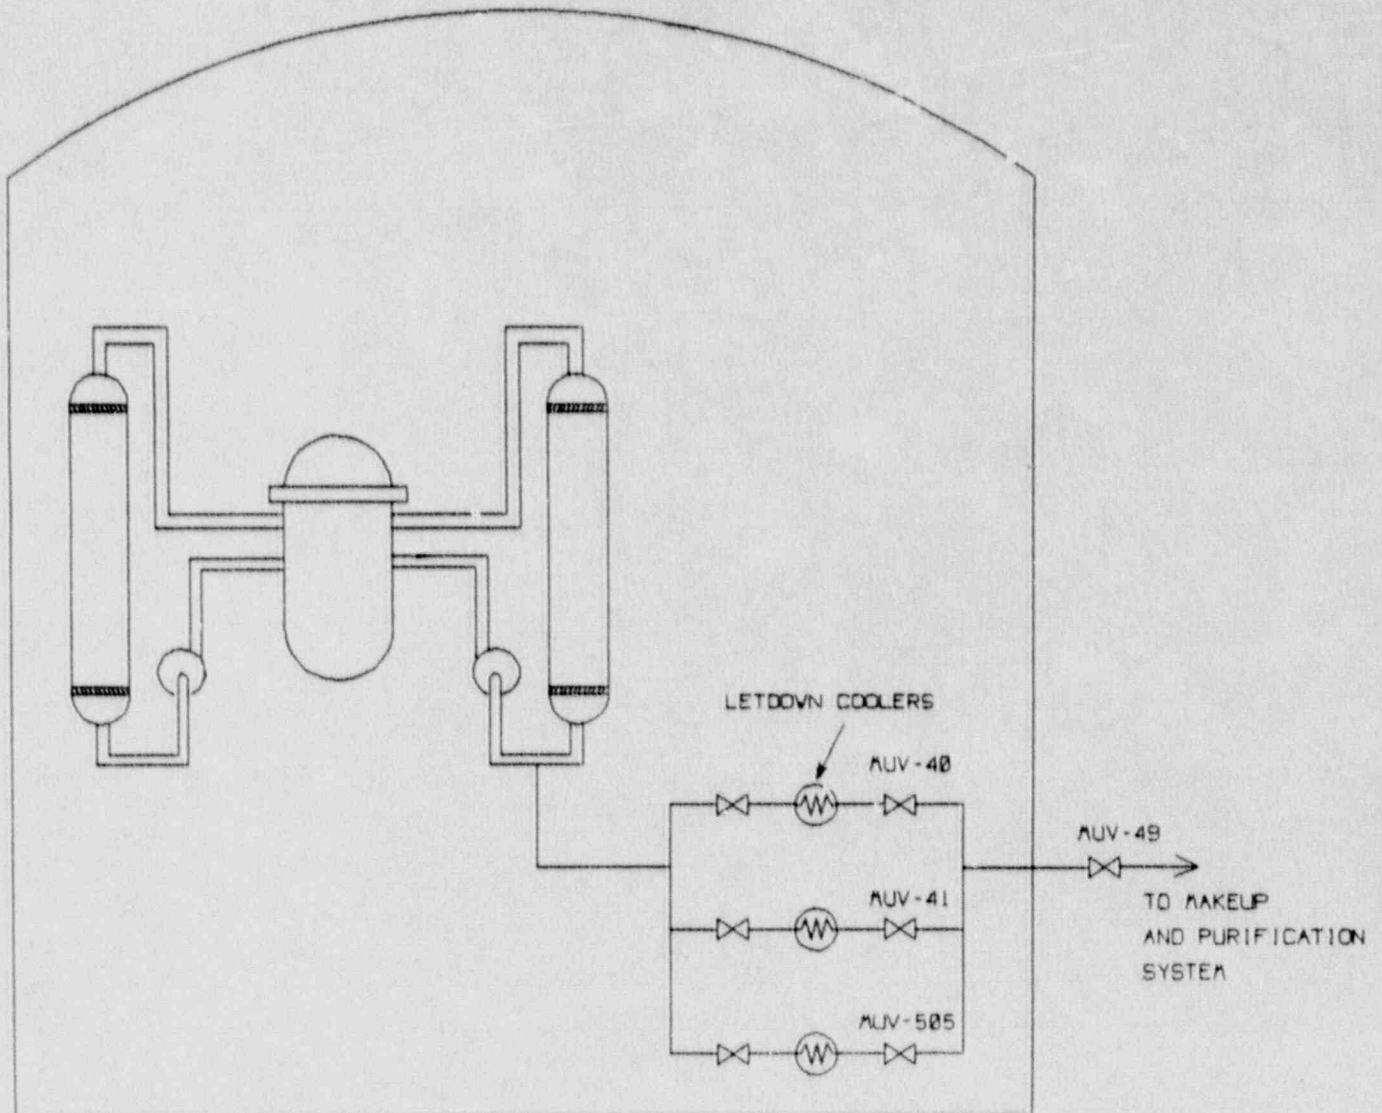
FIGURE 1

On November 7, 1989, Crystal River Unit 3 was in MODE 1, POWER OPERATION, at 855 MWe. The control circuits for two valves [ISV] in the Make-up System [CB] (MUV-40 and MUV-41) that isolate Reactor Coolant System (RCS) [AB] letdown are located on the 124' elevation of the Control Complex [NA]. These two valves, both inside the Reactor Building [NH], comprise one train of letdown isolation (see Figure 1). The valves are part of the equipment required for safe shutdown of CR-3 in the 10CFR50 Appendix R design for a fire on the 124' elevation of the Control Complex. The redundant train is the single isolation valve outside the Reactor Building. For the design fire on the 124' elevation, the outside isolation valve control circuitry is assumed failed. At 1515, it was determined the control circuits for the two inside valves did not meet 10CFR50 Appendix R separation criteria from the outside valve. The valves and control circuits were operable at the time of the event and no equipment failures occurred.
