MEMORANDUM FOR FILE

April 10, 2014

SUBJECT: Assessment of Radiological Events at the Mesa

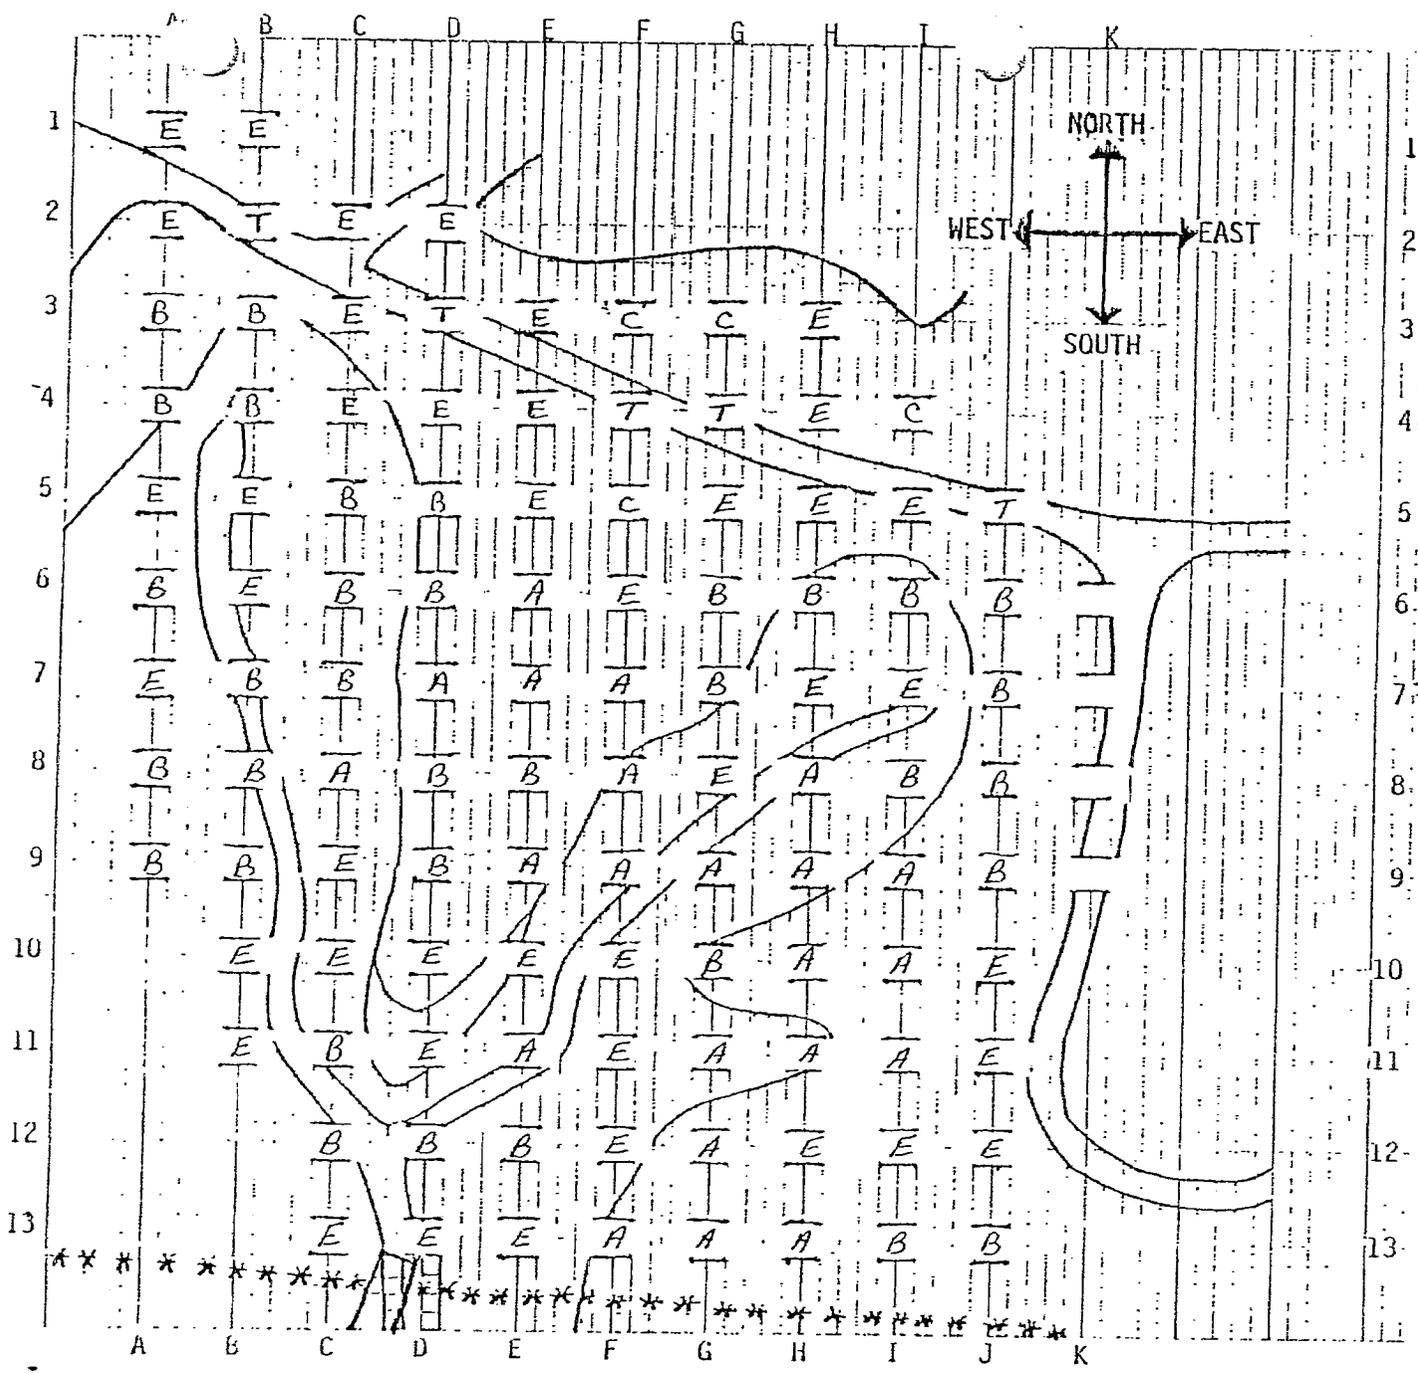
Figure 2 shows the soil classification given to each survey point. From reasearching recent studies made in the field of Environmental Health Physics it was learned that retention of radioactive materials in soil was inversly proportional to soil particle size. This data was also helpful in definining the areas which showed evidence of being actual land fill. Landfill soil was known to be almost entirely beach sand with a relatively low soil particle size and thusly in most cases a characteristically higher natural background reading potential.

Soil Classification

- A - Beach Sand (Lardfill) Small Soil Particle Size
- B - Vegetation Covered Soil - Soil Particle Size not accurately determined.
- C - Mud Soil - Intermediate to Small Soil Particle Size
- D - Clay like Soil - Small Soil Particle Size.
- E - Rocky - Large Soil Particle Size predominant.
- T - ASPHALT TAR SURFACE

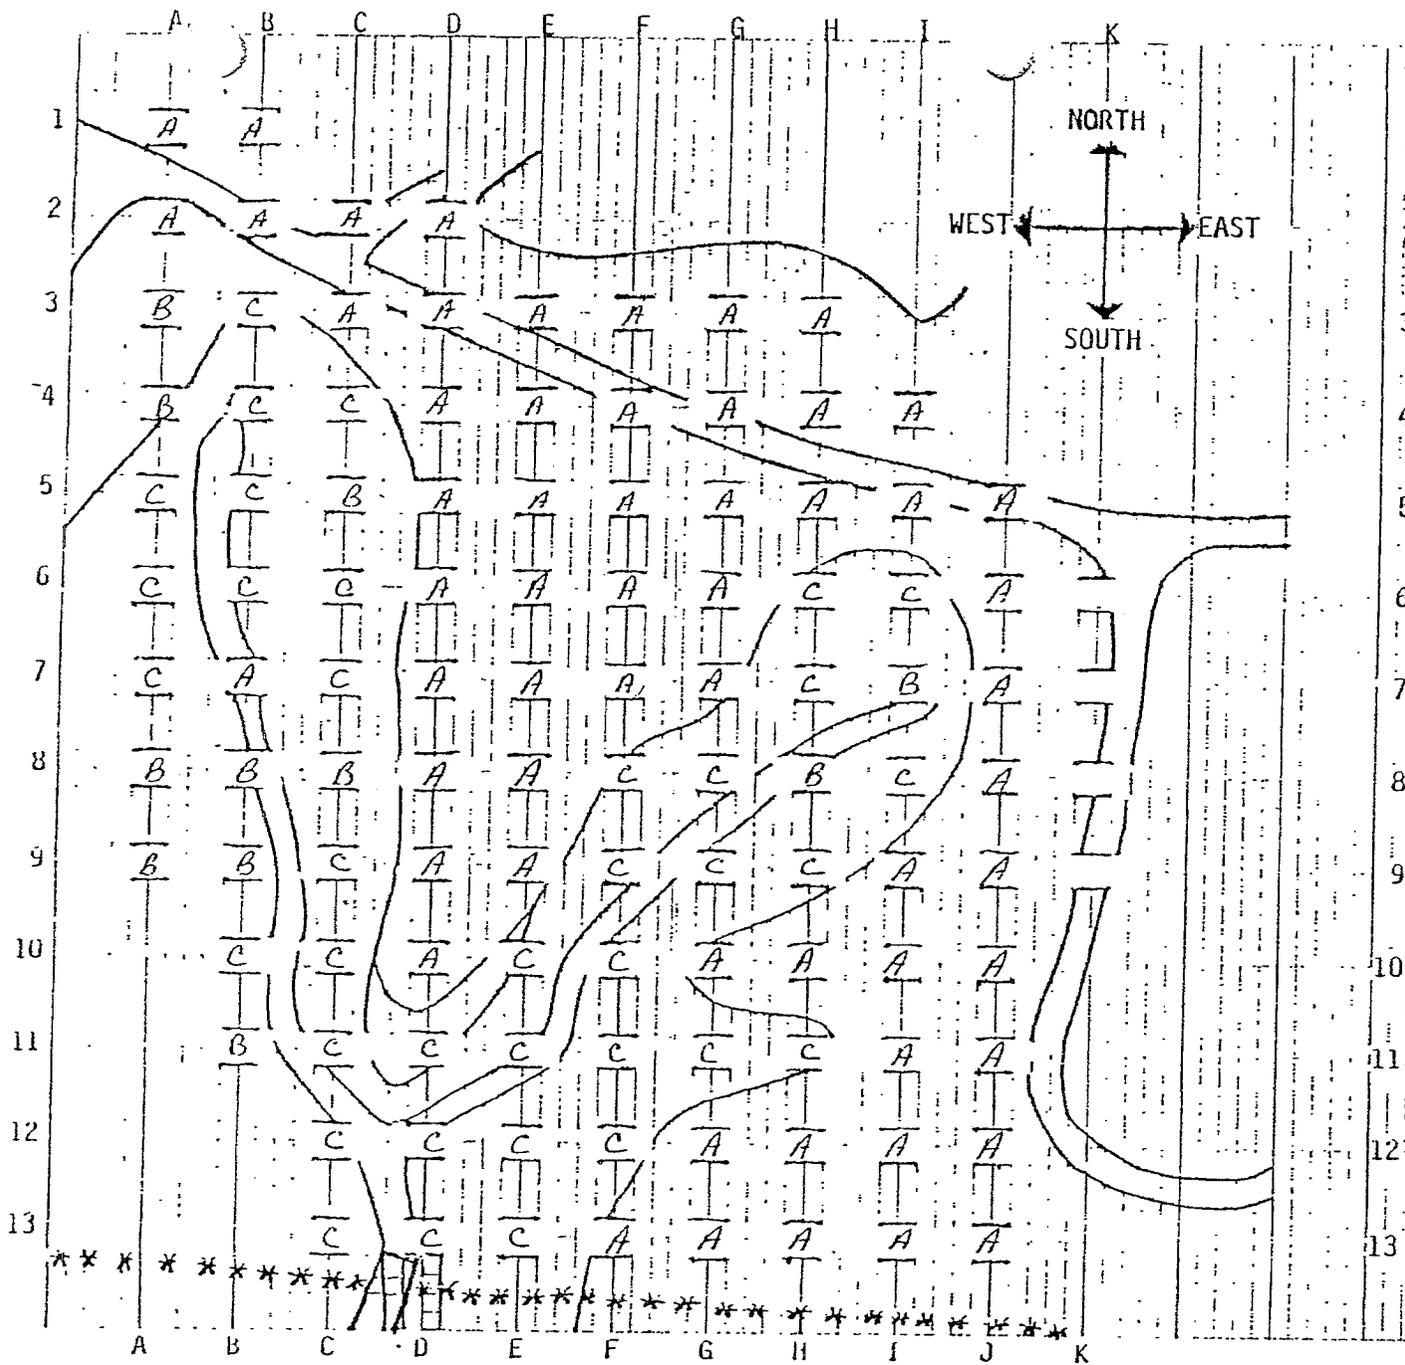
Figure 3
 Angle of Inclination

Finally, Figure 3 depicts the area as to the incline of the soil surface incline encountered at each survey point. Initially this dat was collected to yield a possible understanding of the potential transport mechanism of any radioactive material found at the survey site. This information was also most helpful in making the contours shown as accurate as possible in light of the obviously rude direction and measurement techniques used to select the survey points.

- A - 0-20°
- B - 20-30°
- C - > 30°
