| TITLE | LE PHIPPS BEND NUCLEAR PLAN'T GEOLOGIC FOUNDATION REPORT FAULT DESCRIPTIONS | | | | REPORT NO. CEB 81-47 PLANT/UNIT PBN SAR SECTION(S) 2.5.2 | | |

TENNESSEE VALLEY AUTHORITY

PHIPPS BEND NUCLEAR PLANT GEOLOGIC FOUNDATION REPORT DESCRIPTION OF FAULTS 1-29

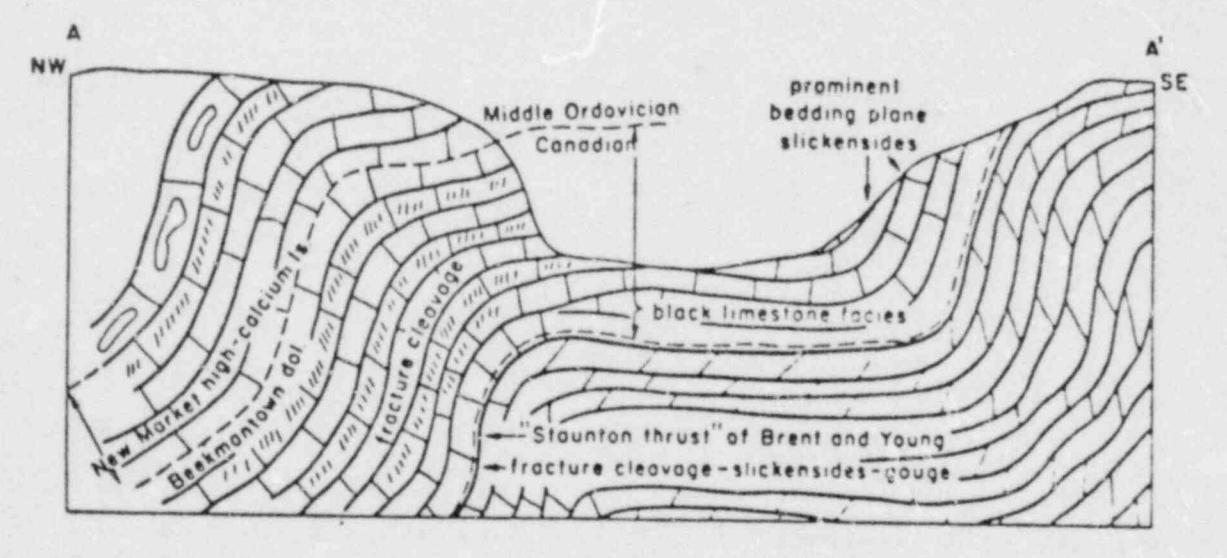
Figure 3. Cross section of Betts Quarry near Harrisonburg, Virginia, showing typical occurrences of shear fracture cleavage and slickensides associated with folding and faulting. From W. D. Lowry, 1971.

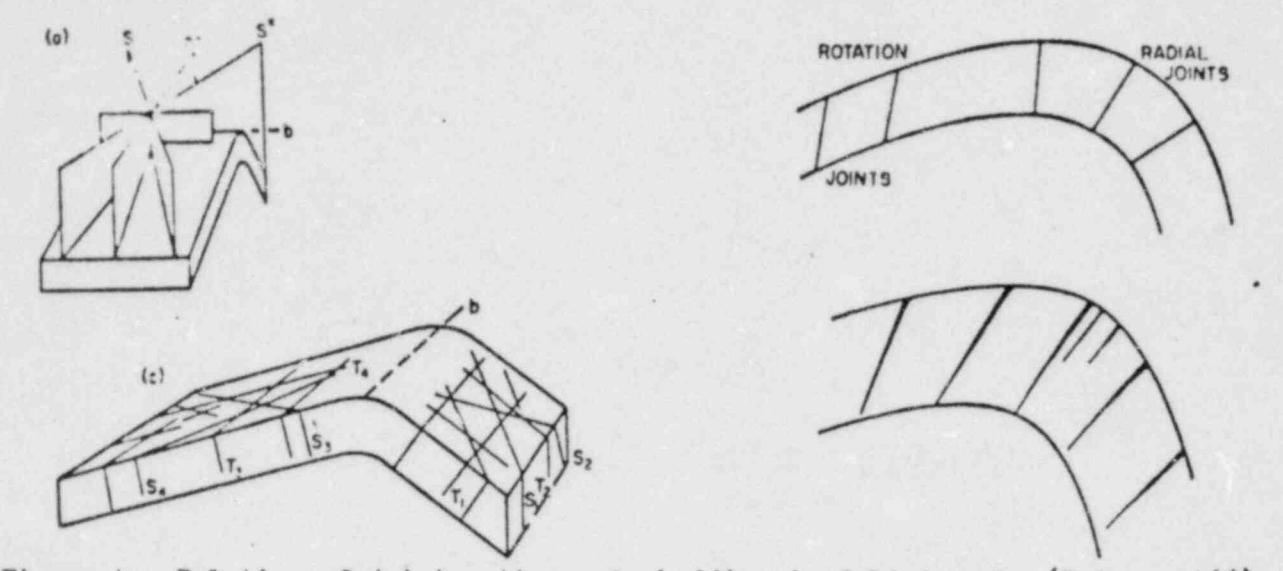
Figure 4. Relation of joint patterns to bedding in folded rocks (Price, 1966). Diagrams at left show 3-D view of shear joints (labelled S₁, S', etc.) and tension joints (labelled T₁, T₂, etc.). The diagrams at the right show radial joints and rotation joints (labelled at top), and axial plane joints filled by mineral deposits (lower diagram).

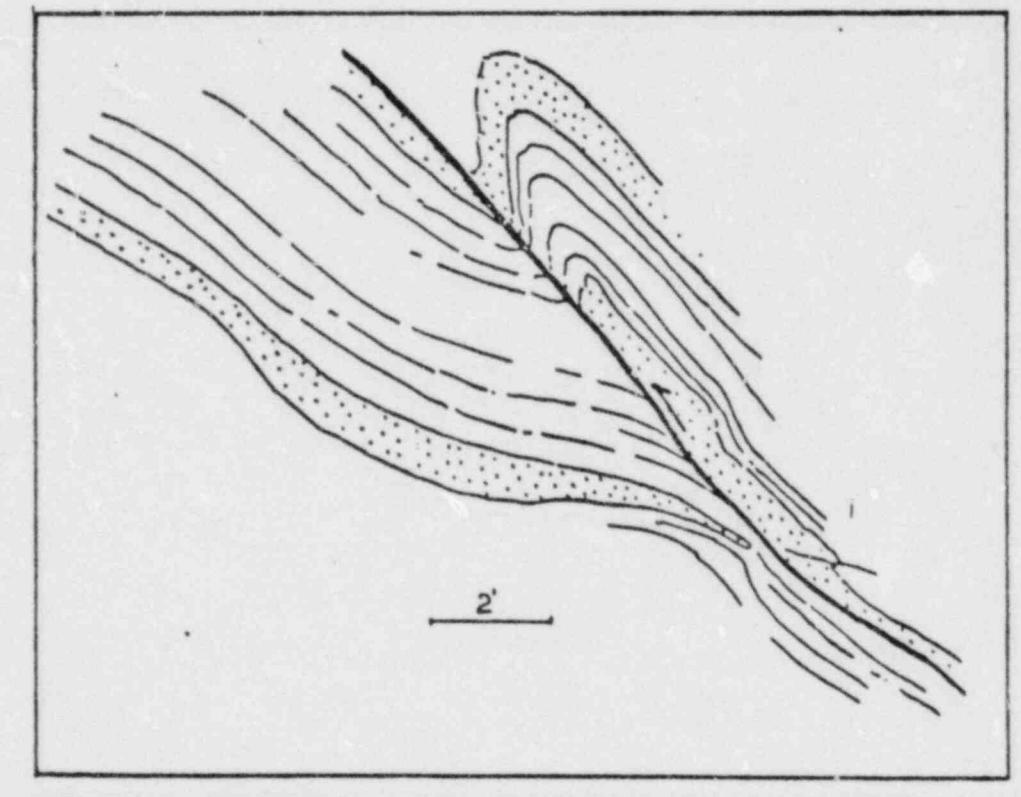
Figure 5. Wedge and fold. Lower sandstone is wedged; upper sandstone, only folded. Wedge may have formed prior to folding because the order of magnitude is different. Road cut east of Hancock, Maryland, Catskill. From Cloos, 1964

Note the migration of the bedding plane fault across overlying bed by ramping.

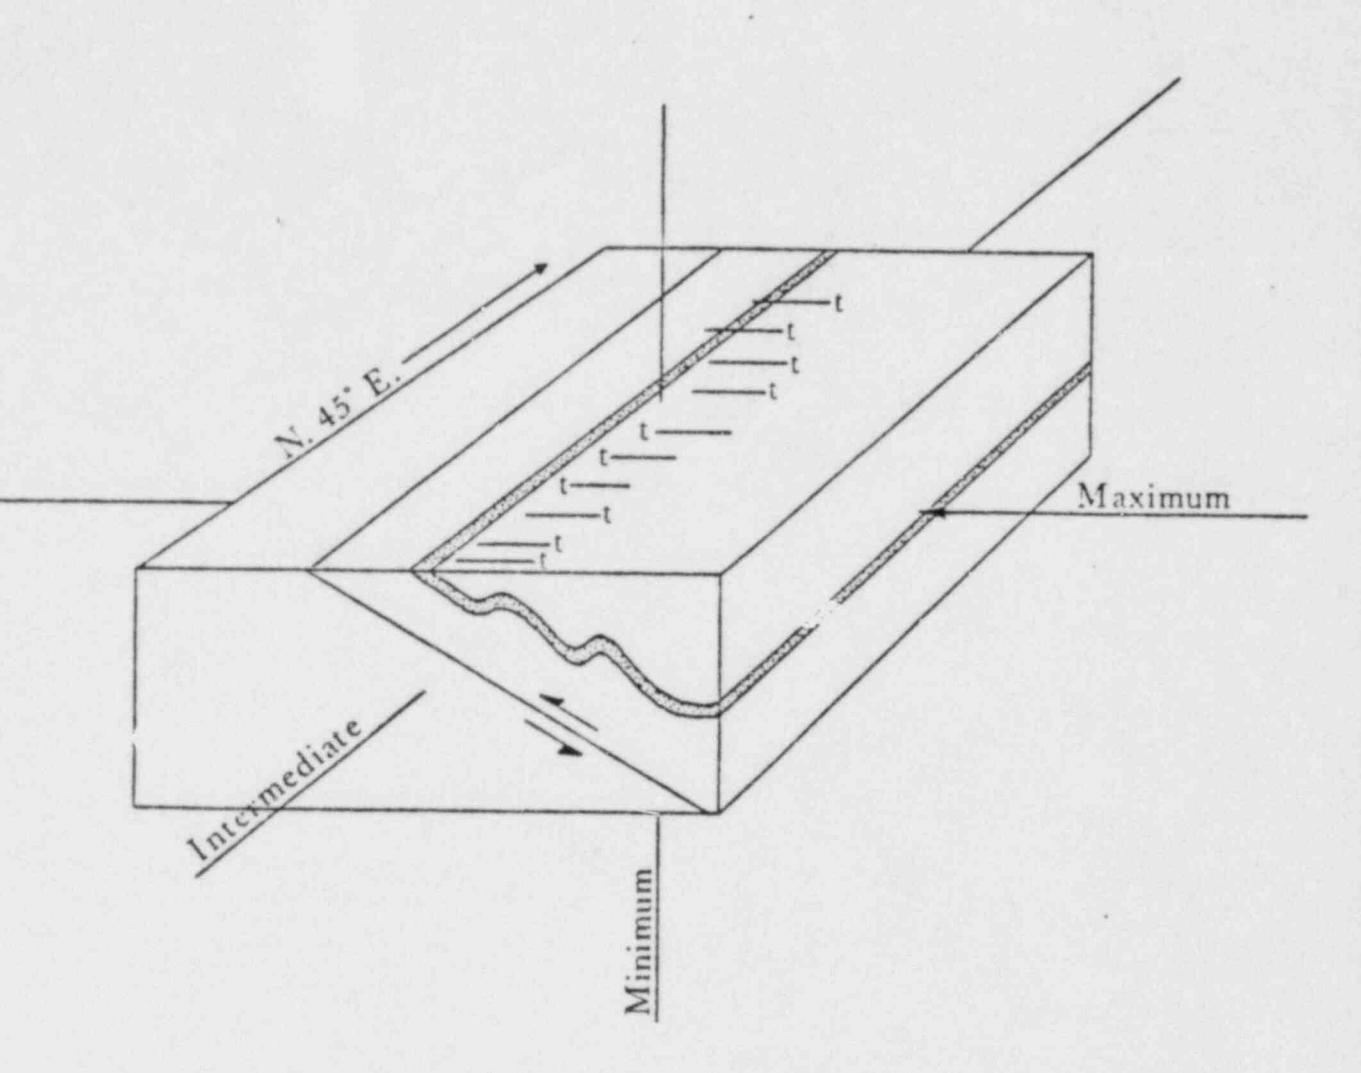
Figure 1. Orientation of stress axes compatible with structural features present in the Phipps Bend, Tennessee, area. Faults and folds are shown diagrammatically. Symbols: t = tensional fractures, arrows show relative motion of fault blocks, and axes are labelled. Modified isometric base distorts right-angle relations.

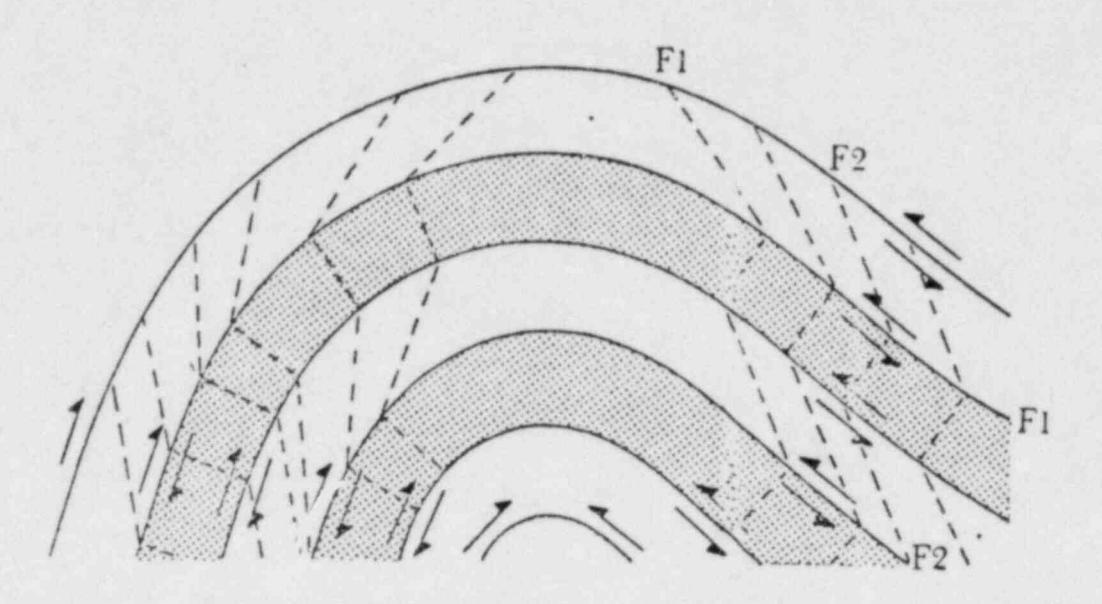
As sandier beds in the sequence are more competent to transmit stress than are the finer-grained shales, the shales are generally transected by more shear fractures that tend to be oriented at acute angles to bedding. Fractures in sandier beds tend to be oriented at nearly right angles to bedding. Thus, the bedding-to-fracture relationship illustrated in Fig. 2 is common.

Figure 2. Typical orientation, generalized, of fractures in interbedded shales and more competent sandy units. Arrows show relative movement directions along bedding planes during flexure folding; dashed lines, F1 and F2, show two examples of possible thrust fault trajectories. Stippled pattern shows sandy units; other units not marked are shaly beds.

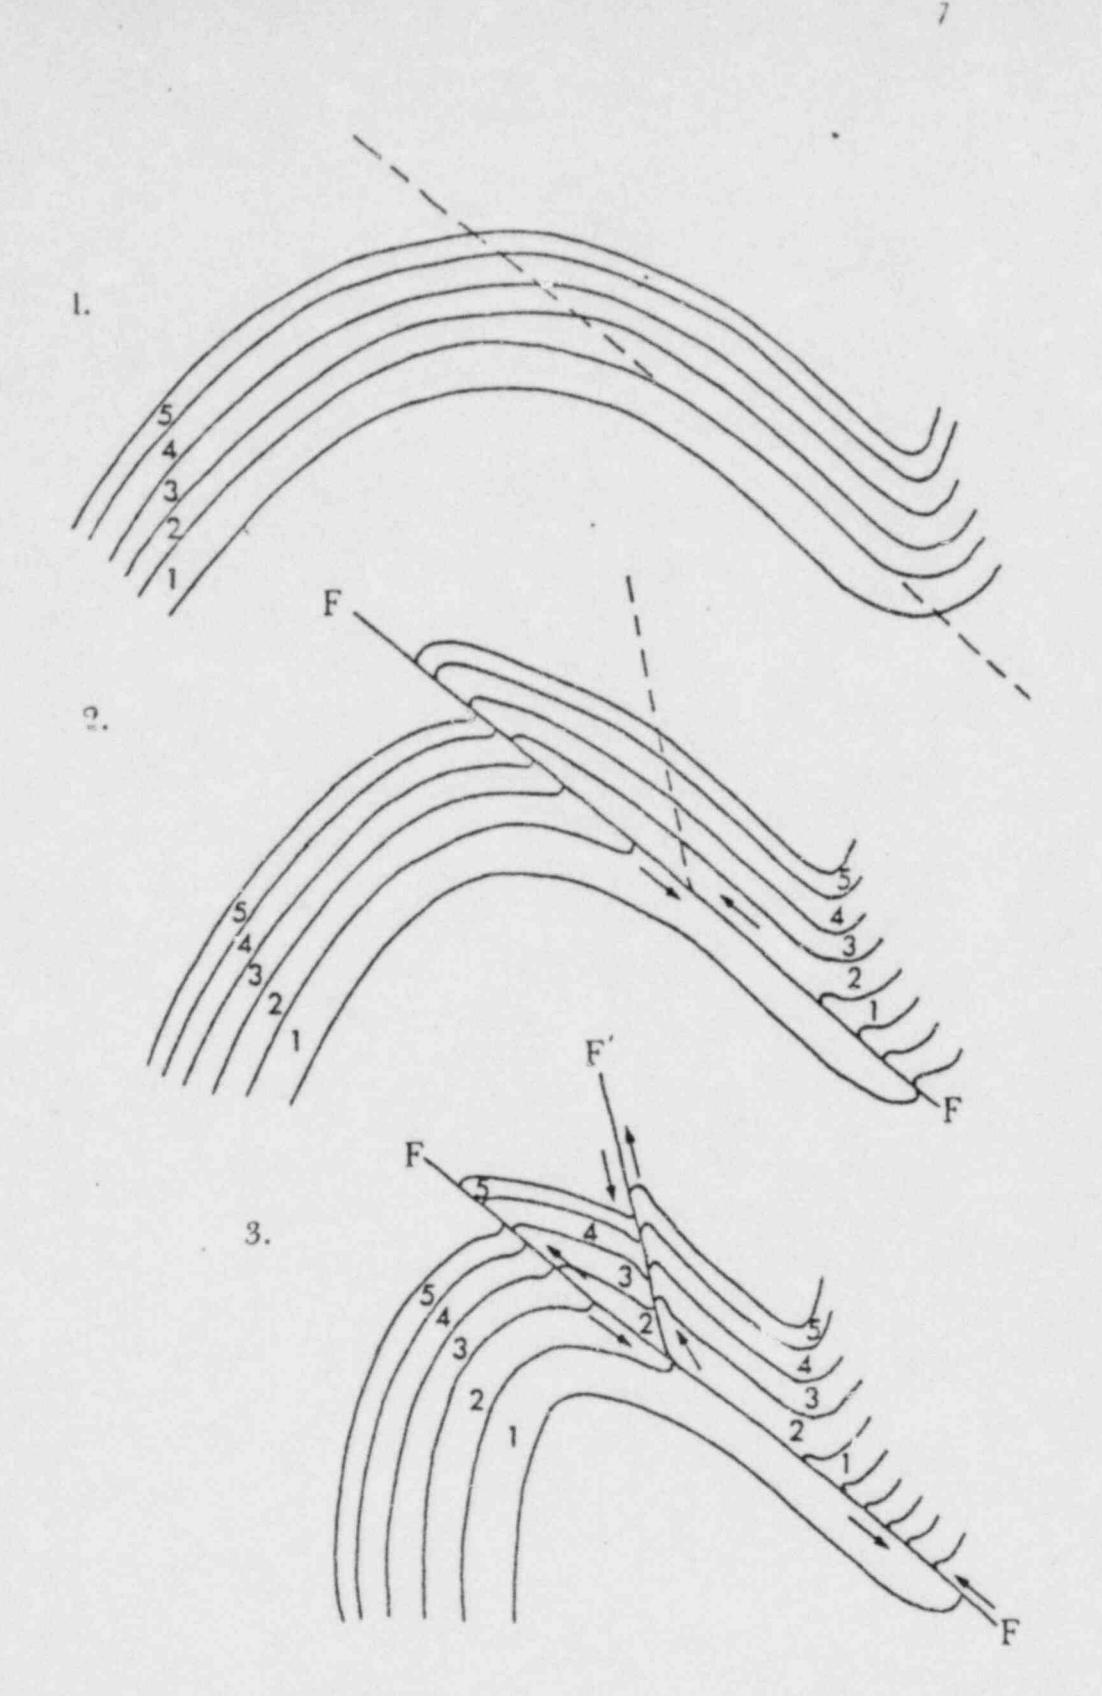
Plate 1 shows three stages in the evolution of faults and folding such as are present at the sites. Chronological order is indicated by numbers 1 -3 (oldest to youngest). Eventual lines of faulting are shown by dashed lines. Faults are labelled FF and F'. Beds are labelled 1 - 5 for purposes of showing displacement along faults. Note that as folding becomes progressively tighter, bedding plane thrust becomes imbricate as fault F' forms. Arrows show relative motions along faults. Note that bed 2 in the sequence on the hanging wall block is in apparent conformable sequence with respect to bed 1 of the fnotwall block in places where the bedding plane thrust occurs. However, the imbricate block in stage 3 has considerably more structural discordance across the fault.

Plate 1. Development stages in formation of imbrication and variable stratigraphic displacement characteristic of the Phipps Bend area. Note crumpling and faulting that occur as partial hinge collapse occurs. FF and F' show faults; arrows indicate movement directions.

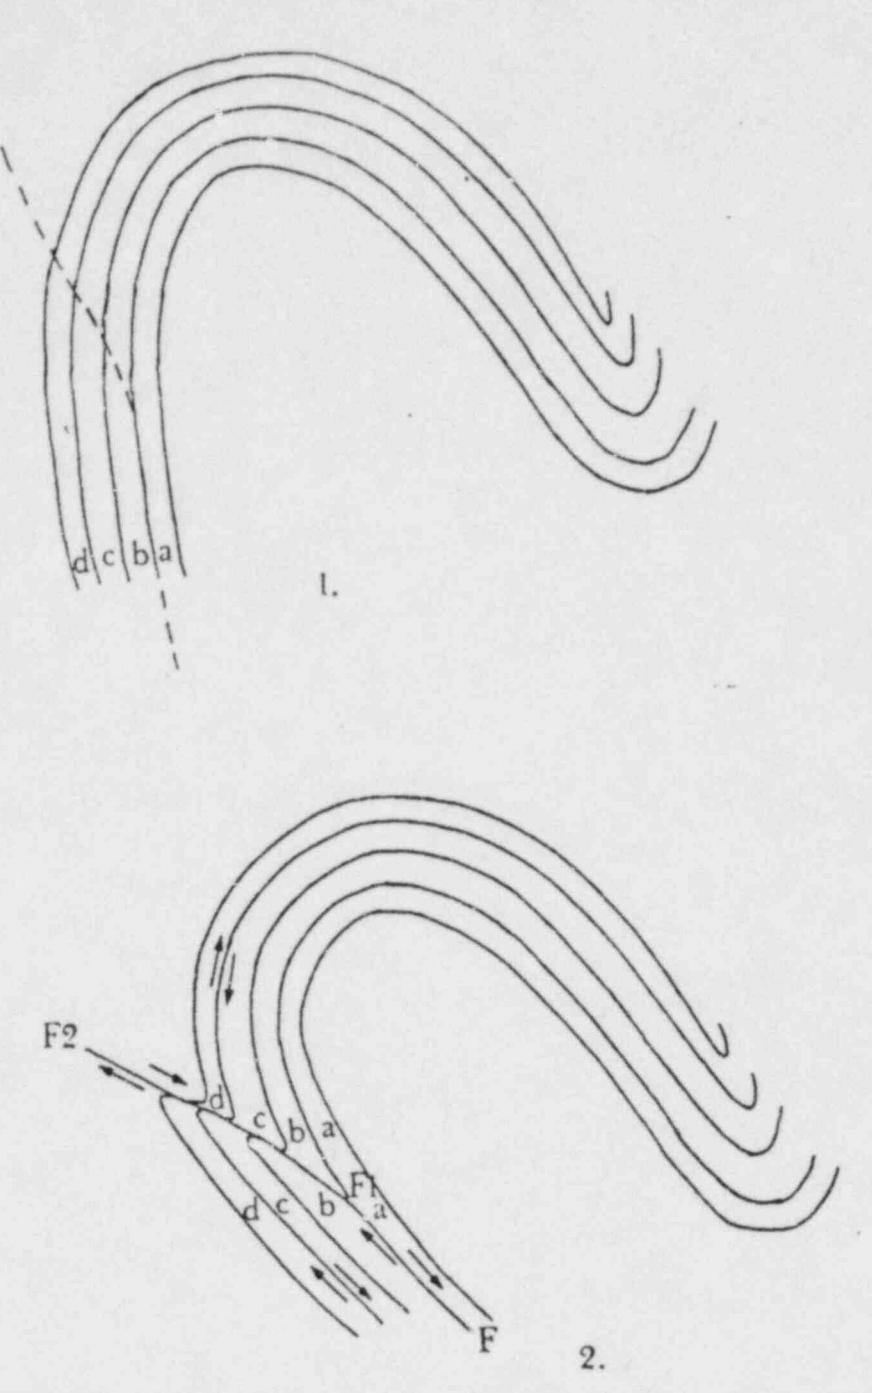
Plate 2. Orientation of oblique-shear and bedding-plane slip surfaces associated with development of strong asymmetry of folds. Top sketch, numbered 1, is initial stage while number 2 sketch is later faulted stage. Note that from F to F1 fault is overturned thrust parallel to bedding and that from F1 to F2 the fault is oblique to bedding. Letters a - d on beds are for matching purposes.

Plate 2 illustrates an initial and final stage in the development of overturned bedding-plane and oblique-shear thrust faults that have an apparent "normal" sense of motion. Note that as the fold becomes tighter the fault labelled F-F1-F2 develops along the line shown as a dashed line in sketch 1. The displacement along the fault progressively becomes more pronounced as the fault becomes collique to bedding between F1 and F2.
