Subject: Preliminary Case Study Report on Solenoid Valve Problems at U.S. Light Water Reactors

Page
EXE	CUTIVE		Y		vii
12345	INTR DESC USE SOLE OPER FAIL	CODUCTION CRIPTION OF SOLE NOID-OP CATING EL URES OR	OF EQUIP NOID-OPER ERATED VA XPERIENCE DEGRADAT	MENT ATED VALVES (SOVS) LVE FAILURE MODES: APPARENT AND ROOT CAUSES : SIGNIFICANT EVENTS INVOLVING COMMON-MODE IONS OF SOVS	1 3 8 10 11

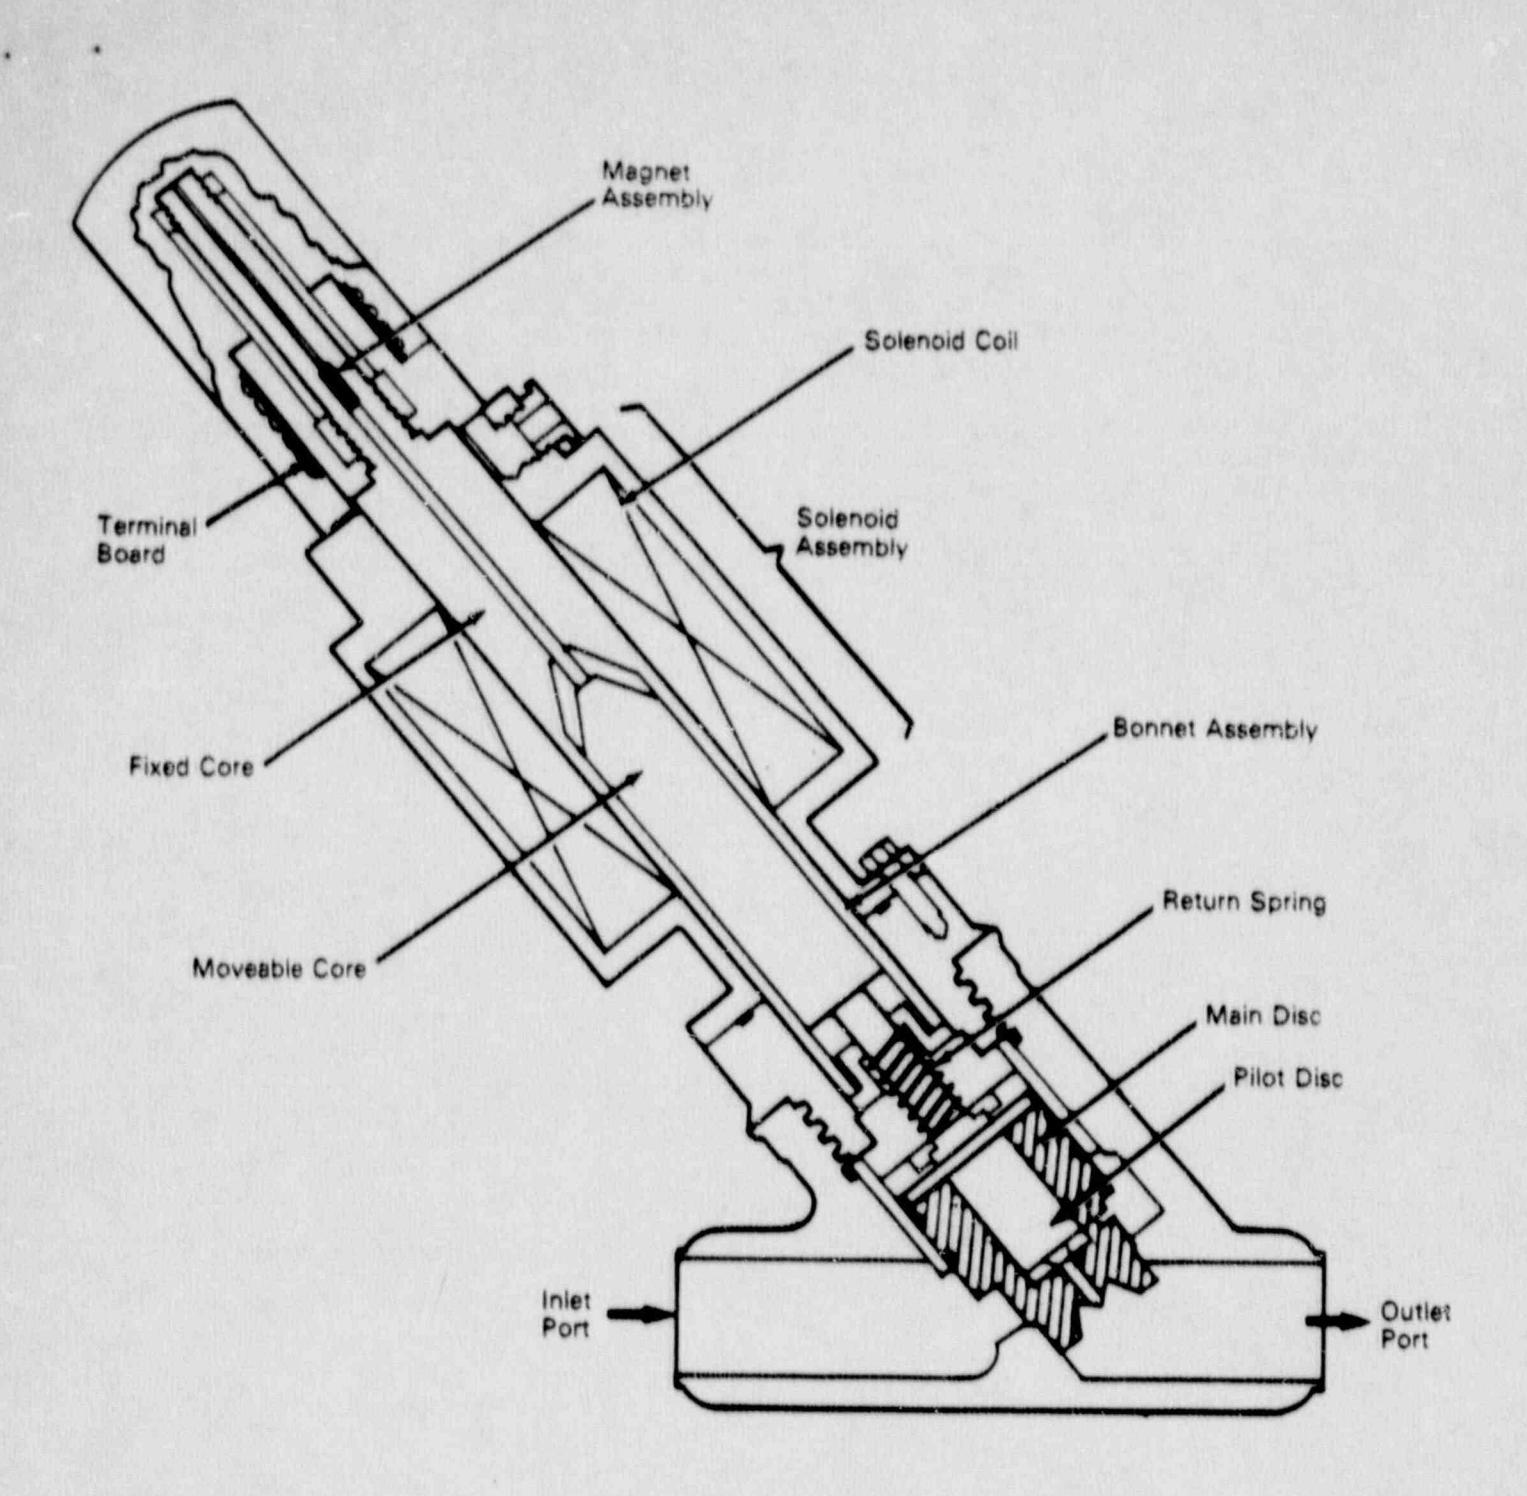
Figure 4 Schematic Drawing of a Target Rock Pilot Assisted Solenoid Operated Valve

shift position upon de-energization were attributed to an amber-colored residue inside the SOVs. The residue was found at the location where the SOV core assembly (plug) contacts the SOV body (solenoid base sub-assembly) see Figure 4. The failed SOVs had been in service about 18 months prior to their failure. The local ambient temperature was about 110°F. The licensee inspected two other ASCO NP8314 SOVs from the same manufacturing lot which were installed adjacent to the three SOVs that had failed. They had been installed at the same time as the ones that failed, but were operated in the de-energized mode. The de-energized SOVs had performed satisfactorily.
