14-DAY REPORT OF A "REPORTABLE EVENT"  
CONCERNING AN INADVERTENT MODIFICATION OF THE  
UNIVERSITY OF VIRGINIA REACTOR CONSOLE

Robert U. Mulder, Director  
U.Va. Reactor Facility

May 12, 1993

14-DAY REPORT OF A "REPORTABLE EVENT"  
CONCERNING AN INADVERTENT MODIFICATION OF THE UVAR CONSOLE

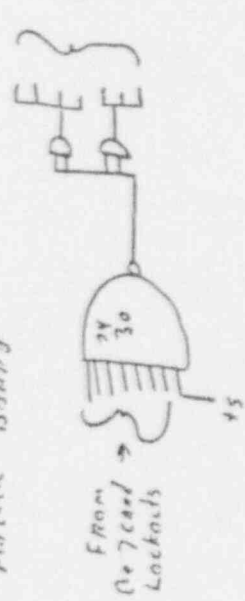
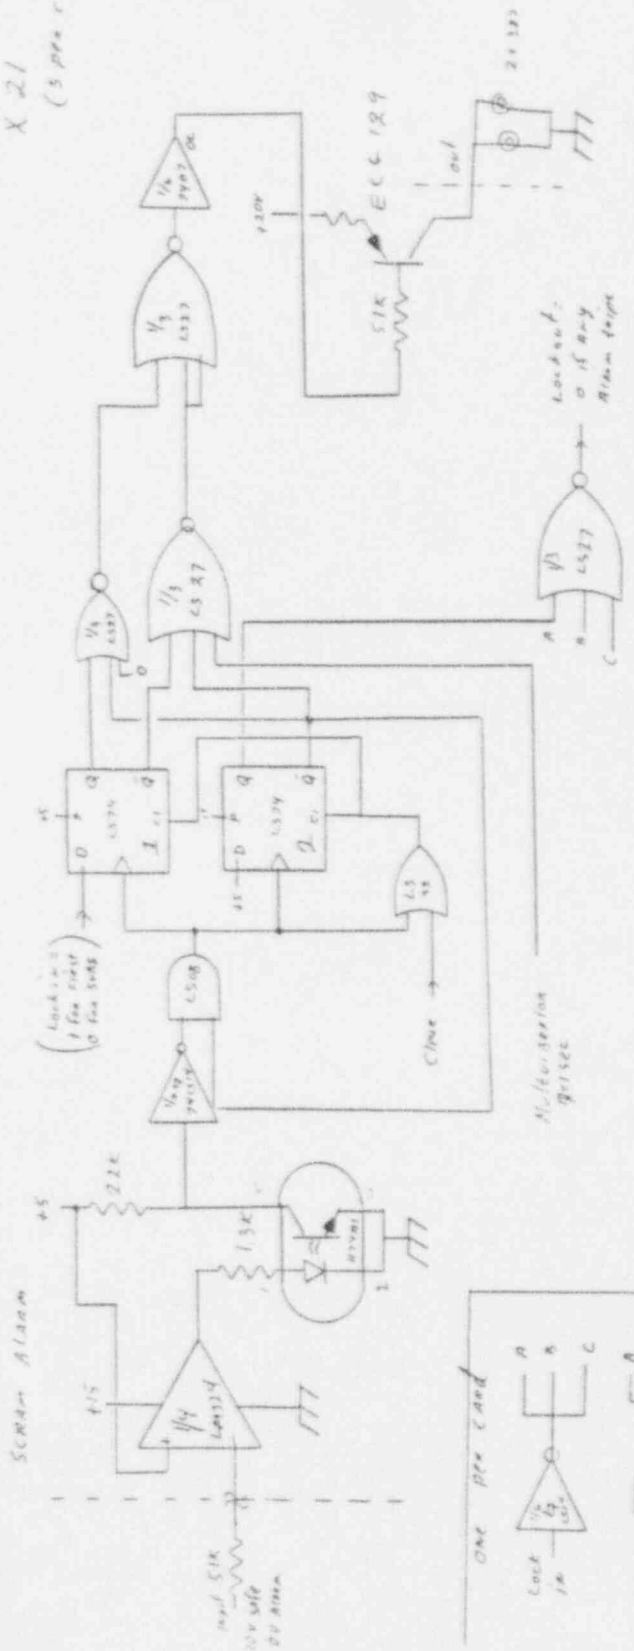
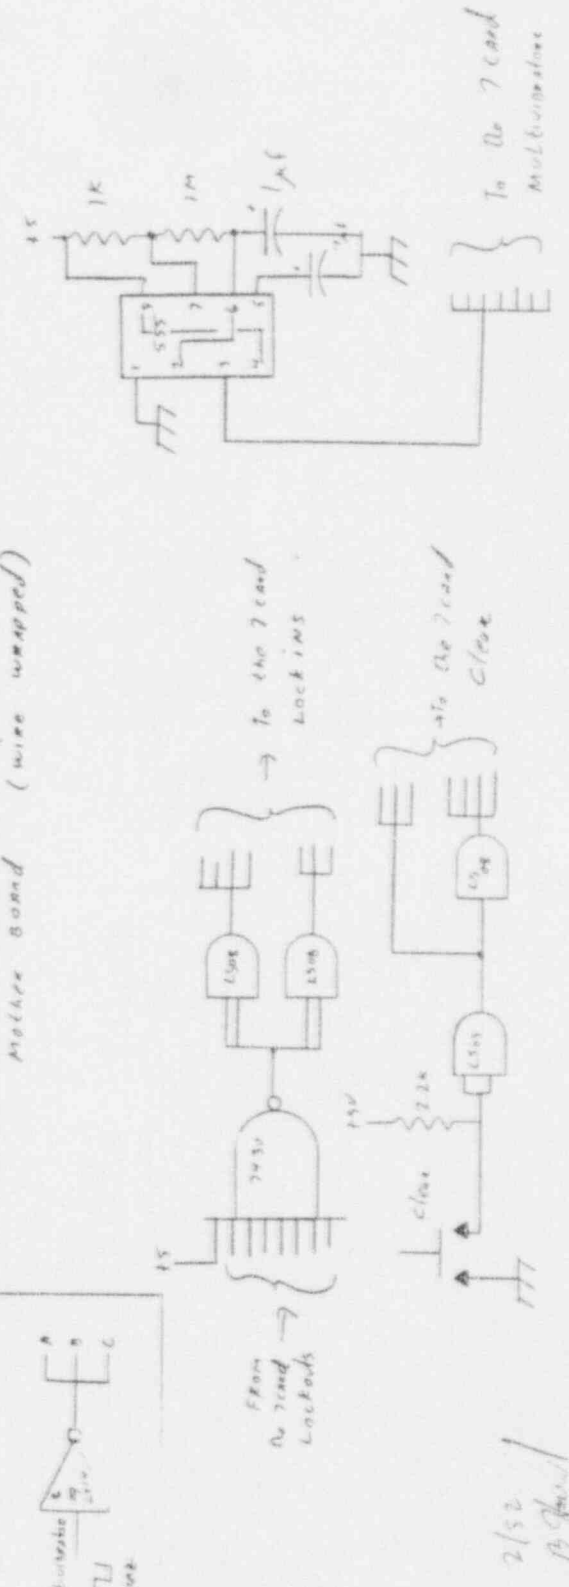
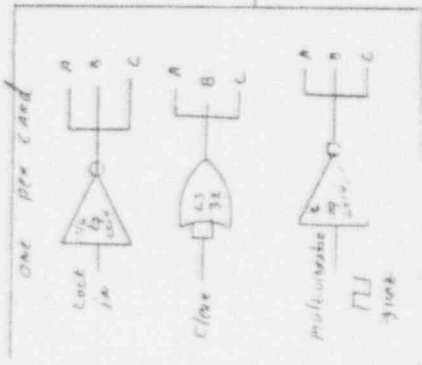
FIGURE III-16 AUXILIARY SCRAM SYSTEM

input impedance of  
 MIXER DRIVER  $\approx 1.1K \Omega$   
 Valley comparison  $\approx 1.79 \Omega$   
 Isolation resistors =  $50K \Omega$

Mixer Board  
 FROM (To 7 card Lockouts)  
 TO (To 7 card Lockout)

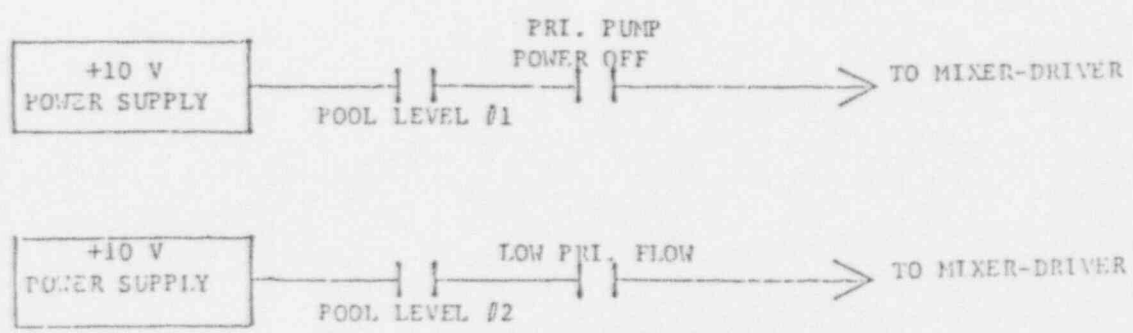
FIGURE III-14 SCRAM LOGIC DRAWER

DUAL PRIMARY SCRAMS
