COMMONWEALTH EDISON COMPANY

QUAD-CITIES STATION

REACTOR WATER CLEAN-UP SYSTEM

TEMPORARY REPAIR OF

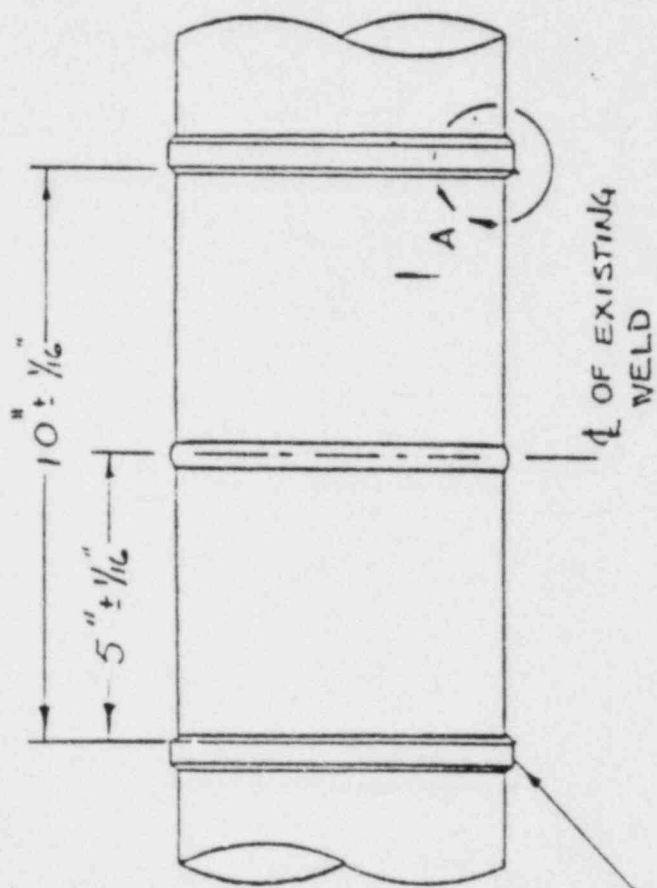
FIGURE 1A

The circumferential flaw repair (Figures 1A, 1B, and 1C) uses a low carbon stainless steel sleeve around the flawed weld extending approximately six inches on either side. The sleeve is machined from wrought material; and is split and welded around the pipe using full penetration welds. The sleeve ends are welded to the pipe using partial penetration welds with

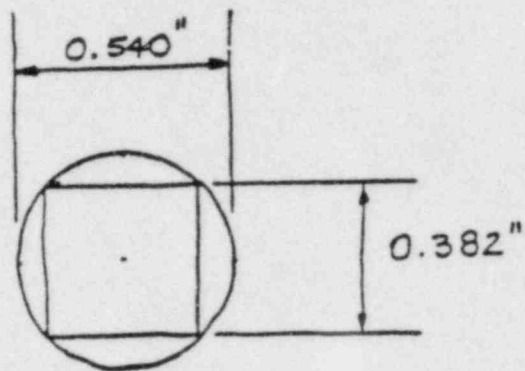
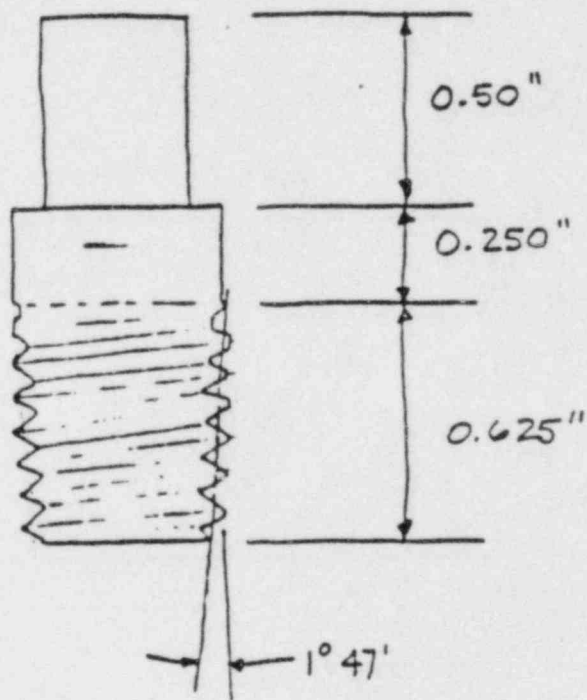
FIGURE 1 D

cover fillets. The sleeve allows space for the existing weld crown. An 1/8 inch hole is drilled in the 6 inch pipe through a 1/4 inch threaded hole in the sleeve. This hole provides an unobstructed pathway to the annulus from the inside of the pipe to prevent excessive pressure buildup in the annulus due to a postulated flow path through the pipe crack. A threaded 1/4 inch plug is seal welded into the sleeve. The plug is shown in Figure 1D.

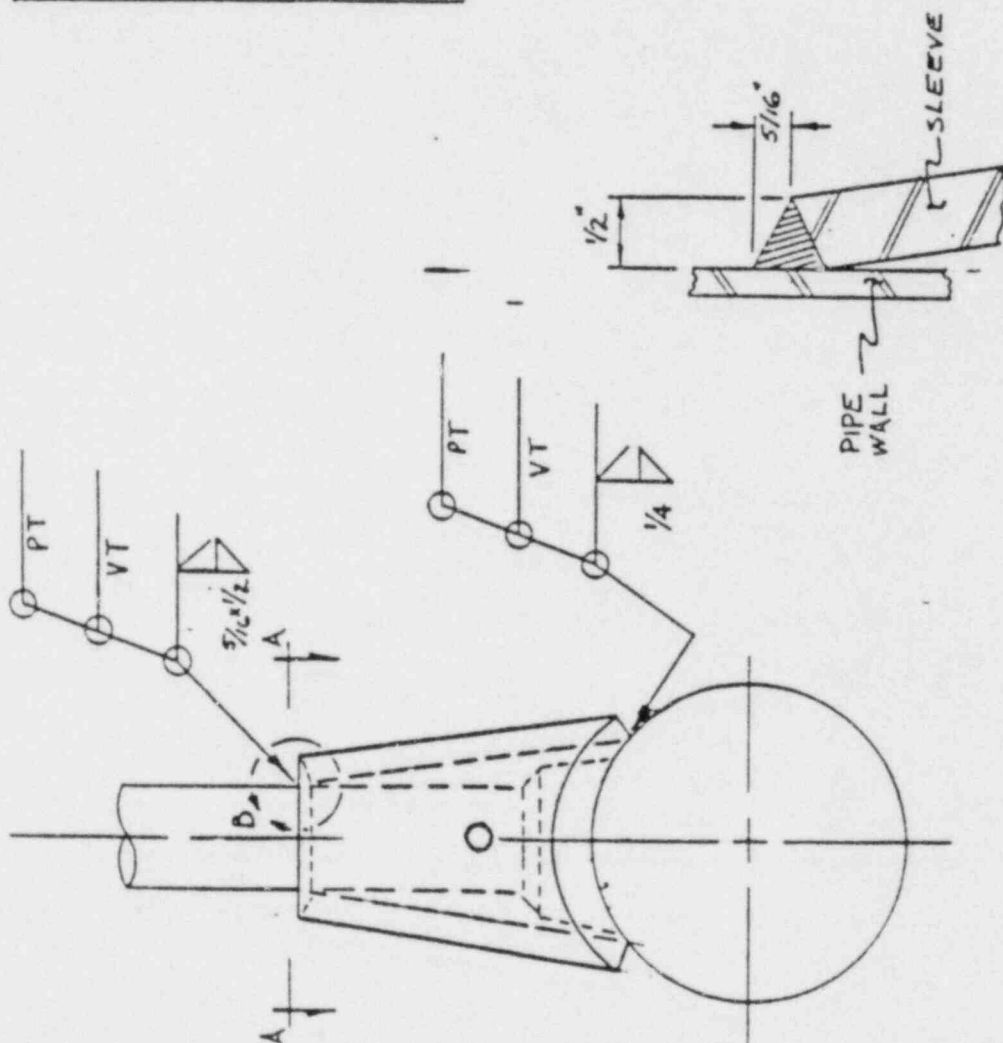
FIGURE 3B

A cone-shaped sleeve is provided around the sock-o-let connecting the two-inch drain line to the six-inch RWCU line. This repair is shown in Figure 3A and 3B. A 1/4 inch threaded hole is provided in the sleeve. It was originally intended to drill an 1/8 inch hole through the 1/4 inch hole into the two inch line, but this was not done due to the extreme likelihood that no crack existed in the first place. A 1/4 inch plug had been machined, and it is located in the QA storage area in the storeroom for future use, if necessary.

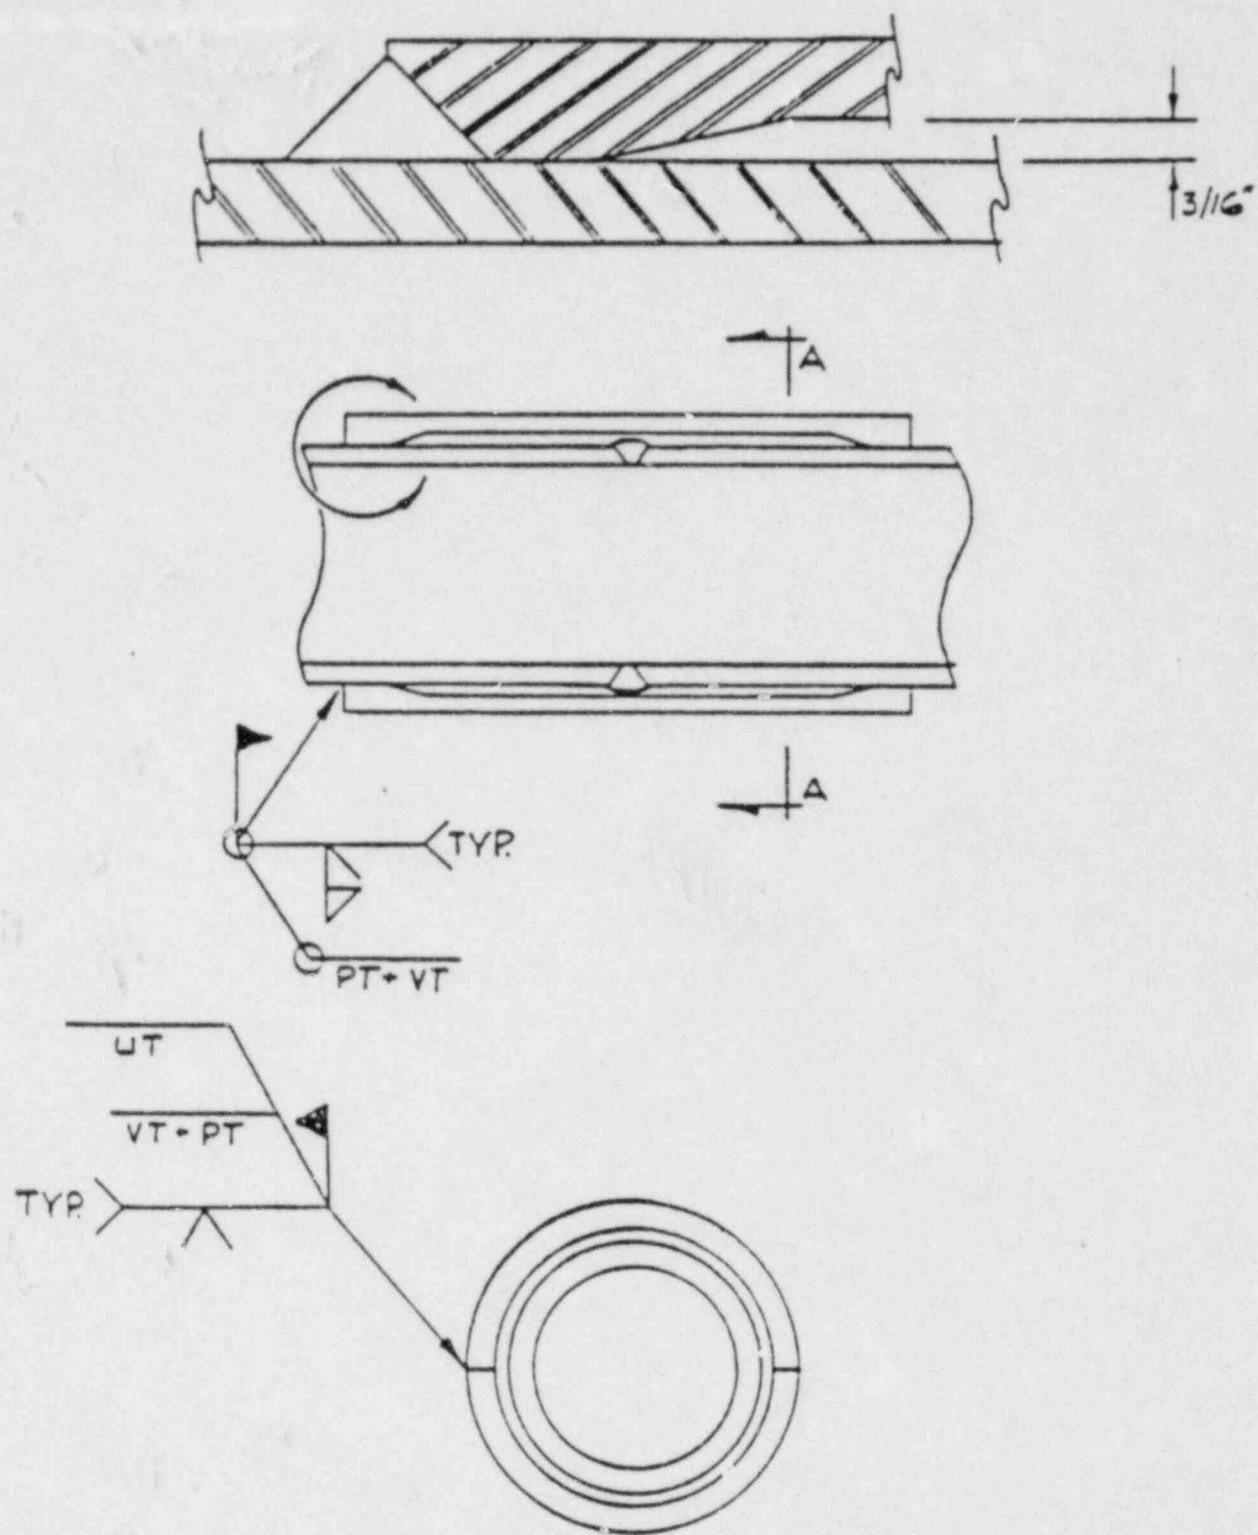
FIG. 1

The pipe to pipe joint F6 containing the circumferential crack indication will be repaired using a sleeve as shown in Figure 1. The sleeve will provide an independent pressure boundary around and to either side of the existing weld F6. Partial penetration welds as shown in Fig. NB-4244(d)2

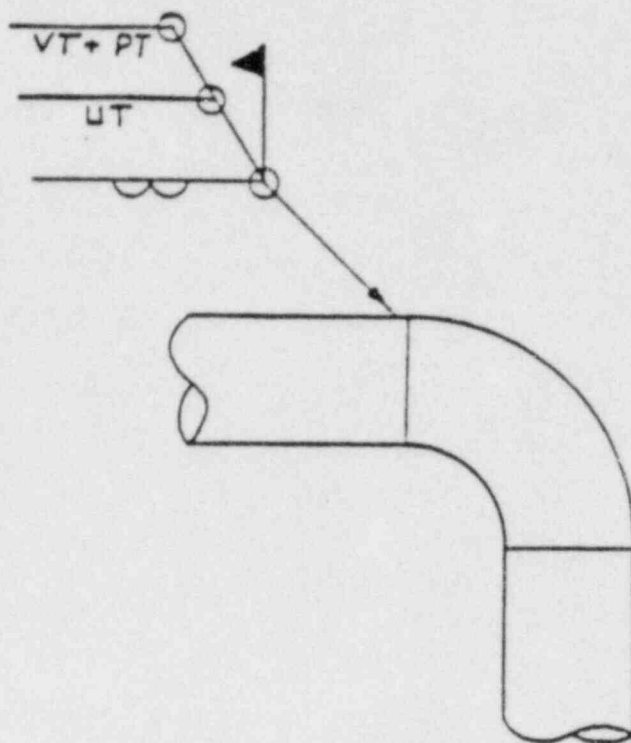
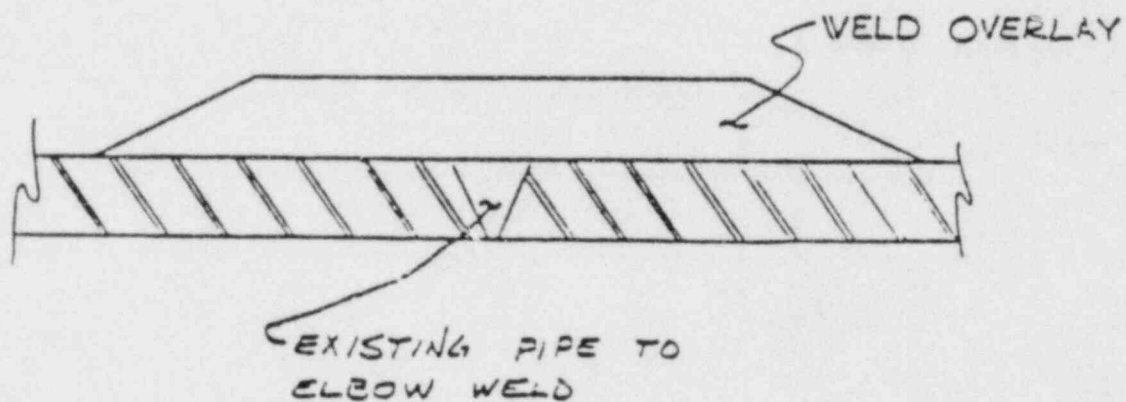
FIG. 2

The longitudinal crack indications in the elbows at joints S9, S10, and P12 will be repaired by depositing weld metal 360° around and to either side of the existing welds (Figure 2). The weld deposited bands will be approximately 6" long and 1/2" thick although final dimensions will be determined by stress analysis. The bands will provide pressure boundaries independent of the of the underlying original weld joints.

The weld deposited bands over the longitudinal crack indications are similar to sleeves and provide independent pressure boundaries around the existing welds. Longitudinal IGSCC cracks should not propagate significantly beyond the HAZ due to the absence of sensitization and the reduced weld residual stresses. The lengths of the longitudinal crack indications in the RWCU line are similar to those found in the investigation of the Quad-Cities Unit 2 core spray piping. The shrinkage of the weld metal during deposition of the bands is expected to produce compressive circumferential stresses in the underlying base and weld metal. Compressive residual stresses should mitigate propagation of the existing indications. Weld metal has proven to be highly resistant to propagation of IGSCC. Therefore even if the existing crack indications should propagate through wall, they would be arrested by the weld metal bands.

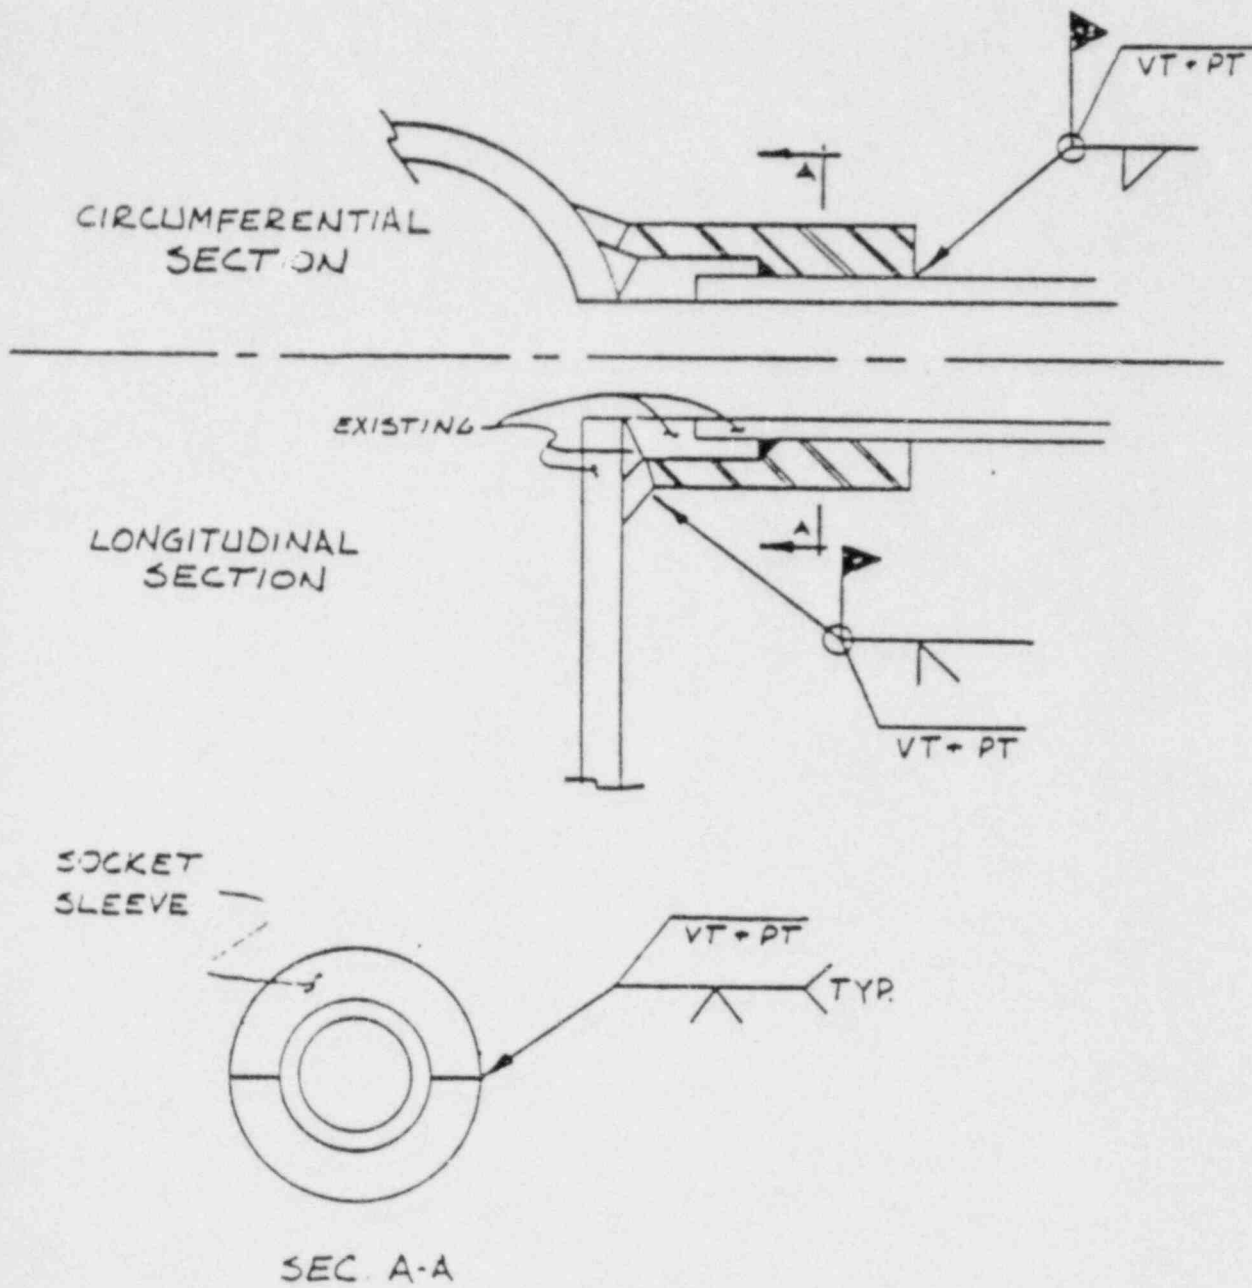
FIG. 3

The suspected leak in the 2" side of the sockolet will be repaired with a sleeve as shown in Figure 3. This sleeve similar to a standard type sockolet will provide an independent pressure boundary around the entire existing sockolet by attaching to the 6" RWCU line and to the 2" drain line above the sockolet.

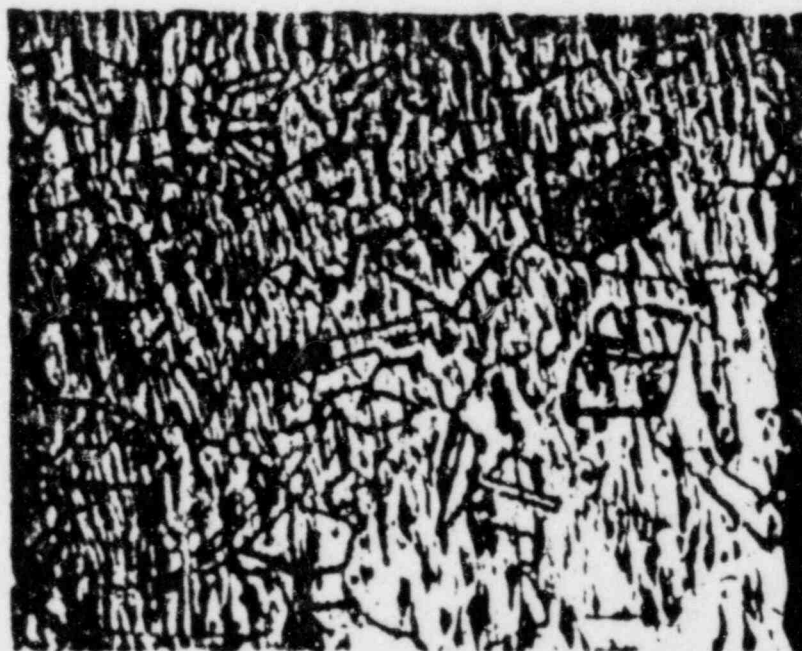
(200x) Figure 2 10% oxalic electrolytically  
Photomicrograph taken adjacent to the fusion line on the pipe side of the spool  
piece. No evidence of sensitization can be seen (stepped structure).

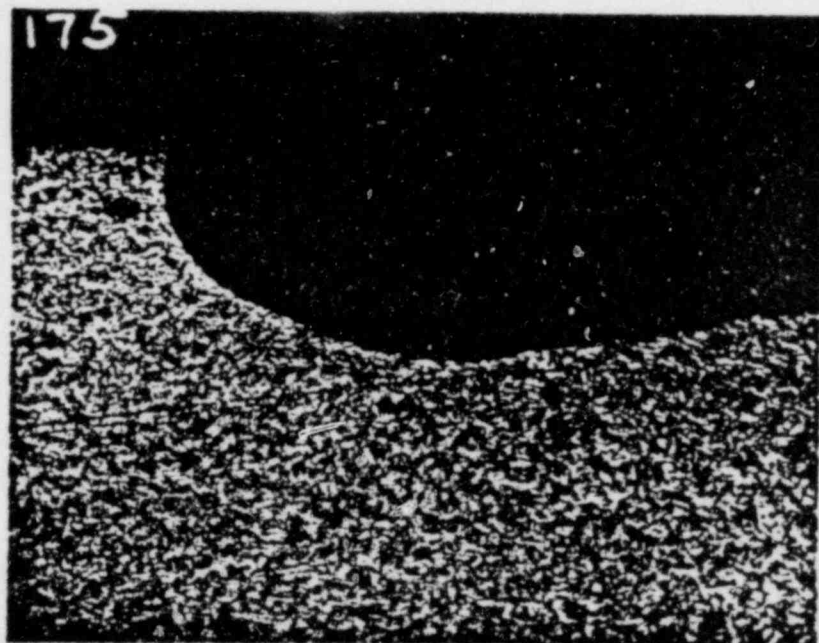
Figure 5

Measurements were made to determine the depth of penetration. Using worst case observations, a conservative approach, the average depth of penetration is 0.050 inches. Figures 5 and 6 are photomicrographs showing the depth of penetration at the toe of the pad weld on the pipe and elbow sides respectively.

Both photomicrographs depict the depth of penetration. As can be seen, the pipe (fig. 5) and elbow (fig. 6) sides of the spool piece, average 0.050 inches.
