SUBJECT: NRC REGION III AUGMENTED INSPECTION TEAM (AIT) REVIEW  
OF THE JULY 1 AND JULY 6, 1993, PALISADES FUEL HANDLING  
EVENTS

PALISADES BROKEN FUEL ROD AND STUCK FUEL ASSEMBLY

Areas Inspected: Augmented Inspection Team (AIT) inspection conducted in response to the broken fuel rod discovered on July 1, 1993, and the stuck fuel assembly event of July 6, 1993, at the Palisades Nuclear Plant. The review included validation of the sequence of events, evaluation of the licensee's failure mechanism determination and root cause analyses, review of the effectiveness of previous corrective actions associated with stuck assembly events, assessment of licensee's evaluation of potential precursors to the fuel rod failure, evaluation of ongoing refueling activities, assessment of the effectiveness of management involvement and the quality assurance organization related to these events, and evaluation of the licensee's corrective actions.

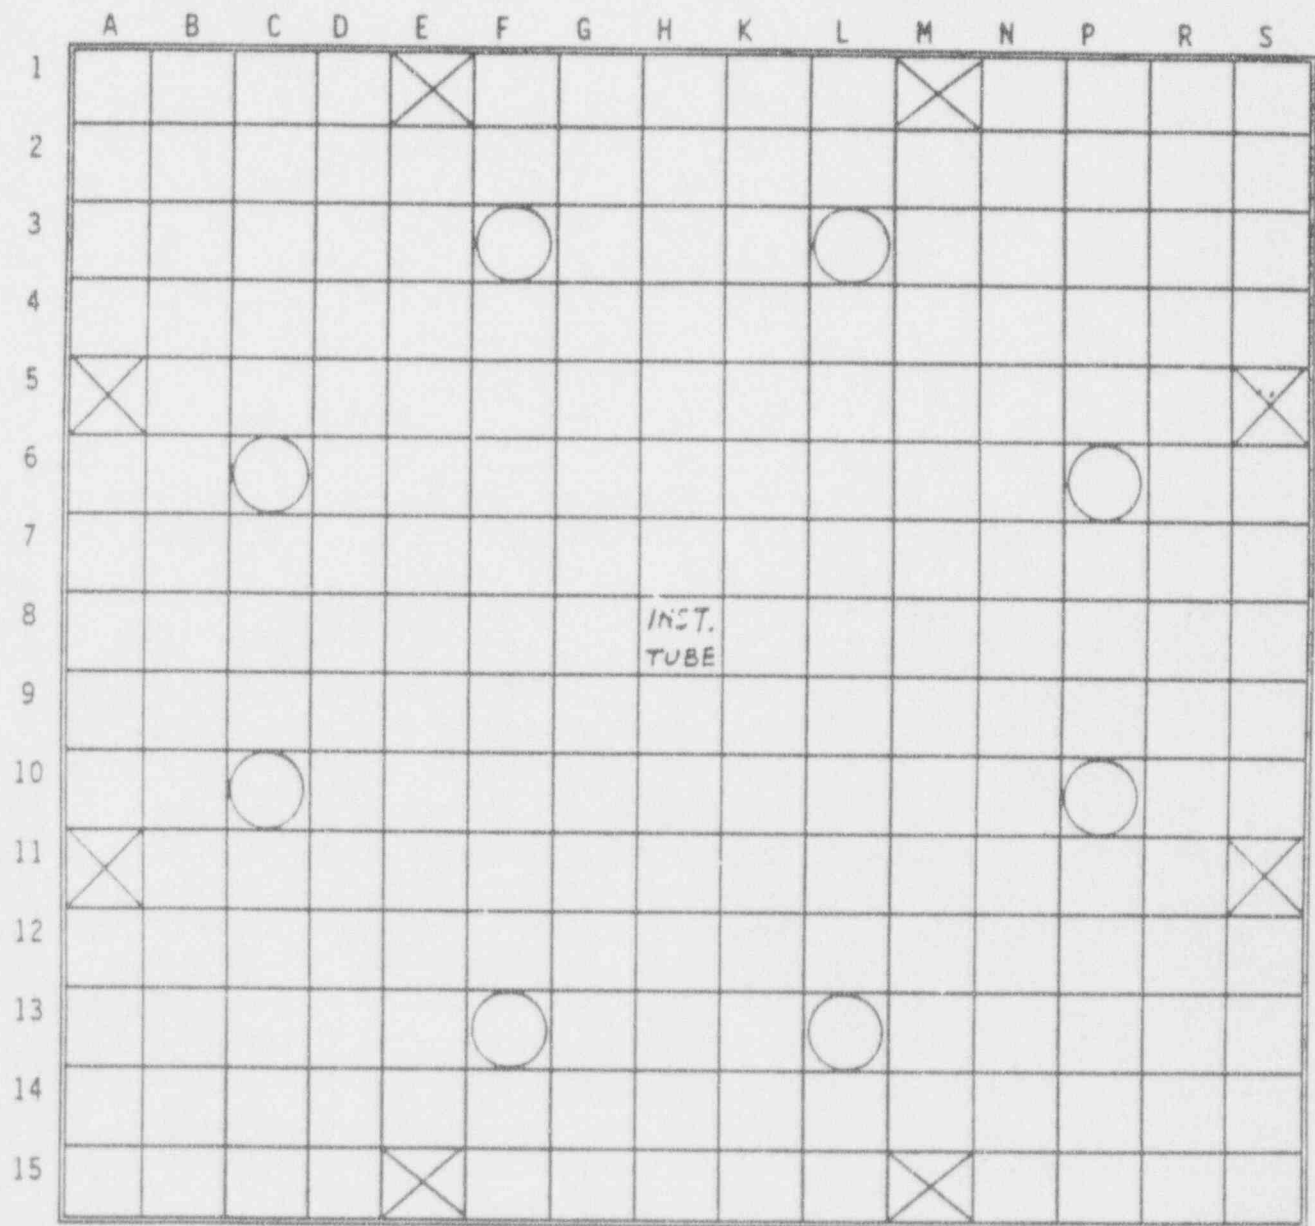
FIGURE 5  
PALISADES FUEL ASSEMBLY MAP

Fuel rod locations are shown in Figure 5. The fuel rod locations are identified starting with the upper left corner being A01, the upper right corner being S01, the lower left being A15 and the lower right being S15. The missing fuel rod from I-24 was from the S15 location. Figure 1 of this attachment shows the fuel rod locations that were tested and the results of the eddy current testing (ECT). The focus was on the corner locations and the fuel rods surrounding the corners. The licensee planned to examine the fuel rods adjacent to the missing fuel rod, but decided not to due to concerns about being able to return the fuel rods to these locations due to the severe damage to the spacers at these locations. The ECT showed wear indications on rod A08 that were attributed to the plenum spring. Fuel rod A15 had 14 or more wear indications from 0.007 to 0.009 inches deep. Fuel rod S01 had 10 or more wear indications 0.008 to 0.012 inches deep. Fuel rod S02 had several minor indications. All of the corner rods that showed wear indications had been located next to a corner location of the shroud for at least one cycle of operation. Corner rod A01 had never been in a corner location of the shroud and showed no wear. All of the wear indications are on the top 1/3 of the fuel rod.

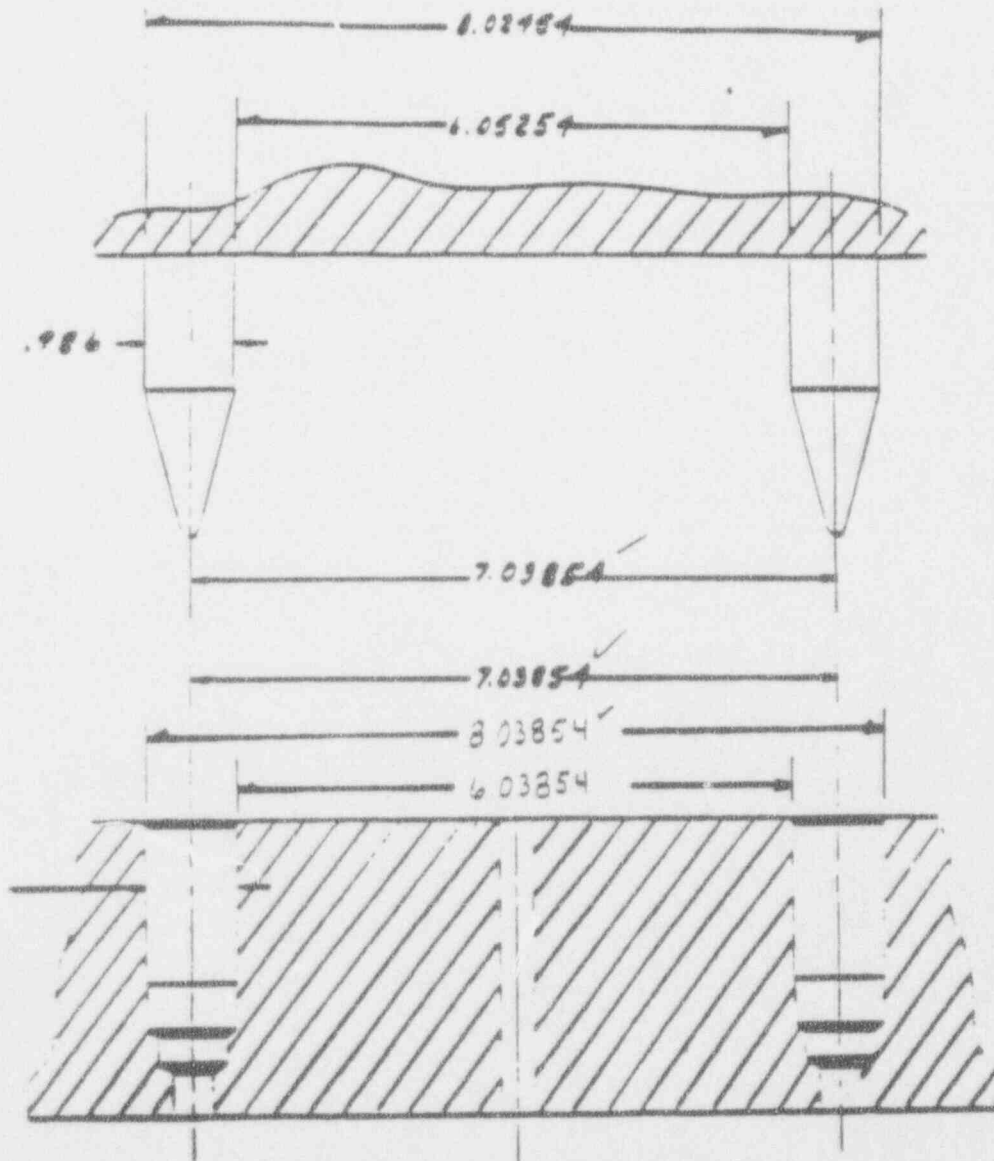
Configuration : Nominal Alignment An Tolerances  
 Nominal Tie Plate Tolerances

Clearance :  $8.03854 - 8.02454 = 0.014 = 6.05254 - 6.03854$

This represents a minimum clearance for the nominal  
 configuration. i.e. The tie plate is shifted all the way to  
 the side of the tie plate mating hole.

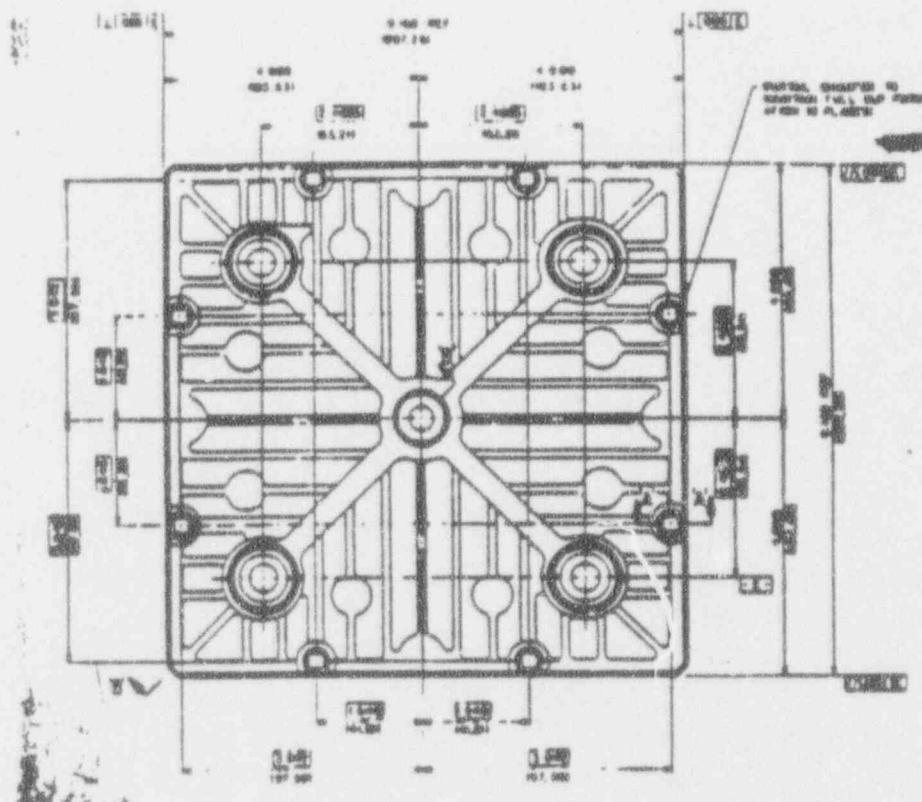
FIGURE 9  
UPPER TIE PLATE DIMENSIONS  
RELOAD M AND AFTER

Upper Guide Structure: The upper guide structure (UGS) consists of a flanged grid structure, 45 control rod shrouds, a fuel assembly alignment plate, and a ring rim (See Figure 8). The UGS aligns and supports the upper end (tie plate) of the fuel assemblies, maintains the control rod channel spacing, prevents the assemblies from being lifted out of position during a severe accident condition, and protects the control rods from the effect of coolant cross flow in the upper plenum. The UGS weighs approximately 57,000 pounds and is approximately 140 inches in both height and diameter. The fuel assembly alignment plate is designed to align the upper tie plates of the fuel assemblies. Each assembly is aligned by inserting the two diagonally positioned UGS fuel assembly alignment pins (See Figure 9) into the corresponding holes in the assembly upper tie plate (See Figure 10). All three stuck assembly events occurred at core location Z-11.
