SUBJECT: THE OPERATING REACTORS EVENTS MEETING  
 OCTOBER 10, 1990 - MEETING 90-25

OPERATING REACTORS EVENTS BRIEFING 90-25  
EVENTS ASSESSMENT BRANCH

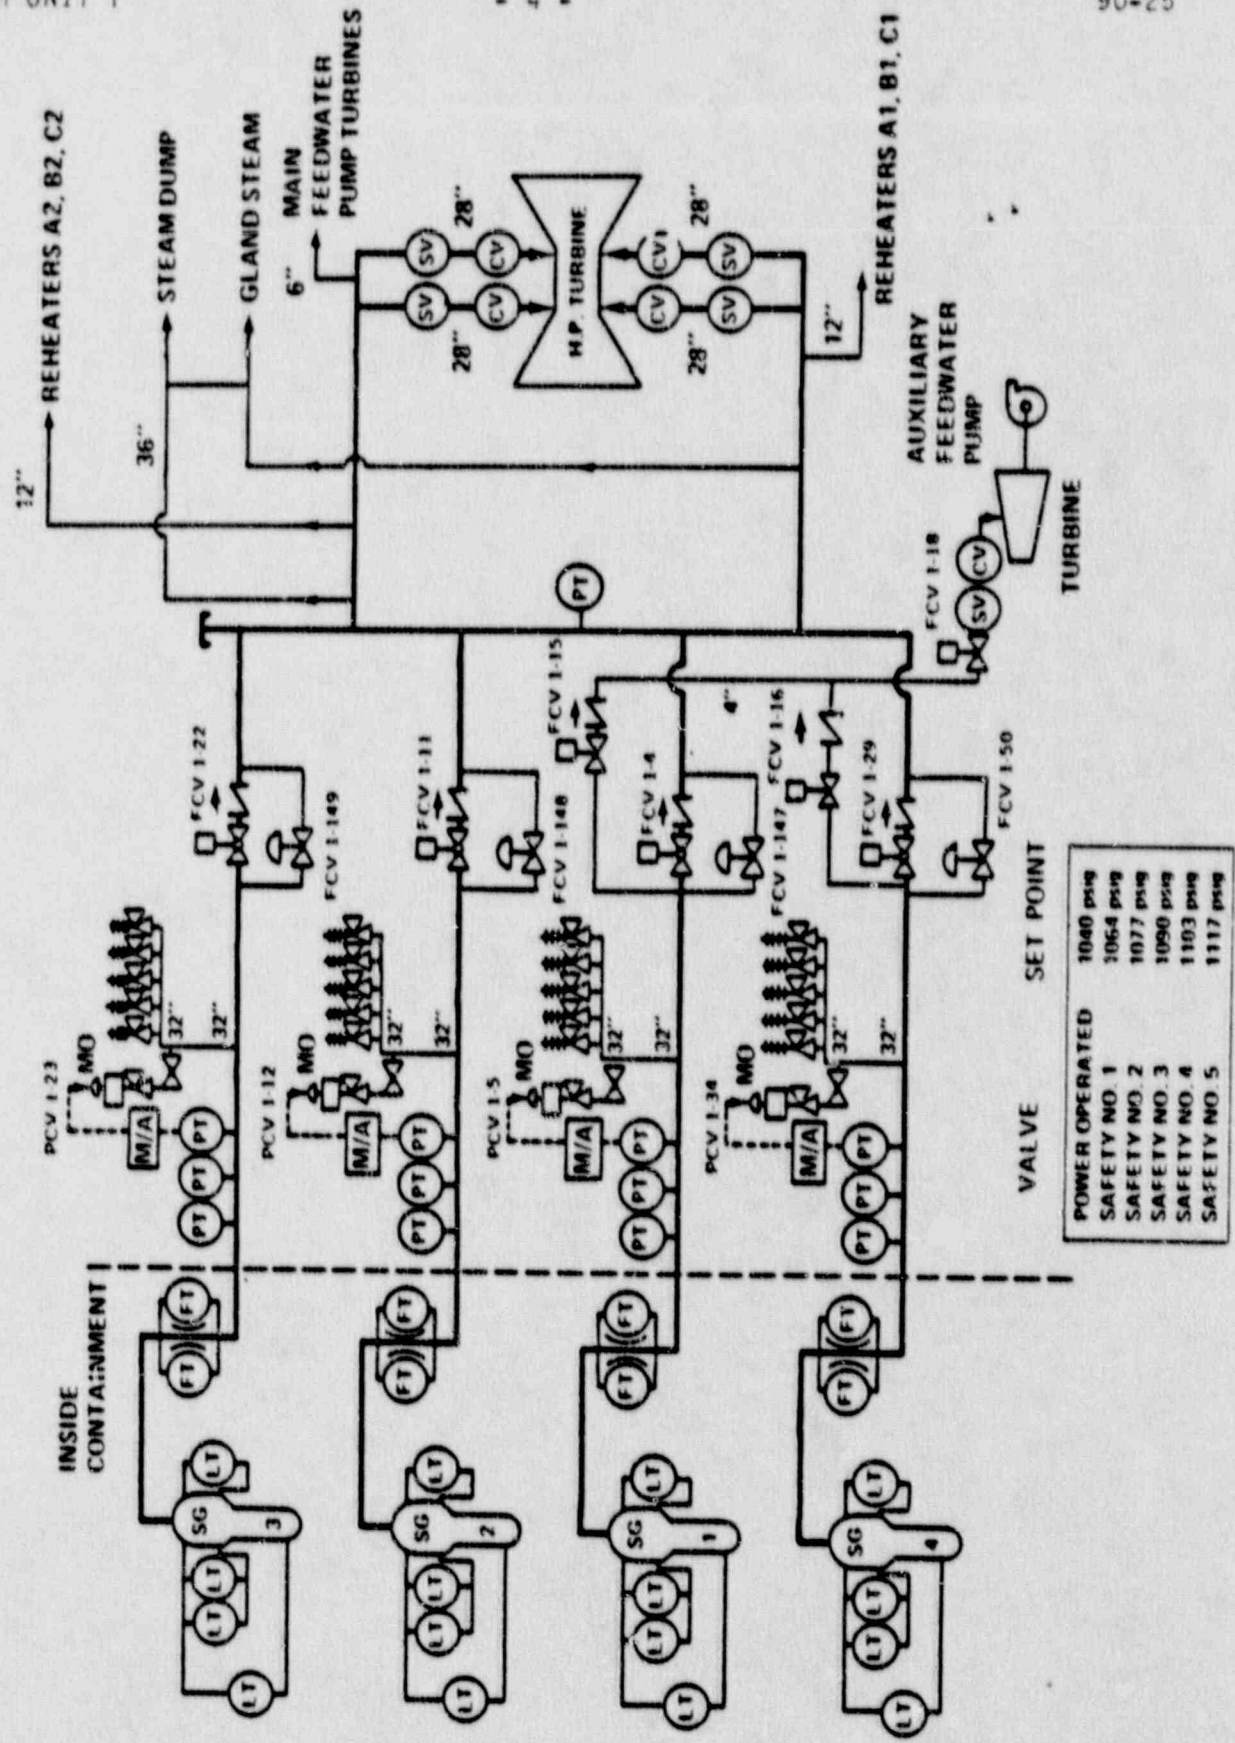
SEQUOYAH UNIT 1

THE LICENSEE FOR UNIT 1 DISCOVERED THAT 3 OF 4 MAIN STEAM LINE CHECK VALVES HAD DISC NUT PIN FAILURES WITH ONE OF THE VALVE DISCS LOCATED DOWNSTREAM OF THE VALVE BODY.

- o THE X-RAY SHOWED THAT THE CHECK VALVE DISC HAD SEPARATED.
- o FURTHER SURVEILLANCE BY THE LICENSEE DISCOVERED THAT 3 OF 4 CHECK VALVES HAD FAILED DISC PINS.

- o THE PINS WERE SHEARED WHERE THE VALVE DISC MEETS THE FLAPPER ARM.
- o ONE VALVE (UPON DISASSEMBLY) REVEALED THAT THE DISC HAD TRAVELLED SOME DISTANCE IN THE MAIN STEAM PIPING AFTER ITS DISC PIN FAILED.

- o THREE OF THE FOUR VALVES ON UNIT 1 HAD BEEN MODIFIED. THE MODIFIED VALVES FAILED. NO FAILURES INDICATED ON THE UN-MODIFIED VALVES.
- o THE MODIFICATION WAS TO PUT A RETAINING PIN THROUGH THE DISC NUT TO PREVENT THE NUT FROM LOOSENING.
