BAW-1732  
July 1, 1982

EVALUATION, REPAIR AND REPLACEMENT  
OF  
DAMAGED INTERNAL AUXILIARY FEEDWATER HEADER  
AT  
DAVIS BESSE 1, OCONEE 3 AND RANCHO SECO

50-346  
50-312  
50-287

**Babcock & Wilcox**

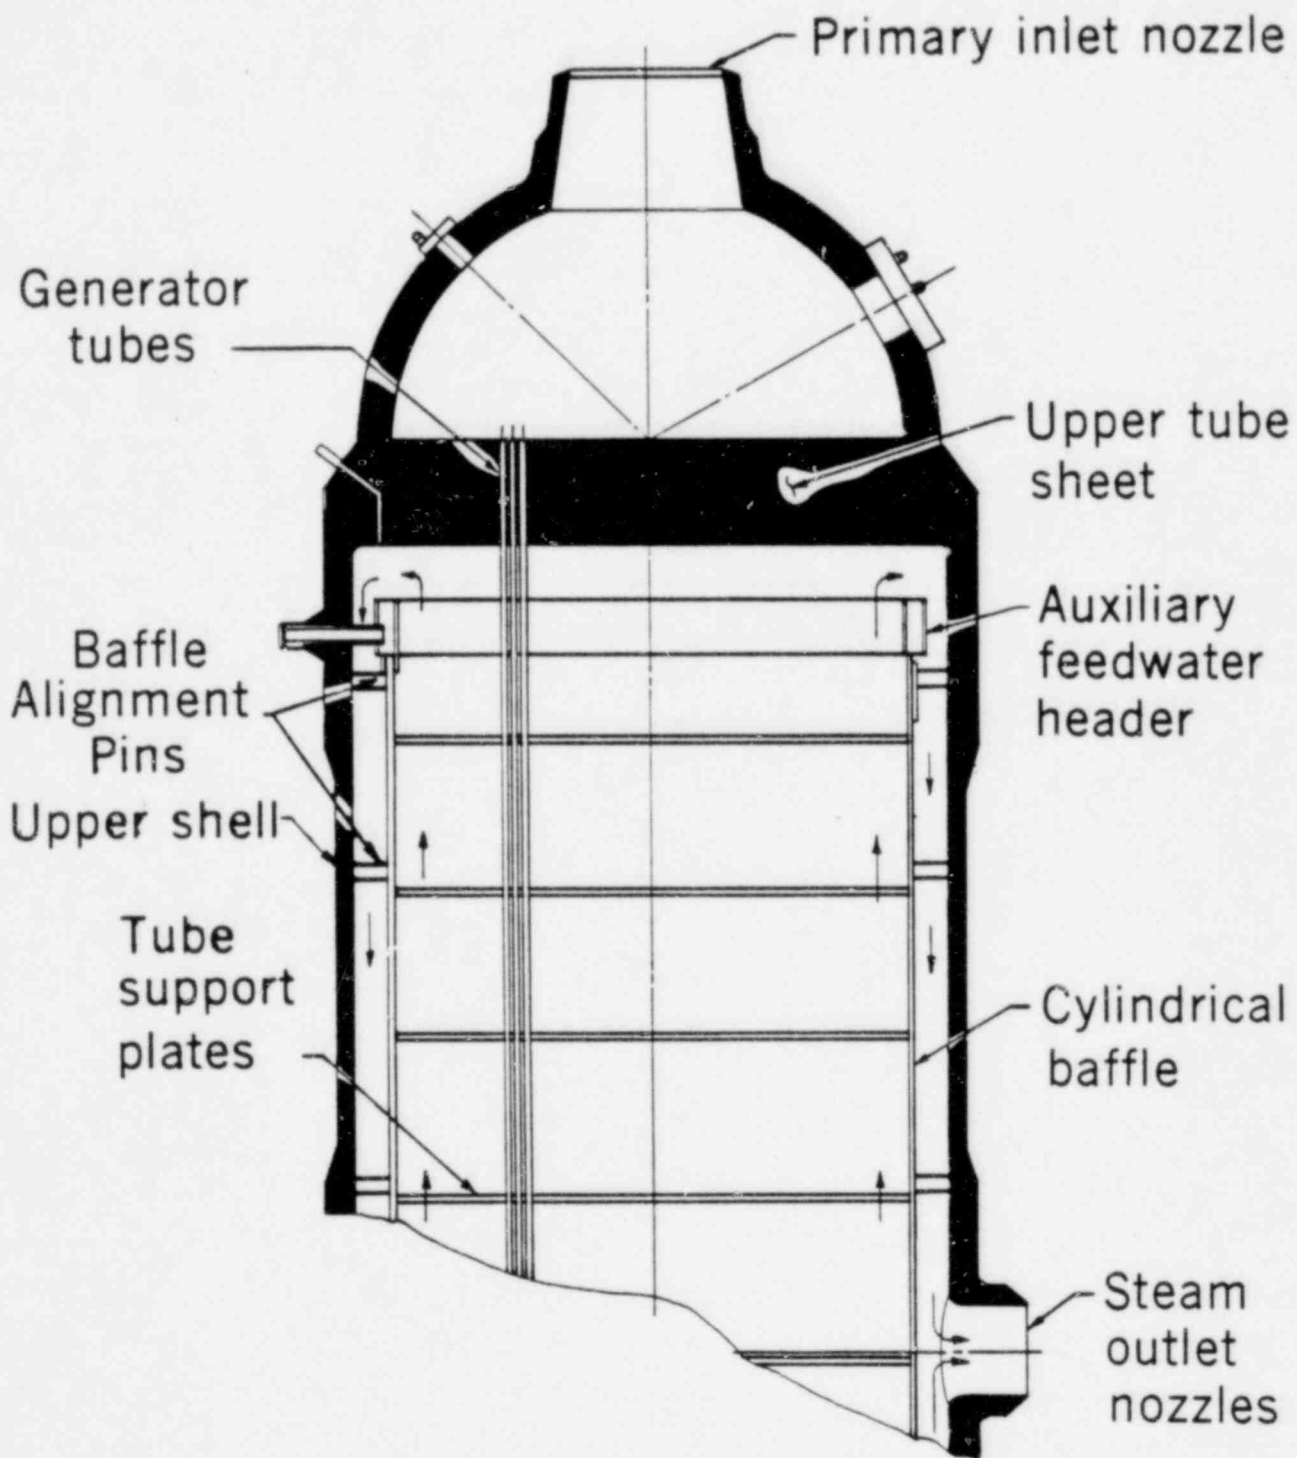
Figure 1-1  
ONCE-THROUGH STEAM GENERATOR  
WITH INTERNAL AUX. FEEDWATER HEADER

The internal AFW header is a rectangularly shaped torus fabricated of welded plate segments. The header is positioned on the upper end of the upper vertical cylindrical baffle (upper shroud) (see Fig. 1-1). The header also serves as a continuation of the upper shroud to separate the tube bundle from the steam annulus. The header is positioned and retained by eight sets of inner and outer brackets welded to the bottom of the header and match drilled through the shroud. A dowel passes through each set of brackets and is welded to the inner bracket (See Fig. 1-2).

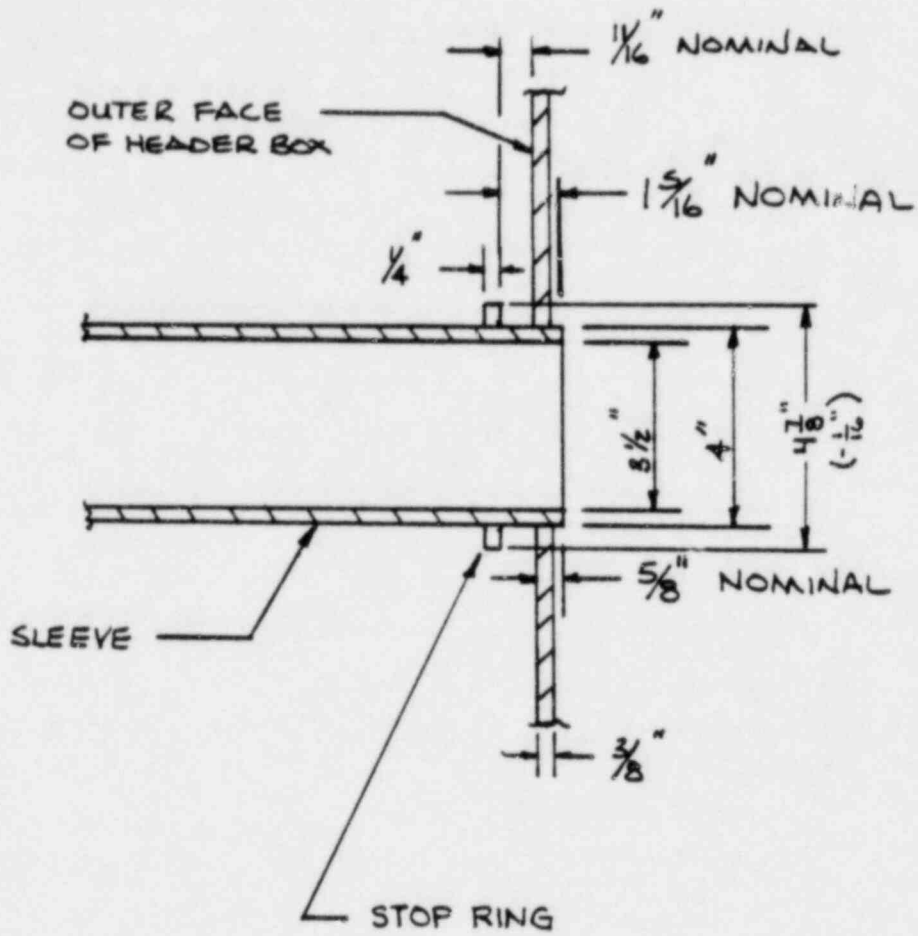
Fig. 1-3

A single 3 1/2 inch diameter AFW nozzle delivers water to the header via a thermal sleeve which slip fits into the header (see Fig. 1-3). Water leaves the header through 60 - 1 1/2 inch diameter flow holes near the top of the inner header wall. The flow holes are equally spaced around the circumference. There are 8 - 1/4 inch diameter drain holes near the bottom of the inner vertical wall (See Figures 1-4 and 1-5).

The concavity approached what was noted at Davis Besse 1. No misalignment of inlet thermal sleeves with the header inlet holes was noted although one sleeve was disengaged from the inlet hole in the header.
