MISSISSIPPI POWER & LIGHT COMPANY

NUCLEAR PRODUCTION DEPARTMENT

SUBJECT: Grand Gulf Nuclear Station
Units 1 and 2
Docket Nos. 50-416 and 50-417
License No. NPF-13
File 0260/0272/L-860.0
Reference: AECM-82/263
PMP Water Level Analysis,
Operating License Condition
2.C (5); SSER-2 1.11 (46)
AECM-82/440

EFFECTS OF PMP WATER LEVEL ON GGNS

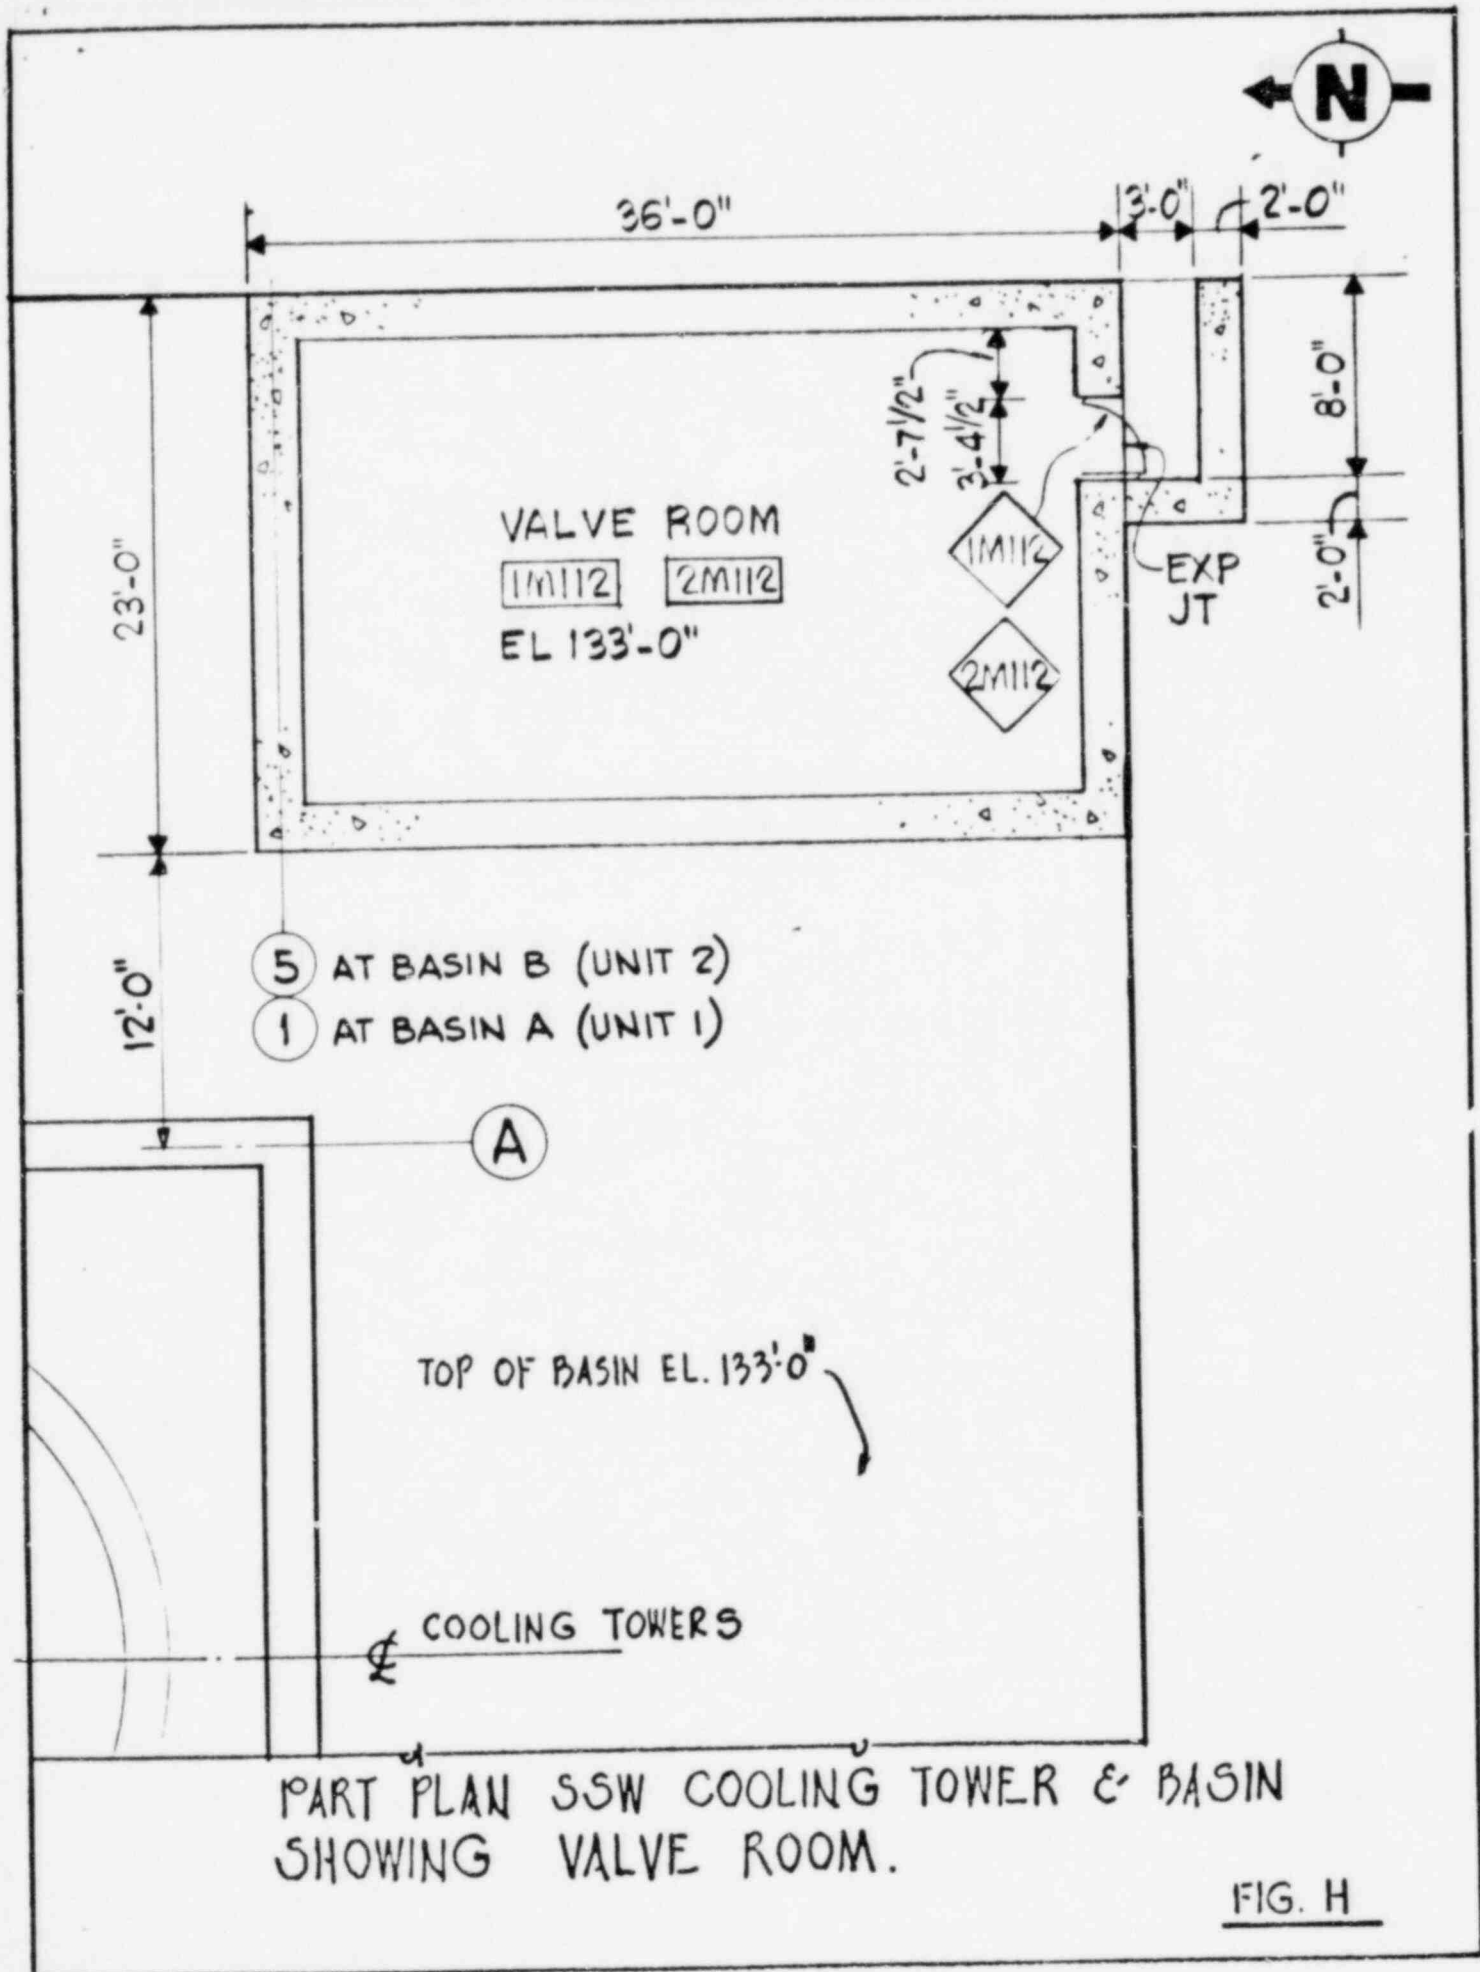
FIG. G

The standby service water basin has six doors which allow water to enter the pump house and the valve rooms. These doors are numbered 1M110, 1M111, 1M112, 2M110, 2M111, and 2M112 and are shown on Figures G and H. These doors permit a maximum leakage rate of 80.9 gpm for Basin A (Unit 1) and 81.9 gpm for Basin B (Unit 2), and the total volume of water entering the basin structure is approximately 27,000 gallons for each basin.

The flow calculations are all conservative, since the 133'-5" height of floodwater was assumed. The basin is not located in Drainage Area L, and the floodwater is not expected to reach this elevation, due to more favorable drainage conditions around the basin. There is no floor drain system for these buildings, and water entering these building would flow down blockouts and unsleeved penetrations in the floor slab to the water basin below.

Additional water from direct rainfall would enter the basins through the cooling fan towers and through backflow from the overflow drains. The cumulative effect of these three flows would cause the basins to overflow and water in the pump houses and valve rooms to reach elevations of 133'-6". This would affect electrical safety-related equipment, creating unsafe conditions.
