UNITED STATES
NUCLEAR REGULATORY COMMISSION

October 20, 1980

FACILITY: Trojan Nuclear Plant

SUBJECT: SUMMARY OF MEETING HELD ON SEPTEMBER 30, 1980 WITH PGE/
WESTINGHOUSE TO DISCUSS INTERIM LABORATORY EXAMINATION RESULTS
OF STEAM GENERATOR ROW 1 U-BEND TUBE SAMPLES REMOVED FROM
TROJAN

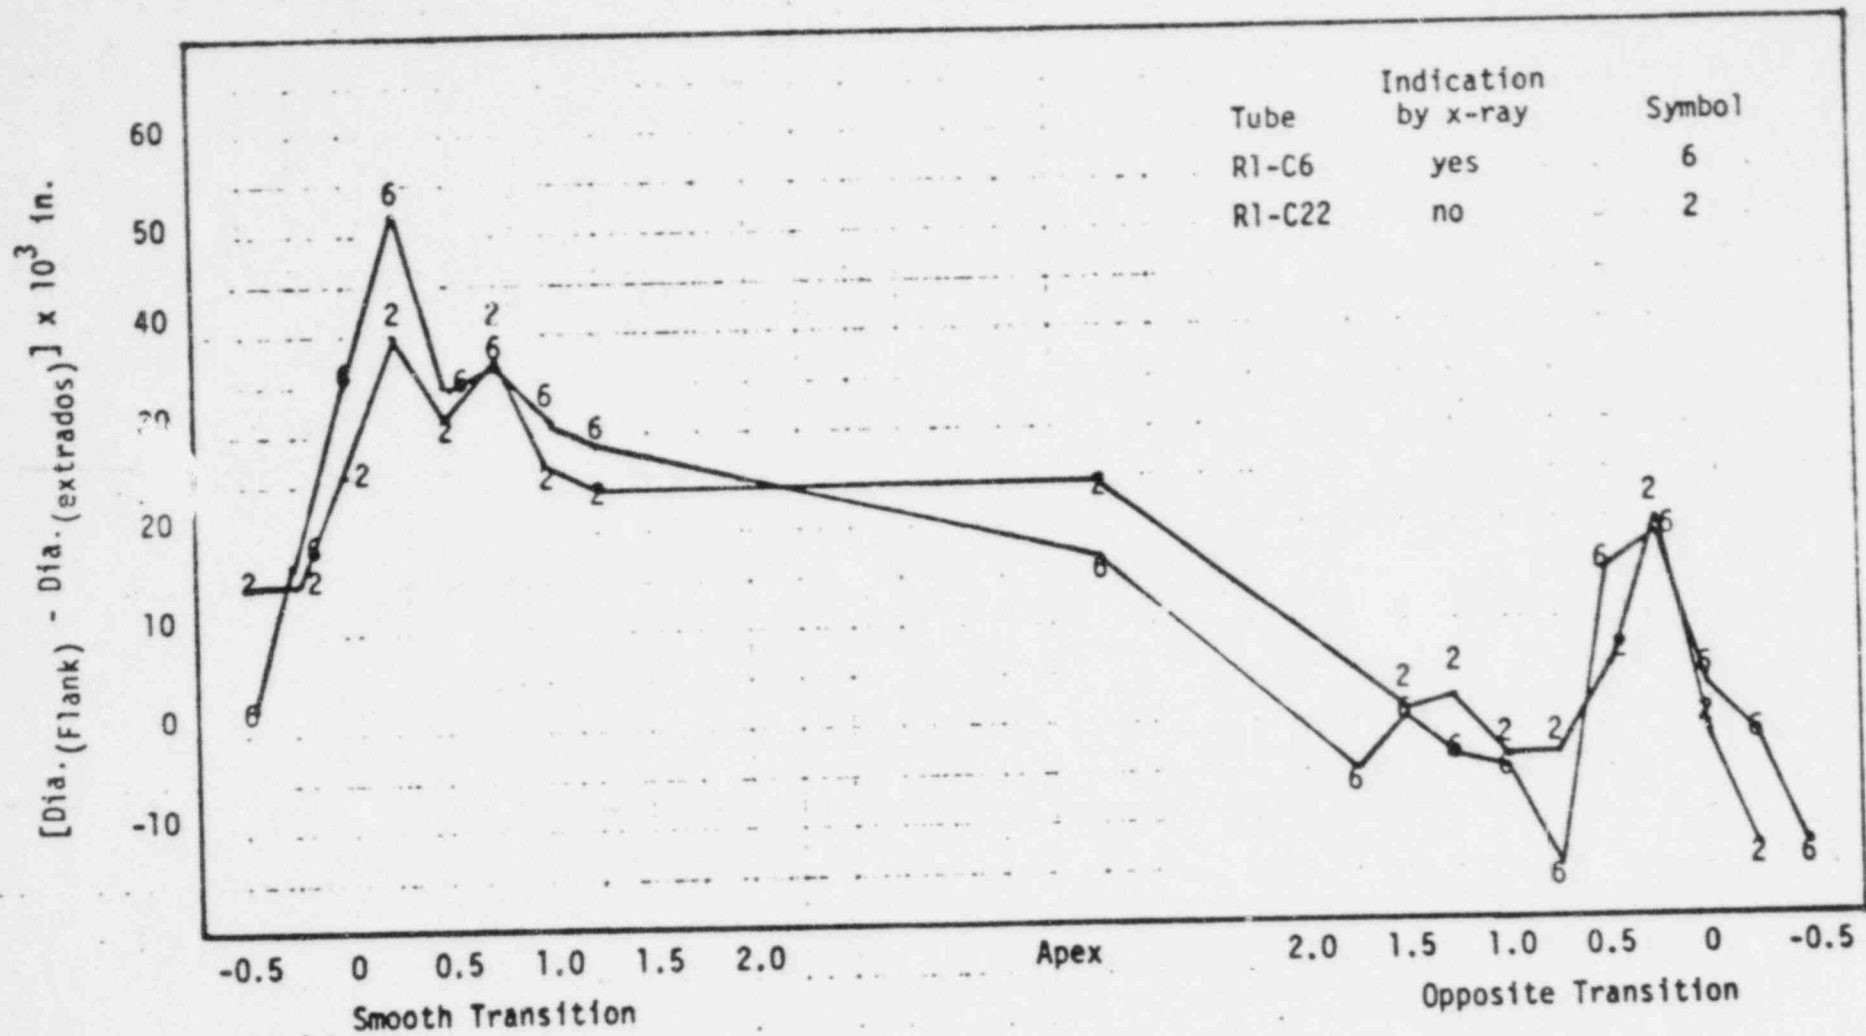
Figure 2. Ovality for tubes R1-C6 and R1-C22 at the smooth transition, apex and opposite transition. Zero positions correspond to intrados transitions.

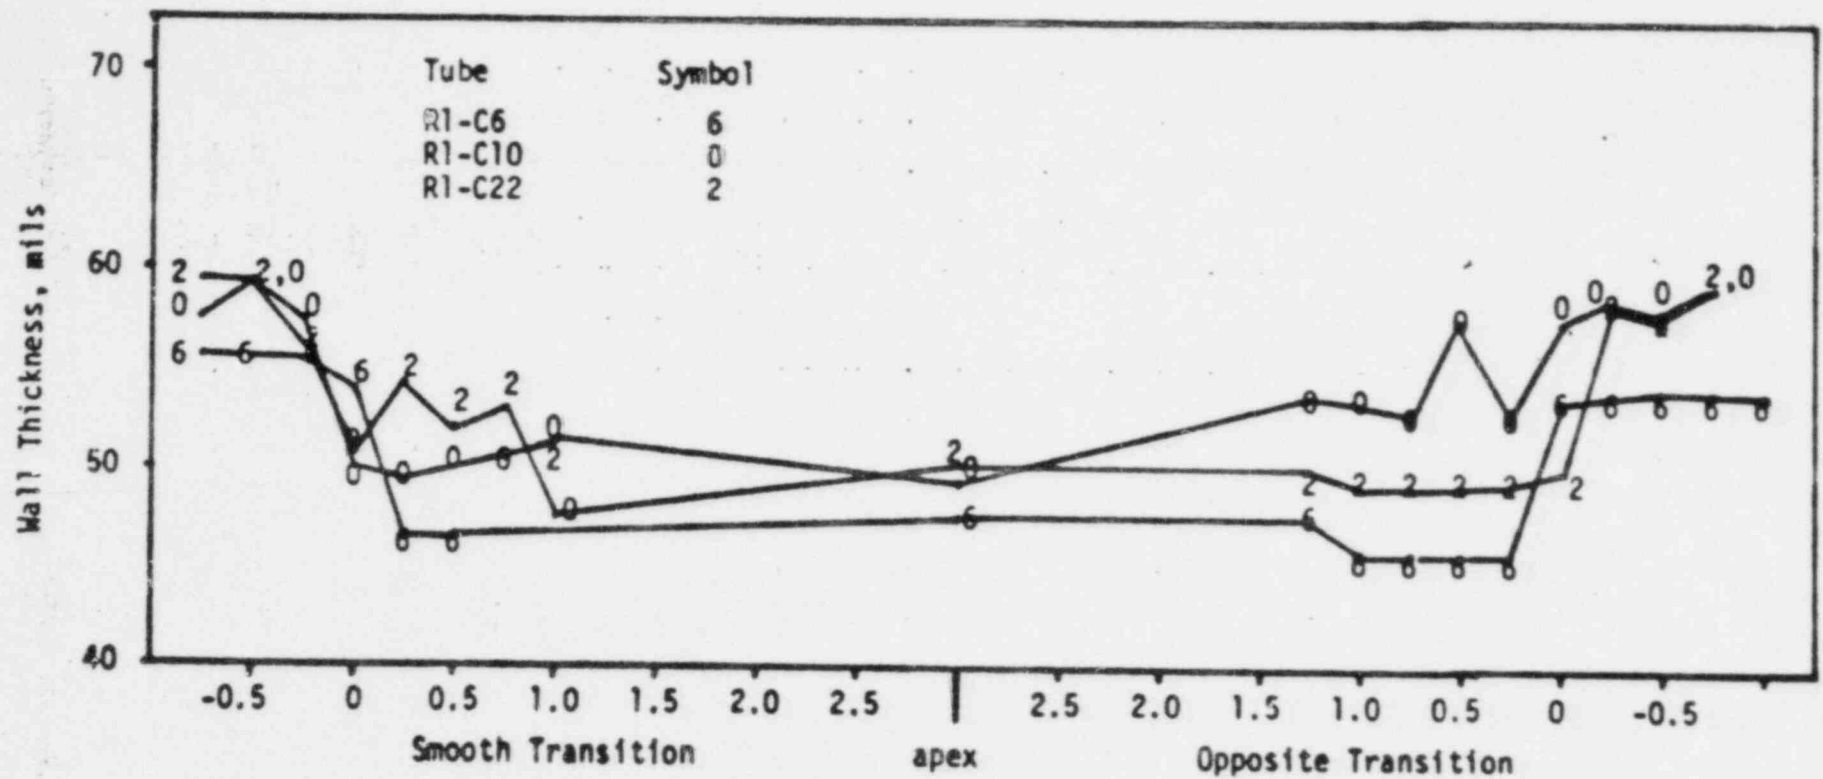
Figure 9. Wall thickness measurements at the extrados (180°) for the smooth transition, apex, and opposite transition. Zeros correspond to extrados transitions.

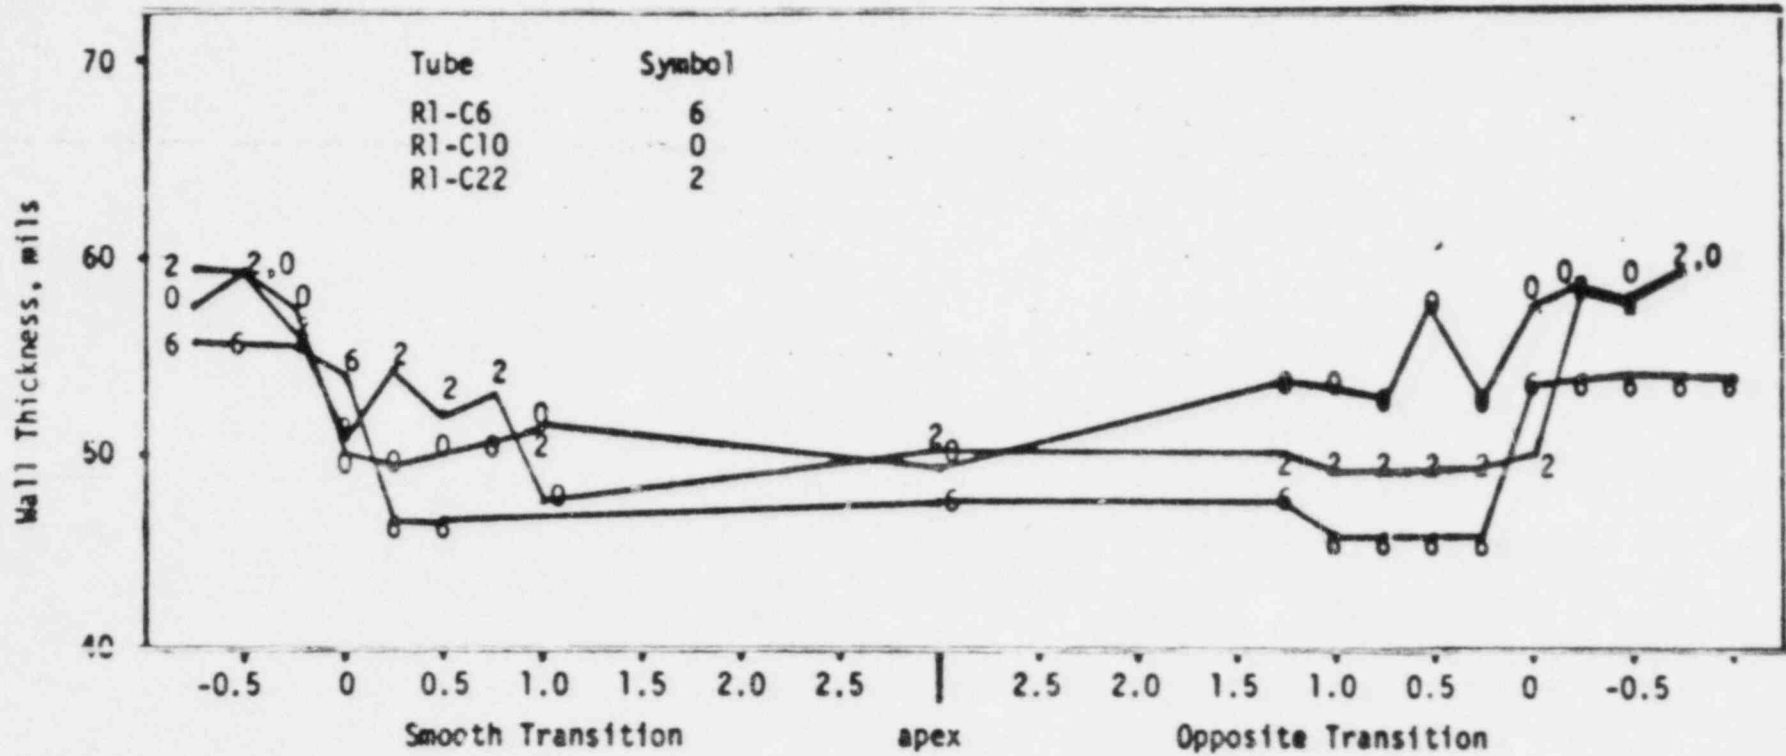
Figure 9. Wall thickness measurements at the extrados (180°) for the smooth transition, apex, and opposite transition. Zeros correspond to extrados transitions.

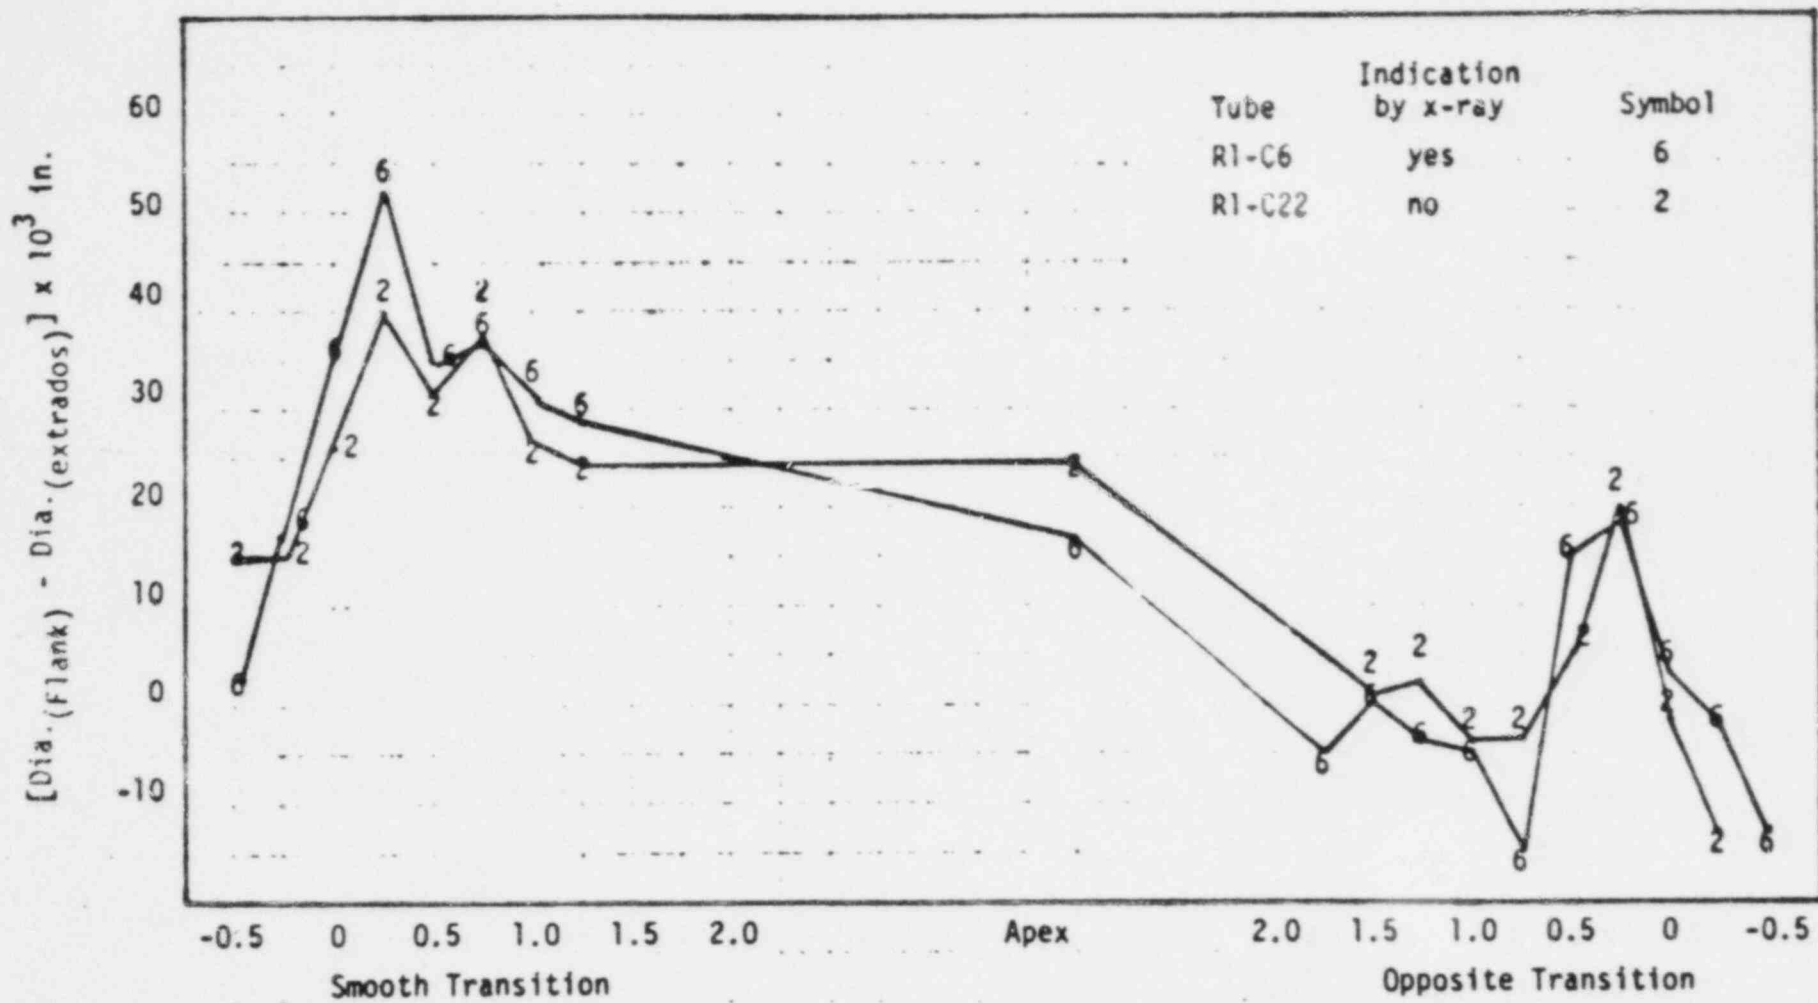
Figure 2. Ovality for tubes R1-C6 and R1-C22 at the smooth transition, apex and opposite transition. Zero positions correspond to intrados transitions.

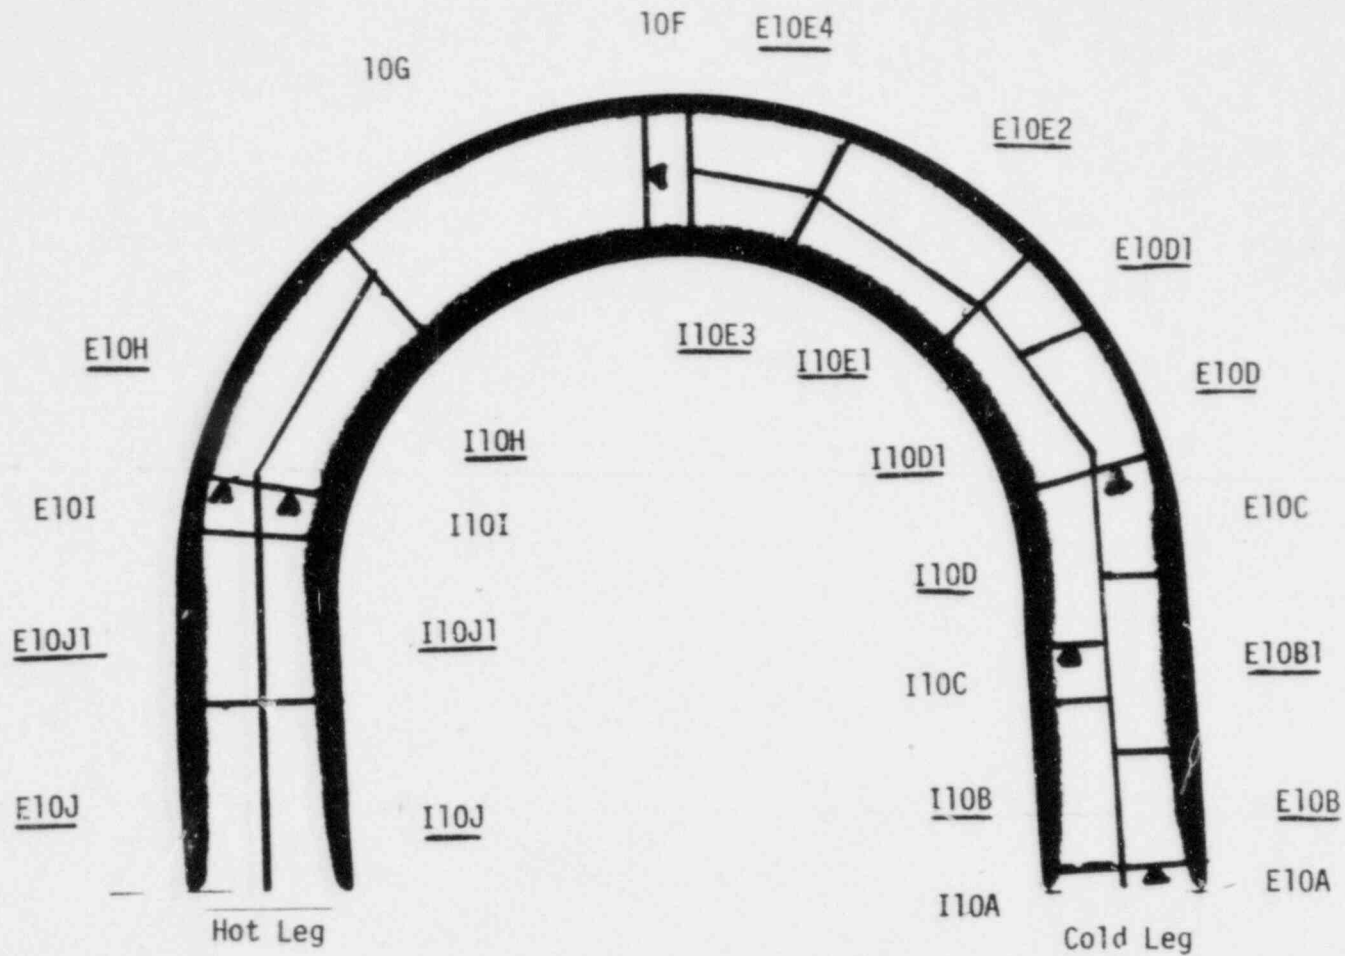
Figure 17. Print of double wall x-ray radiograph of tube R1-C10. Solid lines identify cuts; locations and identification of sections studied are given.

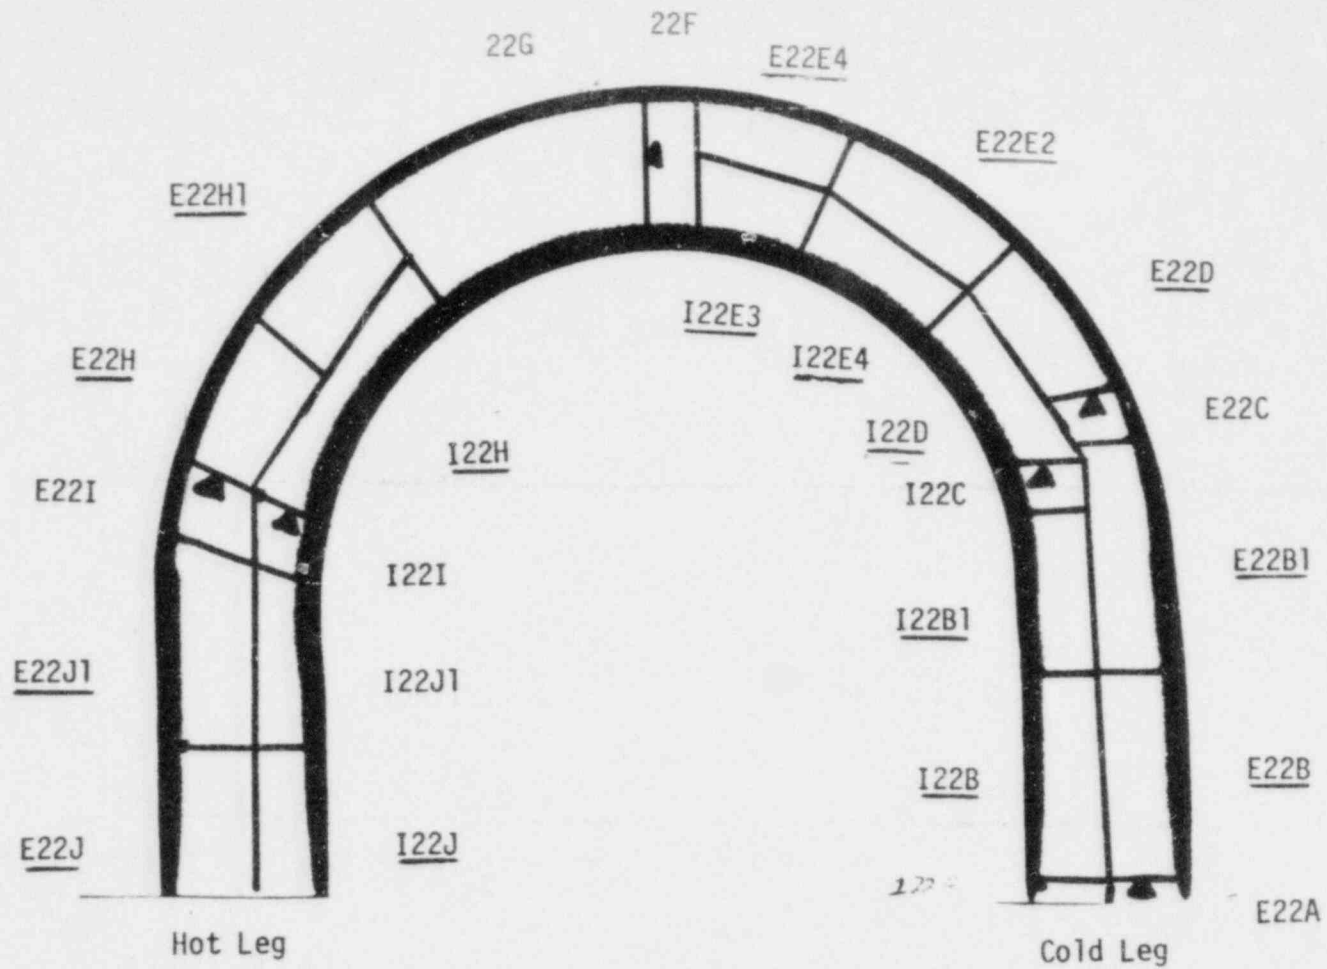
Figure 18. Print of double wall x-ray radiograph of R1-C22. Solid lines identify cuts; locations and identifications of sections studied are given.
