WOLF CREEK GENERATING STATION  
ESSENTIAL SERVICE WATER SYSTEM  
PUMP RESTRAINT EMBED REPORT

Bechtel Power Corporation  
Gaithersburg, Maryland  
July 1, 1982

Prepared by:  
P. Labarta

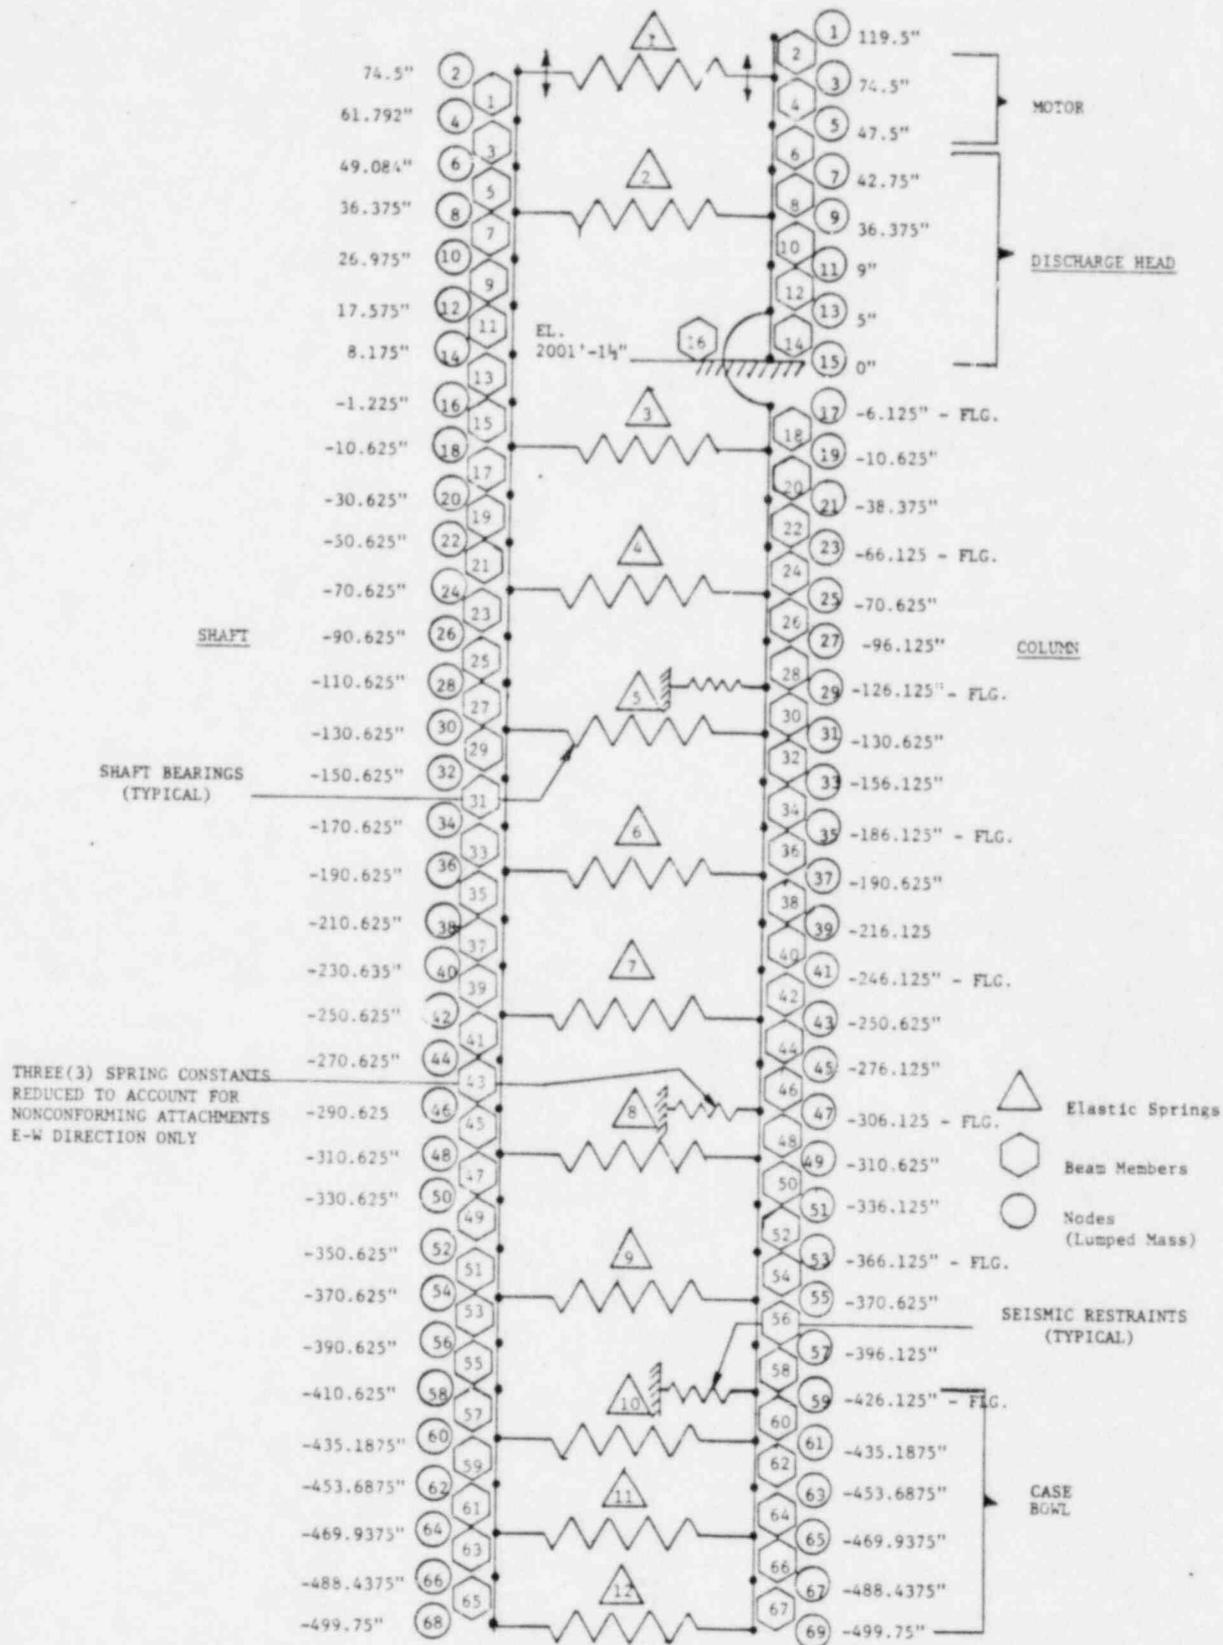
FIGURE 3

- a. The vendor's pump/restraint system lumped mass model was duplicated for the CE-917 and CE-918 analyses (See Figures 3 and 4).
- b. The vendor's original seismic input (floor response spectra) was duplicated in the CE-917 and CE-918 analyses and the results were compared to verify the accuracy of the analysis results.
