AEOD/S93-06

SPECIAL STUDY REPORT

POTTER & BRUMFIELD MODEL MDR ROTARY RELAY FAILURES

December 1993

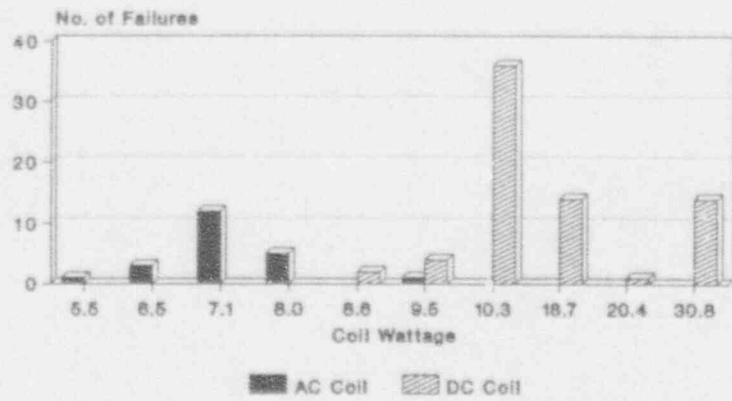
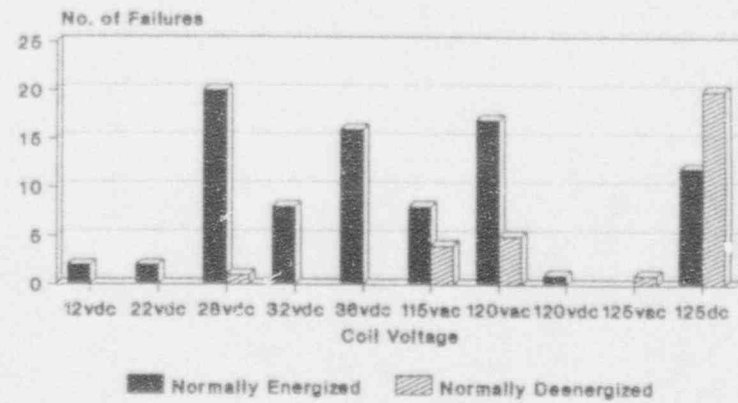
Figure 3-6 P&B MDR relay failures vs coil parameters

While varnish offgassing is affected by coil temperature, Figure 3-6 "P&B MDR Relay Failures vs Coil Parameters," taken from Appendix C and Table 3-1, does not show a relationship between higher coil wattages (with higher temperatures) and MDR failures, as may have intuitively been expected. While the charts show that normal energization of MDR relays has a greater correlation with MDR relay failures, it also includes more than 25 percent (32) of the MDR relay failures that were in normally de-energized ac and dc relays. More than 70 percent (21) of normally de-energized MDR relay failures occurred to non-latching relays, while less than 30 percent (11) of the normally de-energized relay failures occurred in latching type relays, which have either of two coils continuously energized. This may reflect that some normally de-energized relays may be normally energized during plant outages. Thus, normally de-energized MDR relays should not be ignored by licensees in responding to NRC IN 92-04.

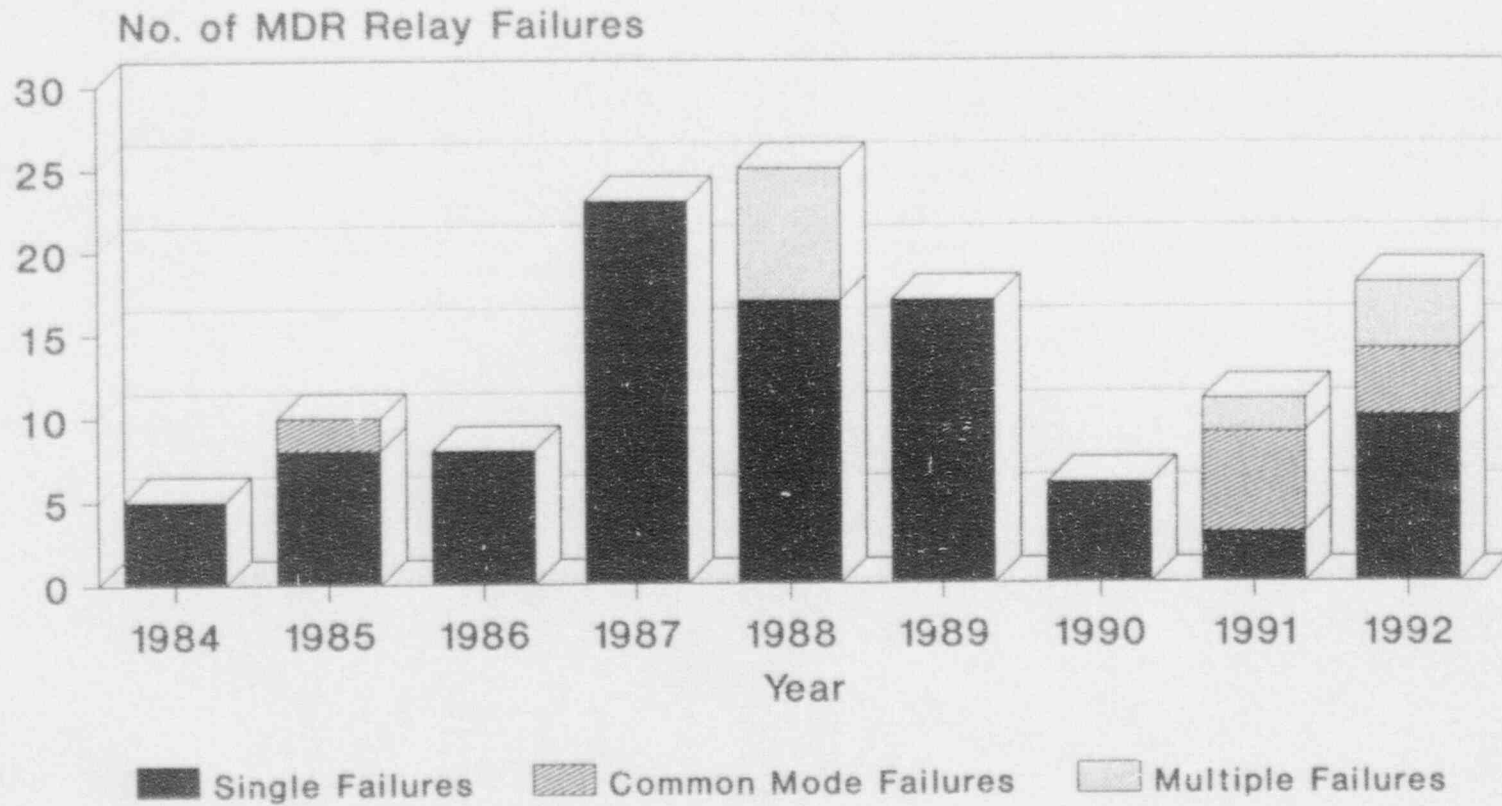
Figure 3-7 P&B MDR relay failures vs year

Figure 3-7, "P&B MDR Relay Failures vs Year," taken from the data in Tables 3-2 and 3-4, reflects simultaneous, multiple MDR relay dependent failure events that occurred three times in 1991 and three times in 1992, due to failures of older relays. In this figure, "single failures" refers to dependent MDR relay failures that occurred one at a time, as identified in Appendix C. "Multiple failures" is a subset of dependent MDR relay failures that occurred simultaneously to multiple MDR relays that did not affect redundant components of a specific system, as indicated in Table 3-2. "Common mode failures" is a subset of dependent MDR relay failures that occurred simultaneously to multiple MDR relays that affected redundant components, as indicated in Table 3-2.

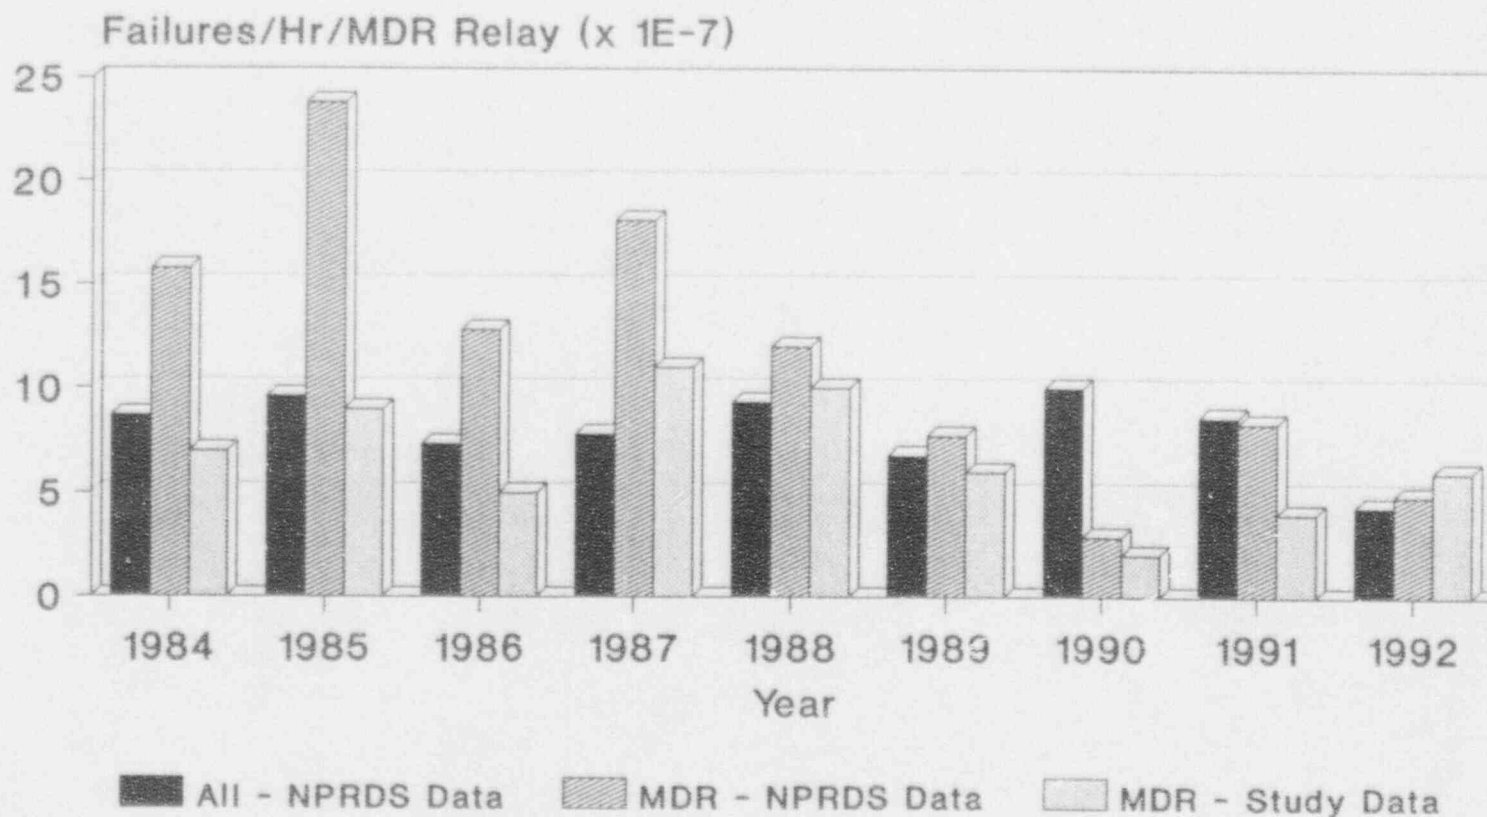
Figure 3-8 P&B MDR relay failure rates vs year

However, best estimates were made with the available data to compare this study's MDR failure rates with the calculated NPRDS database generic relay failure rates and MDR relay failure rates. These are given in Figure 3-8, "P&B MDR Relay Failure Rates vs Year." In all but a few cases, MDR relay failure rates meet or exceed NPRDS generic relay failure rates.

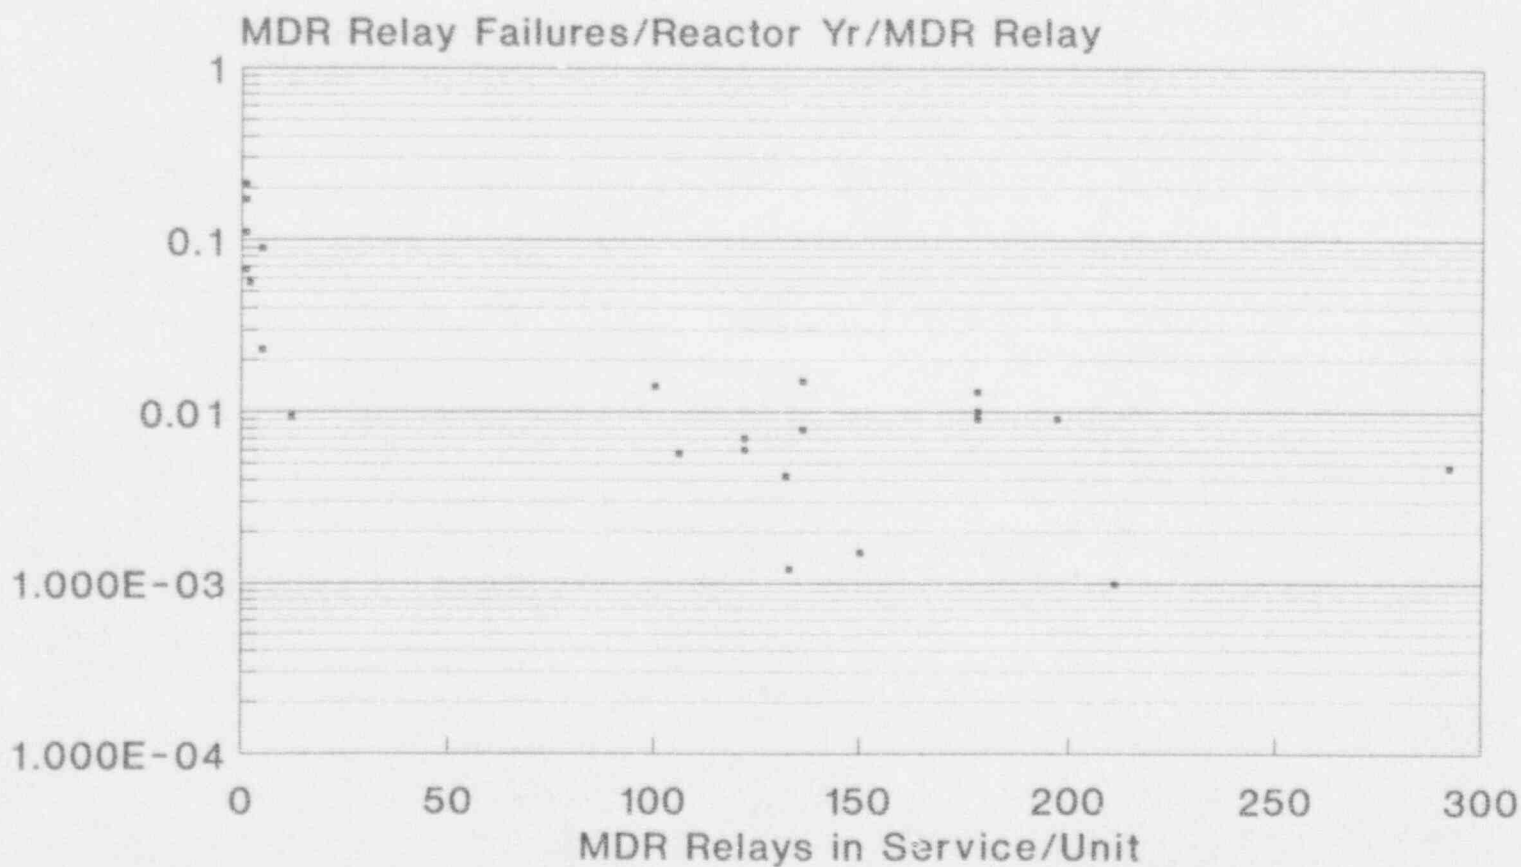
Figure 3-10 P&B MDR relay failure rate by unit vs number in service/unit

The plant specific failure rates listed in Table Appendix B were graphed vs the plant specific number of MDR relays in service in Figure 3-10, "P&B MDR Relay Failure Rate by Unit vs No. in Service/Unit." This shows the wide diversity of plant specific MDR relay failure rates, from 0 to .21 failures per year per MDR relay. This again corroborates NUREG/CR-5993 in that replacement decisions based solely on plant specific MDR relay failure rates could be expected to vary greatly.

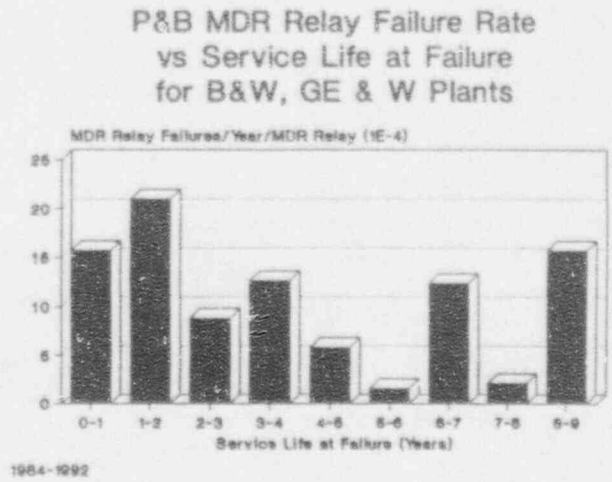
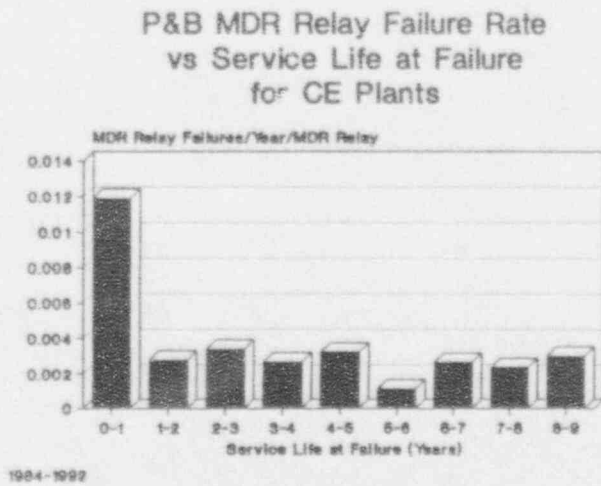
Figure 3-12 P&B MDR relay failure rate vs service life by NSSS

Figure 3-11, "P&B MDR Relay Failures vs Service Life at Failure by NSSS" and Figure 3-12 "P&B MDR Relay Failure Rate vs Service Life by NSSS" shows the number of MDR relay failures and failure rates vs service life at failure by each reactor vendor. The highest number of CE failures appeared at about 4 to 6 years service life. This may reflect: (1) the accumulated service life of the MDR relay population shown in

Figures 3-9 and 3-13, "P&B MDR Relay Accumulated Service Life," representing $1.83E+7$ hours of relay operation, and (2) the history of excessive voltage applied to certain MDR dc coils at CE plants for several years and the replacement of those relays. Thereafter, CE plant MDR failure rates leveled off.

The inservice MDR relay failure rate for the other reactor vendor plants' MDR relays increased again after 7 or 9 years inservice life. Most MDR relays used in CE plants do not have inservice lives in that range. The older relays were the ones failing most often in the MDR relay failure increases in 1991 and 1992. This may be a harbinger that increased age may affect MDR relay dependent failure rates and simultaneous failures in the future.

The River Bend experience has demonstrated how a loss of power to a group of relays can potentially result in multiple failures. The probability of a relay failure may increase with its length of time in service, due to the nature of varnish outgassing and silver contact corrosion failure mechanisms, as shown in Figure 3-12.

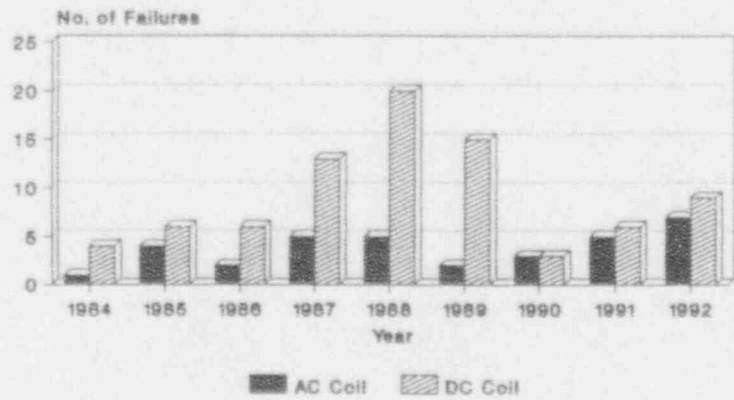
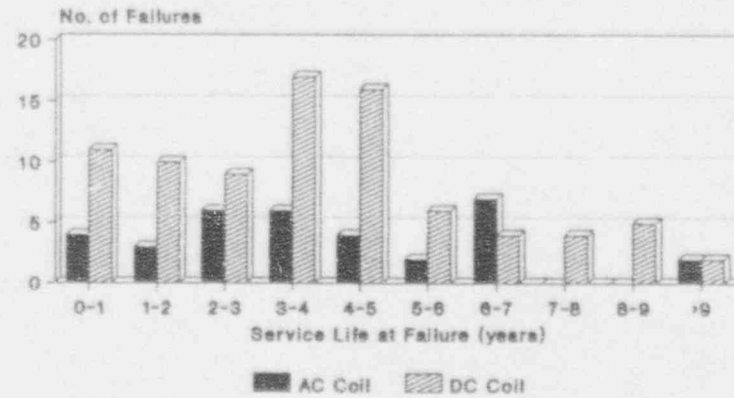
Figure 3-14 P&B MDR relay failures vs year, service life, and coil type

Figure 3-14, "P&B MDR Relay Failures vs Year, Service Life, and Coil Type," and Figure 3-15, "P&B MDR Relay Failures vs Year, Service Life and Normal Coil State," address MDR relay failures vs ac or dc coil type and normally energized or normally de-energized state by year and service life. This data is not normalized for the number of relays in service and may in part reflect the total population in service. Even so, it is reasonable that these figures show a higher number of failures of MDR relays with dc coils. The failures peaked at a service life of 3 to 5 years, which may reflect the influence of the in-service population. Both ac and dc coil failures increased from 1990 to 1992. Normally energized relays failed at a higher rate than normally de-energized relays. The number of normally energized relay failures tripled from 1990 to 1992.
