Report to Congress on Abnormal Occurrences

January - March 1982

**U.S. Nuclear Regulatory
Commission**

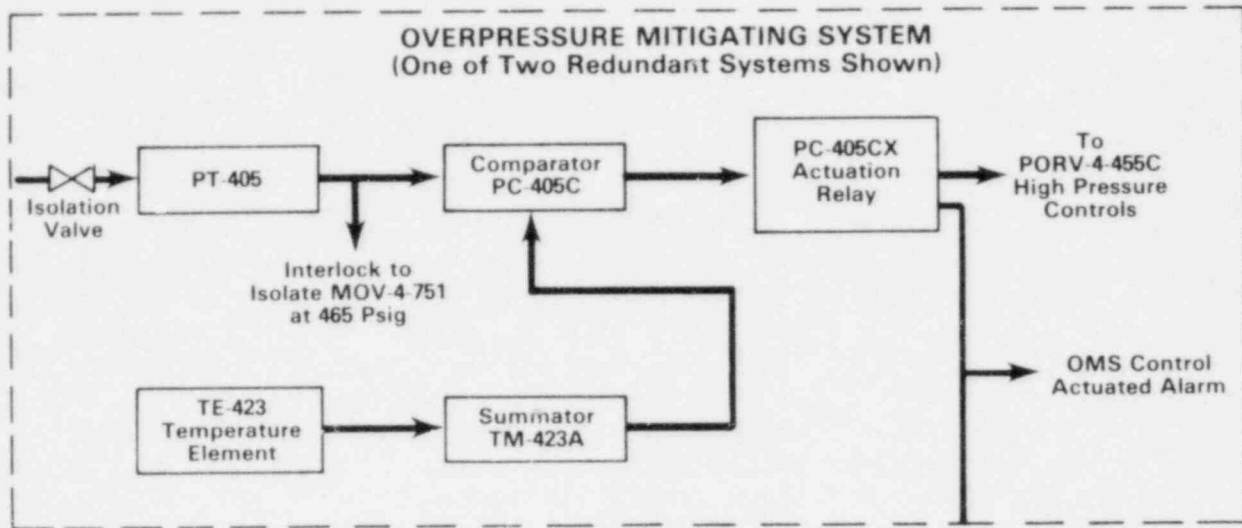
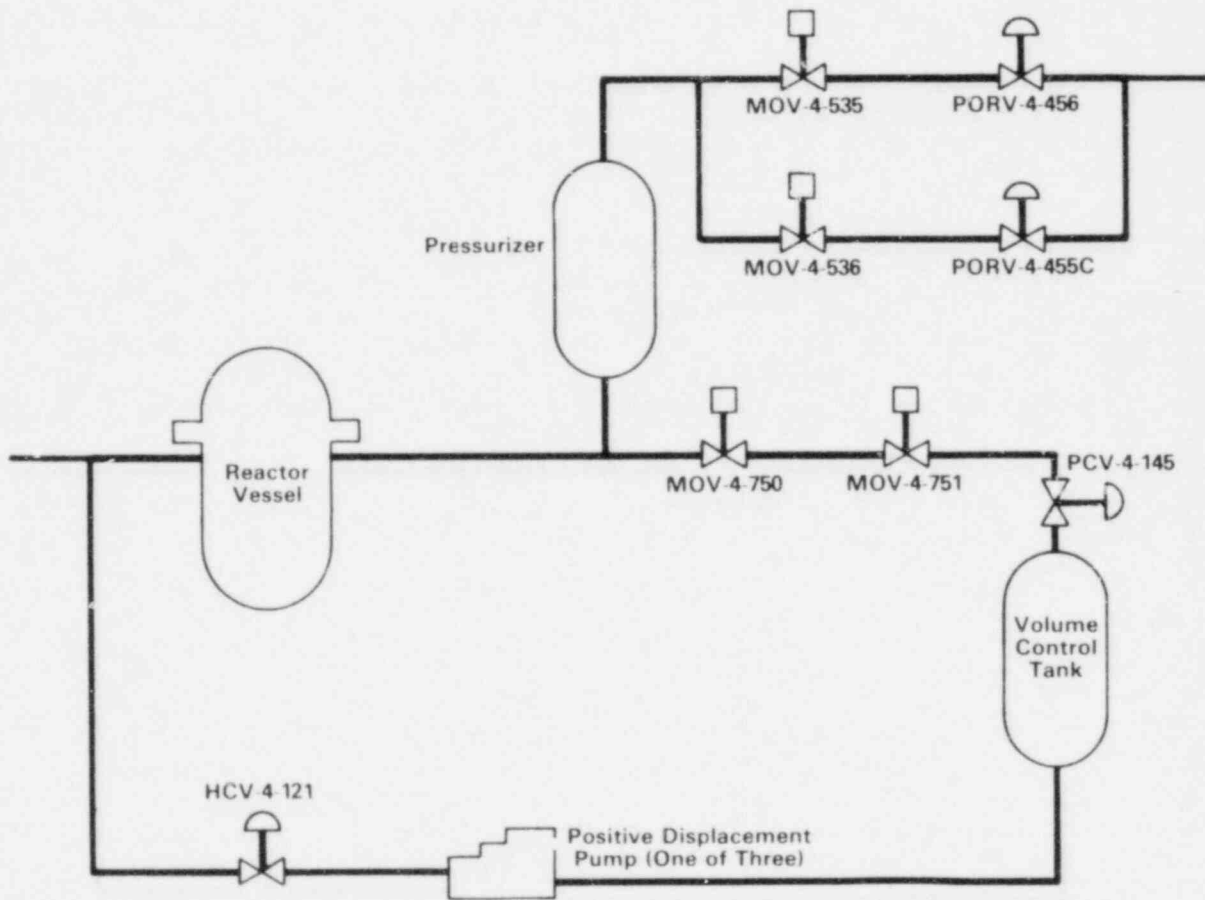
Figure 2. Turkey Point Unit 4 - Schematic of Pressure Control System

On November 28, 1981, at 10:55 p.m., the 4B Reactor Coolant Pump (RCP) was started to begin RCS heatup. The Reactor Control Operator noticed that RCS pressure was approximately 500 psig and increasing. Though it is common for the RCS pressure to surge momentarily following RCP startup, the operator noted that conditions persisted and were thus abnormal. He also noticed that valve PCV-4-145 was in the fully closed position and attempted to open it automatically by lowering the control setpoint. When this attempt failed, the valve was opened using the manual control mode, and the 4B RCP, 4A charging pump, and the pressurizer control heaters were shut off. One Power Operated Relief Valve (PORV-4-455C) was opened by the operator to reduce RCS pressure. The other PORV (PORV-4-456) was isolated and out-of-service for maintenance on the high pressure controls for the PORV. An RHR isolation valve (MOV-4-750) was

found in the closed position and was immediately opened by the operator. PCV-4-145 was returned to auto-control and the 4A charging pump was restarted. The RCS pressure was then maintained constant at approximately 335 psig.

The RCS peak pressure during the transient was 1100 psig. Duration of the overpressure condition was approximately two minutes.

The pressure transient was initially diagnosed as initiating from misoperation of valve PCV-4-145. The root isolation valve for PT-4-405 was also found closed which made the backup OMS train inoperable. The root isolation valve was opened; valve PCV-4-145 was returned to auto-control and RCS pressure was maintained constant.

On November 29, 1981, at 12:55 a.m., the 4B RCP was restarted. An overpressure condition recurred with peak pressure reaching 750 psig. Again the RCP and the charging pump in operation were shut down. PORV-4-455C was manually opened to decrease RCS pressure. Duration of the overpressure condition was approximately one minute.

Cause or Causes - A pressure increase occurred when starting the RCP which exceeded the magnitude expected for a normal RCP start. Contributing to the pressure transients were the subsequent automatic closure of the RHR system suction isolation valves and the malfunction of the OMS while operating in a water solid condition. The automatic closures of the RHR system suction isolation valves were attributed to:

- (1) RCS pressure transmitter PT-4-403 sensing a high pressure and closing MOV-4-750, due to the pressure interlock at 465 psig during the first event, thus resulting in the charging pump operation overpressurizing the system.
- (2) PT-4-405 (the backup OMS input) was reading about 130 psig higher (based on post event testing) than actual RCS pressure when unisolated after the first event. (The transmitter had been relocated and its setpoint may have changed due to hydrostatic testing of the transmitter together with its sensing line.) This variance likely led to MOV-4-751 closing at about 375 psig actual RCS pressure, initiating the second pressure transient.

- (1) One train was inoperable for maintenance as permitted by license conditions.
- (2) The backup train failure was attributed to:

- (a) The root isolation valve to PT-4-405 was shut, isolating PT-4-405, during the first event. (No procedure was found that aligns RCS instrumentation root valves prior to RCS fill.)
- (b) In addition, during both events, the backup OMS temperature summator, which generates the "pressure set point" to which loop pressure is compared to generate the OMS actuation signal, had failed high - about 2335 psig - also rendering the backup OMS inoperable. This condition was unknown because of an inadequate surveillance procedure used to satisfy the technical specification requirement to operationally check each channel. The procedure is OP 1004.4 - Overpressure Mitigating System Functional Test of Nitrogen Backup System - dated May 7, 1981. This procedure did not test the summator.

Licensee - After the first pressure transient, the root valve to PT-4-405 was reopened. In addition, attempts were made to release the redundant OMS loop from clearance and restore it to operating condition, but this was not accomplished by the time the second pressure transient occurred. The immediate corrective action during both events consisted of reducing the RCS pressure to a value within the Technical Specification limits. Subsequent to the second event, the licensee requested an evaluation of the consequences from the Nuclear Steam System Supplier (Westinghouse) and notified the NRC's Region II of the incidents. The licensee also confirmed that the Unit would not be restarted until the NRC has reviewed the results of the requested analyses.
