NUREG/CR-4674
ORNL/NOAC-232
Vol. 18

Precursors To Potential Severe Core Damage Accidents: 1992 A Status Report

Appendices B, C, D, E, F, and G

Oak Ridge National Laboratory

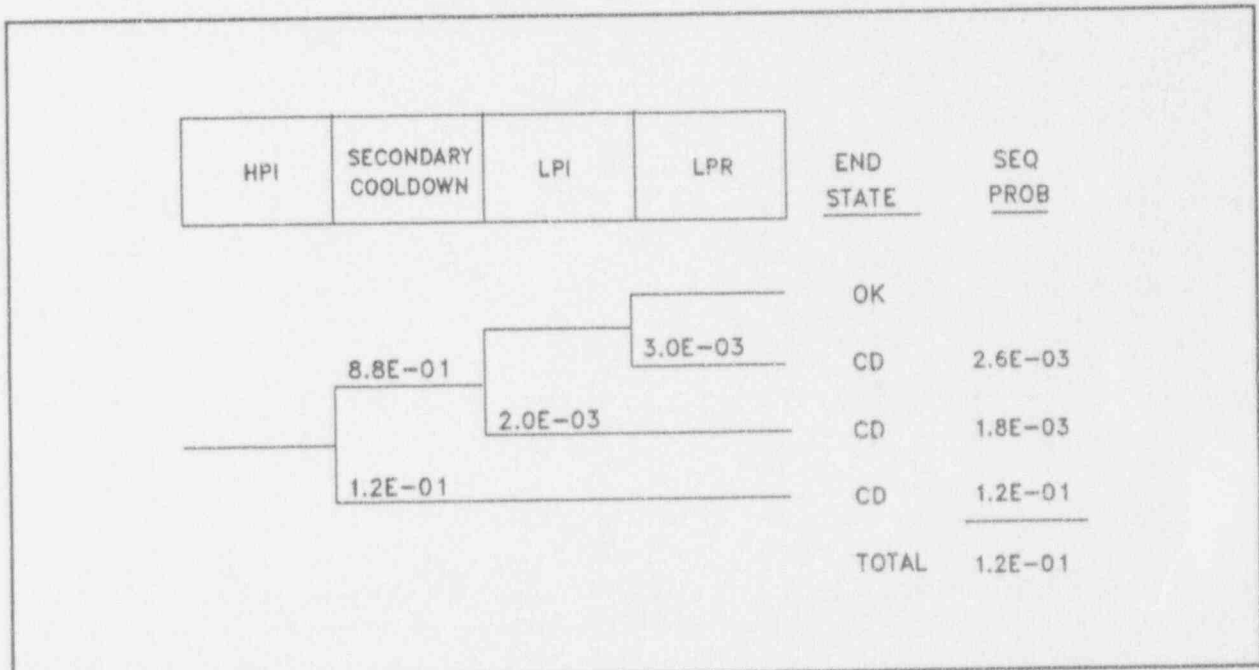
Fig. B.34. Modification to HPR event when HPI fails and AFW or MFW is successful.

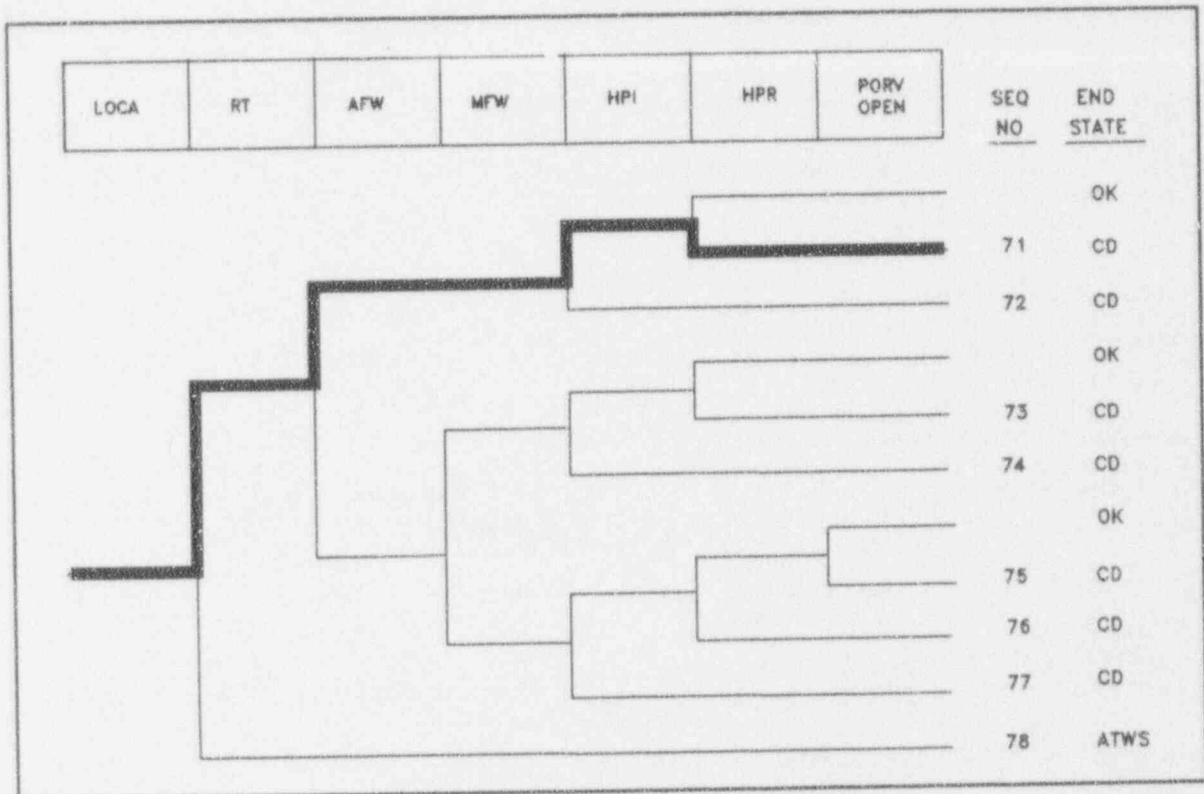
The estimated conditional core damage probability associated with this event is 9.9×10^{-6} . The dominant core-damage sequence, highlighted on the event tree in Fig. B.35, involves a postulated loss-of-coolant accident (LOCA) with successful auxiliary feedwater and high-pressure injection and failure of high-pressure recirculation.

Fig. B.35. Dominant core damage sequence for LER 301/92-003.

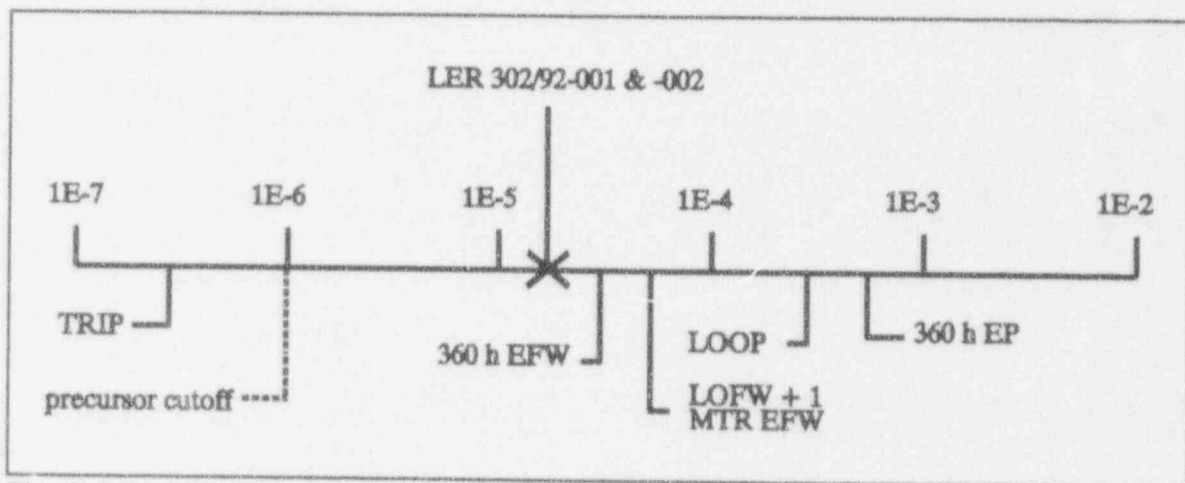
Maintenance work on a vital bus inverter resulted in the loss of the inverter, loss of offsite power (LOOP) to the two safeguards busses, and a plant trip. Following the start of the emergency diesel generators (EDGs), an existing leak in the 3B EDG jacket cooling system increased. After partial restoration of offsite power to the safeguards busses, the 3B EDG was declared inoperable because of the jacket system leakage. The conditional core damage probability for this event is estimated to be 1.7×10^{-5} . The relative significance of this event compared to other postulated events at Crystal River, Unit 3, is shown in Fig. B.36.

Fig. B.36. Relative event significance of LER 302/92-001 and 302/92-002 compared with other potential events at Crystal River 3.

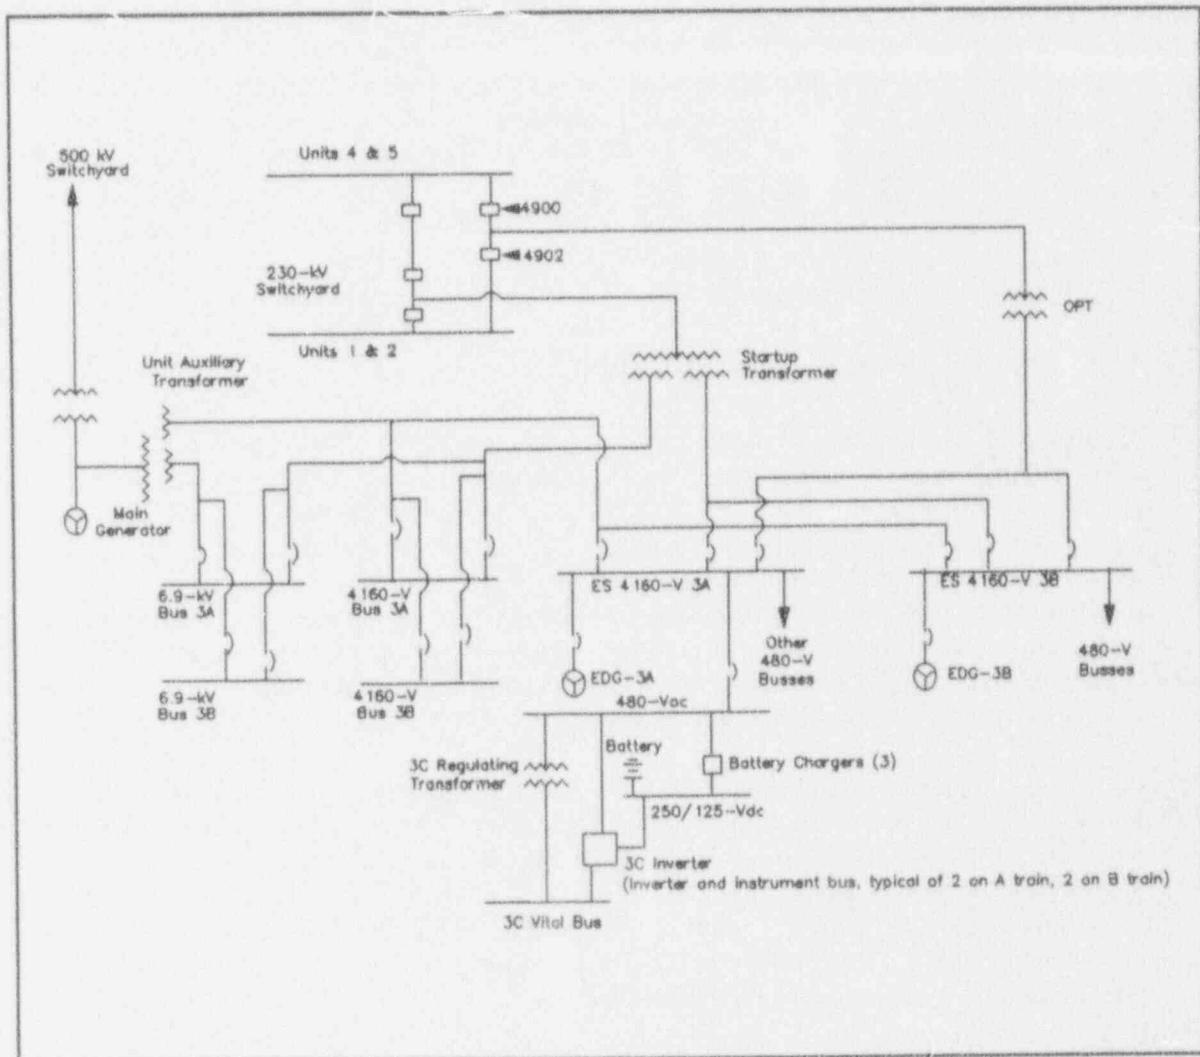
Maintenance was in progress on the C vital bus inverter (see Fig. B.37). The inverter was removed from service, and the C vital bus was being powered by the 480-Vac/120-Vac regulating transformer. When the inverter was repowered from the dc bus at 1308 hours as part of the troubleshooting effort, incomplete isolation of the inverter from the 480-Vac supply resulted in ac voltage swings on the 125-Vdc bus. The voltage swings caused the relays for the Offsite Power Transformer (OPT) to actuate, resulting in the opening of the OPT supply breakers (4900 and 4902). As a result, offsite power to the safeguards busses (ES-3A and ES-3B) was lost. This caused the C vital bus to lose power because the inverter was

Fig. B.37. Electrical distribution system for Crystal River 3

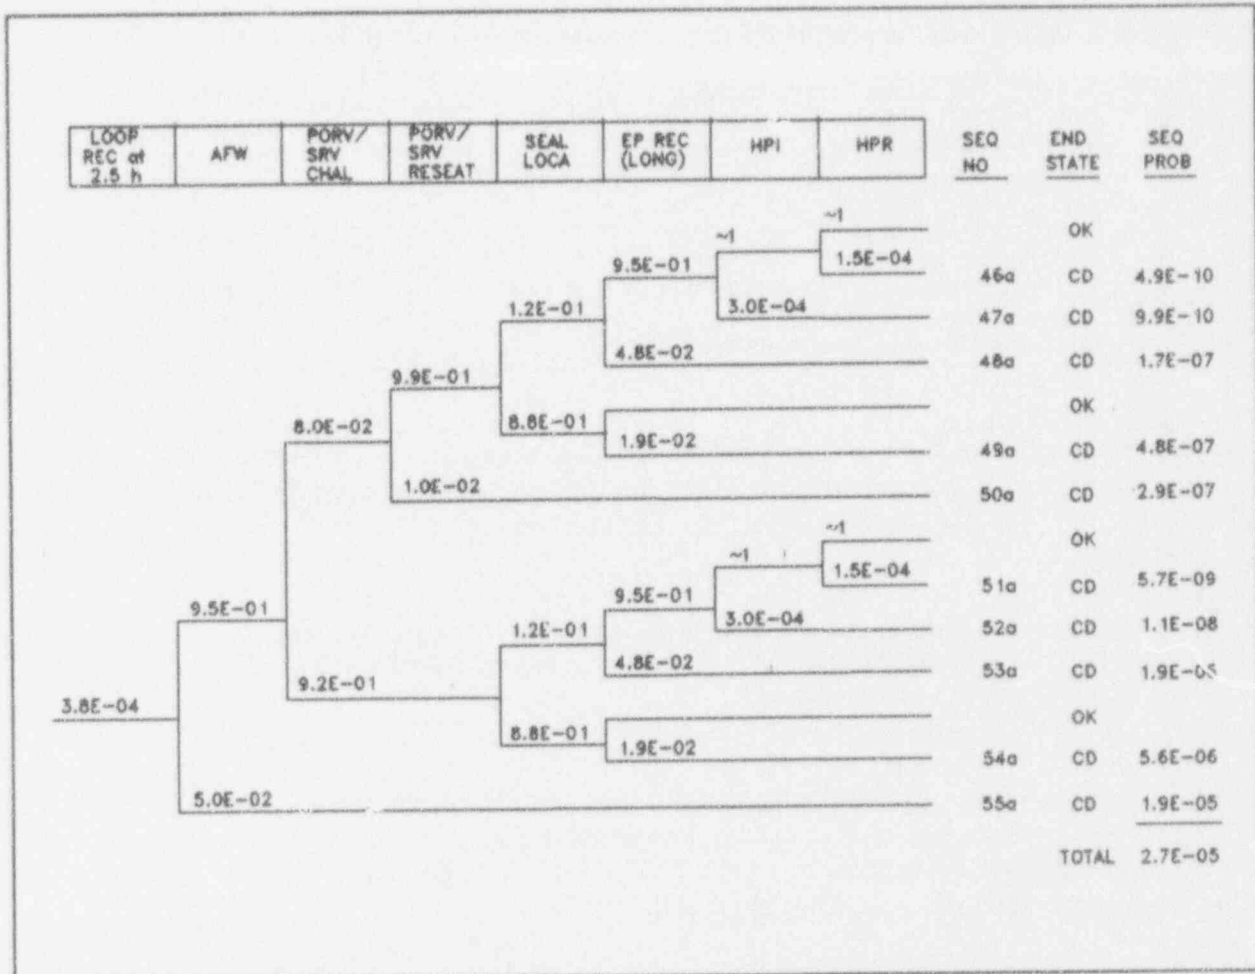
A point estimate calculation was then performed assuming that the "B" EDG would not have been able to function beyond 2.5 h. The event tree was modified to include the failure of the "B" EDG 2.5 h into the event. The modified tree is shown in Fig. B.38. The following sections describe the basis for the event tree probabilities.

Fig. B.38. Modification to event tree to account for failure of EDG "B" at 2.5 hours.

LOOP Recovery at 2.5 h. It was assumed that the "B" EDG would not operate beyond 2.5 h. Therefore, the probability of failure of emergency power at 2.5 h is the probability that the "A" EDG has failed and offsite power recovery has not been successful. This is given by:

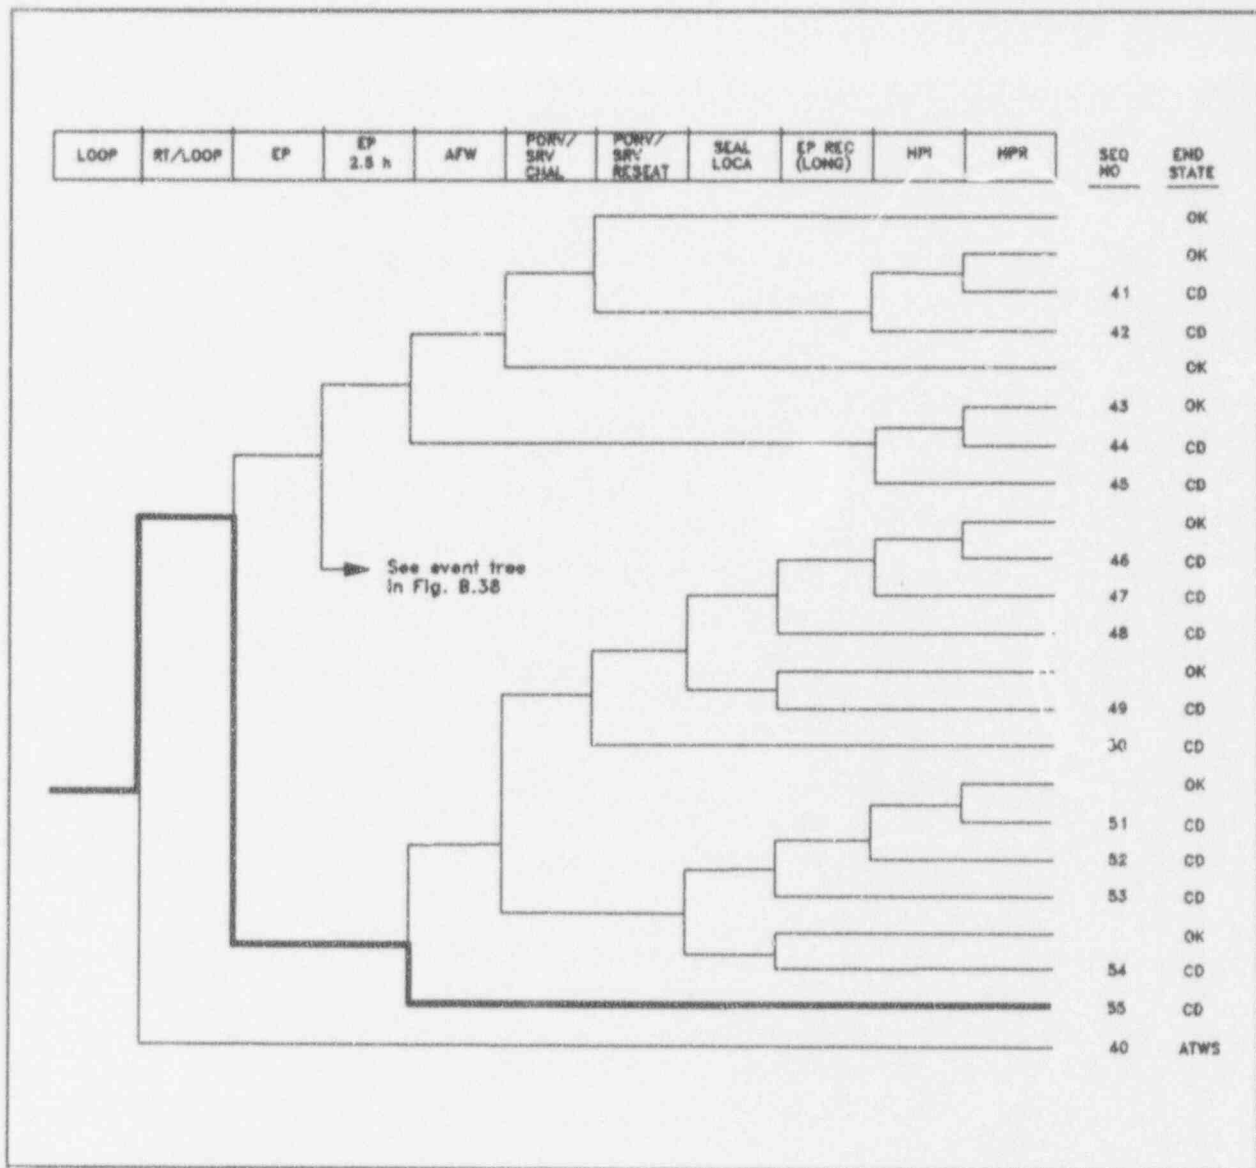
The conditional core damage probability for this event is estimated to be 1.7×10^{-5} . Two cases were run to examine the sensitivity of the results to the operability of the 3B EDG. Case 1 assumes that the 3B train of equipment is not degraded and is operable throughout the event and results in a value of 1.3×10^{-5} . Case 2 assumes that the 3B train of equipment is inoperable throughout the event and results in a value of 2.6×10^{-4} . The dominant core damage sequence, highlighted on the event tree in Fig. B.39, involves a reactor trip, a postulated failure of on-site emergency power, and a postulated failure of auxiliary feedwater.

Fig. B.39. Dominant core damage sequences for LER 302/92-001 and 302/92-002

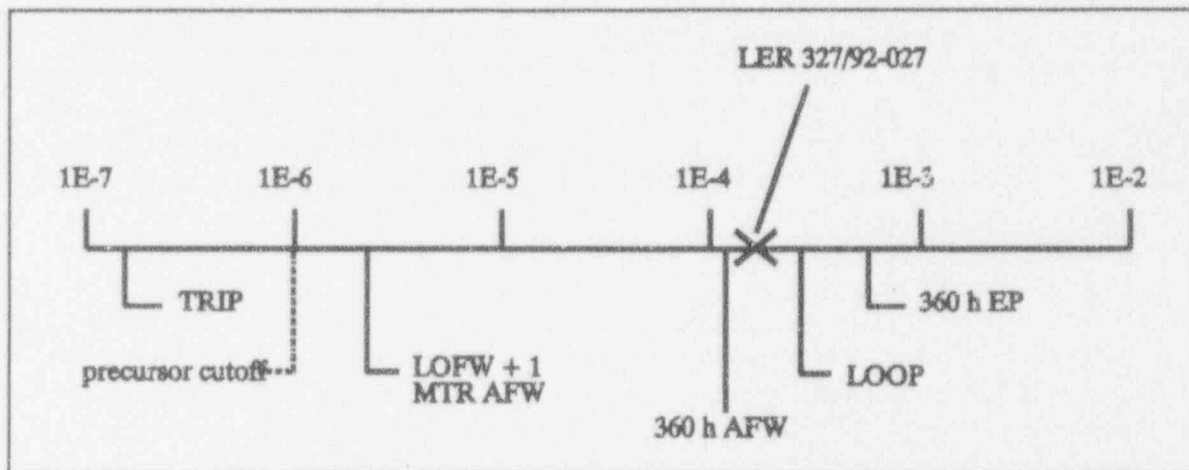
Shortly after a switchyard tie breaker was installed, it faulted and caused an undervoltage condition in the switchyard. This resulted in the tripping of both units from 100% power after both unit's reactor coolant pumps (RCPs) tripped on undervoltage. Because of the momentary undervoltage condition on the safeguards buses, the emergency diesel generators started and loaded. The conditional core damage probability estimated for this event is 1.8×10^{-4} per unit. The relative significance of this event compared to other postulated events at Sequoyah is shown in Fig. B.40.

Fig. B.40. Relative event significance of LER 327/92-027 compared with other potential events at Sequoyah 1 & 2.

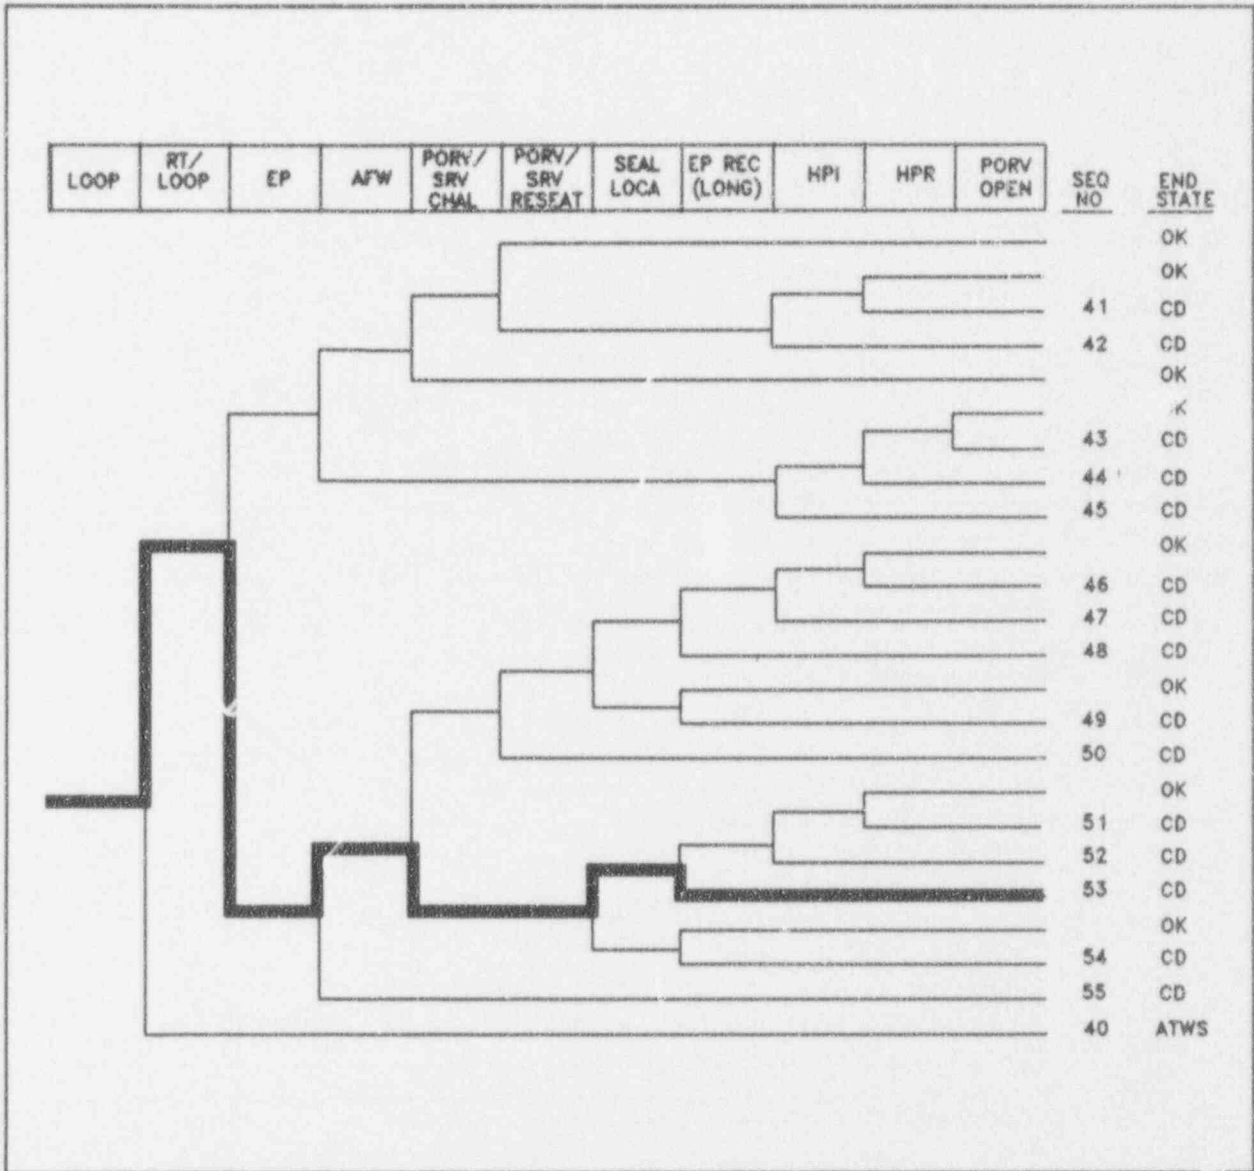
The conditional probability of core damage estimated for this event is 1.8×10^{-4} per unit. The dominant core damage sequence, highlighted on the event tree in Fig. B.41, involves failure of emergency power restoration resulting in an RCP seal LOCA.

Fig. B.41. Dominant core damage sequence for LER 327/92-027.

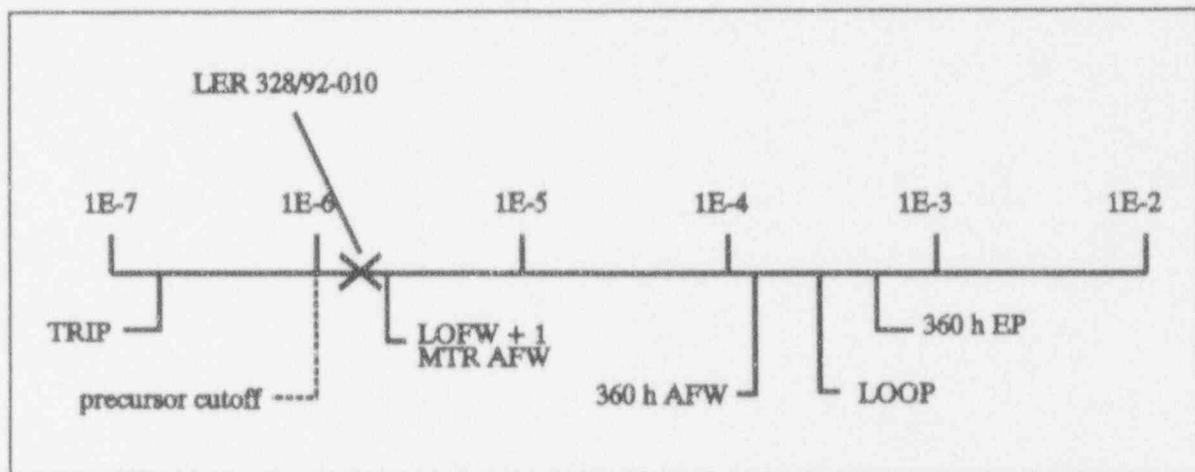
During performance of a surveillance procedure on the 2B-B Residual Heat Removal (RHR) pump, it was found that the miniflow control valve continuously cycled open and closed when it should have remained opened. While the 2B-B RHR pump was inoperable, the 2A-A emergency diesel generator (EDG) was inoperable for 17 h and the 2A-A centrifugal charging pump was inoperable for 6 h. The conditional core damage probability estimated for this event is 1.9×10^{-6} . The relative significance of this event compared to other postulated events at Sequoyah, Unit 2 is shown in Fig. B.42.

Fig. B.42. Relative event significance of LER 328/92-010 compared with other potential events at Sequoyah 2.

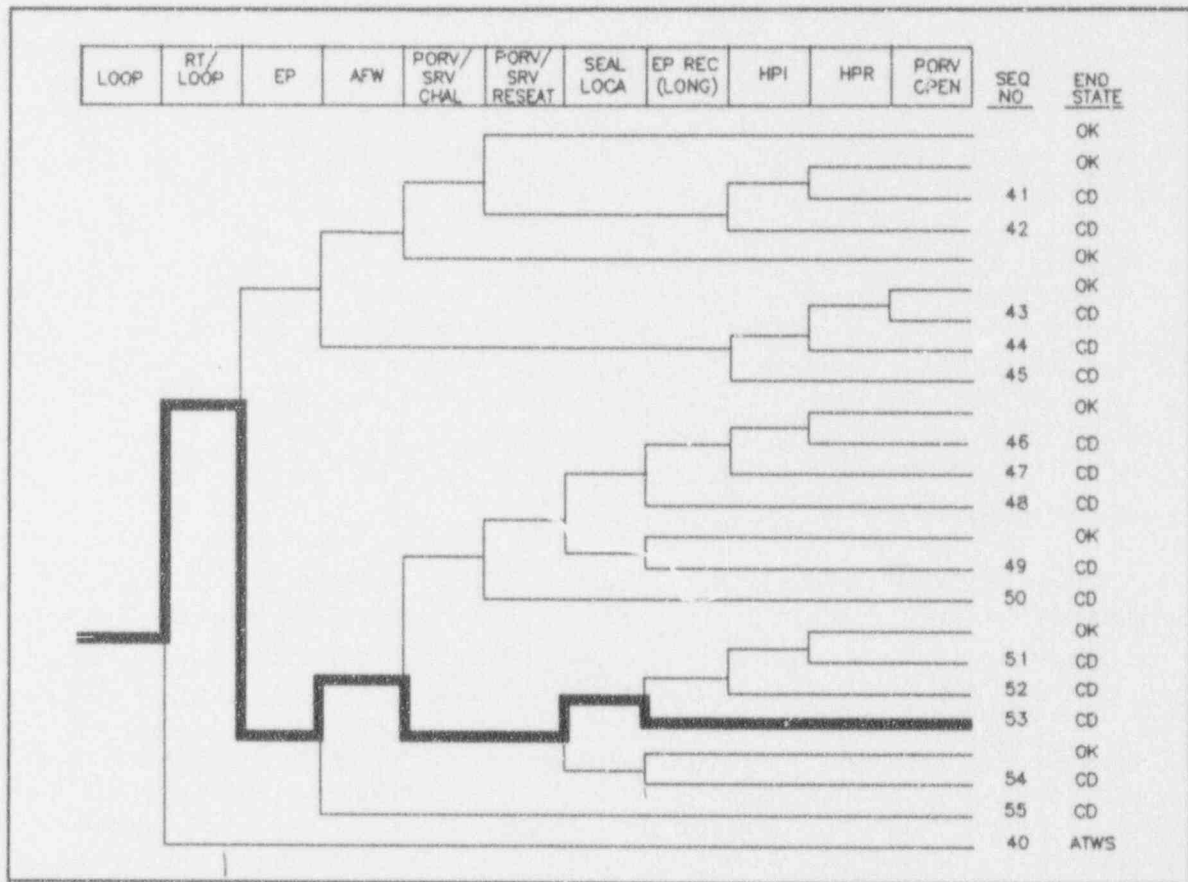
The conditional probability of core damage estimated for this event is 1.9×10^{-6} . The dominant sequence, highlighted on the event tree in Fig. B.43, involves a postulated LOOP with failure of on-site emergency power, and failure to recover offsite power prior to a RCP seal LOCA.

Fig. B.43. Dominant core damage sequences for LER 328/92-010

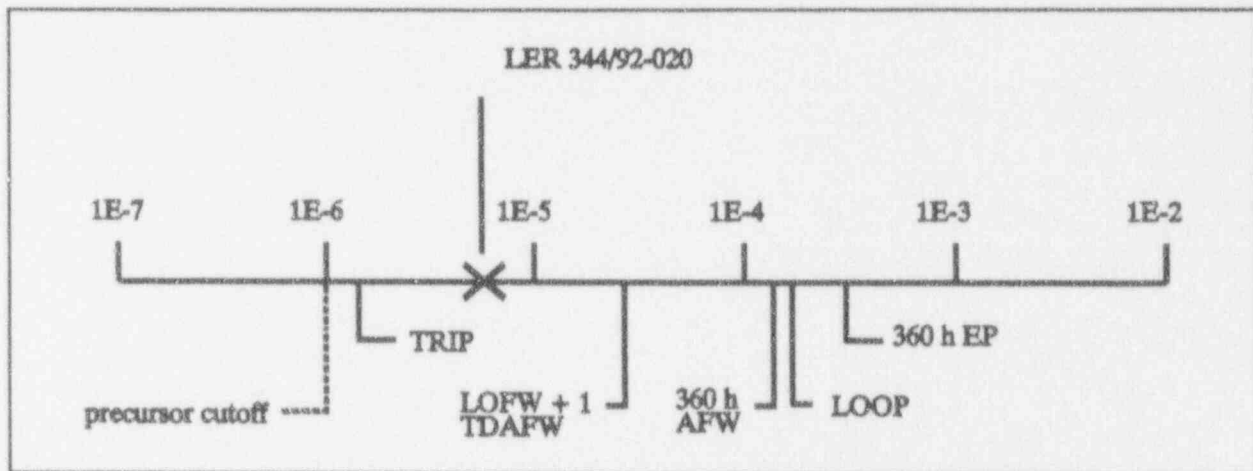
Trojan was operating at 100% power on July 22, 1992 when erratic controller performance on one main feedwater (MFW) pump and controller failure on the other MFW pump resulted in a reactor trip on low-low steam generator (SG) level. The controller for the auxiliary feedwater (AFW) pump turbine also failed, rendering one of two safety-grade AFW pumps inoperable. The conditional core damage probability estimated for this event is 5.9×10^{-6} . The relative significance of this event compared to other postulated events at Trojan is shown in Fig. B.44

Fig. B.44. Relative event significance of LER 344/92-020 compared with other potential events at Trojan.

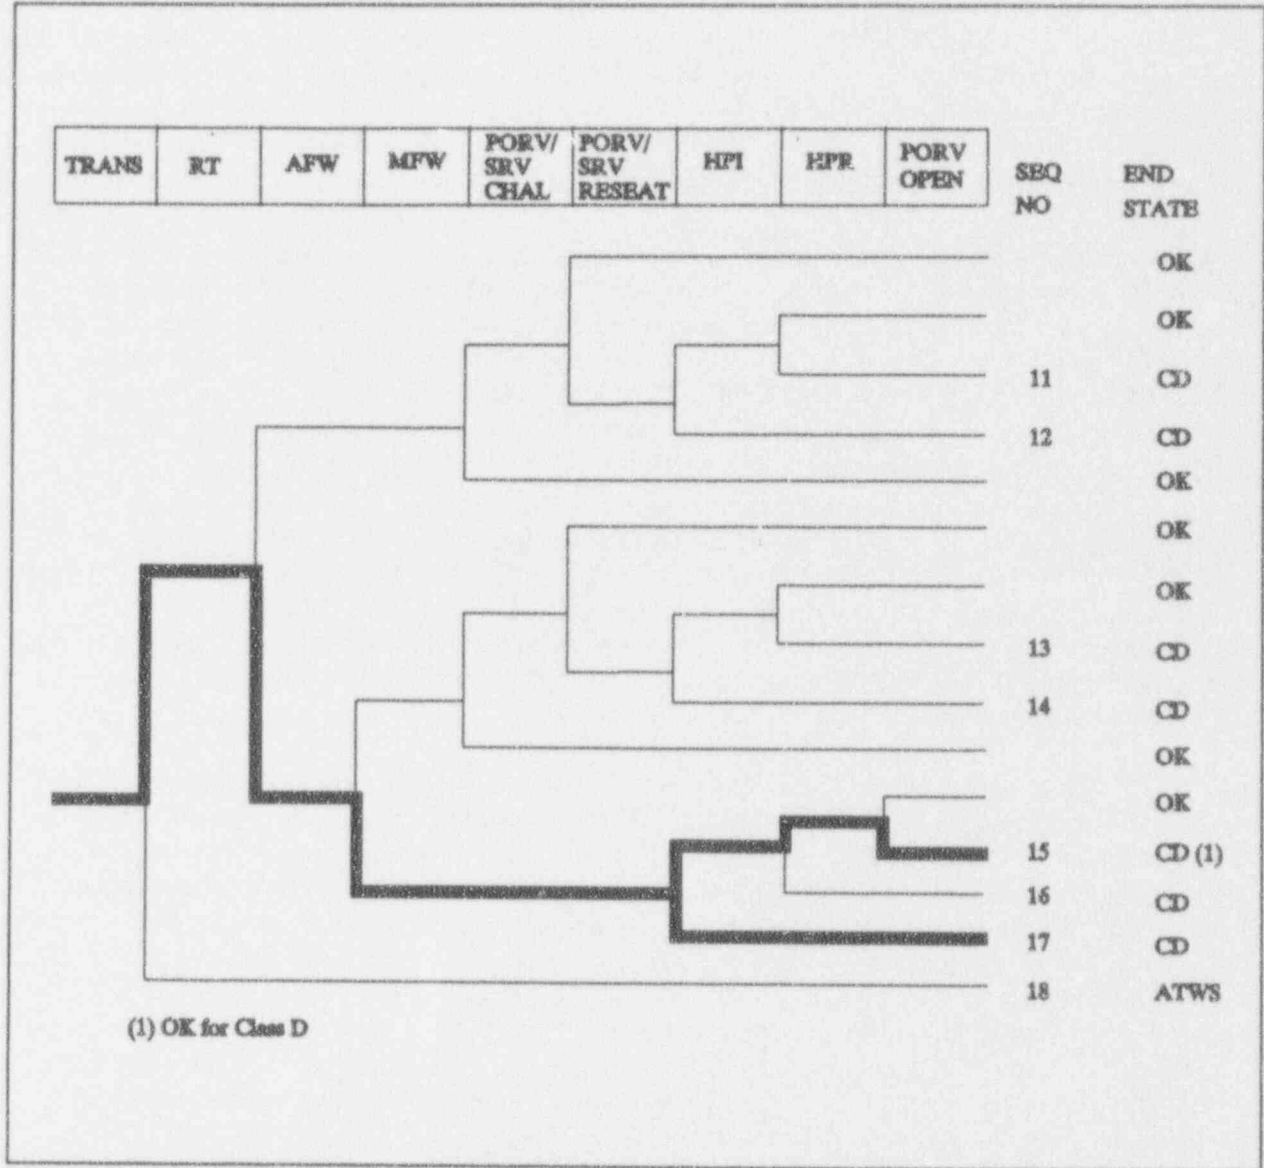
The conditional probability of subsequent core damage estimated for this event is 5.9×10^{-6} . The dominant core damage sequences, highlighted on the following event tree in Fig. B.45, involve failure of all sources of SG makeup and failure of feed-and-bleed cooling.

Fig. B.45. Dominant core damage sequences for LER 344/92-020

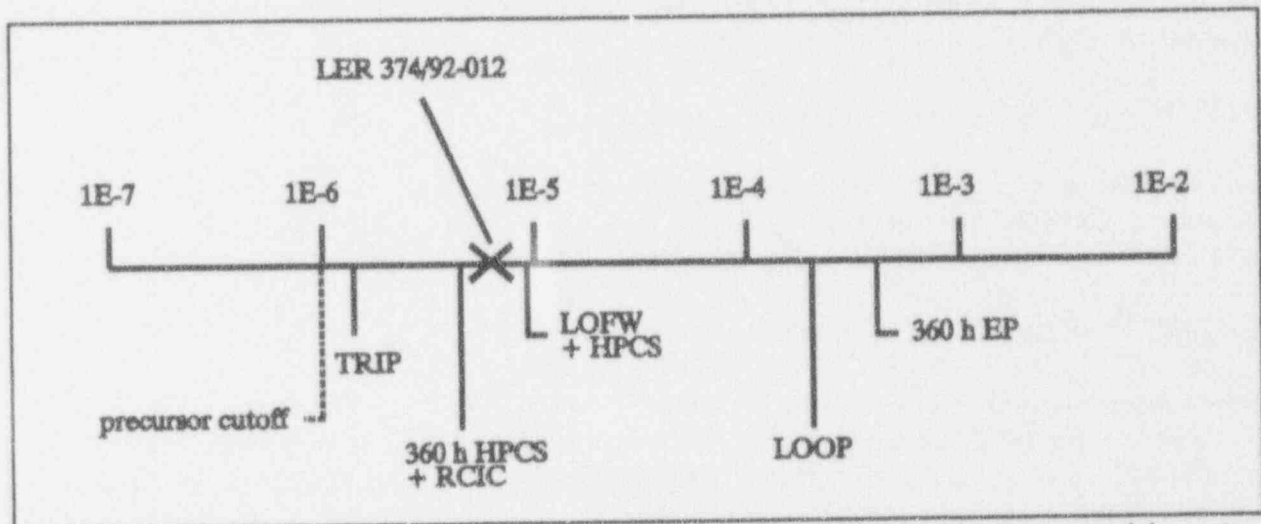
The reactor scrammed from 80% power because of a main turbine trip. The main turbine tripped due to a thrust bearing failure indication. The reactor core isolation cooling system (RCIC) auto-started, and the motor-driven feed pump (MDFP) was started in preparation for tripping the turbine-driven feed pumps (TDFPs). However, when the TDFPs failed to trip, the reactor water level rose, resulting in a trip of the MDFP and RCIC. In an attempt to prevent flooding of the steam lines, the outboard main steam isolation valves (MSIVs) were manually closed, resulting in a TDFP shutdown. Later, the operators experienced difficulty in starting RCIC for reactor pressure control. Water that had accumulated in the steam line passed through the pump turbine and into the exhaust header. Flashing of that water to steam prevented RCIC startup due to high exhaust pressure trip signals. The conditional probability of subsequent core damage estimated for the event is 6.1×10^{-6} . The relative significance of the event compared to other postulated events at LaSalle 2 is shown in Fig. B.46.

Fig. B.46. Relative event significance of LER 374/92-012 compared with other potential events at La Salle.

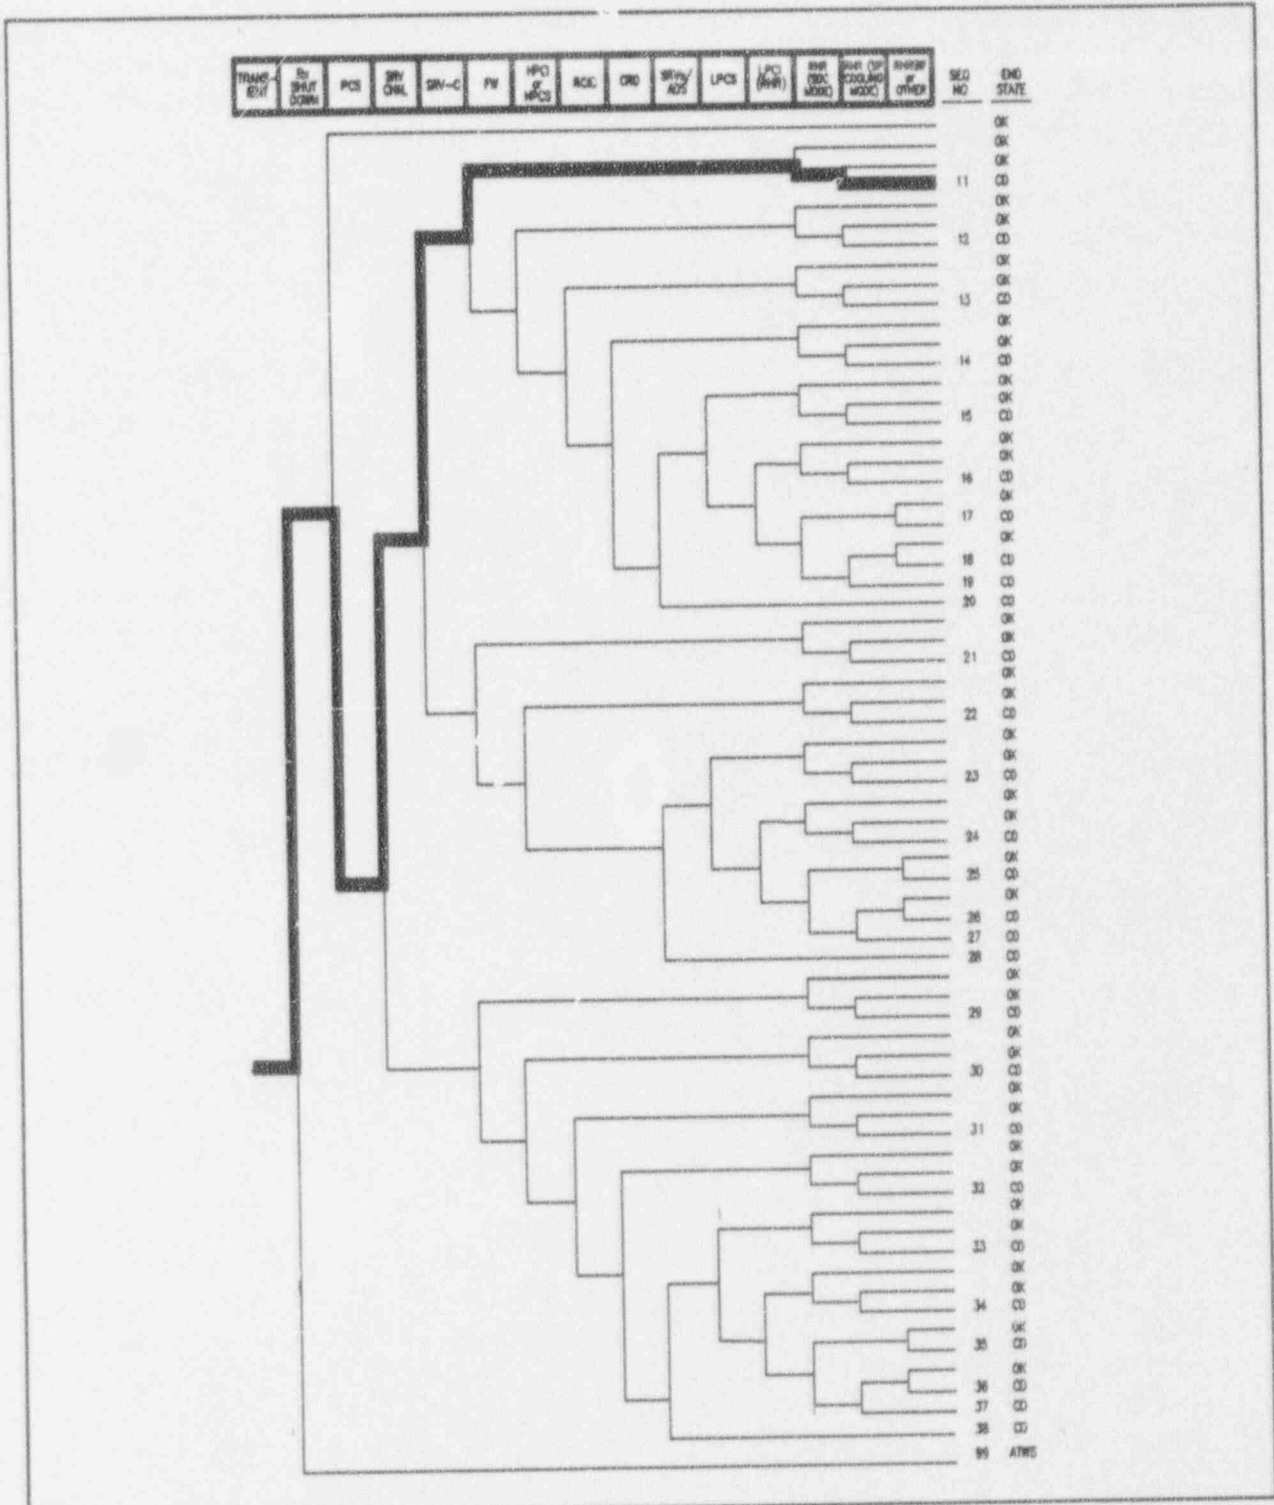
Fig. B.47. Dominant core damage sequences for LER 374/92-012

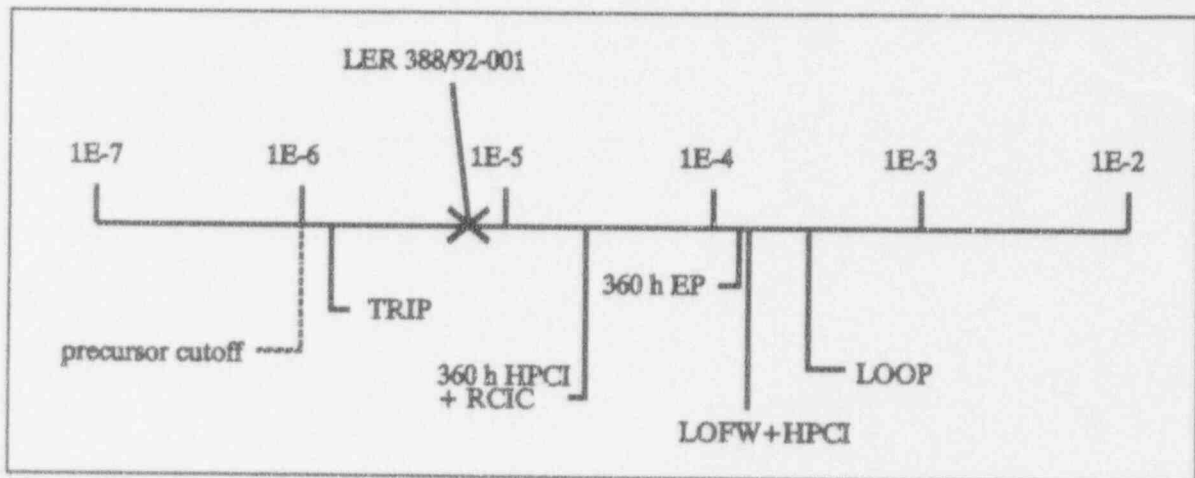
Susquehanna 2 was operating at 100% power on March 18, 1992 when emergency diesel generator (EDG) B failed during surveillance testing, preparations were begun to align the spare diesel, EDG E, in its place. During the course of these preparations, ESF bus C suddenly isolated. Since this isolated the containment instrument gas supply required for control of the main steam isolation valves (MSIVs), the reactor was manually scrammed in anticipation of an automatic scram on MSIV closure. The conditional core damage probability estimated for this event is 6.6×10^{-6} . The relative significance of this event to other postulated events at Susquehanna is shown in Fig. B.48.

Fig. B.48. Relative event significance of LER 388/92-001 compared with other potential events at Susquehanna 2.

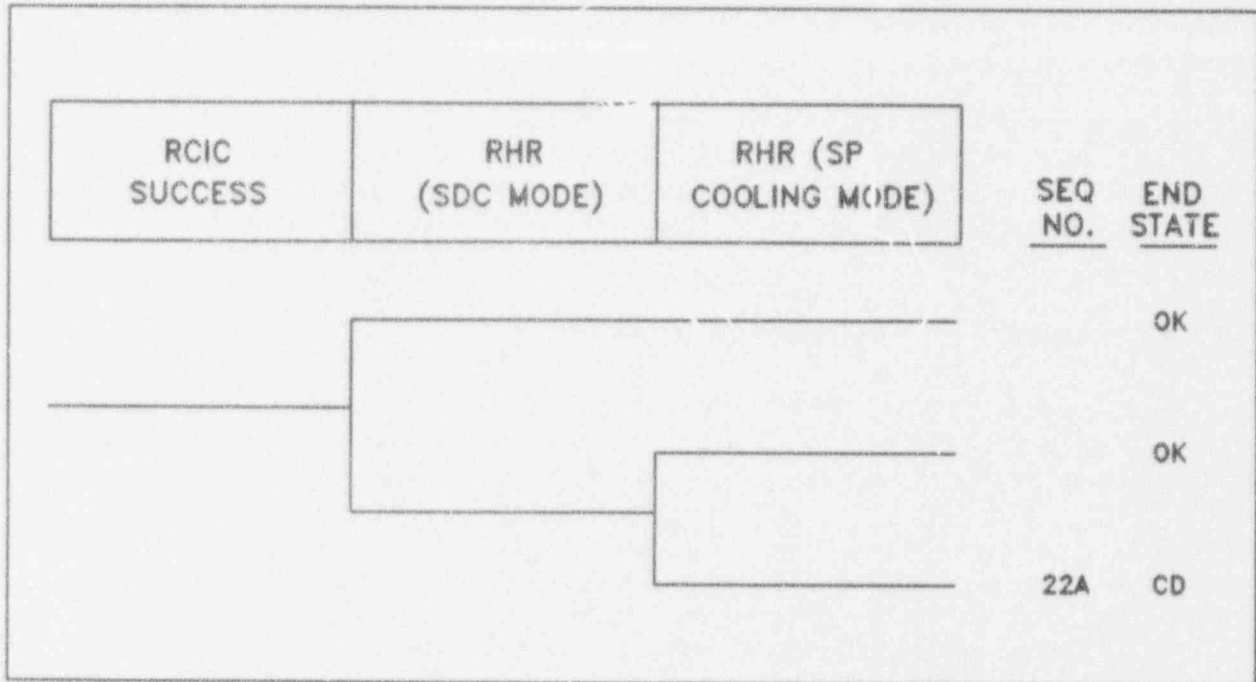
Fig. B.49. Modification to event tree when power conversion, feedwater, and HPCI systems are unavailable and an SRV has opened but failed to close.

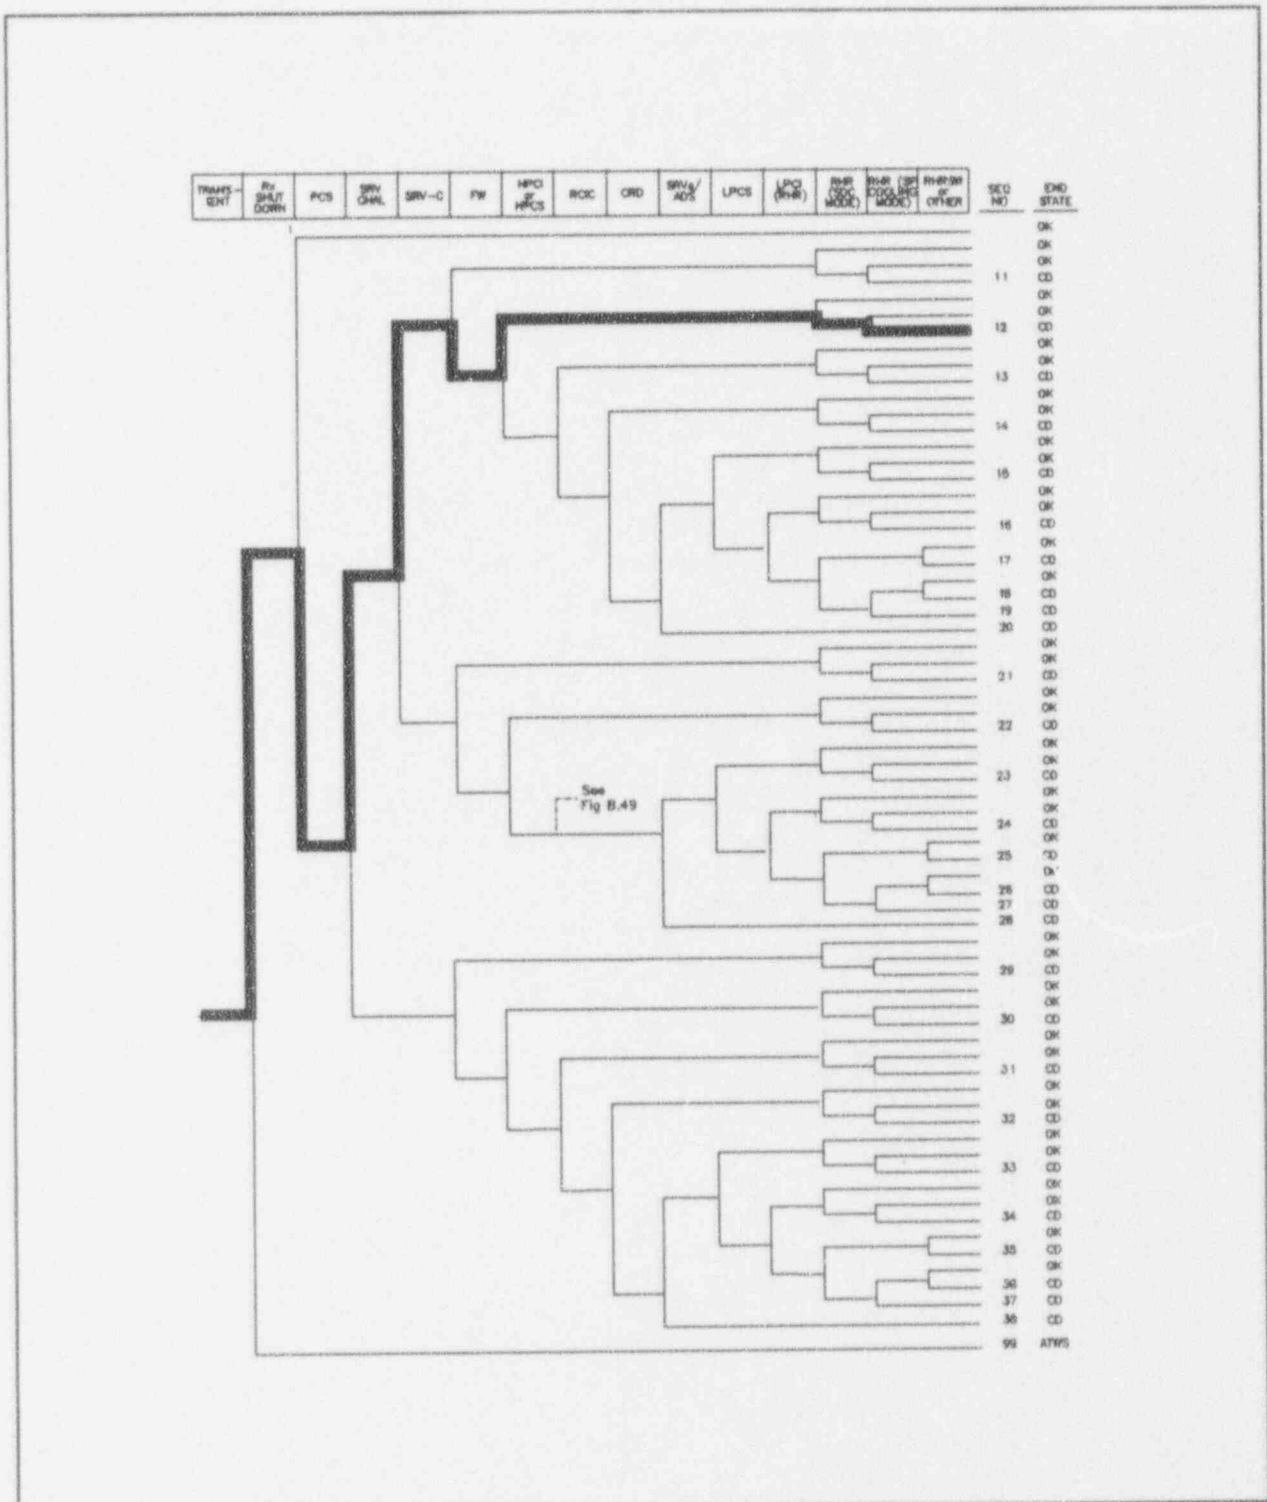
The conditional probability of core damage for this event is estimated to be 6.6×10^{-6} . The dominant core damage sequence for this event, shown in Fig. B.50, involves scram with feedwater and power conversion systems unavailable, SRV operation and successful closure, HPCI success and failure of RHR shutdown cooling and suppression pool cooling modes.

Fig. B.50. Dominant core damage sequence for LER 388/92-001.

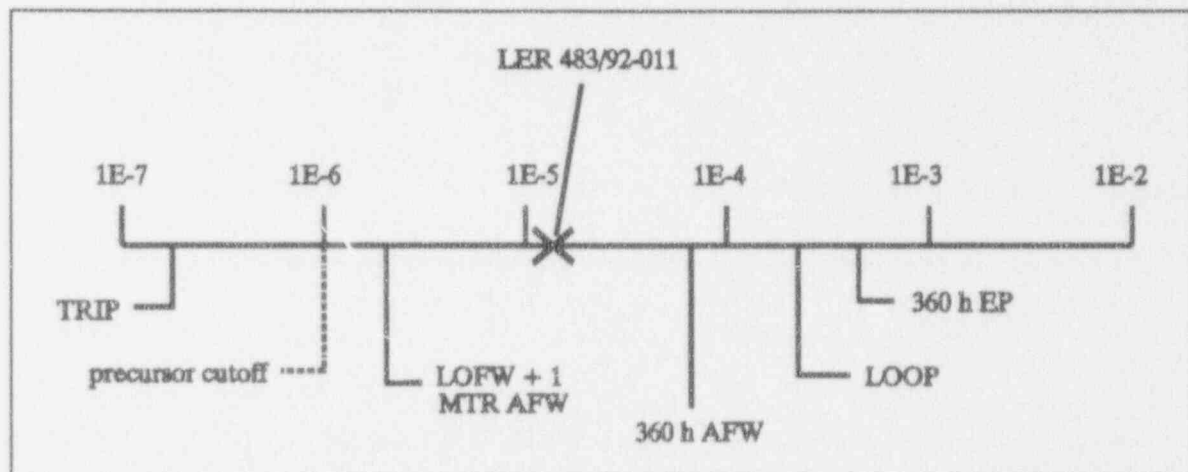
Callaway was at 100% power on October 17, 1992. At 0100 hours a replacement power supply for the annunciator system was being placed into service. Failure of this power supply had caused 198 main control board (MCB) annunciator windows to fail and caused 76 to light. During this replacement process, a short circuit caused logic power supply fuses to blow, lighting 371 of 683 MCB annunciator windows and thus causing the annunciator system to fail. Blown fuses in the four field contact power supplies were found and replaced about 1 h later. The operators assumed that this fuse replacement would return the annunciator system to normal operation, although anomalous behavior was still being observed. Actually, 164 annunciator windows remained inoperable. The remaining failed fuses were found and replaced, and the annunciator system was tested and confirmed operable at 1937 hours. The conditional core damage probability estimated for this event is 1.3×10^{-5} . This estimate may be conservative; the analysis was performed using screening human error probabilities (HEPs) and with limited information concerning the activities that were in progress at the time of the event. The relative significance of this event compared to other postulated events at Callaway is shown in Fig. B.51.

Fig. B.51. Relative event significance of LER 483/92-011 compared with other potential events at Callaway.

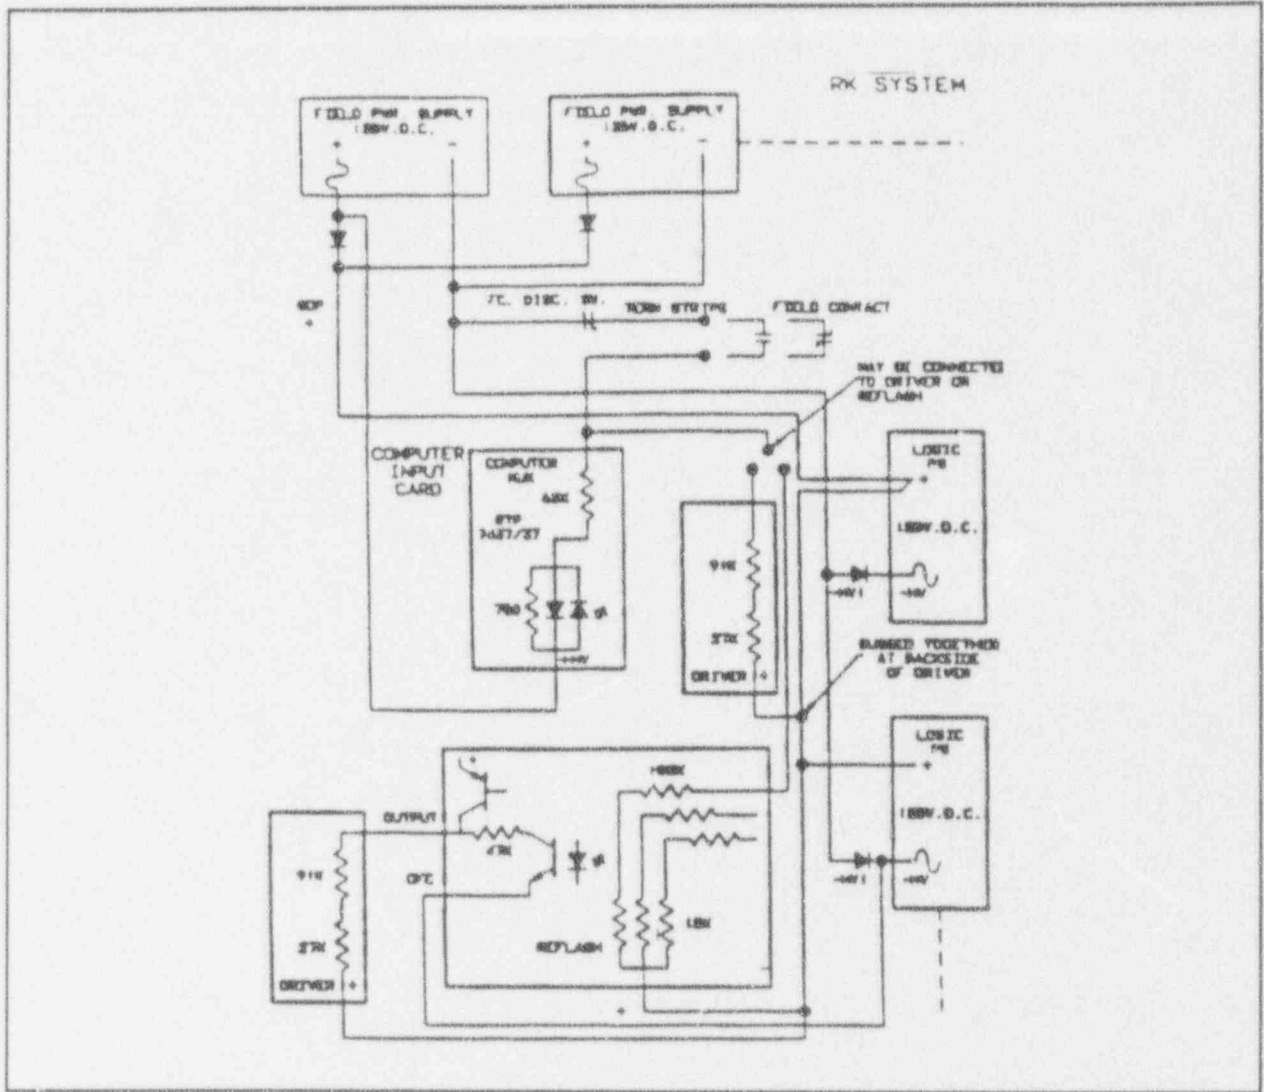
The system has four power supplies connected to a 125-Vdc station battery to power the 1400 field alarm contacts. These power supplies have common (parallel-connected) inputs and outputs, and each power supply input and output is protected by a 1 ampere "slow-blow" (delayed opening) fuse. There are also 14 logic power supplies that receive their input power from one of the two 125-Vdc station battery systems, one of which is common to the field contact power supplies discussed above. The logic power supplies provide five different voltages to the system. Each power supply has a protective fuse associated with its voltage. None of the fuses (78 total) have local indication or indicating lights to monitor their operability. The arrangement of the power supplies is shown in Fig. B.52.

Fig. B.52. Callaway annunciator power supplies.
 (Original figure was illegible.)
