NUREG/CR-4674
ORNL/NOAC-232
Vol. 18

Precursors To Potential Severe Core Damage Accidents: 1992 A Status Report

Appendices B, C, D, E, F, and G

Oak Ridge National Laboratory

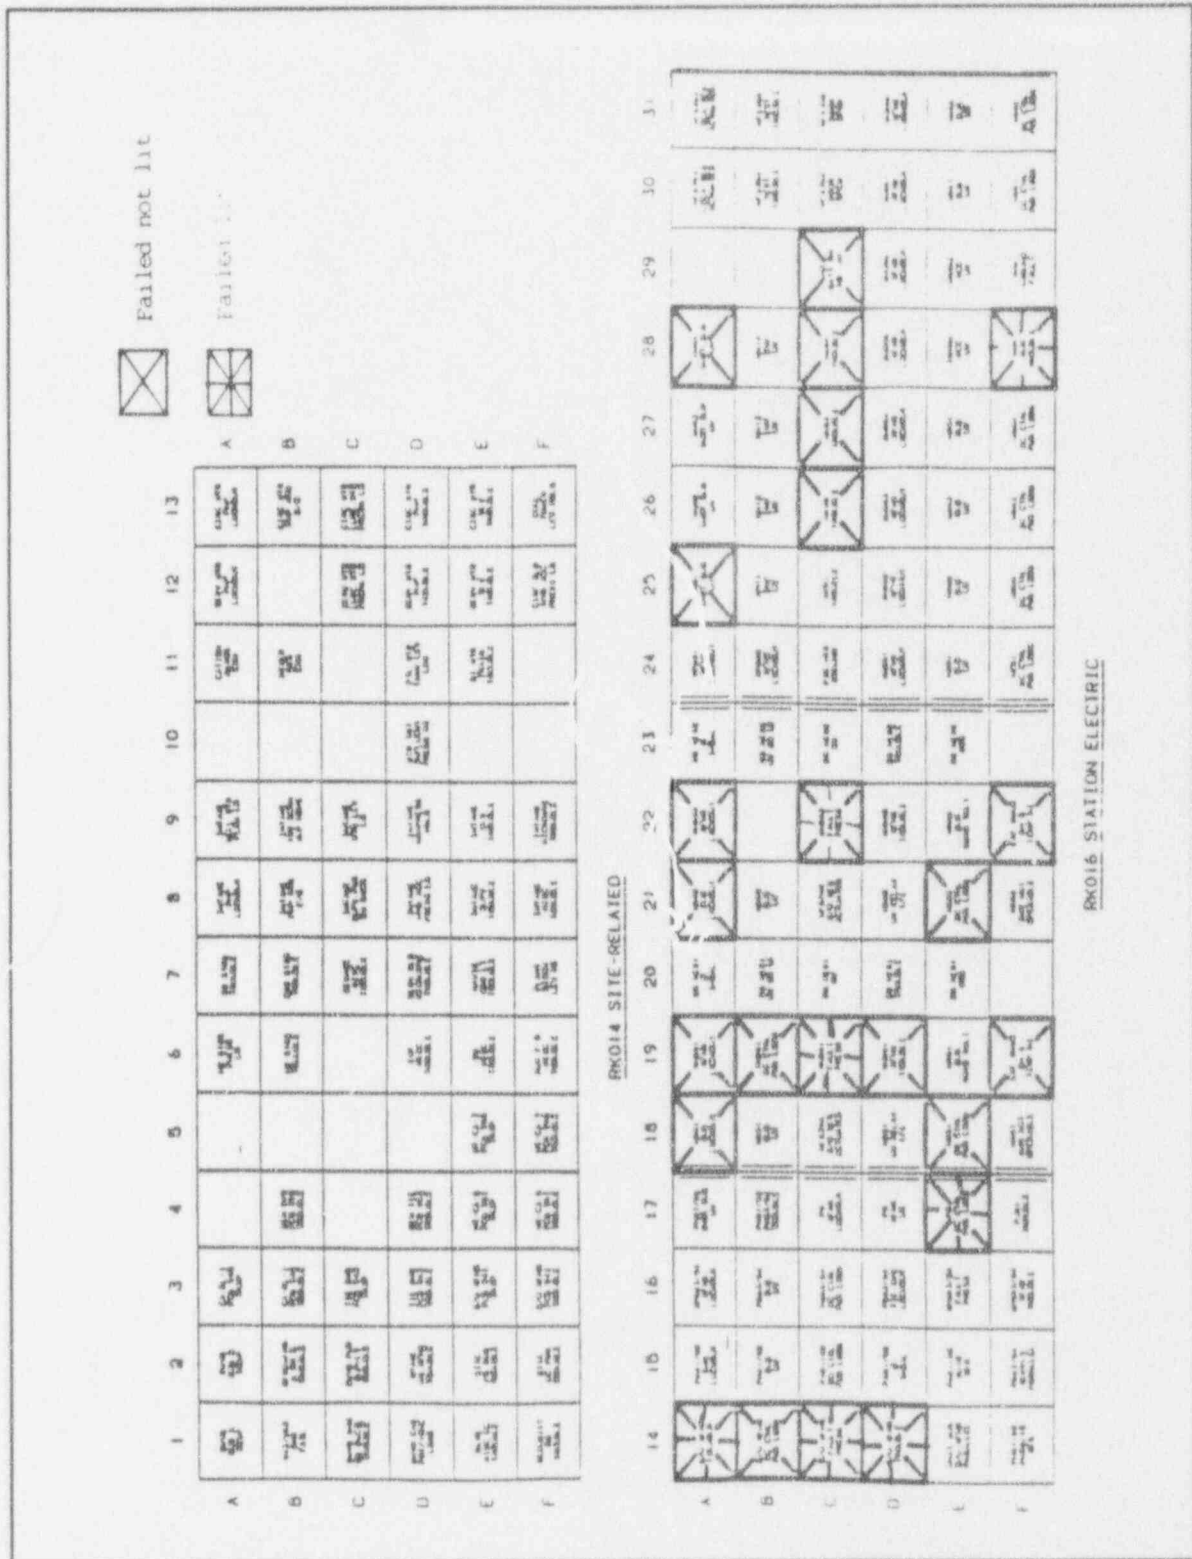
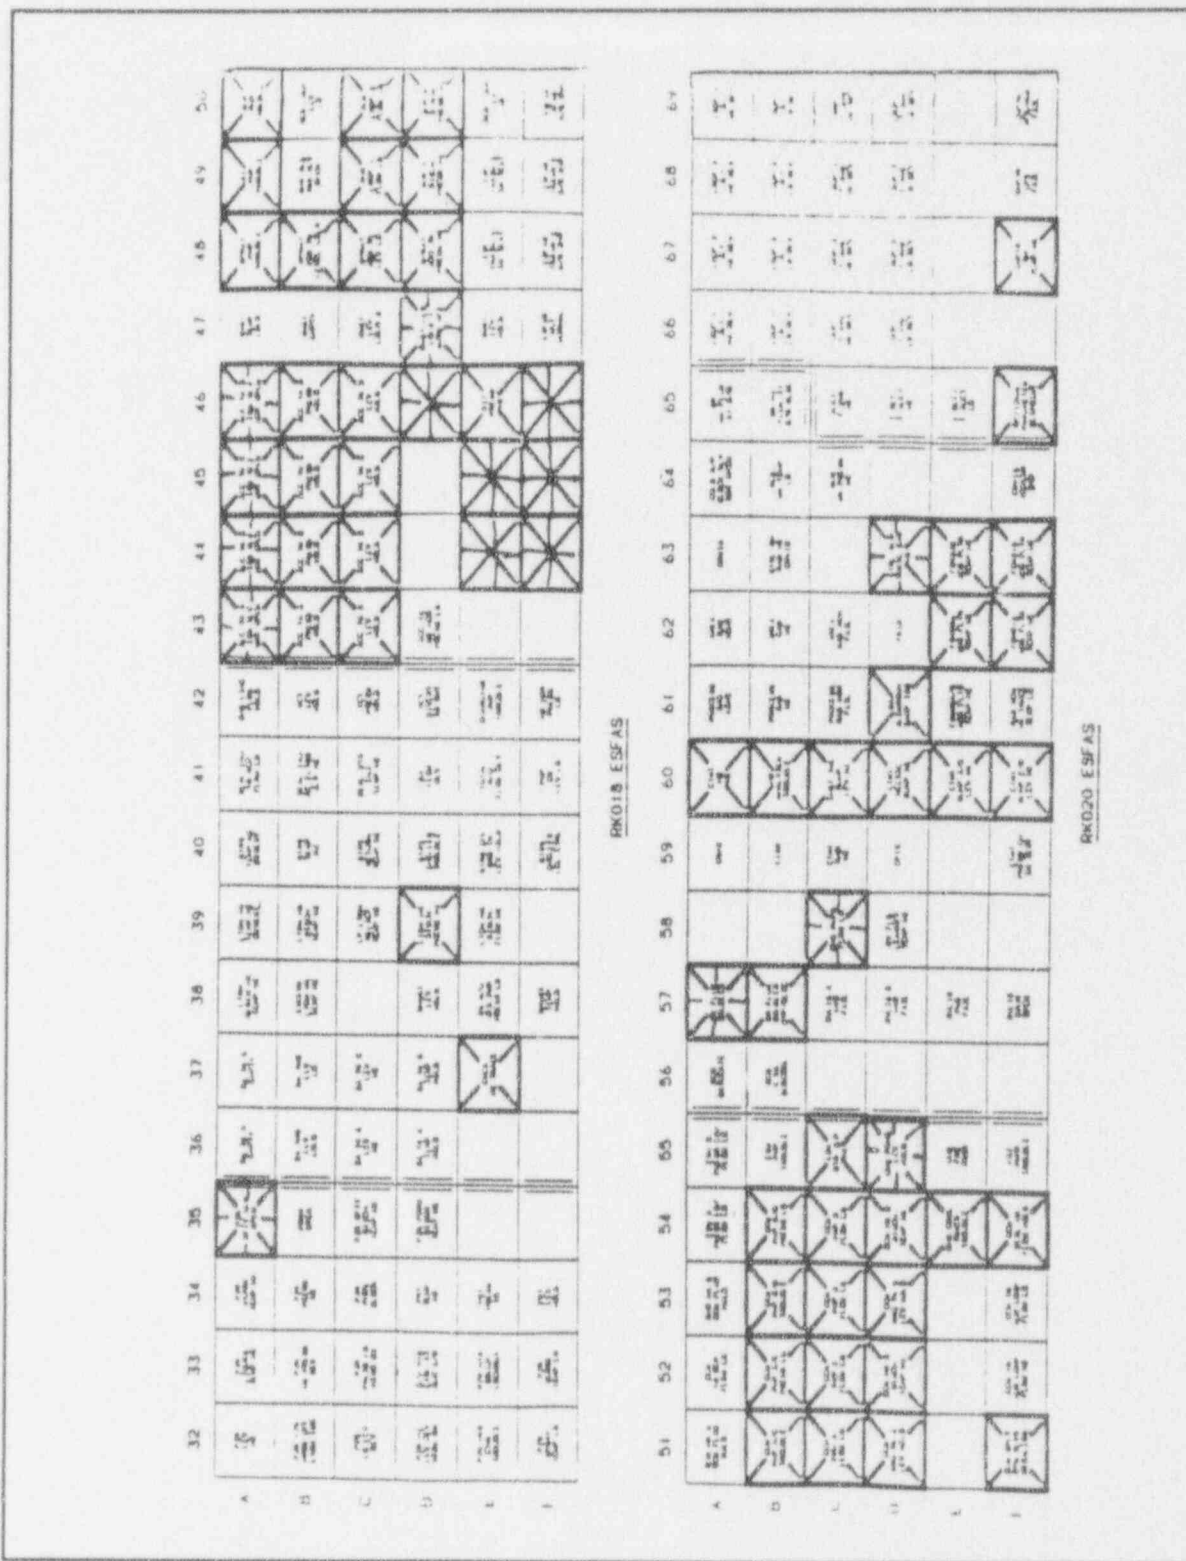
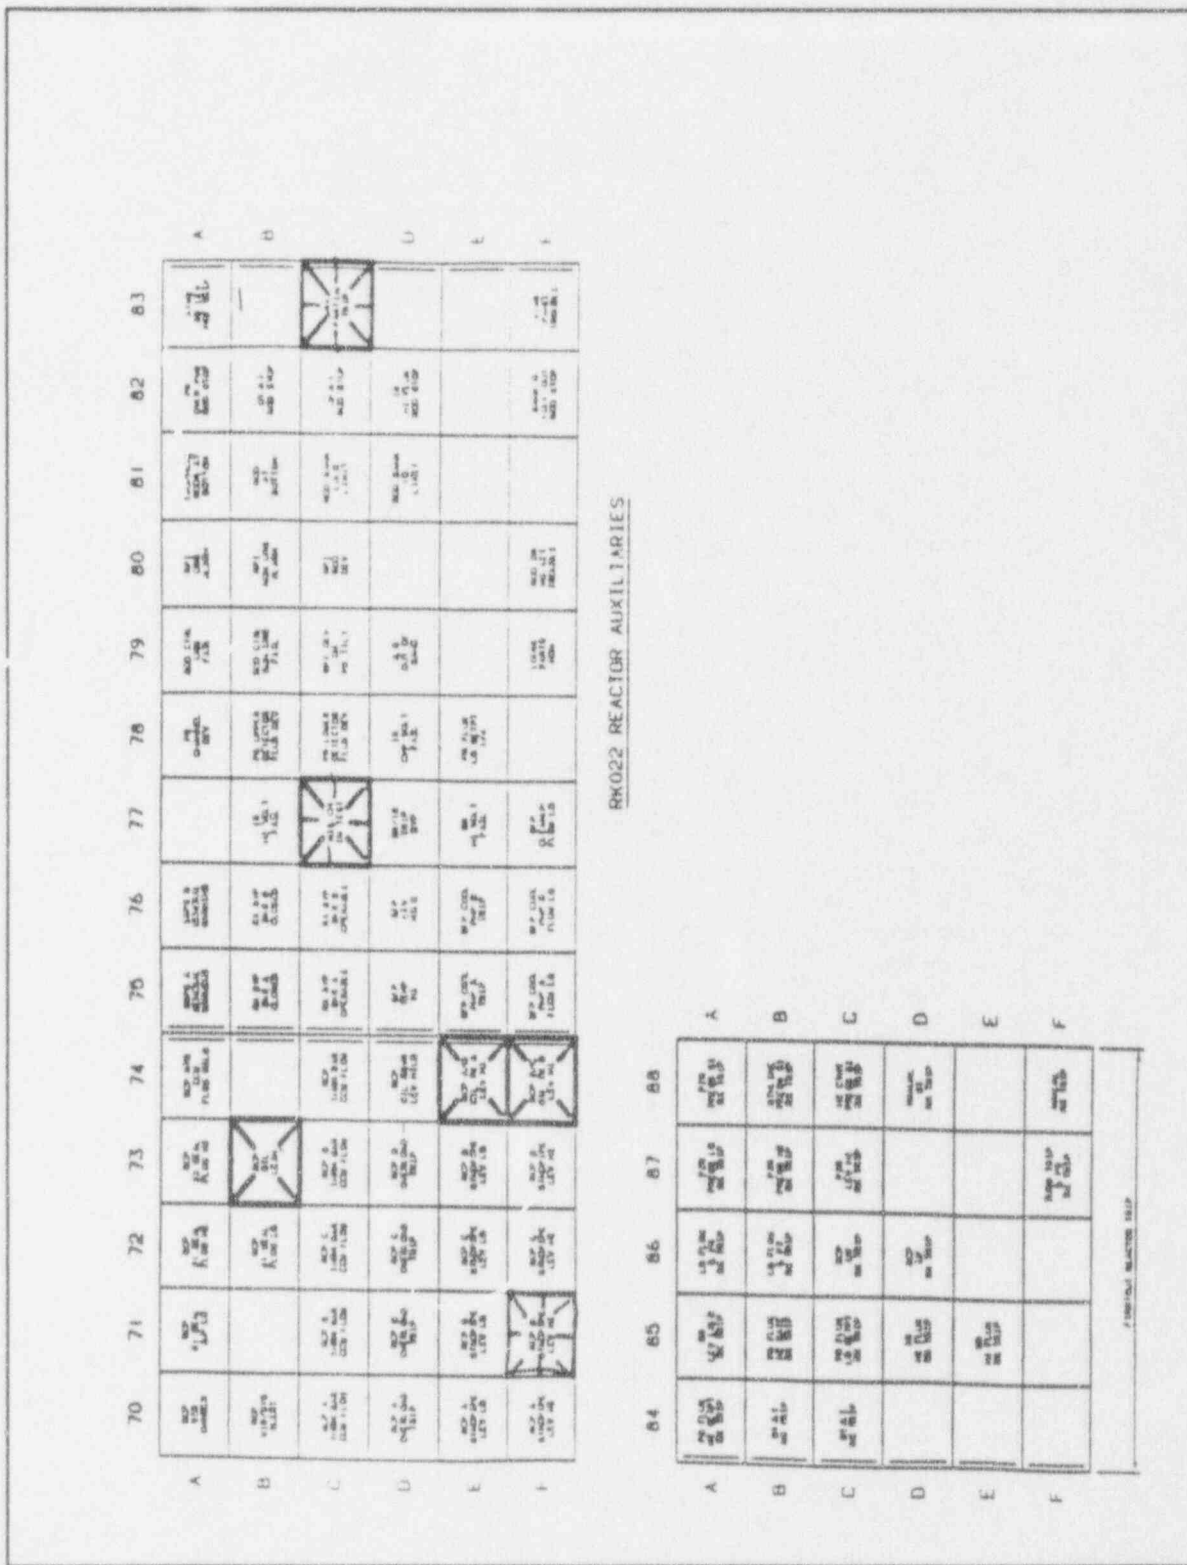
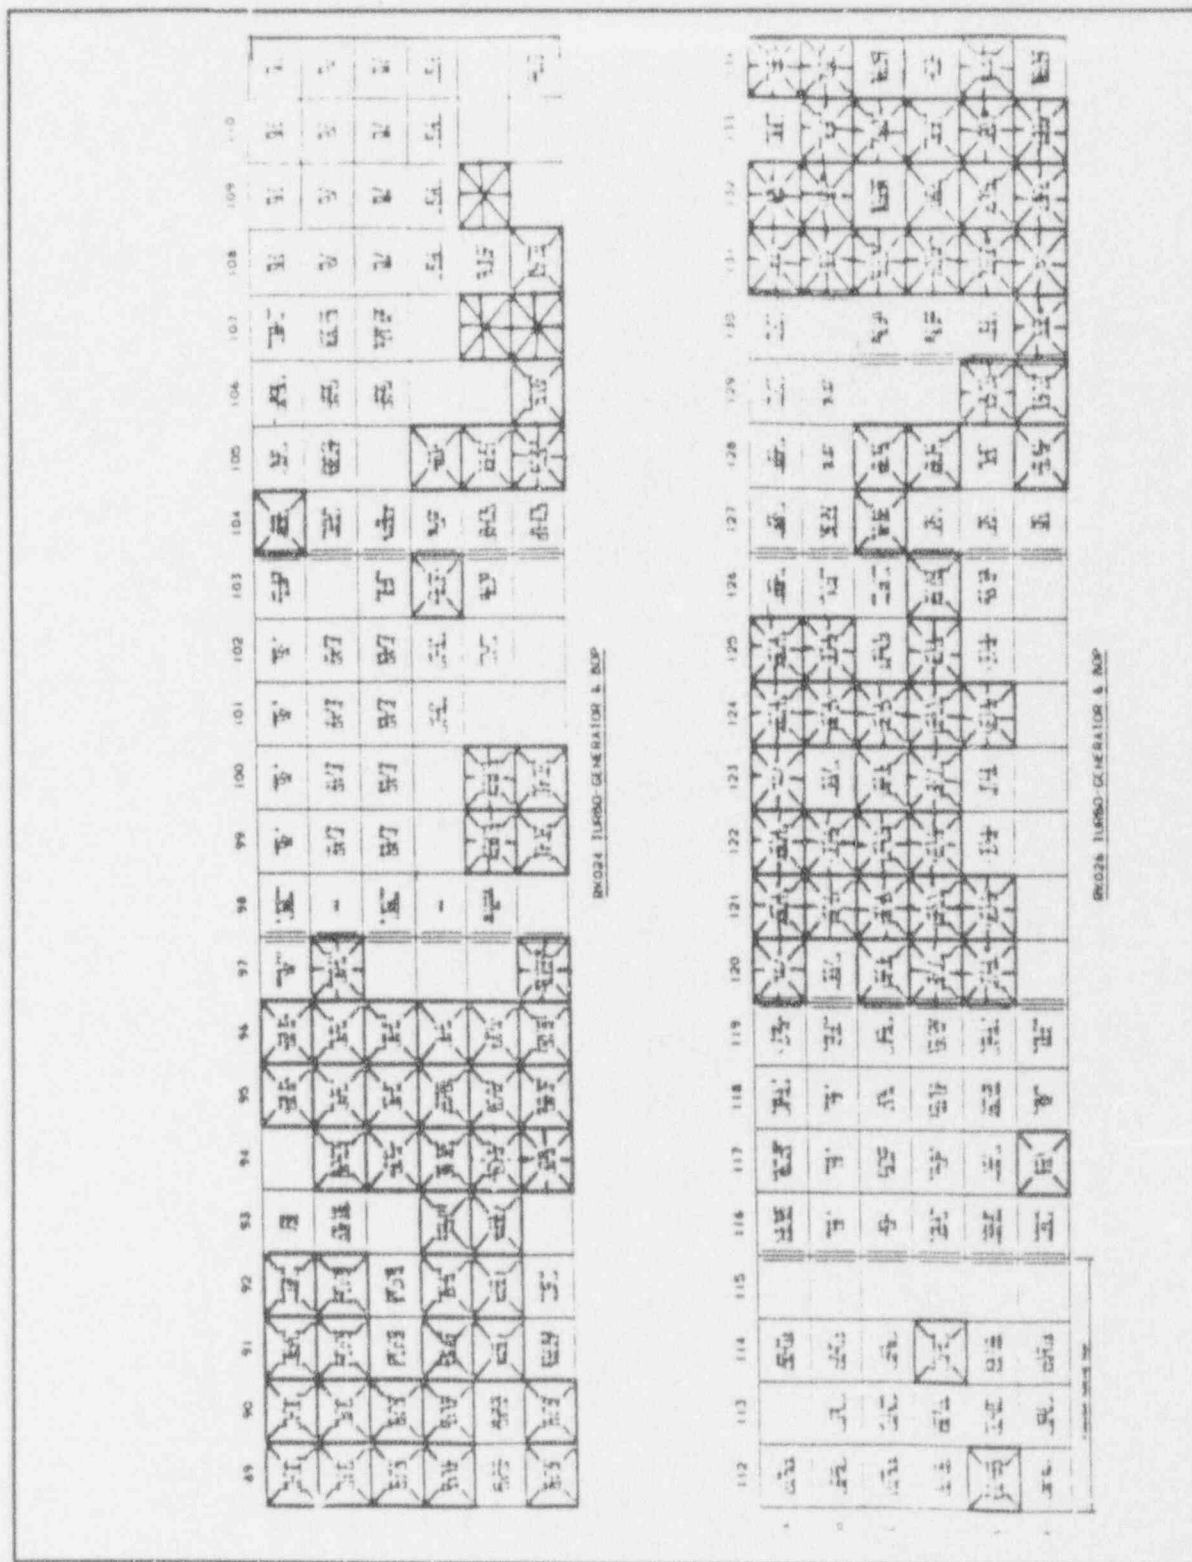
Annunciators that were inoperable prior to 0100 hours on October 17, 1992 (when one power supply was failed), are shown in Fig. B.53. Annunciators that were inoperable following the fuse replacement at 0156 hours are shown in Fig. B.54.

Fig. B.53. Failed annunciators prior to 0100 hours on October 17, 1992.
(Original figure was illegible.)

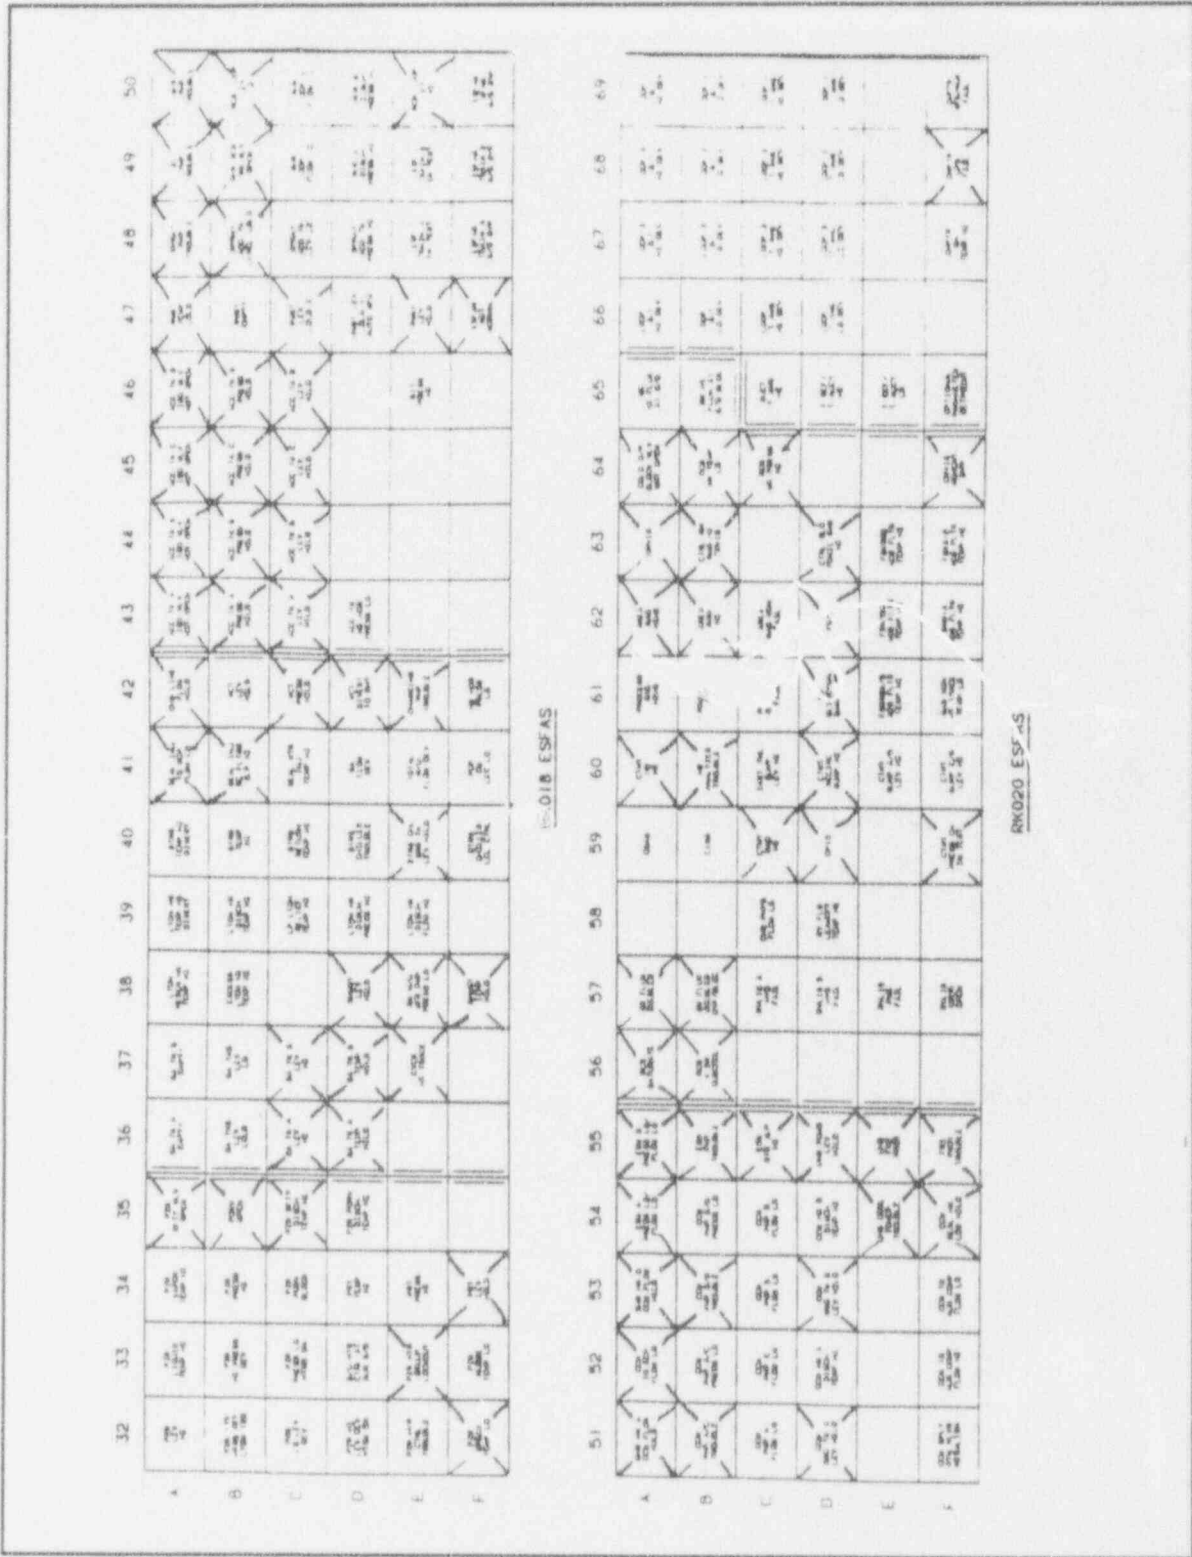
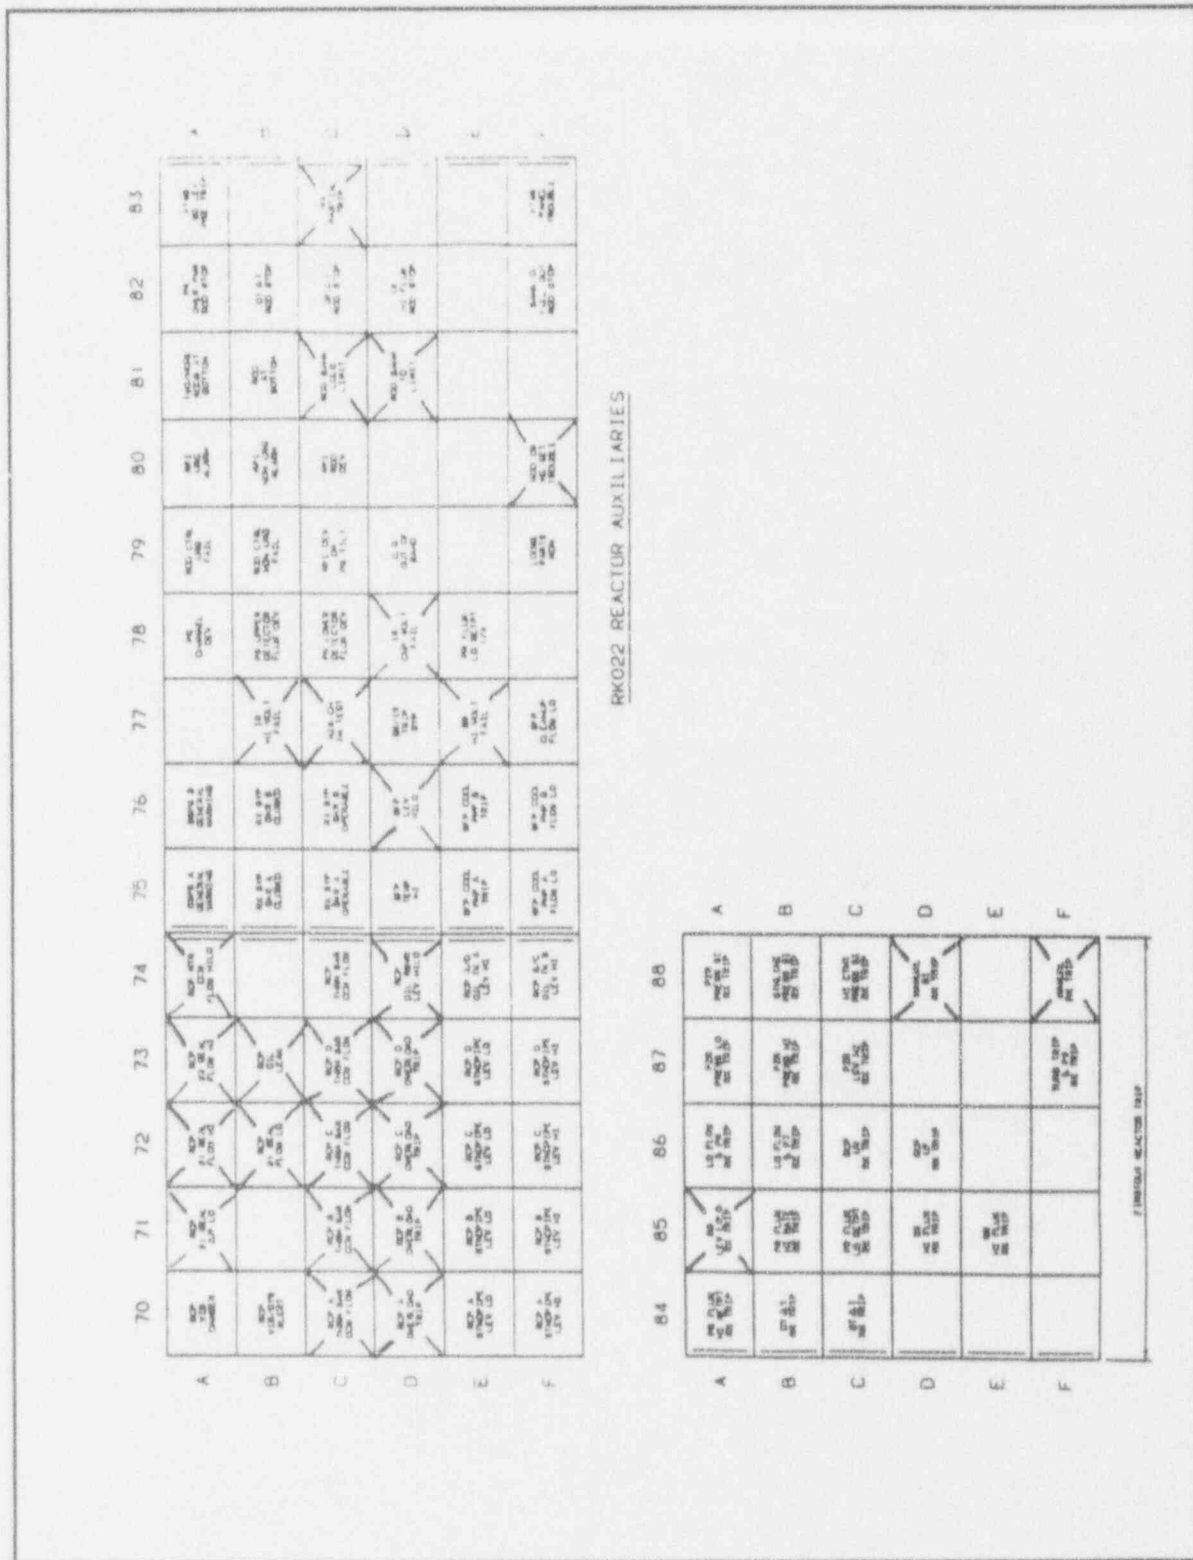
Fig. B.54. Failed annunciators after 0156 hours on October 17, 1992 (cont.).
 (Original figure was illegible.)

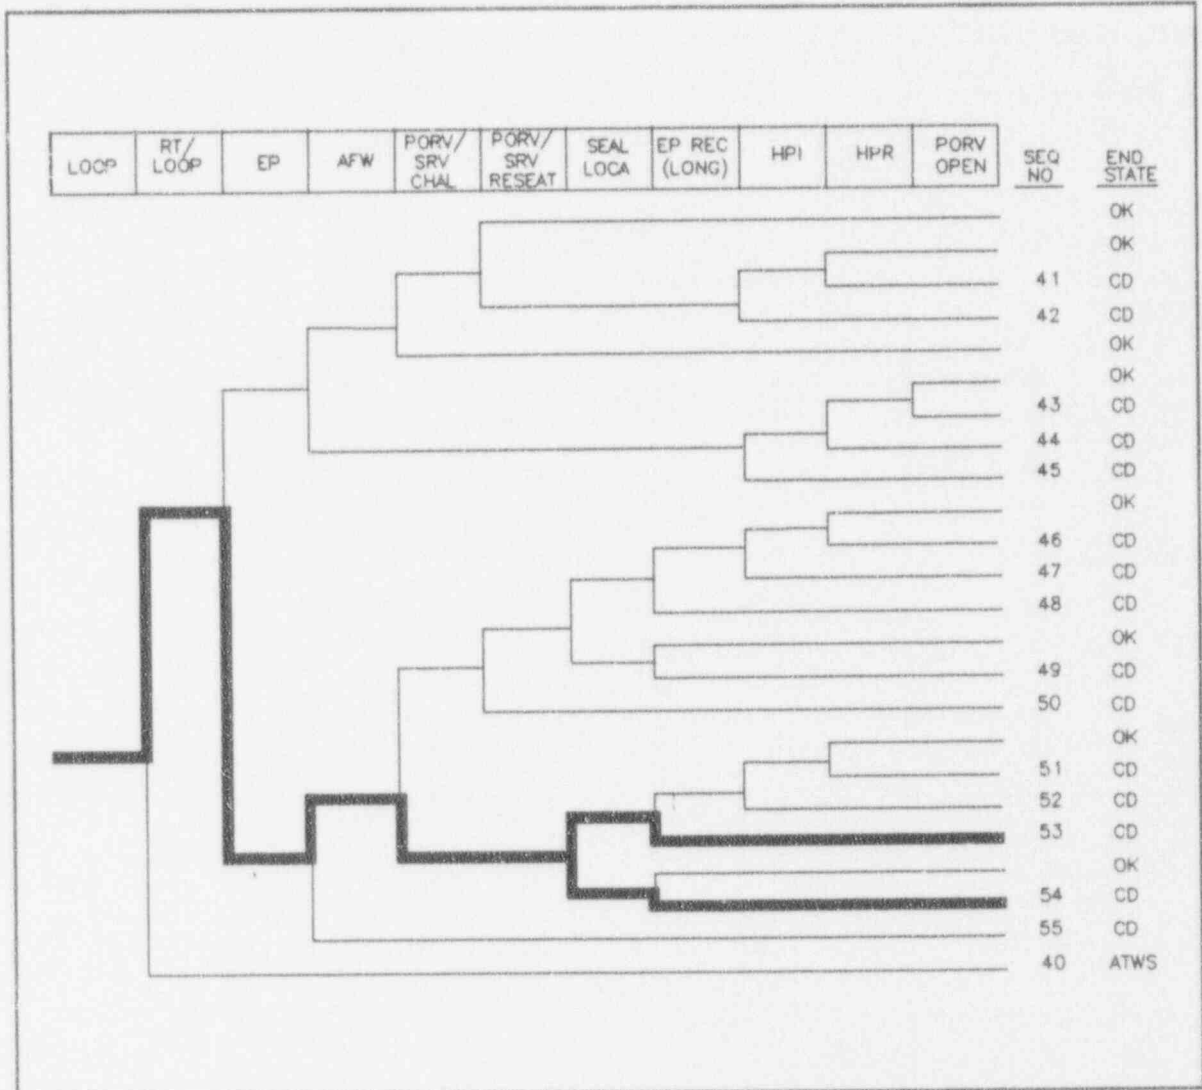
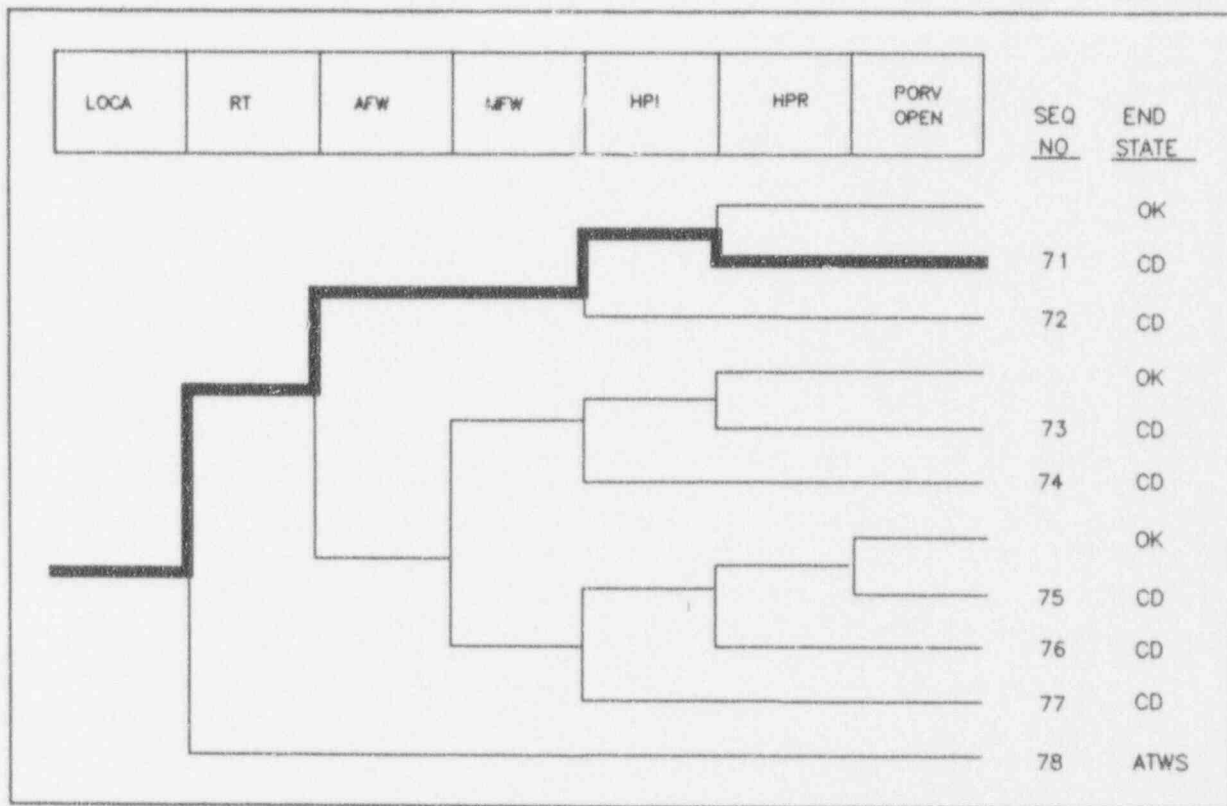
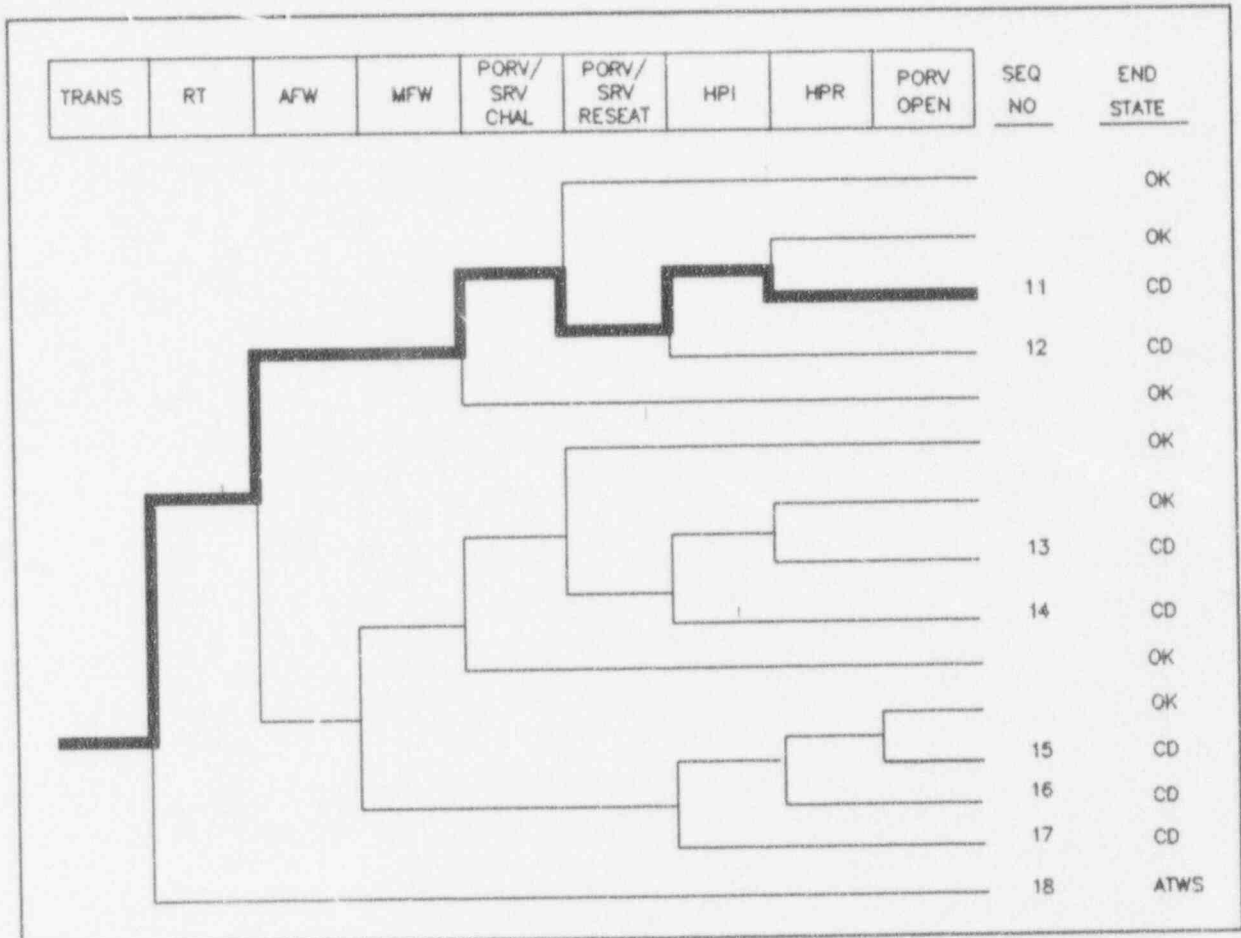
and Fig. B.57. The first sequence involves a postulated LOOP with a non-recoverable loss of emergency power, a reactor coolant pump seal LOCA, and failure to recover ac power prior to core unrecovery. The other two sequences had somewhat lower core damage probabilities. The second sequence involves a failure to initiate high-pressure recirculation following a postulated small-break LOCA with trip, AFW, and HPI success. The third sequence also involves the failure of high-pressure recirculation, but, in this instance, it follows a postulated transient-induced LOCA. This analysis used screening human error probabilities and limited information concerning the activities that were in progress at the time of the event. As such, the analysis is potentially conservative.

Fig. B.55. Dominant core damage sequences for LER 483/92-011.

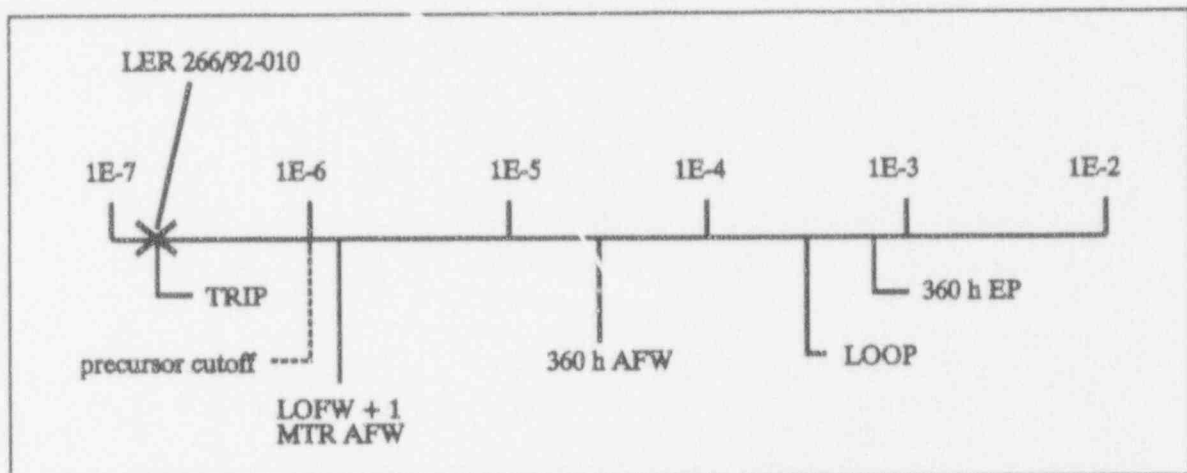
Quarterly valve stroke tests were found to isolate the minimum flow recirculation line common to each unit's two safety injection (SI) pumps. If the pumps were demanded when the recirculation line was isolated, pump failure would occur quickly for high reactor coolant system (RCS) pressure conditions. The conditional core damage probability estimated for this event is 1.7×10^{-7} . This probability is applicable to both units. This estimate is below the minimum level defined for precursors; however, the event is interesting enough to warrant its inclusion in the report. The relative significance of this event compared to other postulated events at Point Beach is shown in Fig. D.1.

Fig. D.1. Relative event significance of LER 266/92-010 compared with other potential events at Point Beach.

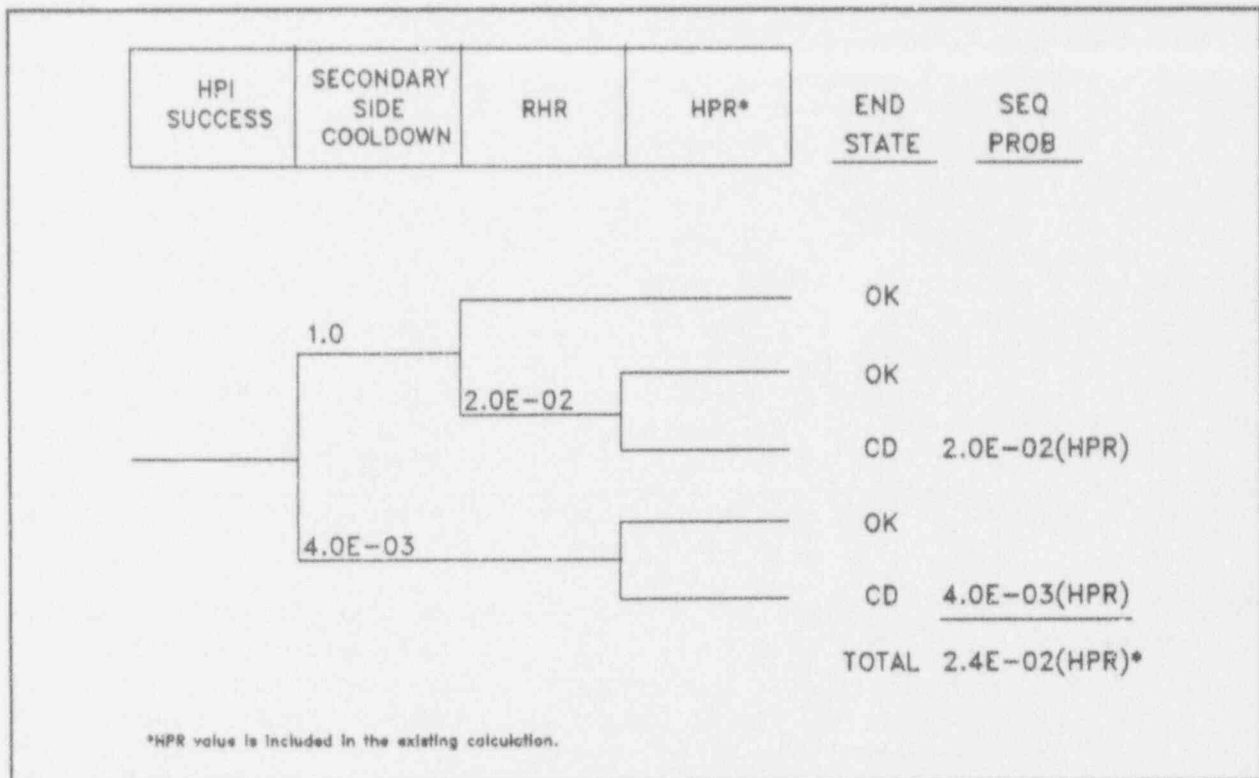
To address these issues, LOCA-related sequences involving HPI success and AFW or MFW success (transient sequences 11 and 13, LOOP sequence 41, and small-break LOCA sequences 71 and 73 -- see Appendix A, Sect. A.3.1) were modified to include the branches in Fig. D.2.

Fig. D.2. Modification to event tree when HPI is successful and AFW or MFW is successful.

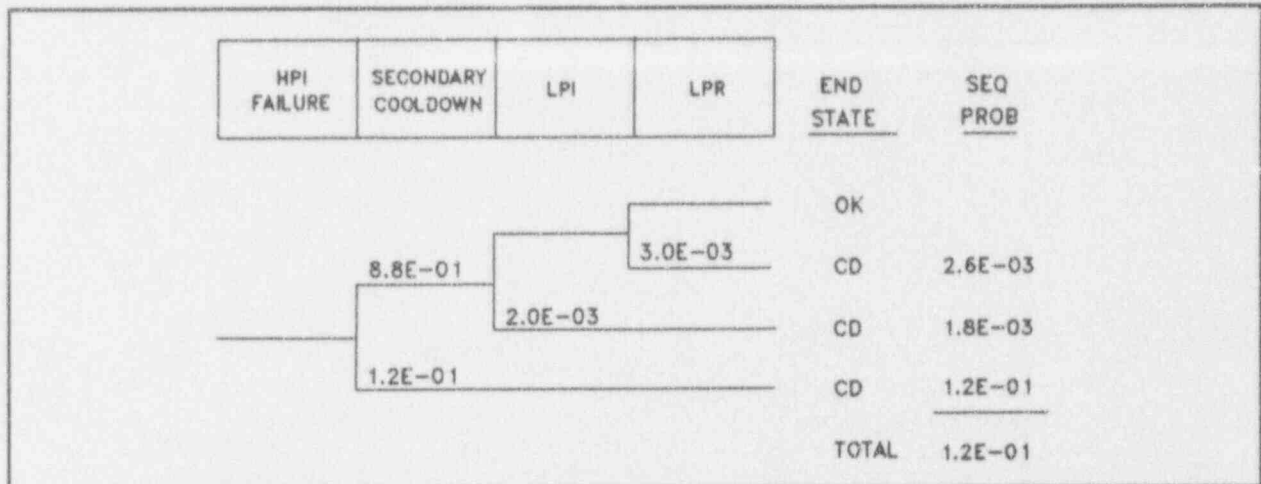
LOCA-related sequences involving HPI failure (sequences 12, 14, 42, 72 and 74) were also modified to include the branches in Fig. D.3.

Fig. D.3. Modification to HPR event when HPI fails and AFW or MFW is successful.

In this case, the probability of failing to initiate rapid secondary side depressurization was estimated to be 0.12 (ASP recovery class R3 - see Appendix A, Sect. A.1). An equipment failure probability of 3×10^{-3} results in a probability of failing to complete secondary side depressurization of 1.23×10^{-1} . LPI success requires the opening of the motor-operated injection valve and the start of the LPI (RHR) pump in one of the two redundant trains. A failure probability of 2.0×10^{-3} was estimated for LPI, again assuming a nominal failure probability of 0.01 for pumps and motor-operated valves, and a common-cause (beta factor) of 0.1. LPR success requires the opening of the containment sump isolation valves (2 per train) to allow recirculation of water spilled into the containment sump from the break back to the RCS, using the LPI pumps. LPR failure is dominated by failure of the sump isolation valves to open. Therefore, the LPR failure probability is 3.0×10^{-3} (including 1.0×10^{-3} for failure to initiate recirculation). The combined failure probability for the three branches (secondary side depressurization, LPI and LPR) is 1.2×10^{-1} . The conditional probabilities for sequences 12, 14, 42, 72, and 74 estimated using the existing ASP models were multiplied by this value to address the potential use of LPI and LPR to provide core cooling in the event of HPI failure with AFW or MFW success. Since the conditional probability for sequence 72 is more than two orders of magnitude greater than the conditional probability for each of the other sequences, sequence 72 is the only significant sequence.

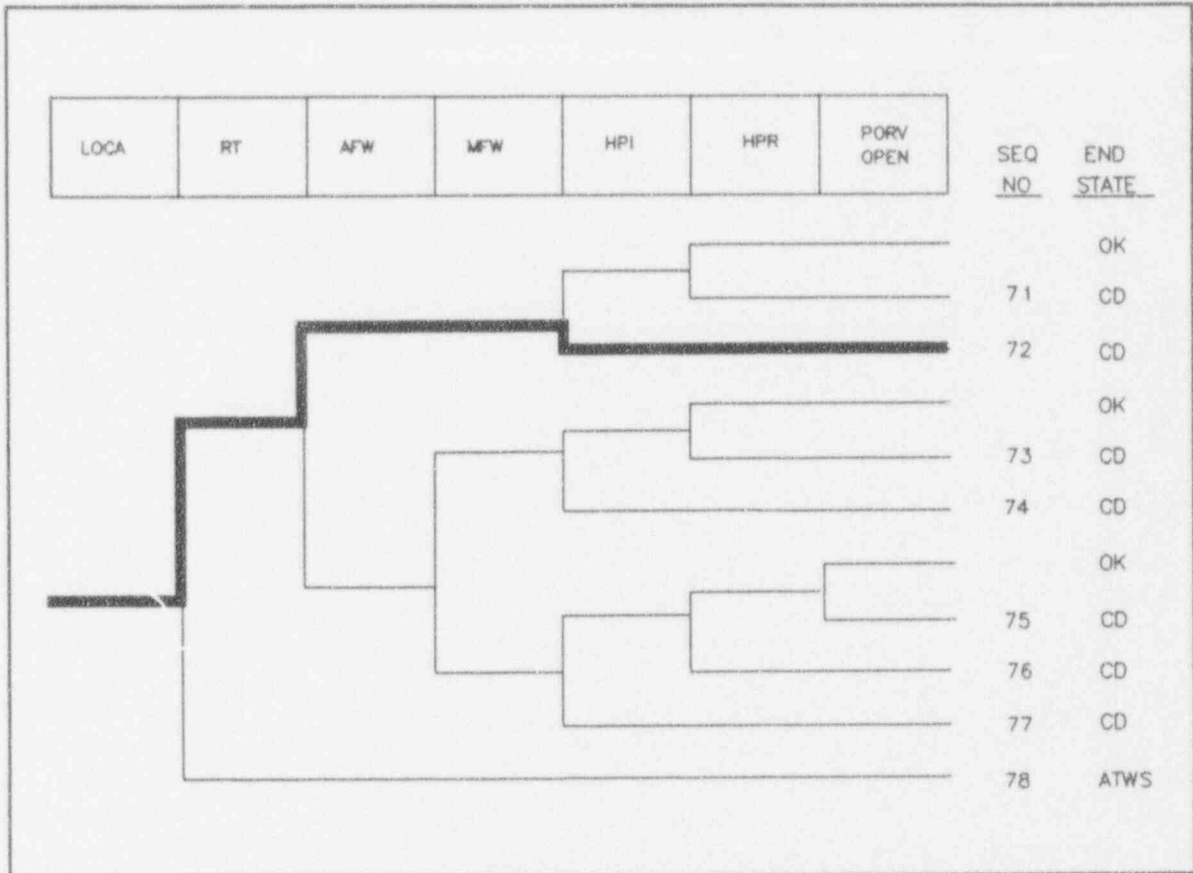
The conditional core damage probability estimated for the event is 1.7×10^{-7} . This is the result of the probability estimated using the existing ASP model (1.4×10^{-6}) times the value for the additional relevant mitigation factors (1.2×10^{-1}). The dominant core damage sequence, highlighted on the event tree in Fig. D.4, involves a potential small-break LOCA with failure of HPI, and failure to depressurize the secondary side to permit the use of LPI and LPR. As noted above, the minimum flow recirculation valves are not closed for the entire 2-h quarterly test period, and therefore this analysis is somewhat conservative.

Fig. D.4. Dominant core damage sequences for LER 266/92-010.

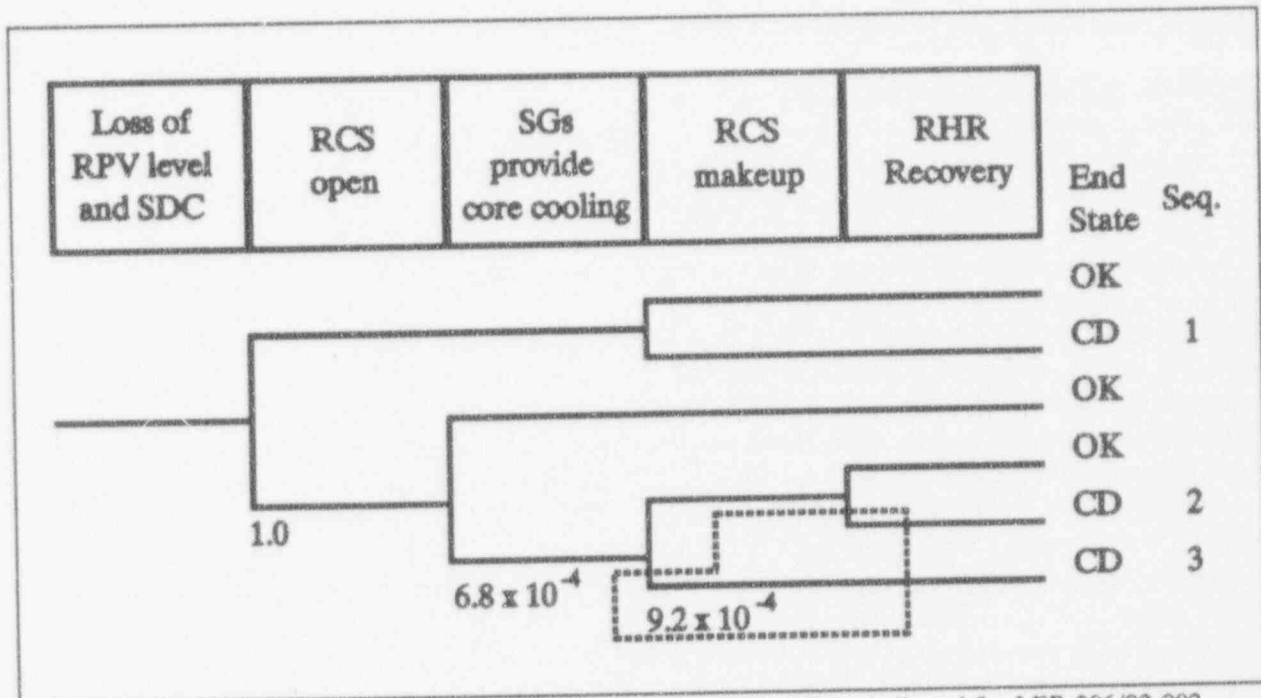
Fig. D.5. Event tree for loss of shutdown cooling with branch probabilities indicated for LER 306/92-002

Combining these numeric values results in an estimate for failure of RCS makeup or failure to recover shutdown cooling of 9.2×10^{-4} . The overall probability estimated for sequences 2 and 3 is therefore $(1.0) \times (6.8 \times 10^{-4}) \times (9.2 \times 10^{-4}) = 6.3 \times 10^{-7}$.

The event tree model for this event, including branch probabilities described above, is shown in Fig. D.5. The estimated conditional core damage probability for the event is 6.3×10^{-7} . The dominant sequence involves the loss of RPV level and SDC with failure to provide core cooling using the SGs and the RHR pumps. The calculated probability is strongly influenced by estimates of failing to recover failed systems (primarily RHR) over long time periods. These estimates involve substantial uncertainty, and hence the overall core damage probability estimated for the event also involves substantial uncertainty.

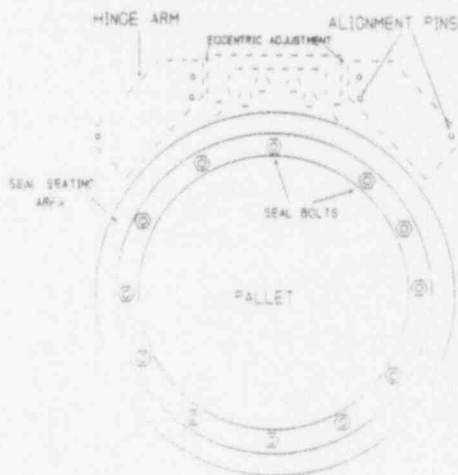
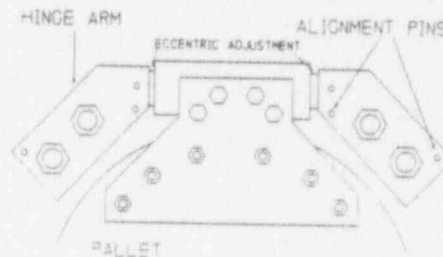
Testing performed on 5/26/92 indicated bypass leakage was present, but the actual path of the leakage could not be determined. Once the unit was placed in shutdown and the drywell purged, an entry into the Suppression Chamber was made to determine the location of the leakage. Three Suppression Chamber to Drywell Vacuum Breakers, "F", "G" and "H" were identified as having leakage as air flow passing through the valves was audible. The "G" vacuum breaker seal was replaced terminating the leakage through the valve. The "F" and "H" vacuum breaker seals were replaced but the leakage through these two valves continued. Further investigation revealed that the valve pallets were misaligned, not allowing the seal to properly seat. When the valves were disassembled, the alignment pins for the hinge arm, which maintains the alignment of the pallet, were found sheared. Maintenance Department Personnel replaced the hinge alignment pins and adjusted the pallet to attain proper seating of the seal. When the valves were reinstalled, leakage through the valve persisted. Maintenance personnel then readjusted the seal bolting to attain a satisfactory seal.
