**TMI-1**  
**Steam Generator**  
**Recovery Program**  
**Task 7**  
**Primary System Review**  
**Reactor Coolant System Inspections**  
**And Requalification**

**Appendix C**  
**Examination Results**

APPENDIX C

Examination Results and Validation

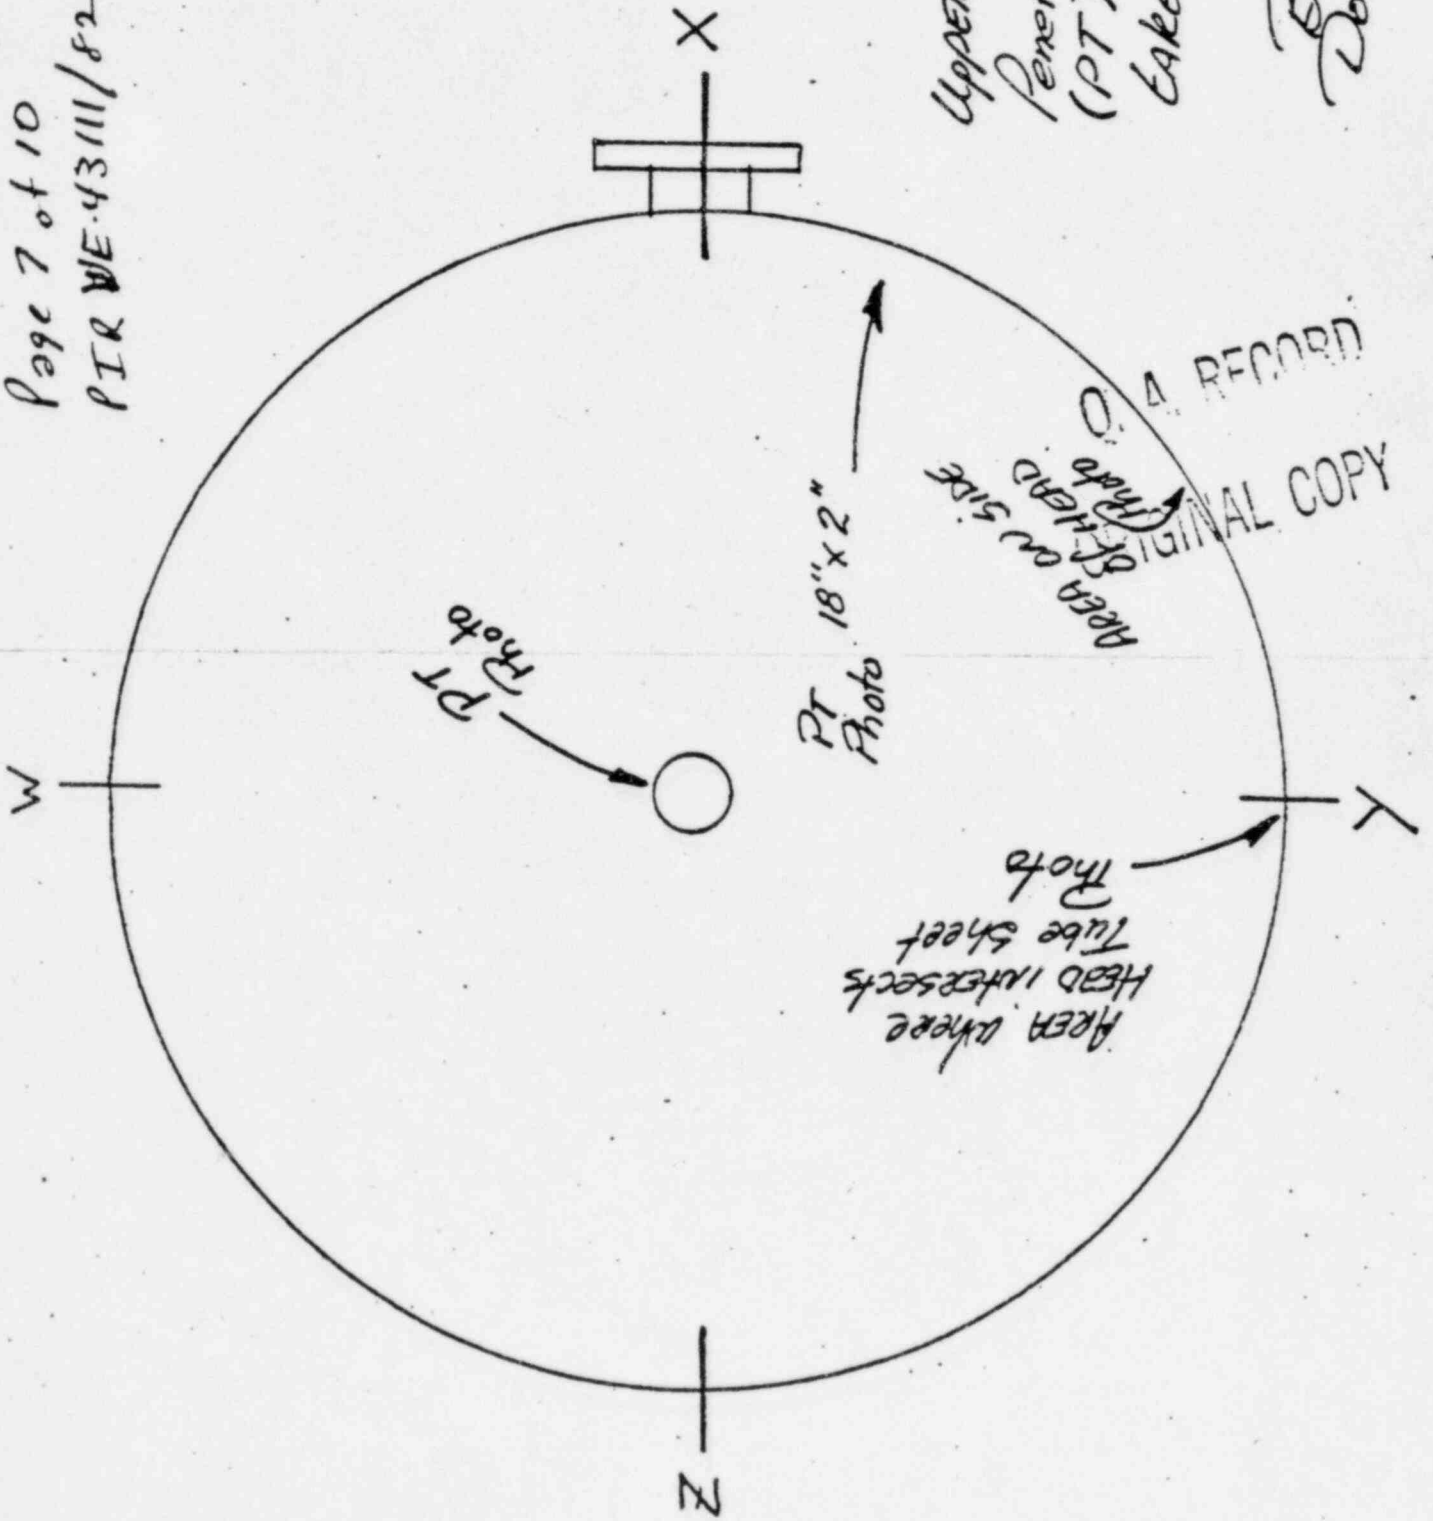
Upper "A" Generator  
Penetrant Examination  
(PT) & Photographs  
Taken

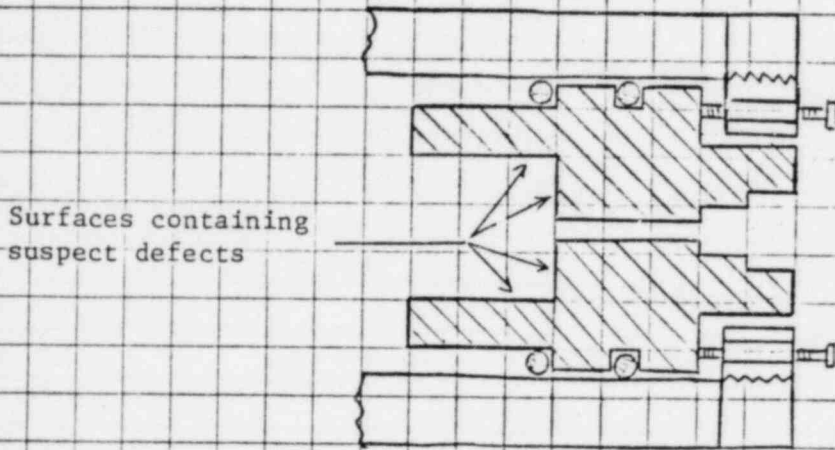
Figure 1. Sketch of CRDM Insert.

- (1) Eddy current examination from the exterior of this part revealed no indications.
- (2) Low magnification light microscopy revealed possible intergranular corrosion on some inner surfaces of the CRDM insert as shown in Figure 1.
- (3) Metallographic examination of the suspect defect at the interior of the CRDM insert revealed no intergranular attack, suggesting that the microscopic observation identified in item (2) was probably oxide cracking.

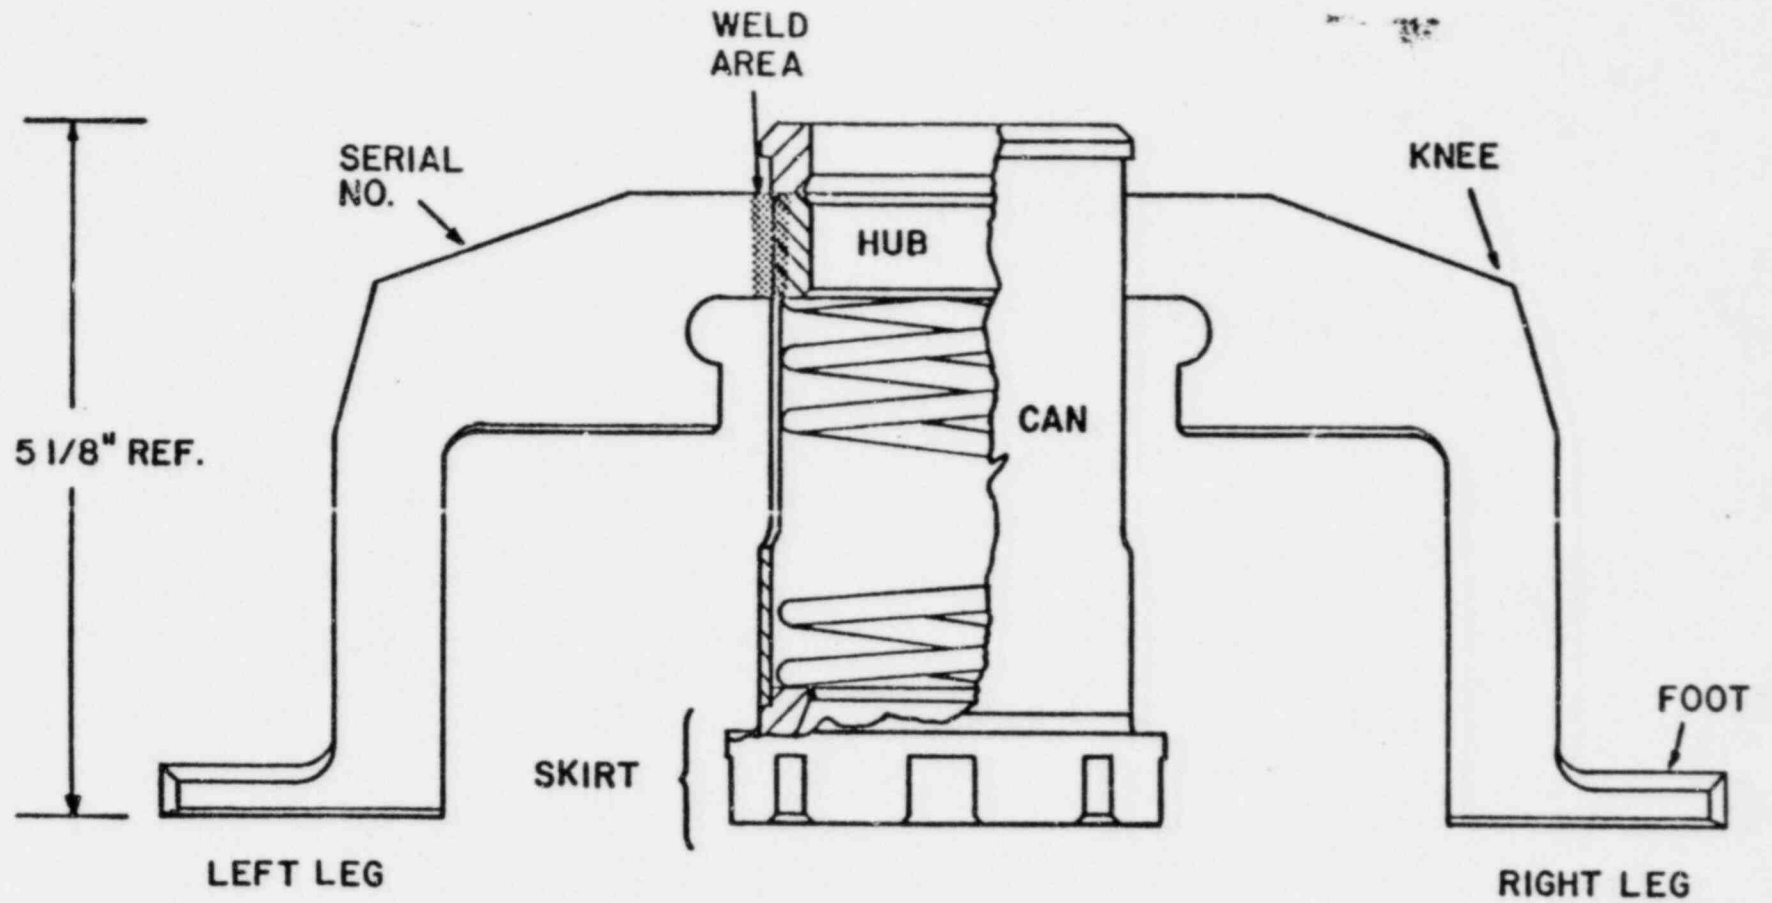
Figure 1. Front View of RNS Retainer

A visual inspection of the retainer, prior to disassembly, showed no cracks in the weld, knee, or foot regions of the retainer legs. A schematic view of a retainer identifying its various components is shown in Figure 1. Typical macro photos of the leg weld, knee, and foot regions are shown in Figure 2. Virtually no crud was observed on the outside surface. Overall views of the retainer are shown in Figures 3 and 4.

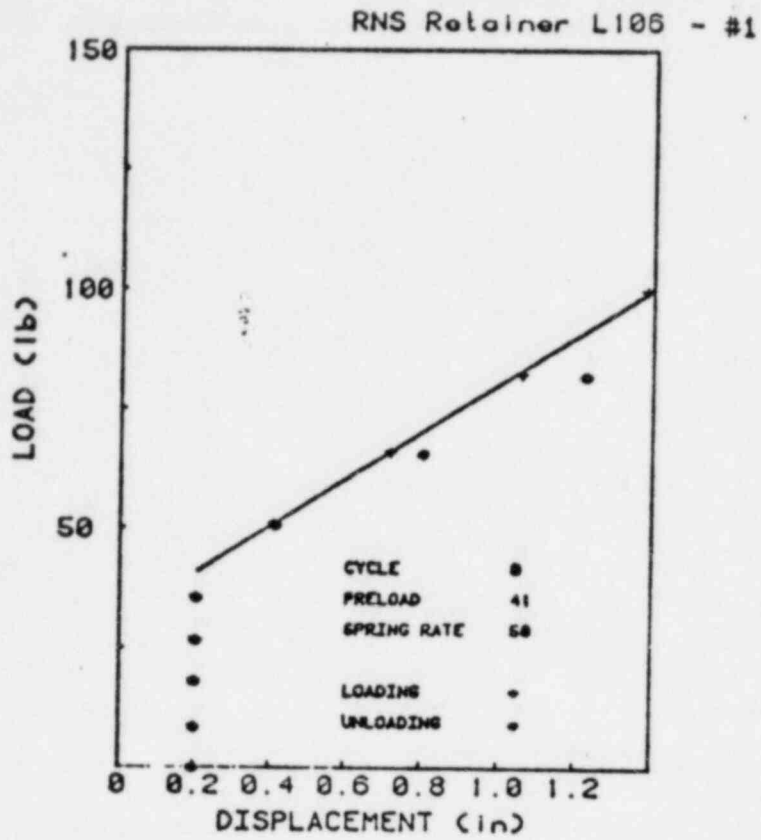
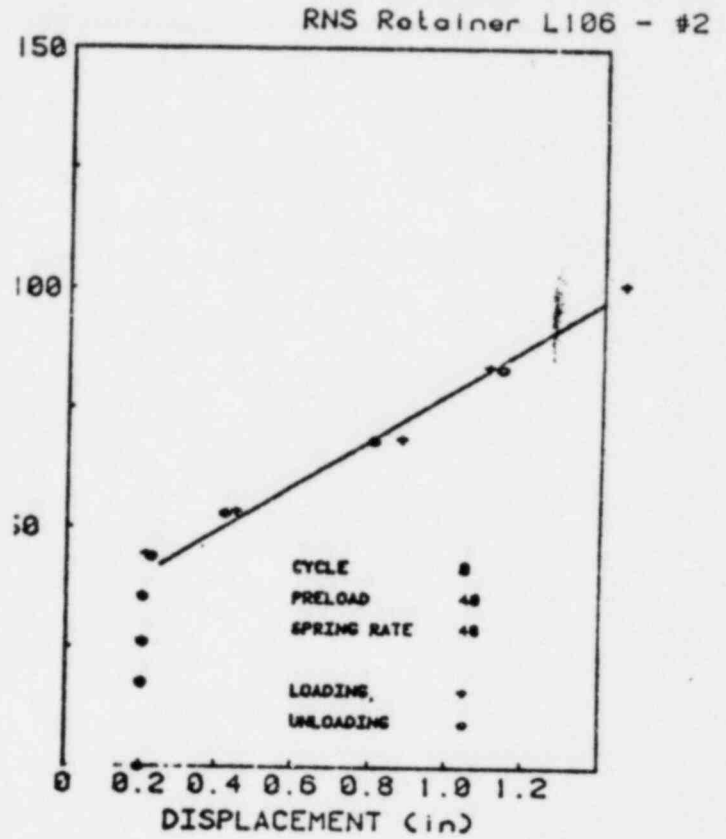
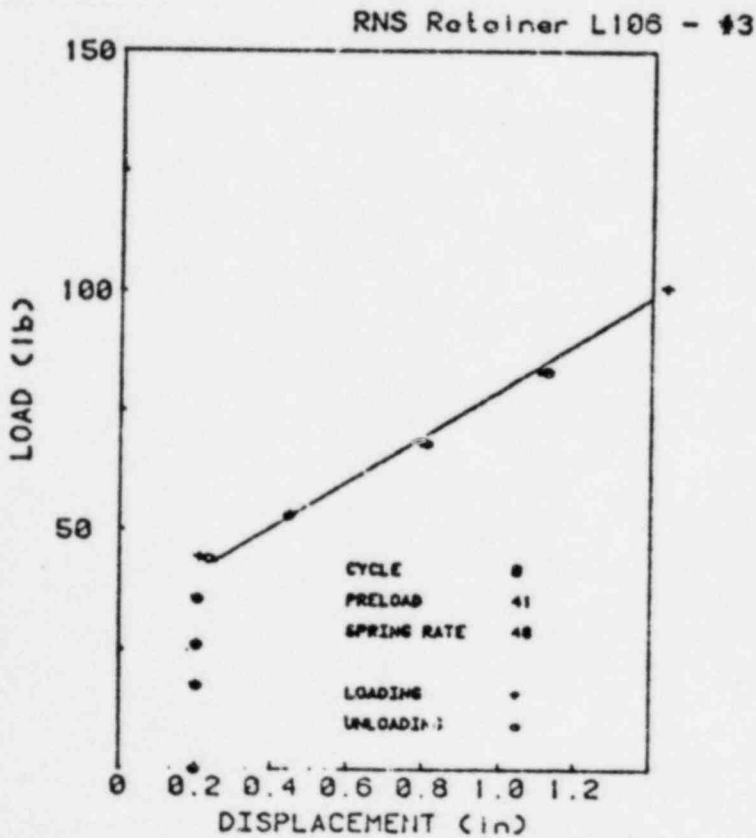
Figure 6. Load-Deflection Data From Retainer L106

Three load-deflection curves were recorded and are shown in Figure 6. Measured spring preloads ranged from 40 to 41 pounds and spring rates from 48-50 pounds per inch. These values are considered normal and agree with other retainer data.

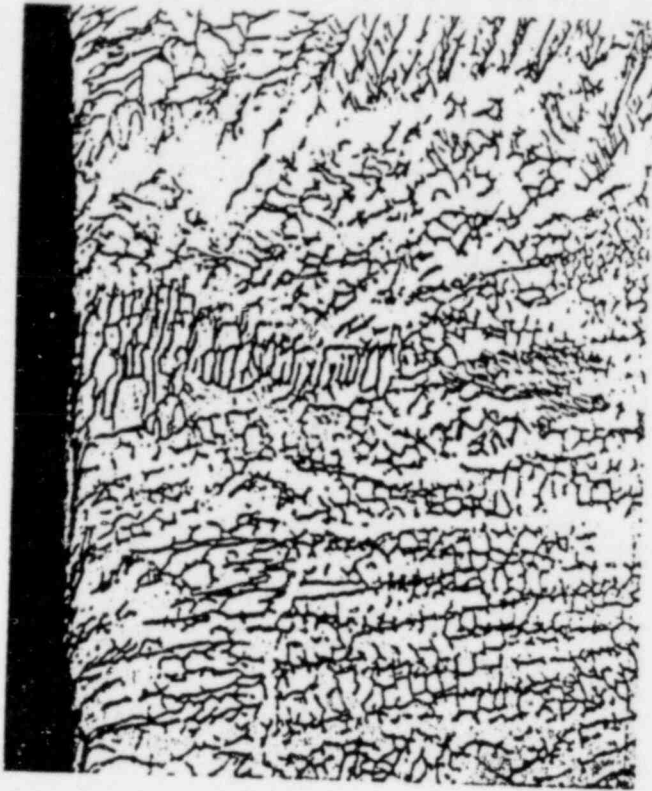
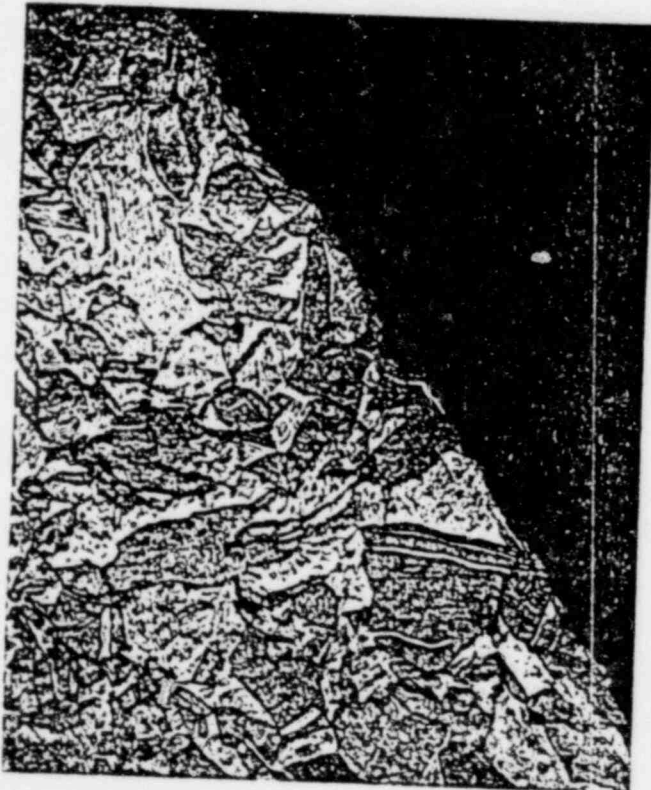
Figure 8. Typical Etched  
Appearance of  
Retainer Component  
Microstructures (400X)

The microstructure of all the samples appeared normal and no evidence of intergranular attack was observed. Figure 8 shows typical etched microstructures of the 304 SS base metal, 308 SS weld metal, and X750 spring. The weld area and heat-affected zone are shown at 50X in Figure 9.

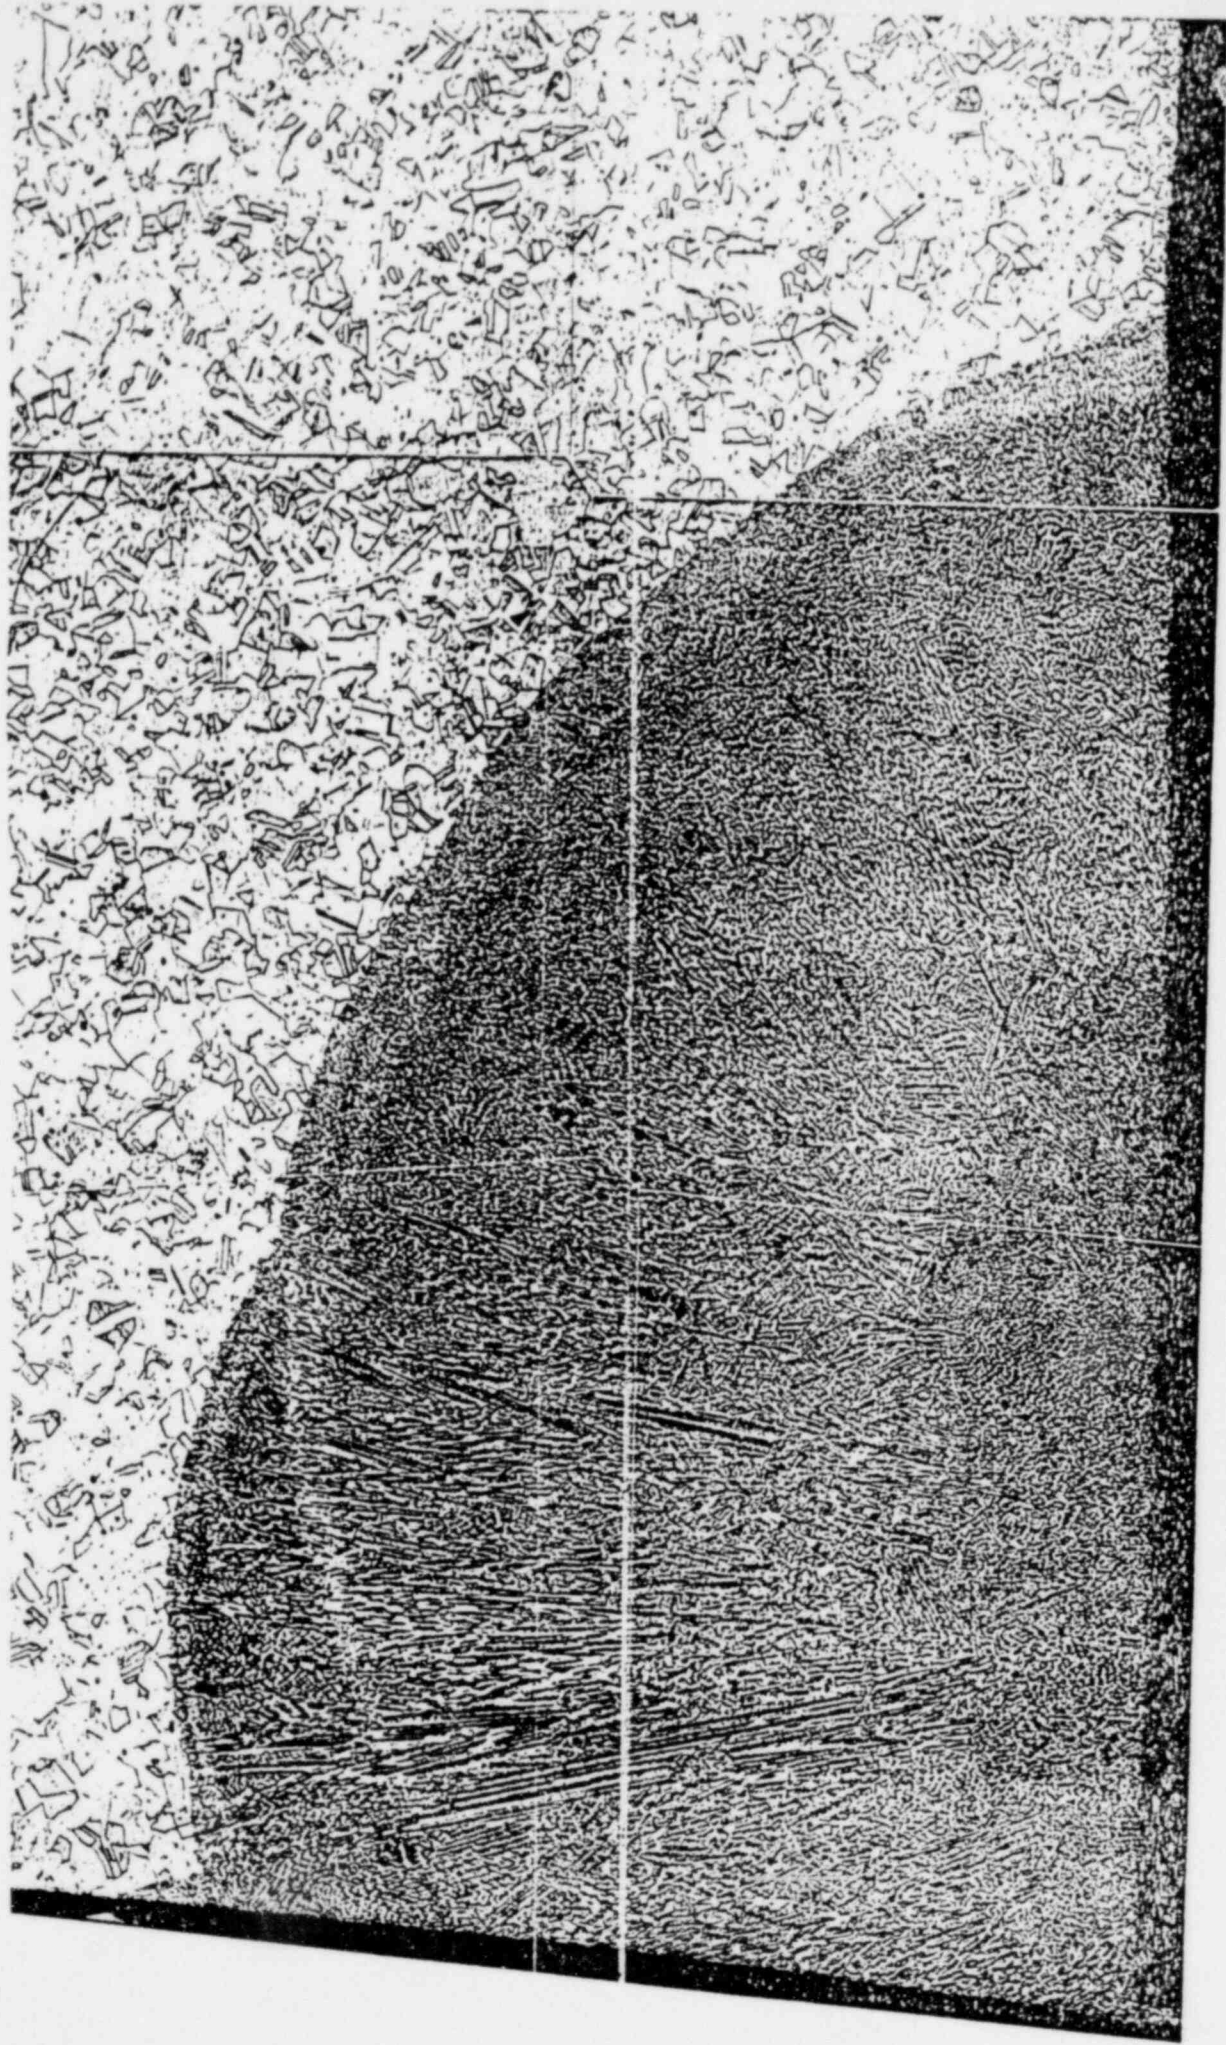
Figure 9. Retainer Leg Weld and Heat Affected Zone (50X)

The leg weld was bent through approximately 45 degrees with no visible crack initiation, indicating a sound weld. The spring sample was bent and fractured. The fracture surface was examined with an SEM to characterize the mode of failure. The SEM examination showed the fracture surface was new and failure was 100 percent ductile. Examples of the appearance of the fracture surface are shown in Figure 7. No evidence of intergranular cracking was observed.

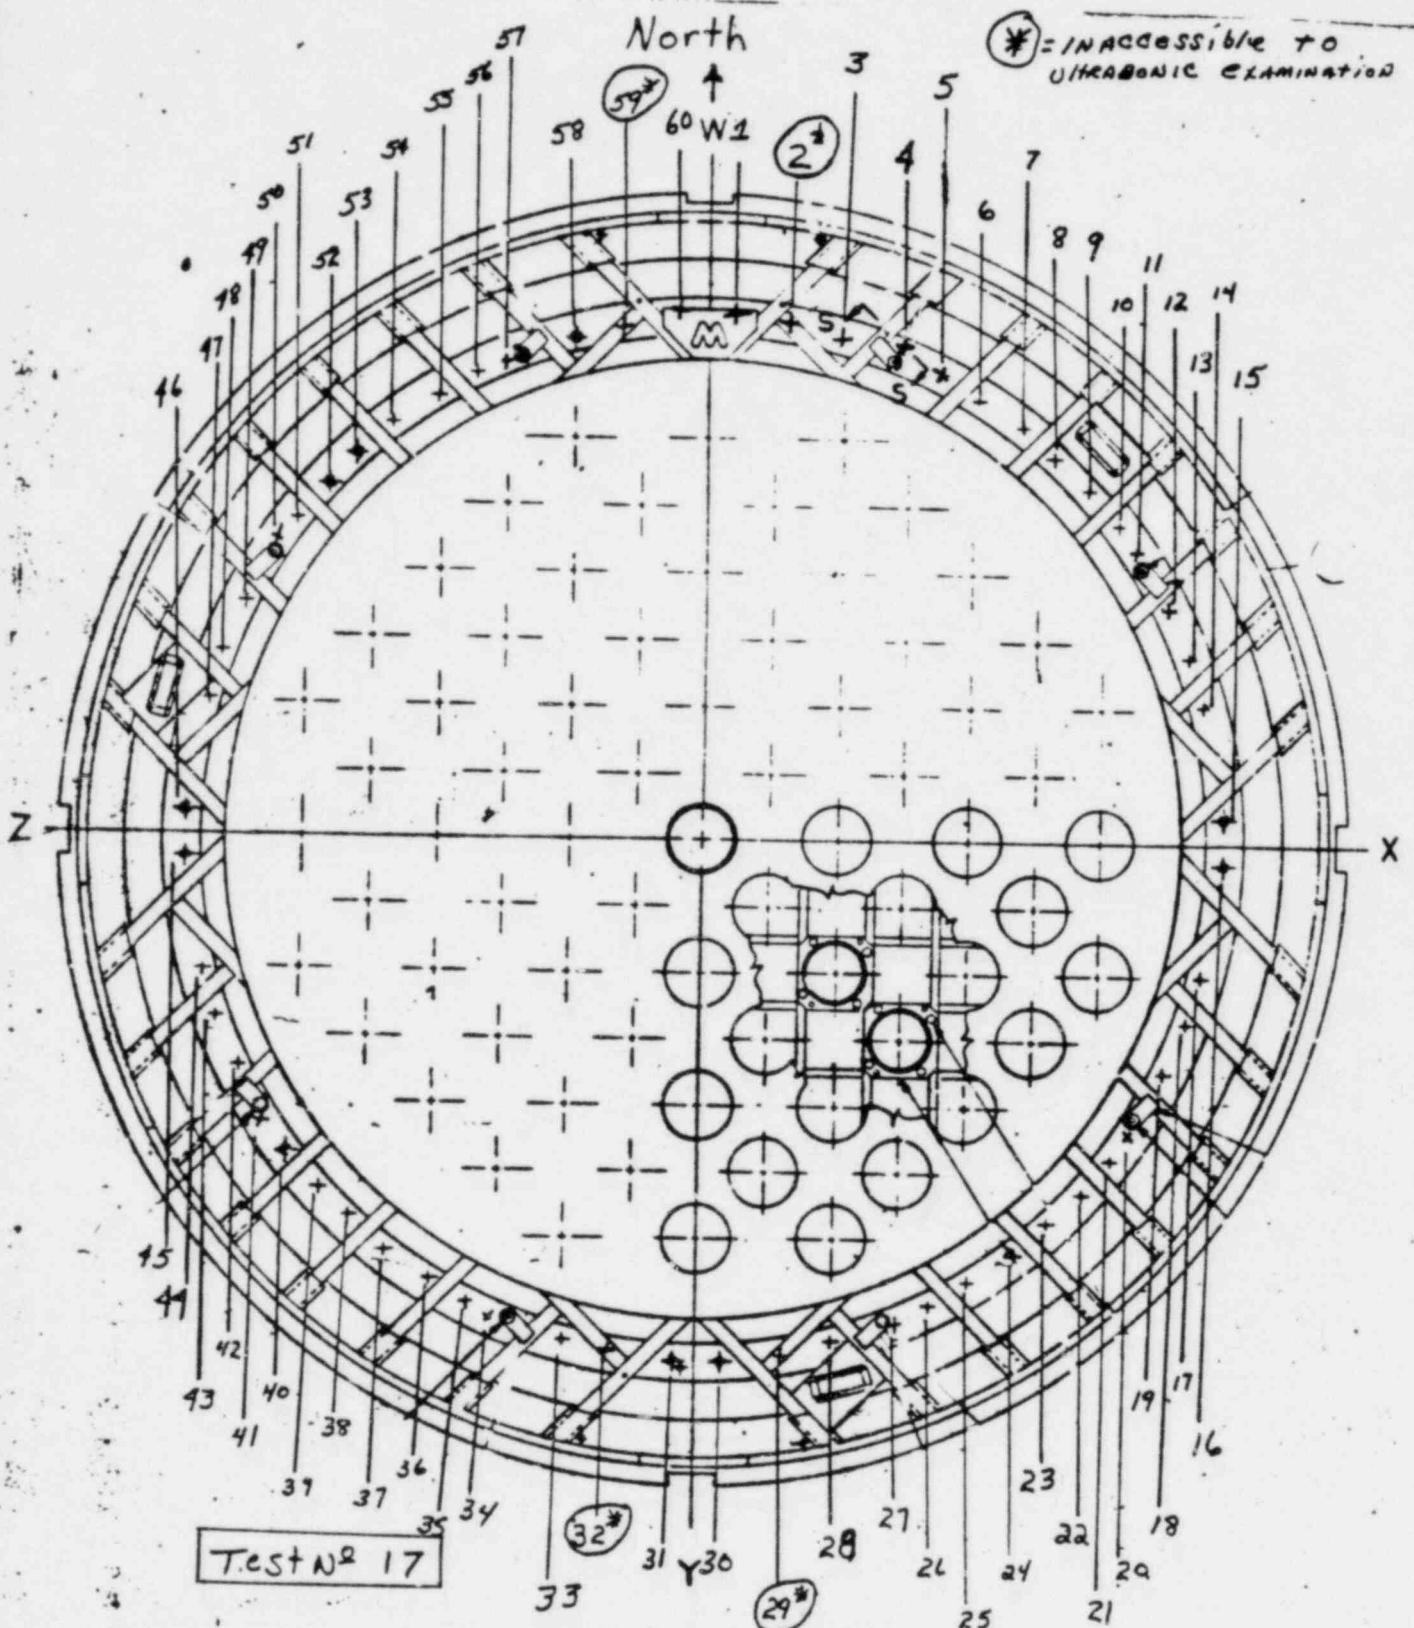
Plenum cylinder to Plenum cover bolts  
Figure 4

On April 14, 1982, two (2) B & W personnel and myself ultrasonically examined the bolting on the above subject. The test was performed in the canal using direct contact by hand of the UT probe. The original plan was to use handling tools from the bridge with the water in the canal. The direct contact method allowed a superior UT examination with greater access to more bolts. Attached is figure 4 from the UT procedure ISI 166, Rev. 0, STP 1-82-0012 which was used in the performance of this examination. Figure 4 numbers each bolt that is capable of being visually seen from this position and the numbering of these bolts are only applicable for this test. Four (4) bolts that were capable of being seen were inaccessible to UT due to the fact that they penetrated the beam of the plenum. These bolts are numbered 2, 29, 32, and 59. The remaining bolts from 1 through 60 (as depicted on figure 4) were UT examined and found acceptable to the criteria set forth in B & W EIR Document 51-1132419-00.
