SUBJECT: OPERATING REACTORS EVENTS BRIEFING
 FEBRUARY 9, 1994 - BRIEFING 94-06

OPERATING REACTORS EVENTS FULL BRIEFING (94-06)

OPERATING REACTORS EVENTS BRIEFING 94-06

DRESDEN UNIT 1
COLD WEATHER IMPACT ON DECOMMISSIONED REACTOR FACILITY
JANUARY 24, 1994

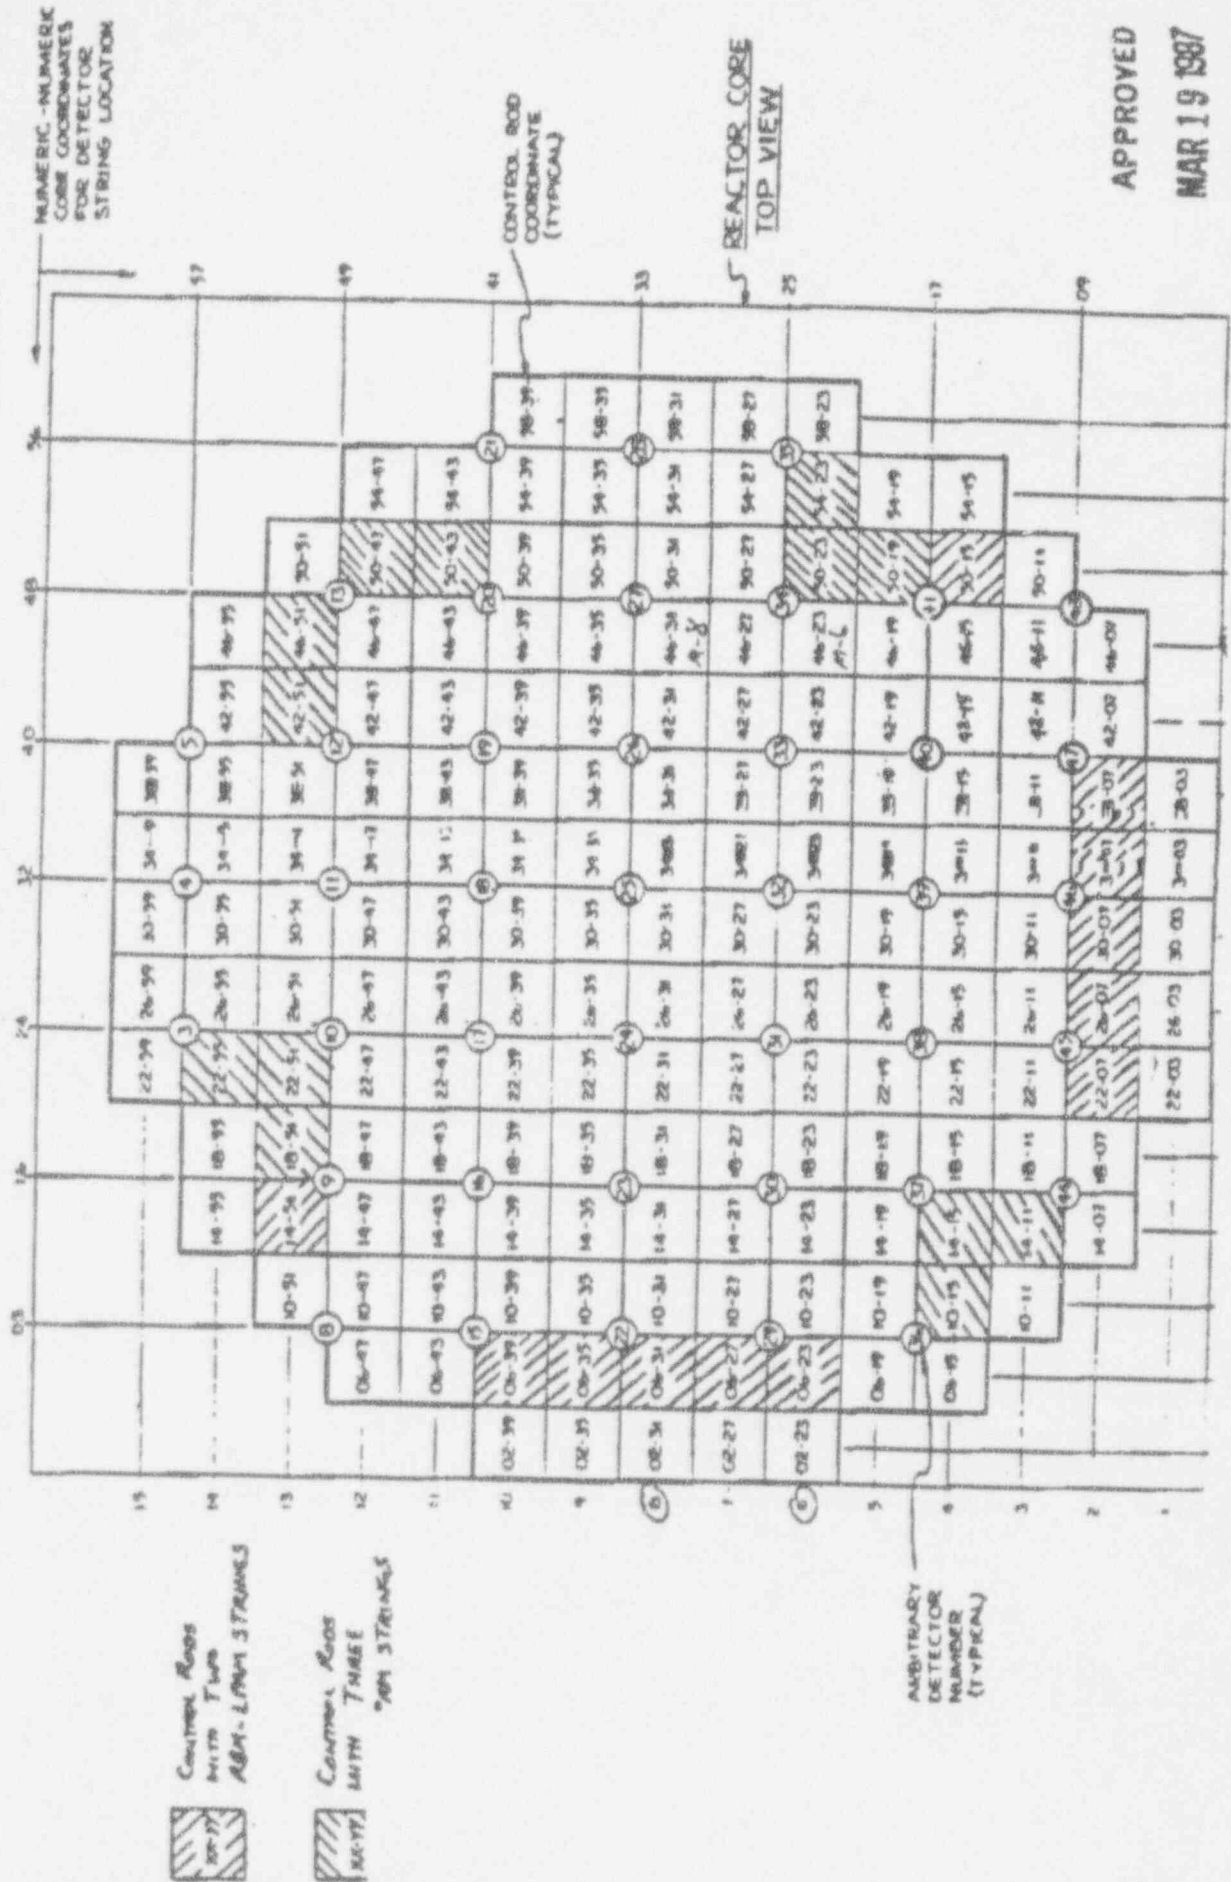
LOCATION OF CONTROL RODS WITH
TWO OR THREE RBM-LPBM STRINGS

- FOLLOWING THE SCRAM, THE ROD REMAINED AT THE OVERTRAVEL POSITION (--).
- QNE2 VERIFIED SCRAM TIME AND THE TEST DIRECTOR NOTED ON THE TEST SHEET THAT ROD M-8 TESTED SAT AND WAS AT POSITION 00.
