SUBJECT: REQUEST FOR ADDITIONAL INFORMATION CONCERNING C-E OWNERS  
GROUP REQUEST FOR ESFAS SUBGROUP RELAY TEST INTERVAL  
EXTENSIONS (TAC NO. M81374)

SUBJECT: POTTER & BRUMFIELD MODEL MDR ROTARY RELAY FAILURES

POTTER & BRUMFIELD MODEL MDR ROTARY RELAY FAILURES

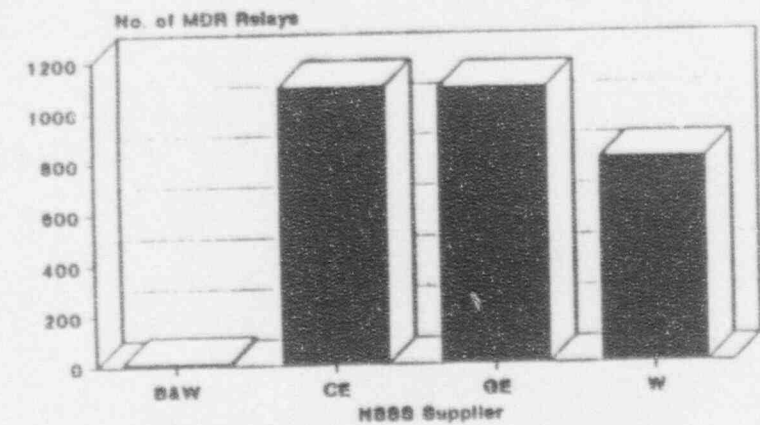
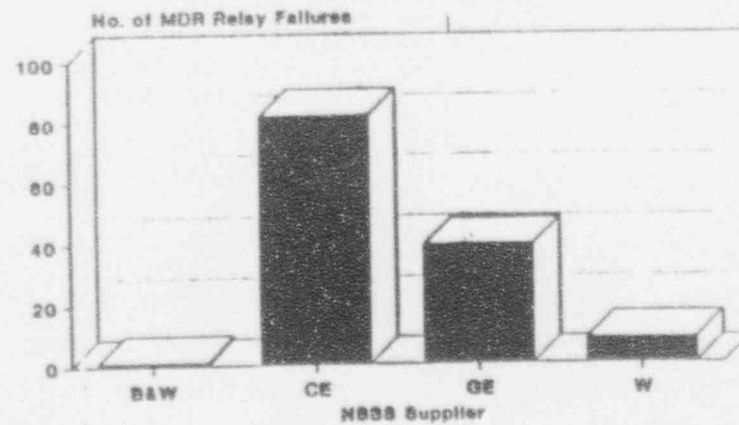
Figure 3-4 P&B MDR relay usage & failures vs reactor supplier

Figure 3-4 shows that CE plants have the highest failure rate of 8% out of 1097 relays, followed distantly by GE plants with 35 out of 1088 relays. This may be only partially explained by CE's use of excessive voltage on 28 V dc relays to ensure the relays latched. Why W plants experienced only 8 failures out of 802 relays has not been explained.

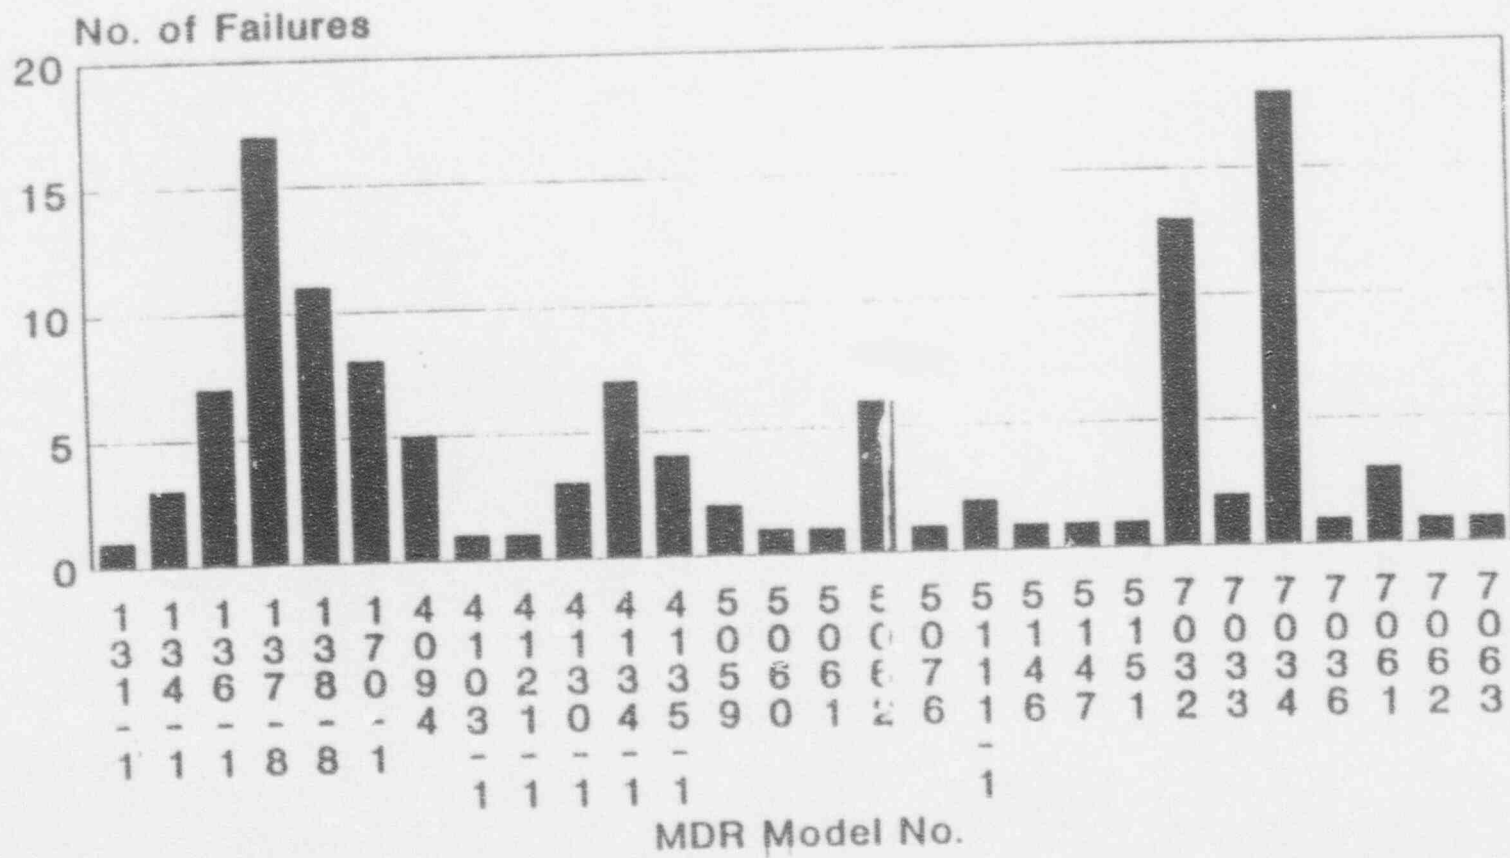
Figure 3-5 P&B MDR relay failures vs model number

Figure 3-5 shows that the dependent failure mechanisms described in this study affected many different MDR relays used in NPPs, as may be expected, because of identical construction materials and configuration that contribute to the identified failure mechanisms. The MDR dc relays shown with higher numbers of failures were widely used in CE plants, where excess voltage was applied to the coils.

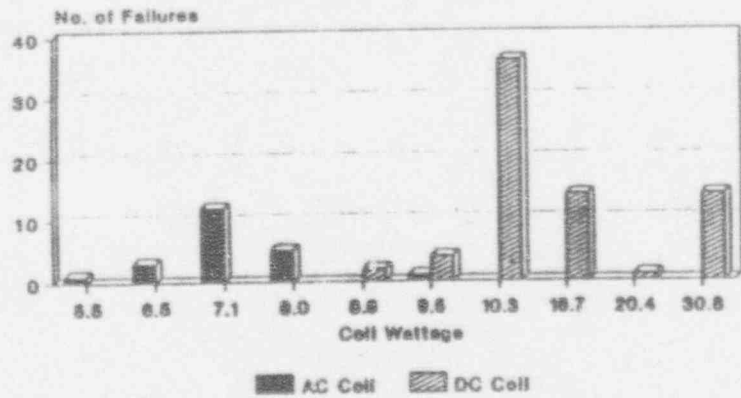
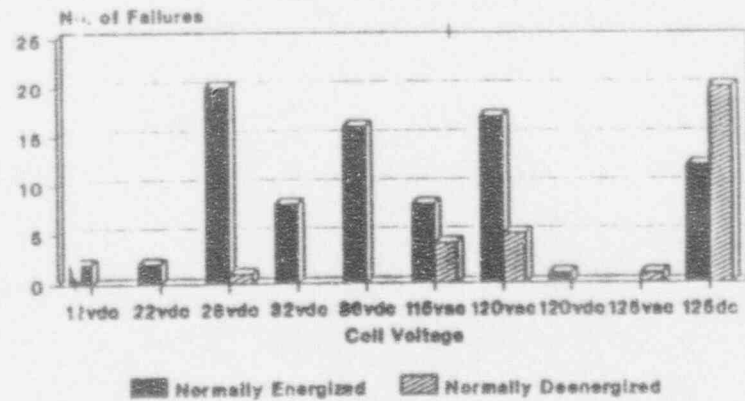
Figure 3-6 P&B MDR relay failures vs coil parameters

While varnish offgassing is affected by coil temperature, Figure 3-6 "P&B MDR Relay Failures vs Coil Parameters," taken from Appendix C and Table 3-1, does not show a relationship between higher coil wattages (with higher temperatures) and MDR failures, as may have intuitively been expected. While the charts show that normal energization of MDR relays has a greater correlation with MDR relay failures, it also includes more than 25 percent (32) of the MDR relay failures that were in normally de-energized ac and dc relays. More than 70 percent (21) of normally de-energized MDR relay failures occurred to non-latching relays, while less than 30 percent (9) of the normally de-energized relay failures occurred in latching type relays, which have either of two coils continuously energized. This may reflect that some normally de-energized relays may be normally energized during plant outages. Thus, normally de-energized MDR relays should not be ignored by licensees in responding to NRC IN 92-04.

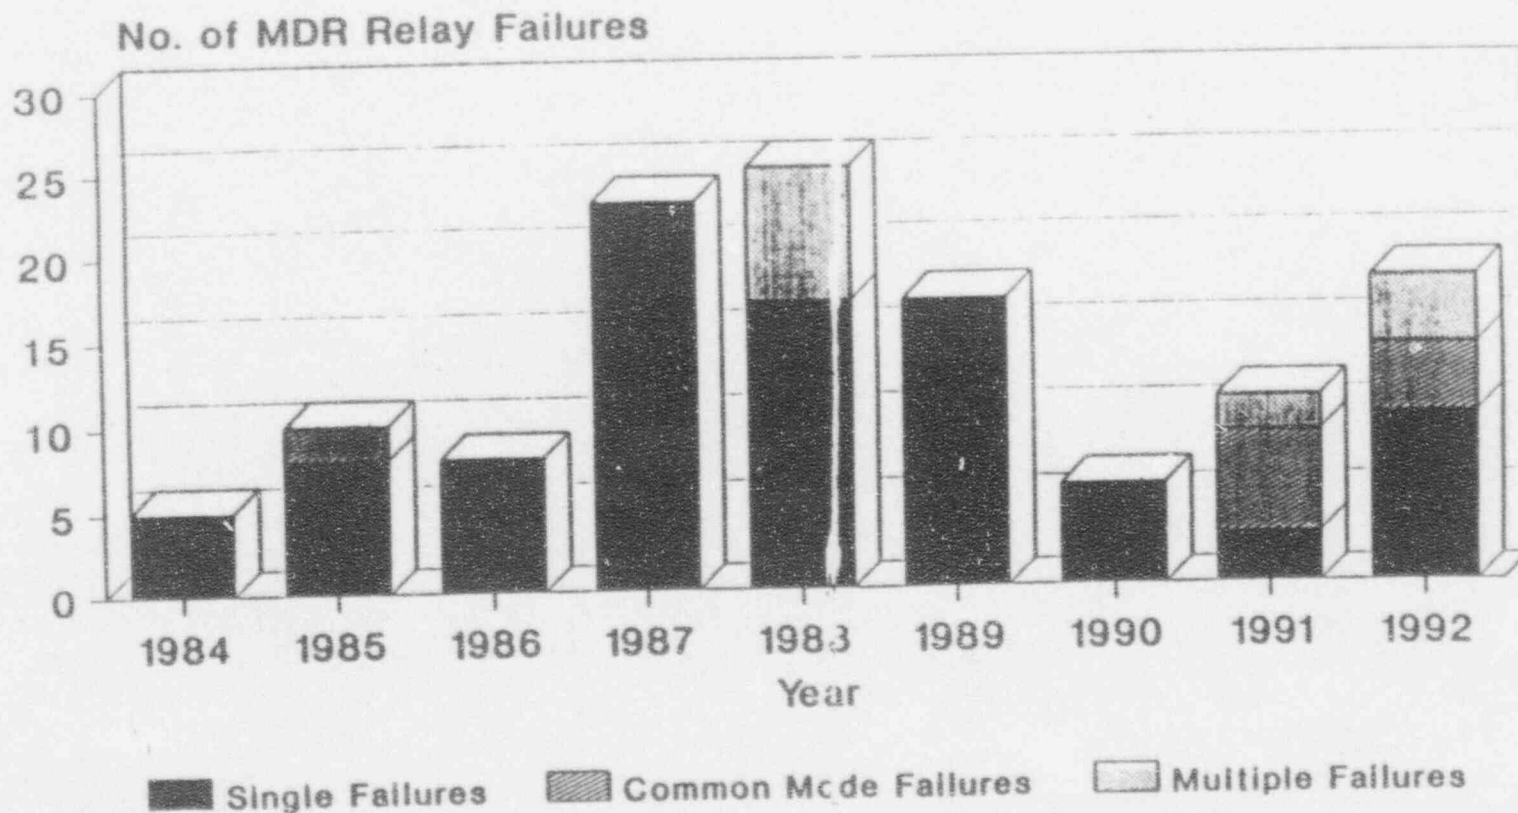
Figure 3-7 P&B MDR relay failures vs year

Figure 3-7, "P&B MDR Relay Failures vs Year," taken from the data in Tables 3-2 and 3-4, reflects simultaneous, multiple MDR relay dependent failure events that occurred three times in 1991 and three times in 1992, due to failures of older relays. In this figure, "single failures" refers to dependent MDR relay failures that occurred one at a time, as identified in Appendix C. "Multiple failures" is a subset of dependent MDR relay failures that occurred simultaneously to multiple MDR relays that did not affect redundant components of a specific system, as indicated in Table 3-2. "Common mode failures" is a subset of dependent MDR relay failures that occurred simultaneously to multiple MDR relays that affected redundant components, as indicated in Table 3-2.

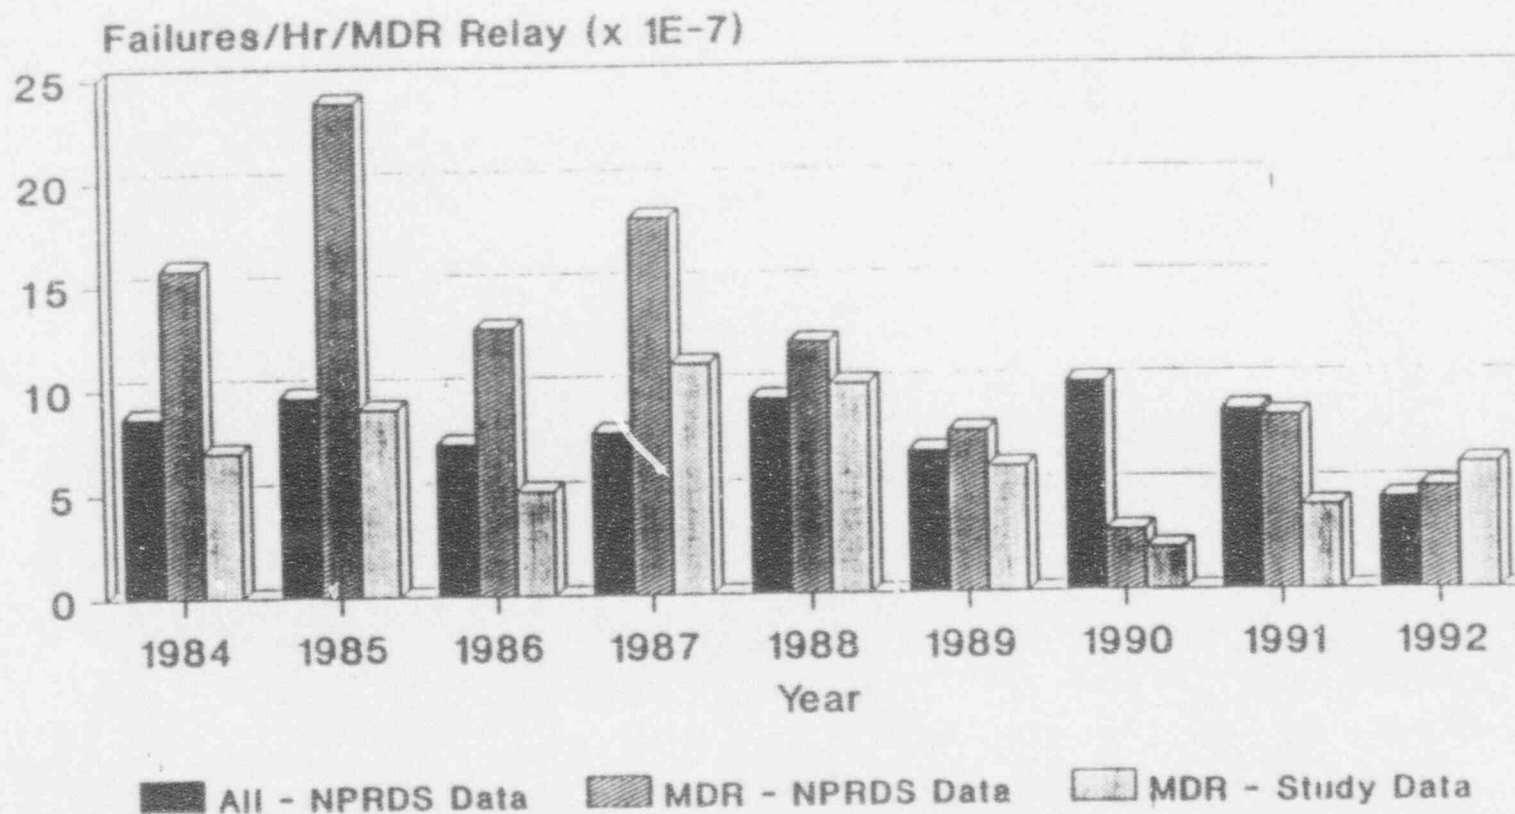
Figure 3-8 P&B MDR relay failure rates vs year

However, best estimates were made with the available data to compare this study's MDR failure rates with the calculated NPRDS database generic relay failure rates and MDR relay failure rates. These are given in Figure 3-8, "P&B MDR Relay Failure Rates vs Year." In all but a few cases, MDR relay failure rates meet or exceed NPRDS generic relay failure rates.

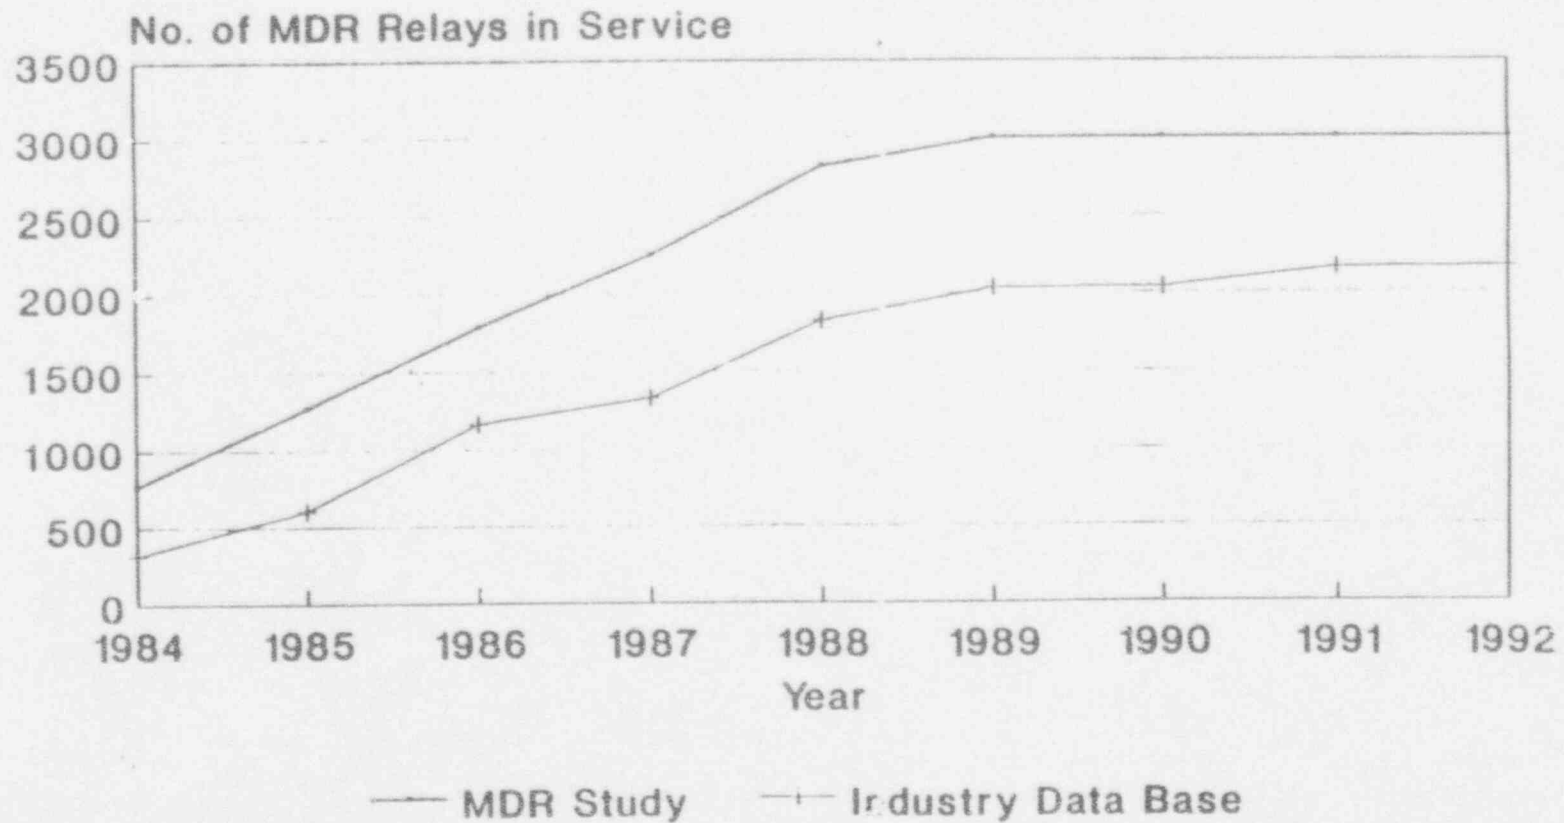
Figure 3-9 P&B MDR relays in service vs year

Figure 3-9, "P&B MDR Relays in Service vs Year" helps explain some of the differences between the industry database MDR relay failure rates and this study's. While the industry database included 319 MDR relays in its population in 1984, this study found 767 (140 percent more) in service. Discrepancies occurred in each year as more MDR relays were put into service. The largest difference occurred in 1989, when the database listed 2034 in service and this study found 2999. In addition, only 75 percent (92) of the MDR failures included in the 124 failures considered in this study were the same as those from the NPRDS database.

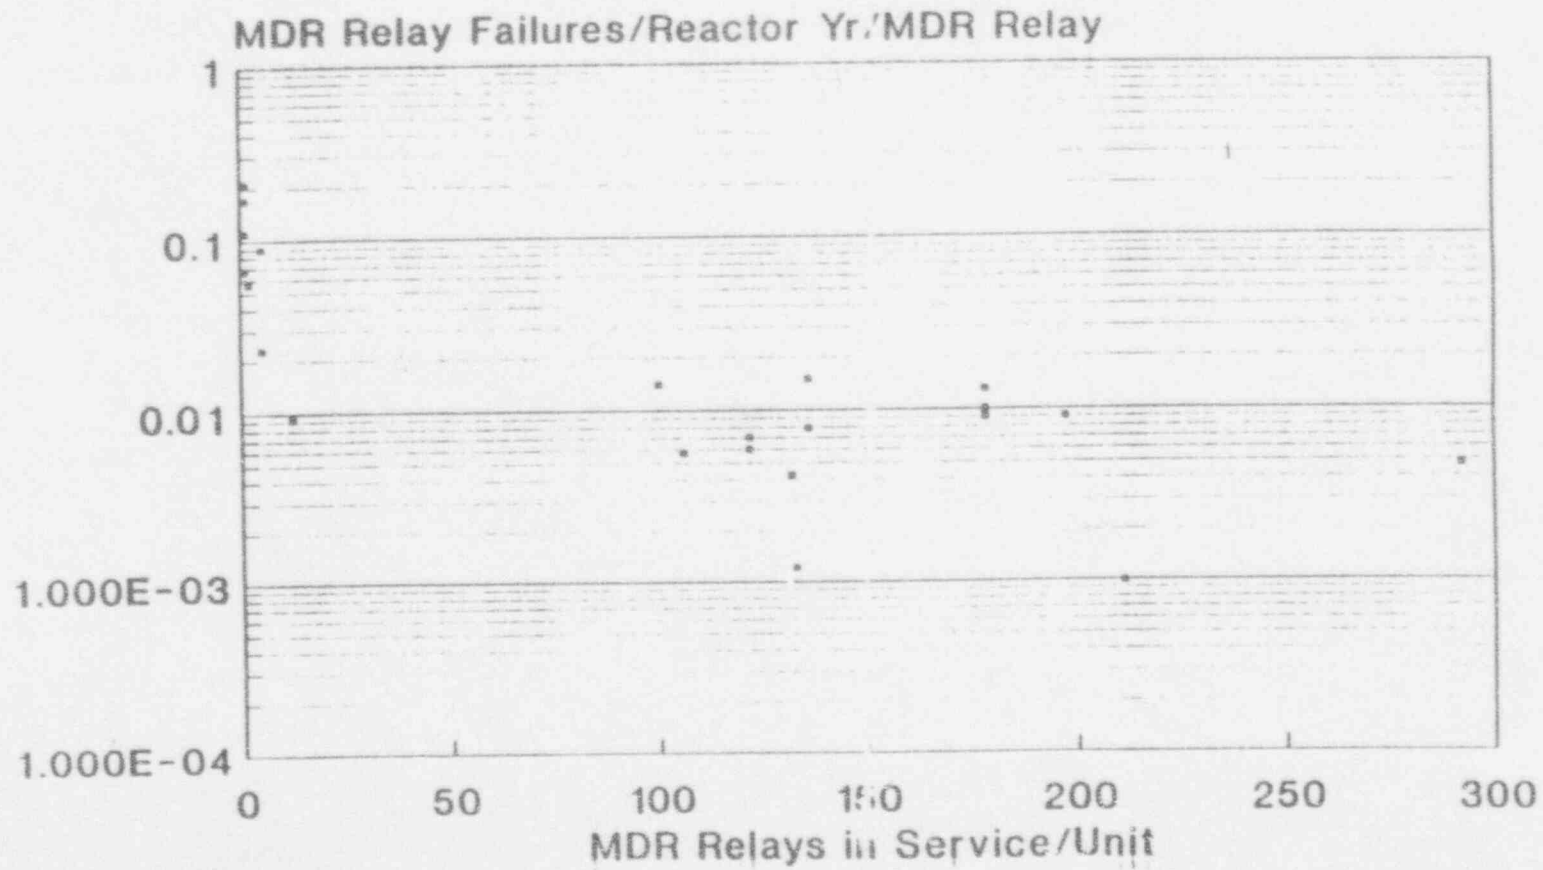
Figure 3-10 P&B MDR relay failure rate by unit vs number in service/unit

The plant specific failure rates listed in Table Appendix B were graphed vs the plant specific number of MDR relays in service in Figure 3-10, "P&B MDR Relay Failure Rate by Unit vs No. in Service/Unit." This shows the wide diversity of plant specific MDR relay failure rates, from 0 to .21 failures per year per MDR relay. This again corroborates NUREG/CR-5993 in that replacement decisions based solely on plant specific MDR relay failure rates could be expected to vary greatly.

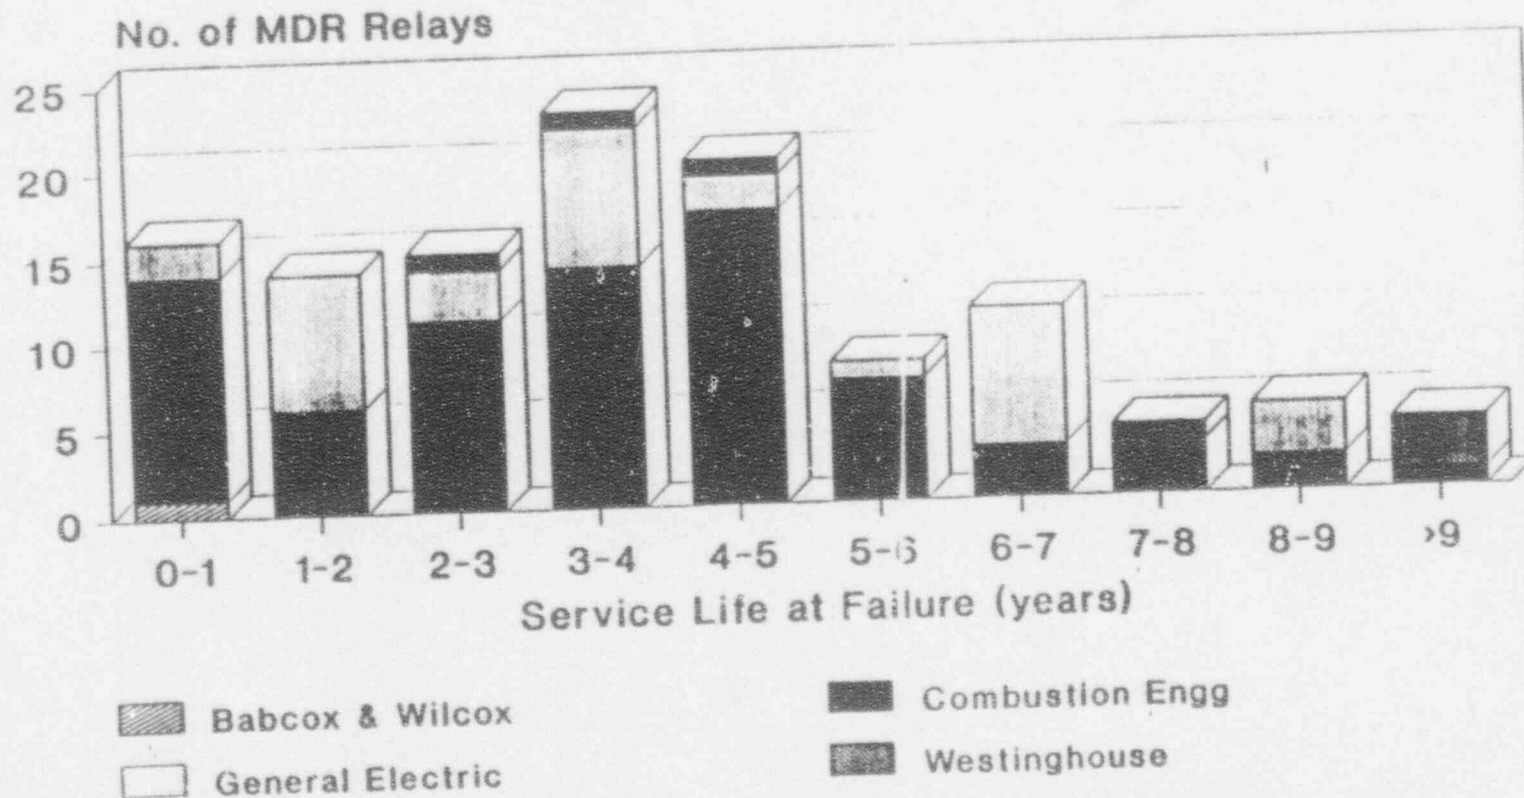
Figure 3-11 P&B MDR relay failures vs service life at failure by NSSS

Figure 3-11, "P&B MDR Relay Failures vs Service Life at Failure by NSSS" and Figure 3-12 "P&B MDR Relay Failure Rate vs Service Life by NSSS" shows the number of MDR relay failures and failure rates vs service life at failure by each reactor vendor. The highest number of CE failures appeared at about 4 to 6 years service life. This may reflect: (1) the accumulated service life of the MDR relay population shown in

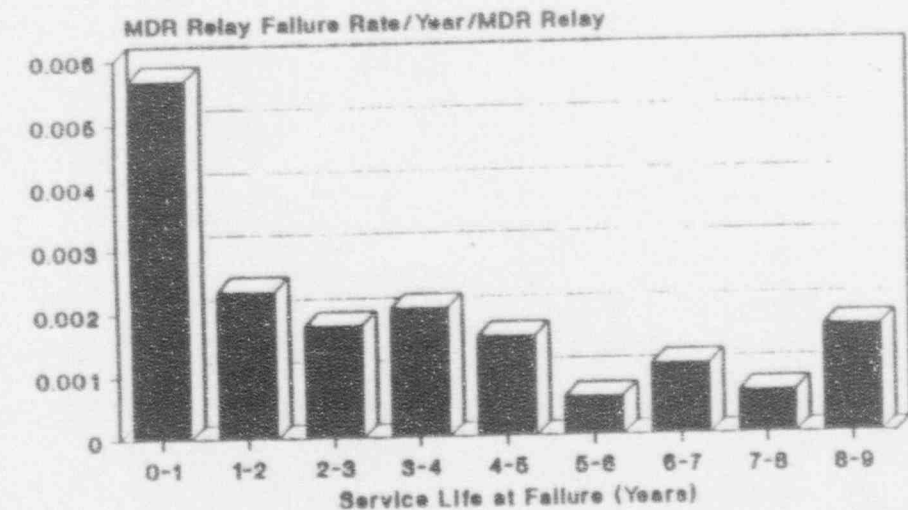
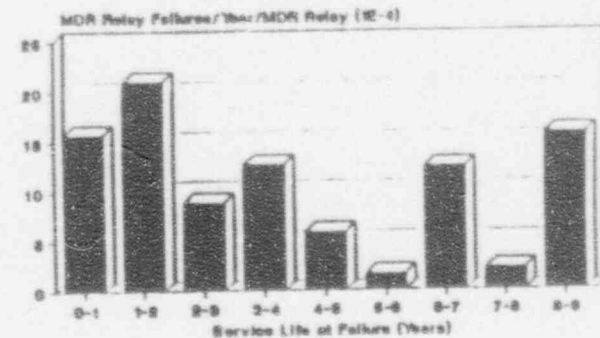
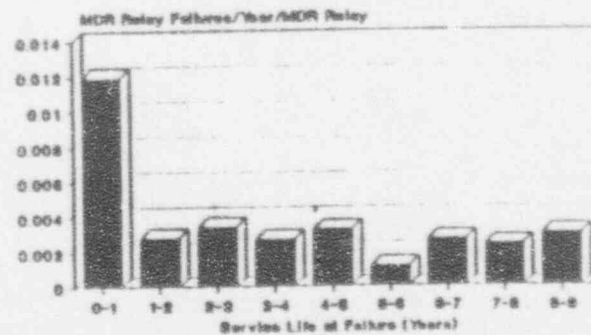
Figure 3-12 P&B MDR relay failure rate vs service life by NSSS

The River Bend experience has demonstrated how a loss of power to a group of relays can potentially result in multiple failures. The probability of a relay failure may increase with its length of time in service, due to the nature of varnish outgassing and silver contact corrosion failure mechanisms, as shown in Figure 3-12.

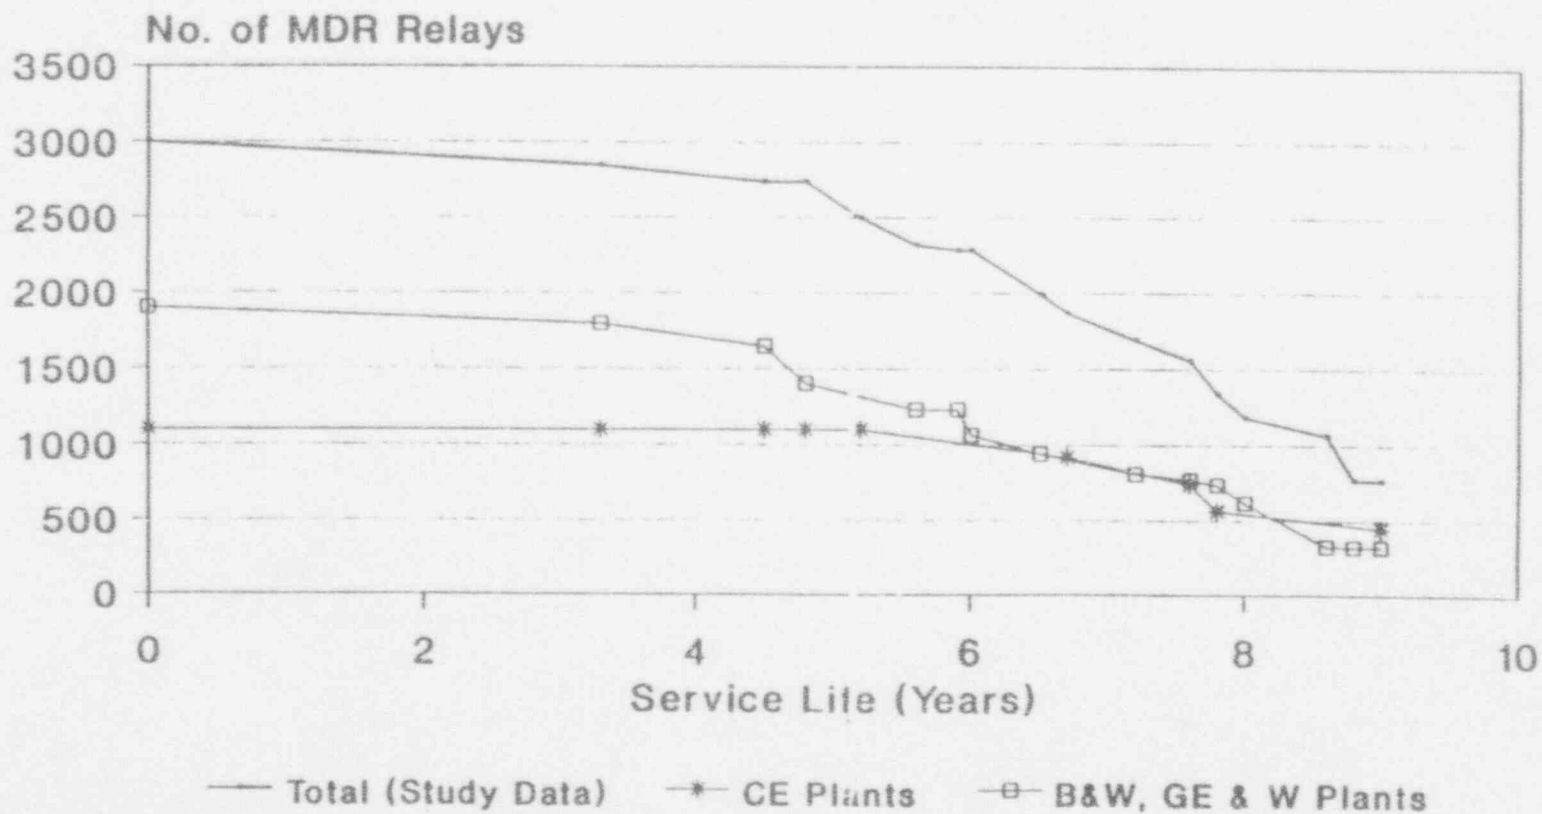
Figure 3-13 P&B MDR relay accumulated service life

Figures 3-9 and 3-13, "P&B MDR Relay Accumulated Service Life," representing  $1.83E+7$  hours of relay operation, and (2) the history of excessive voltage applied to certain MDR dc coils at CE plants for several years and the replacement of those relays. Thereafter, CE plant MDR failure rates leveled off.

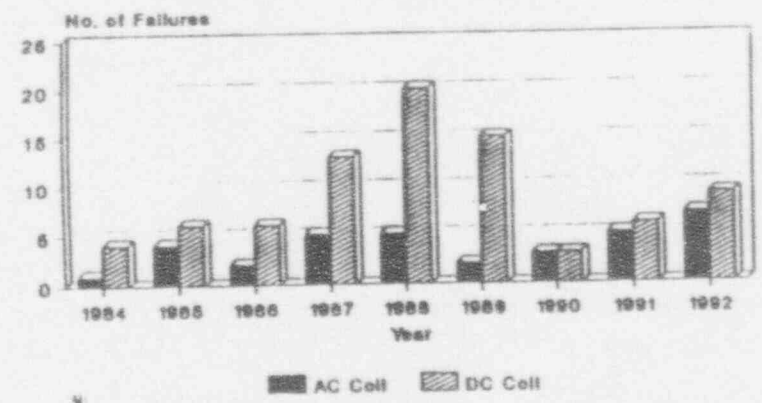
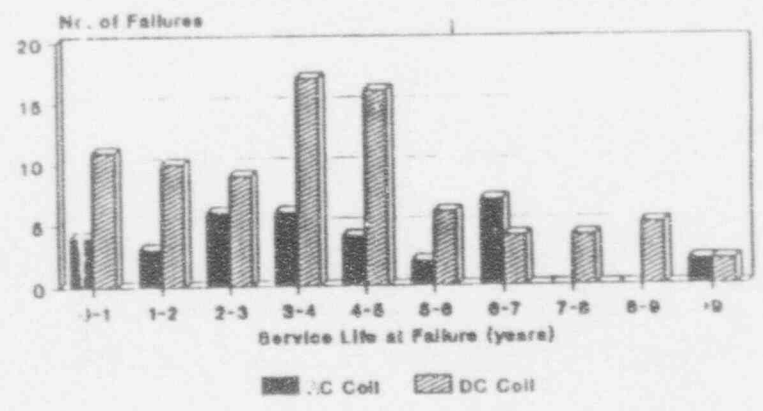
Figure 3-14 P&B MDR relay failures vs year, service life, and coil type

Figure 3-14, "P&B MDR Relay Failures vs Year, Service Life, and Coil Type," and Figure 3-15, "P&B MDR Relay Failures vs Year, Service Life and Normal Coil State," address MDR relay failures vs ac or dc coil type and normally energized or normally de-energized state by year and service life. This data is not normalized for the number of relays in service and may in part reflect the total population in service. Even so, it is reasonable that these figures show a higher number of failures of MDR relays with dc coils. The failures peaked at a service life of 3 to 5 years, which may reflect the influence of the in-service population. Both ac and dc coil failures increased from 1990 to 1992. Normally energized relays failed at a higher rate than normally de-energized relays. The number of normally energized relay failures tripled from 1990 to 1992.
