NEW ENGLAND POWER COMPANY  
HARRIMAN DAM IMPROVEMENT PROJECT  
FINAL REPORT  
MARCH, 1982

SUBJECT: Engineering Report for  
Harriman Dam Improvement Project

# HARRIMAN DAM IMPROVEMENT PROJECT

## ENGINEERING REPORT

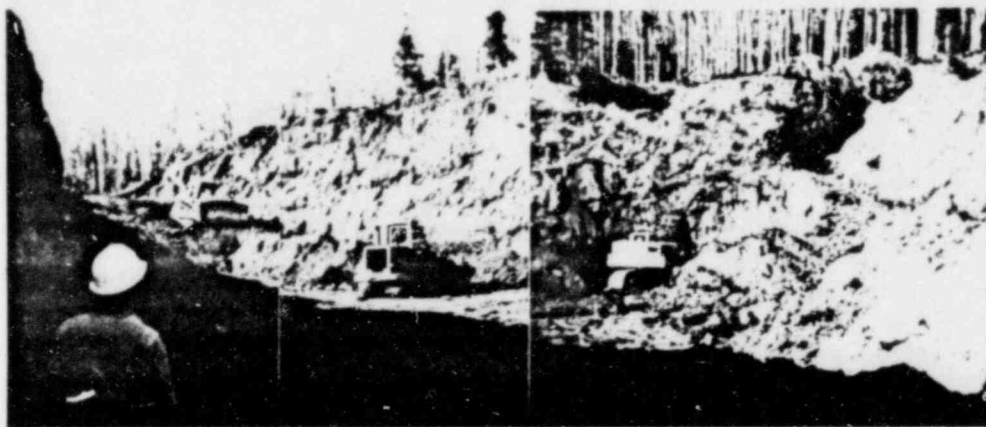
- (3) Impervious Rolled Fill - The major portion of the overlay was constructed with glacial till found along the right abutment. This material was well suited for the project with a natural moisture content averaging one percent above optimum (based on Standard Proctor tests) and the wet bulk density achieved during compaction was better than expected, averaging above 146.0 pounds per cubic foot (pcf). Minimal processing was required to prepare the till, and loaders were used to remove oversize in the pit (see Photo 1). Any oversize found on the overlay were pushed aside with dozers and hand labor.

PHOTO 1  
IMPERVIOUS TILL BORROW SOURCE (11-3-81)

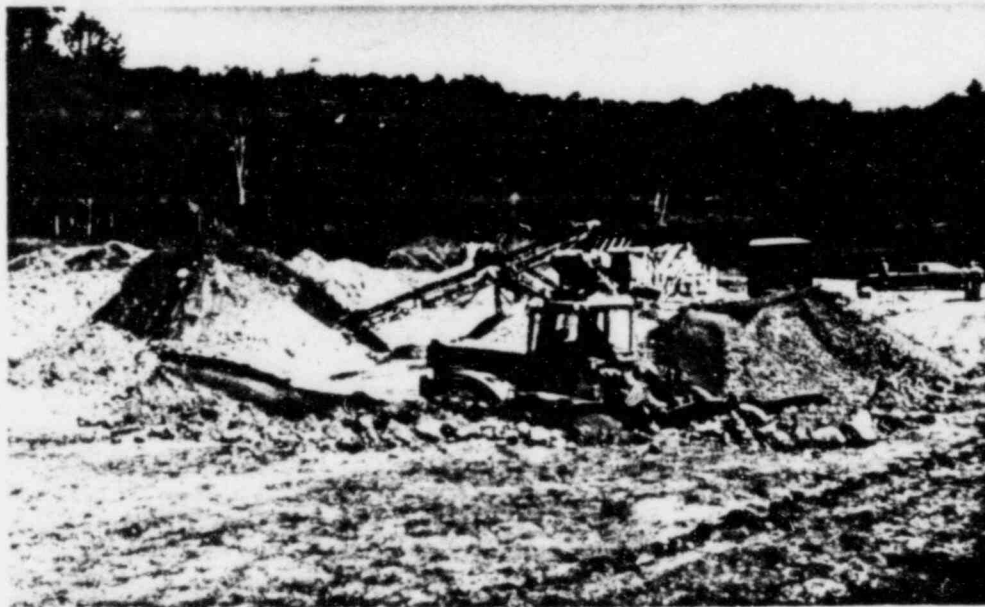
PHOTO 2  
"CARBIDE PIT" — FILTER BLANKET BORROW SOURCE.  
MATERIAL PROCESSING INCLUDED SCREENING AND CRUSHING  
(8-20-81)

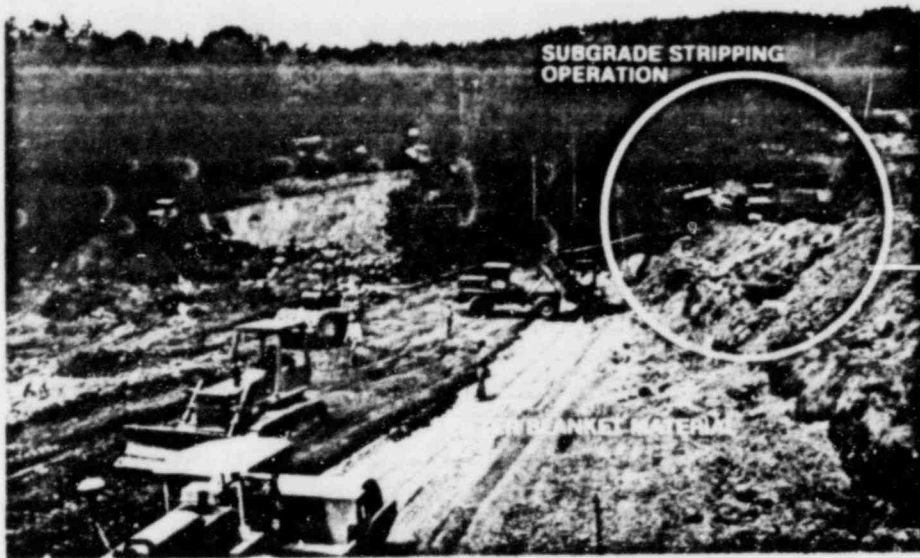
During the initial phases of construction, subgrade excavation on the existing embankment was restricted to exposing only an area 15 feet above the overlay placement operations, as shown in Photo 3. As time went on, this restriction was relaxed due to the excavation operation holding up overlay placement. Therefore, subgrade excavation was extended up to 45 feet above overlay operations. Photo 9 illustrates the exposed subgrade from elevation 1330.0 to 1355.0. This change allowed for unrestricted overlay placement; when there was inclement weather, the filter blanket portion of the overlay was cleaned of all slope wash debris. Several times the subgrade was over-excavated to remove rain water saturated material back to a reasonable dry, solid material.

PHOTO 3  
OVERLAY CONSTRUCTION  
AT EL. 1240 (9-4-81)

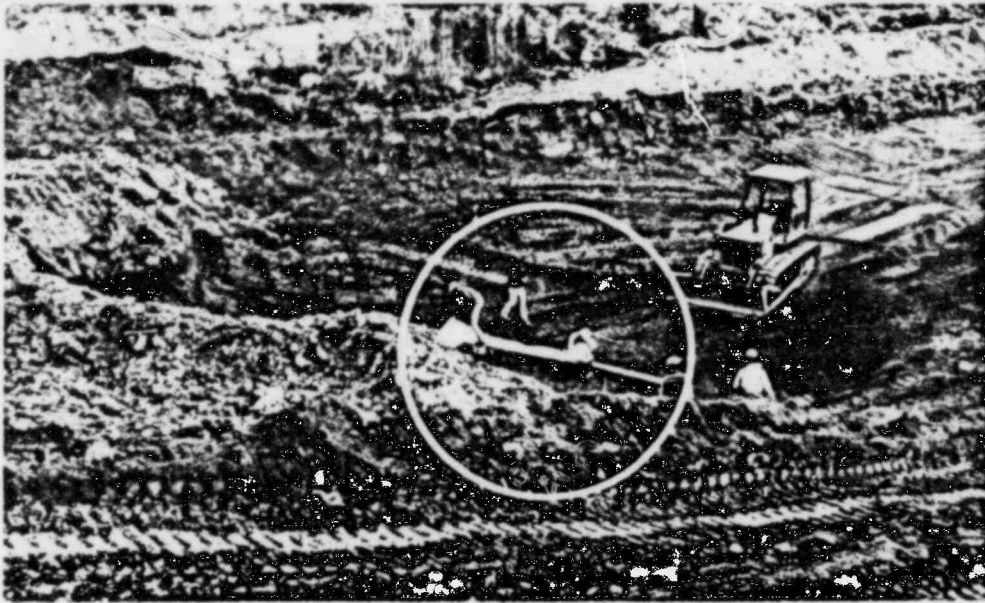
g. Drain Collector System - A series of perforated drain pipes were installed within the filter drain blanket. These drain pipes were located along the abutments and downstream toe of the embankment overlay as shown on Photo 6 and on Plates 4 and 7. Additional drain pipes were installed near visible wet spots, notably the drain pipe replacing the former french drain near station 12+00 (elevation 1327.0). Locating the drain pipe near the wet areas facilitates more rapid dewatering. At the

PHOTO 6  
PLACEMENT OF  
FILTER BLANKET  
MATERIAL WITH TOE  
DRAIN COLLECTOR  
SYSTEM (9-21-81)

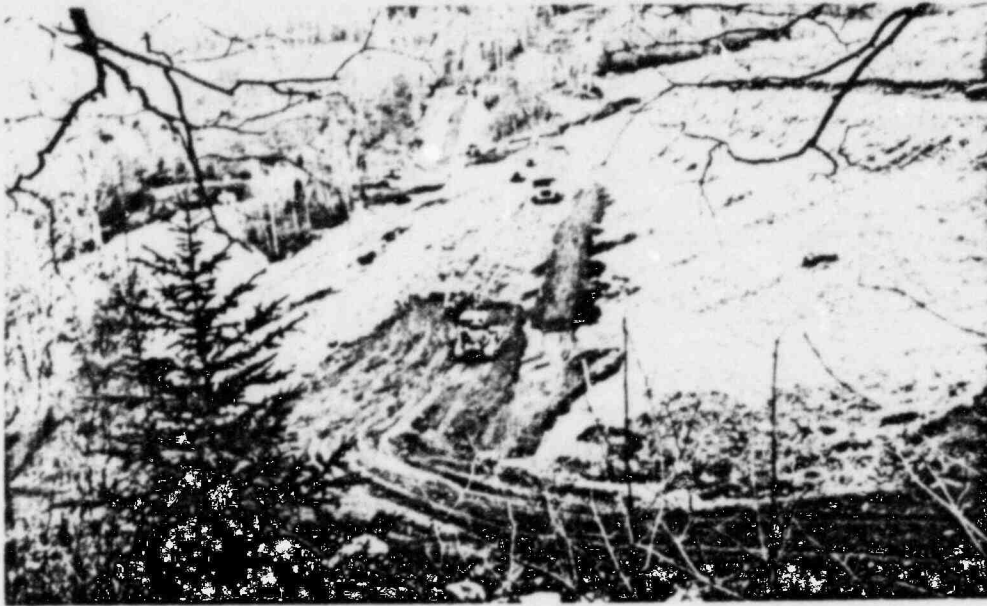
PHOTO 9  
OVERLAY CONSTRUCTION  
AT EL. 1330 (10-16-81)

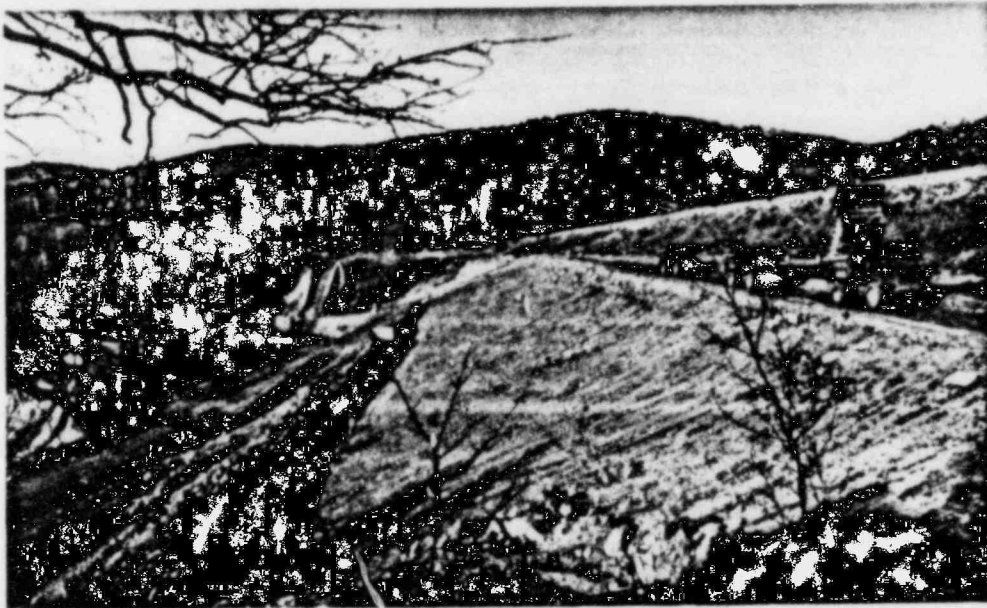
PHOTO 10  
OVERLAY CONSTRUCTION  
AT EL. 1382 (11-12-81)

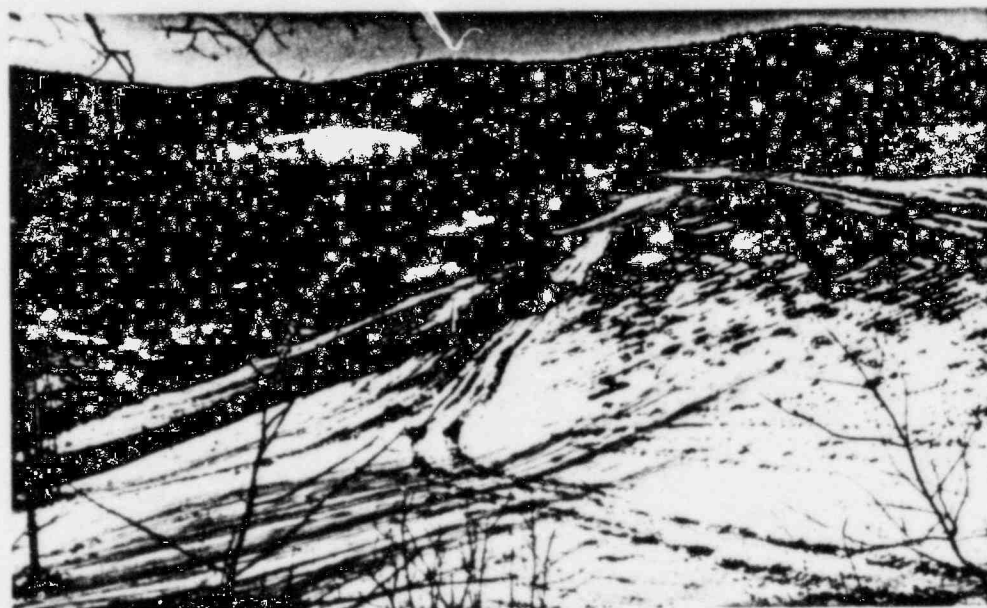
PHOTO 11  
COMPLETED OVERLAY  
(1-30-81)

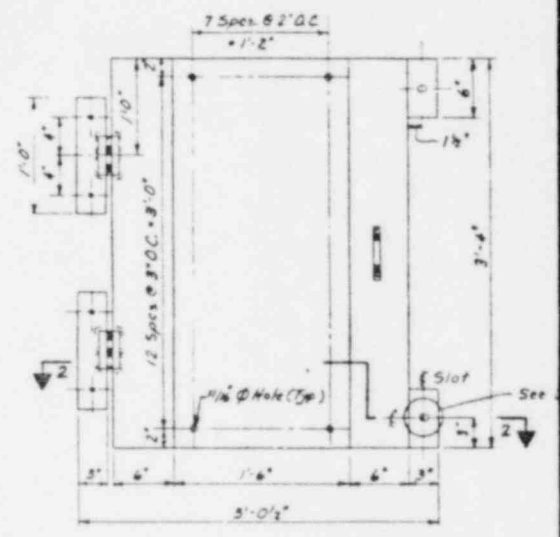
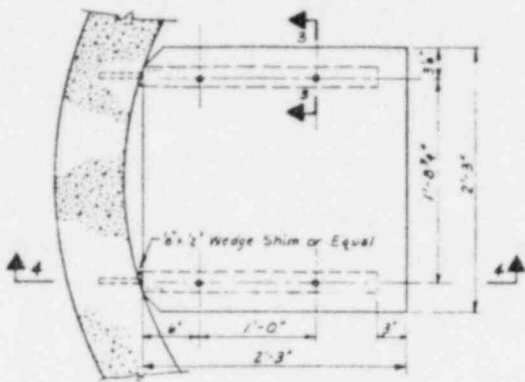
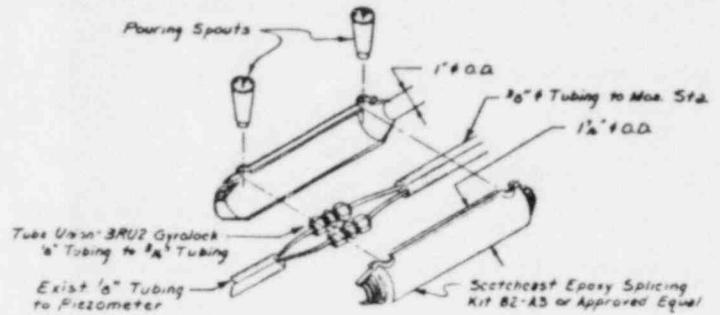
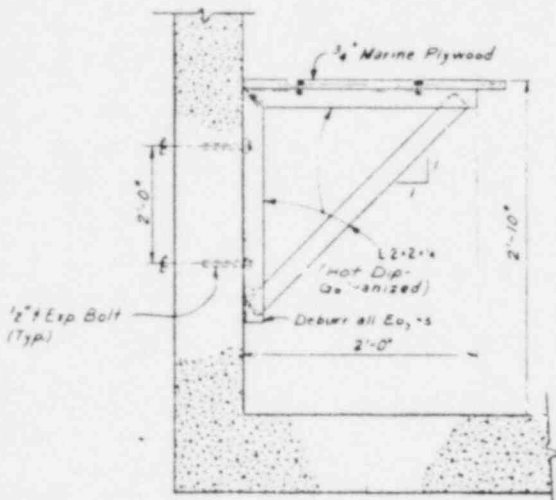
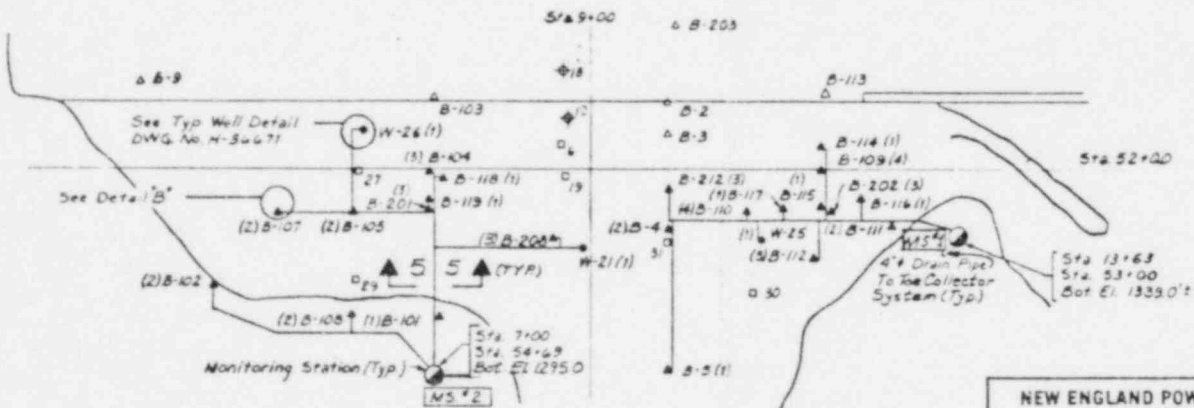
PLATE 6

the readings might have changed. Plate 6 illustrates the details of the piezometer lead relocation program. None of the piezometer readings change significantly, but the time to obtain initial reading became longer, e.g. two to four minutes. Once the piezometer leads were filled with the nitrogen gas after the initial readings, the reading time was significantly reduced. The leads were then placed in trenches excavated at least two feet below the proposed stripping grades. Once the trenches were excavated to their required elevation, they were backfilled with two or three inches of filter material for bedding, then the piezometer leads were set on top. A two foot minimum of filter material was backfilled over the leads to insure proper protection. Random fill (till) was backfilled over the filter material to protect against truck traffic and slope wash. Locations of all the piezometer lead relocation trenches are shown on Plate 7.

There are two piezometer monitoring stations that contain all of the downstream leads. Monitoring Station No. 1 is located on the left abutment and Monitoring Station No. 2 is located on the right abutment. Details concerning the monitoring stations are shown on Plate 6. All piezometer leads are mounted with quick connect fittings to the instrument panel. In all cases, the black tube (output) is mounted on the left and the white tube (input) is mounted on the right. The layout arrangement for each panel is noted in the Haley & Aldrich, Inc. Memorandum to Pizzagalli Construction Co. dated 9 October 1981. This memorandum is included in Appendix C. In addition, this memo contains all piezometer readings recorded during the construction period.

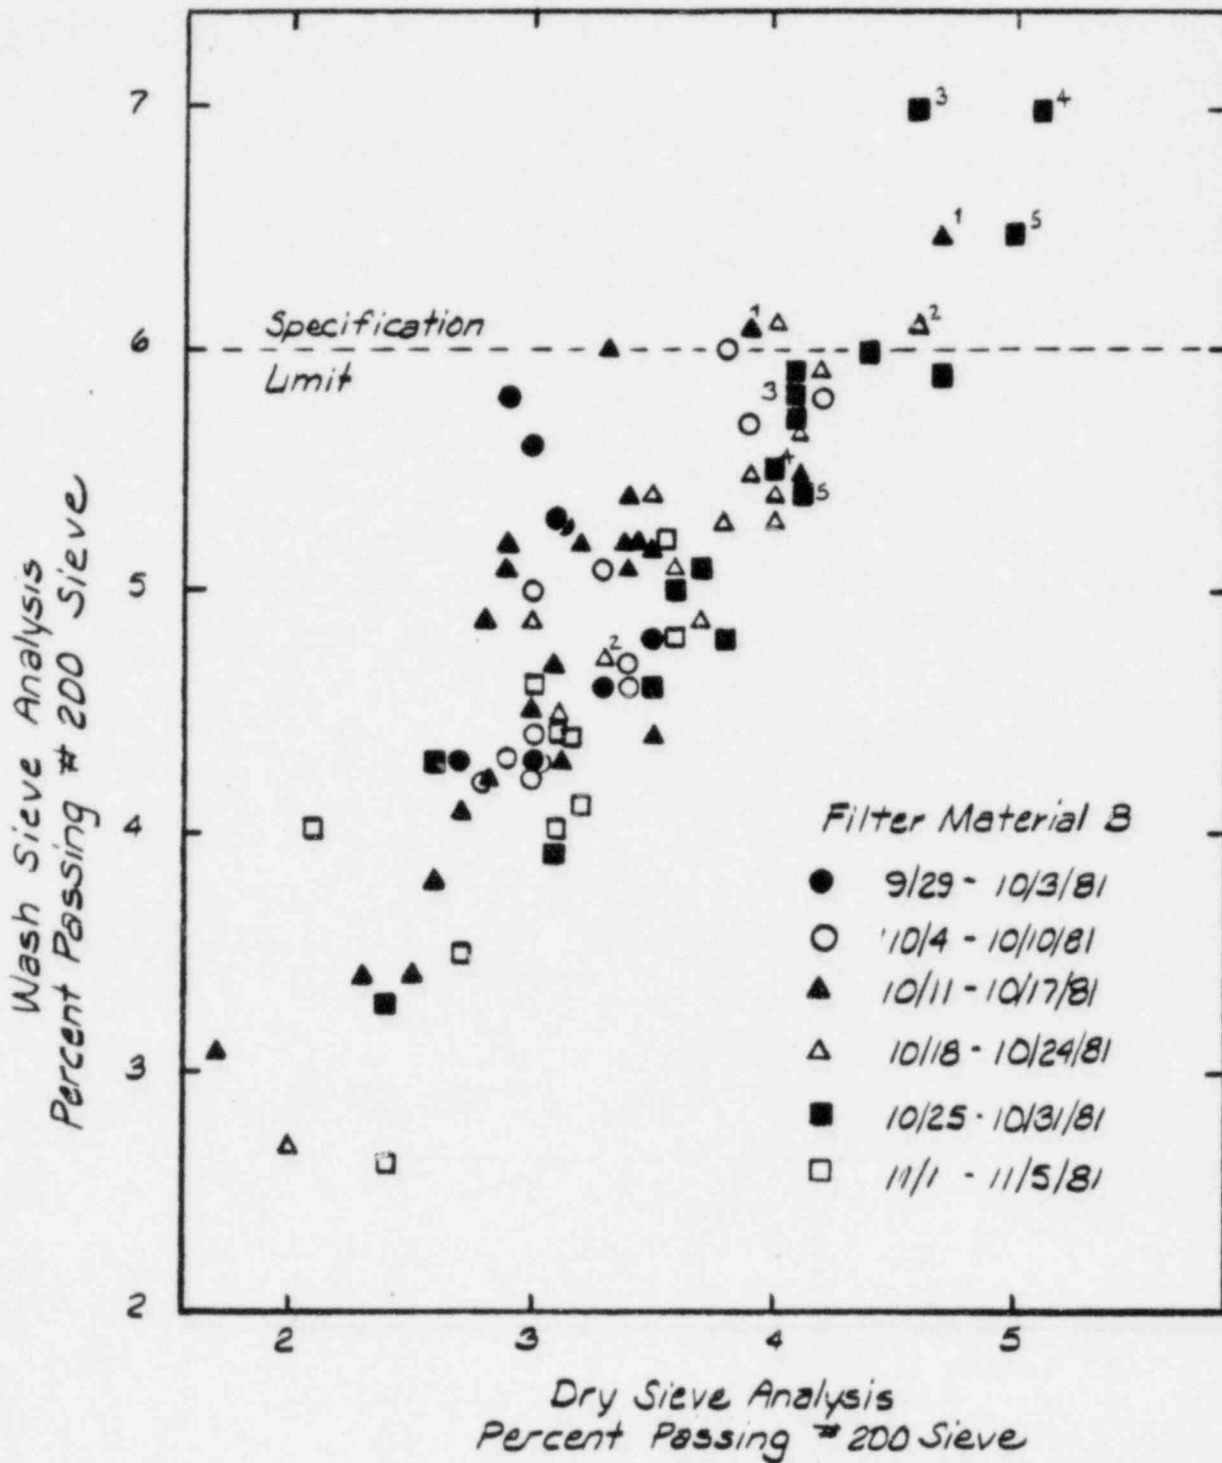
CLIENT 188 PLATE  
1270 76 A(3)

Test Results Exceeding 6% Fines  
Were Retested. The Numbered  
Tests Show Both Initial Failure  
And Retest Data.
