Fourth Inspection Report  
of the  
New England Power Company  
Deerfield River Project  
Harriman and Sherman Developments  
Project No. 2323  
June 1982

Inspection and Report  
by  
CHAS. T. MAIN, INC.

SUBJECT: Fourth Inspection Report  
New England Power Company  
Deerfield River Project  
Harriman and Sherman Developments  
Project No. 2323

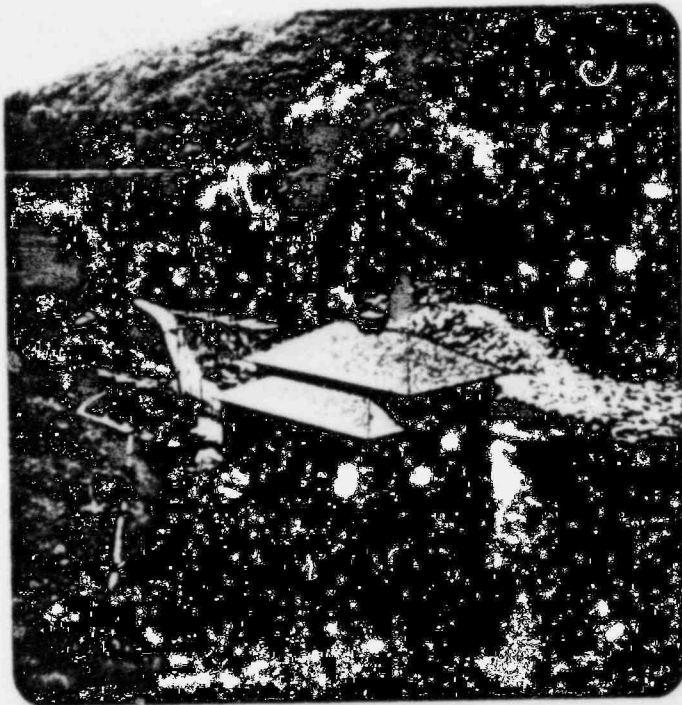
The powerhouse itself shows no serious adverse conditions. Cracks and seeps in the foundation are minor and do not suggest large differential settlement. Some concrete deterioration appears at and below the waterline above the draft tube exit, though it is not serious and does not have structural consequences.

Photo No. 6  
Face of Powerhouse Over Draft Tubes  
Note Deteriorated Concrete at Water  
Line
