UNITED STATES
NUCLEAR REGULATORY COMMISSION
WASHINGTON, D. C. 20555

AEOD/E119

JUL 22 1981

SUBJECT: LOSS OF RESIDUAL HEAT REMOVAL (RHR) CAPABILITY AT BRUNSWICK
UNITS 1 AND 2

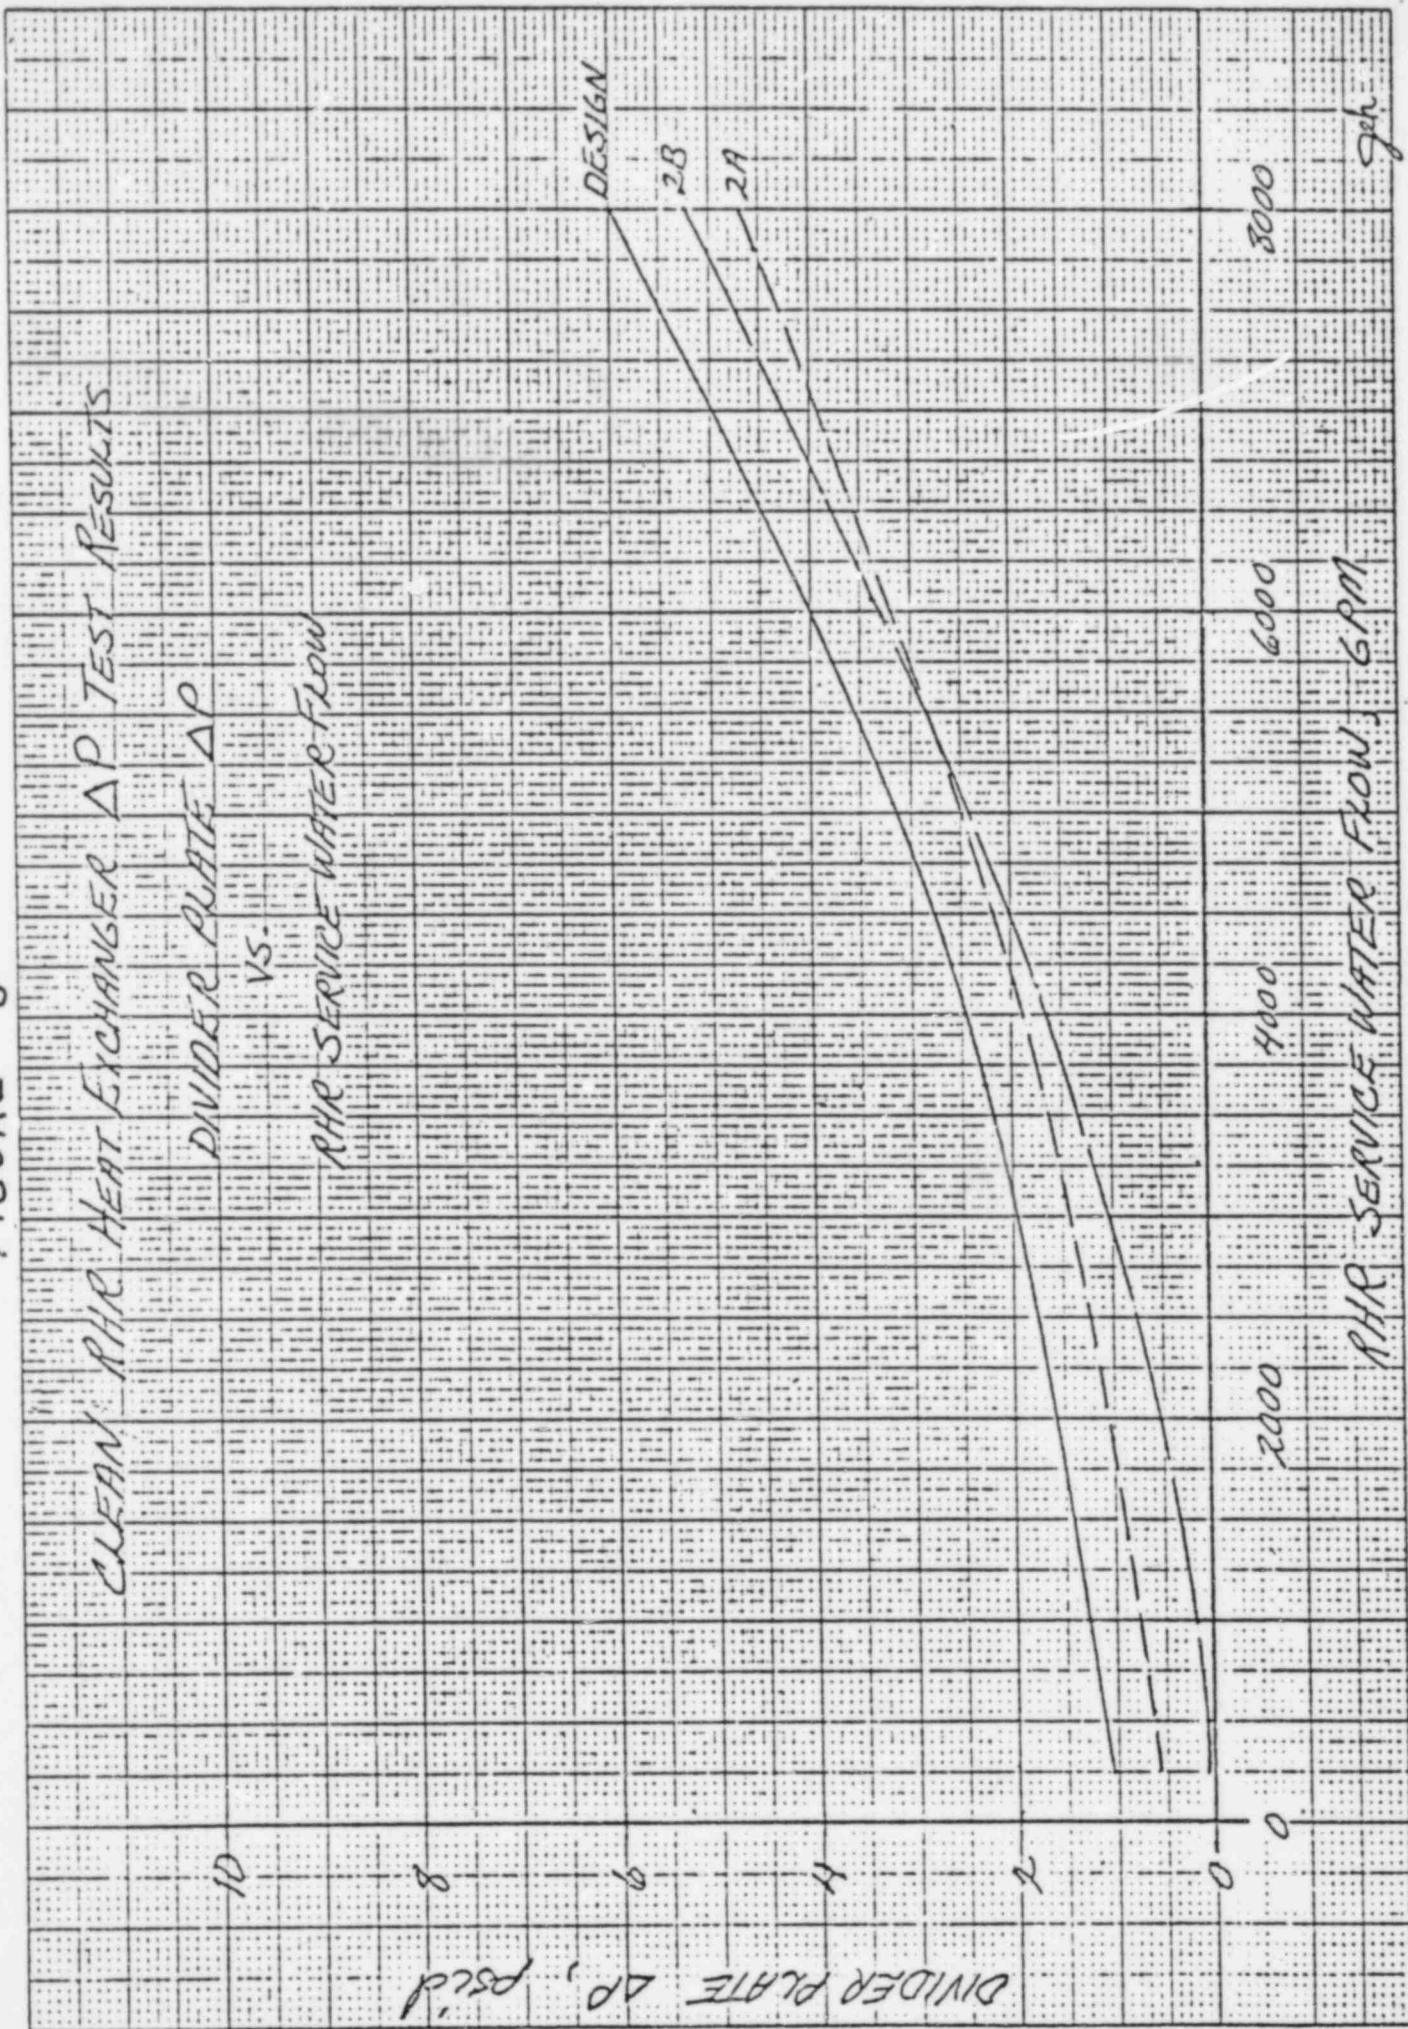
FIGURE 8

Following the cleaning operations, the buckled RHR heat exchanger baffle plates were replaced and the heat exchangers were returned to their original design specifications (see Figure 8). Due to the Cu Ni used in these components, neither the welds nor the baffle plates themselves are as strong as in HXs in other plants with carbon steel baffles and water boxes. Figure 7 illustrates the deformation found in the heat exchangers and Table 3 summarizes the work which has been performed.
