SUBJECT: ENFORCEMENT CONFERENCE SUMMARY

BRUNSWICK NUCLEAR PROJECT
ENFORCEMENT CONFERENCE RELATED TO
UNPLANNED PERSONNEL RADIATION EXPOSURE

AUGUST 6, 1990

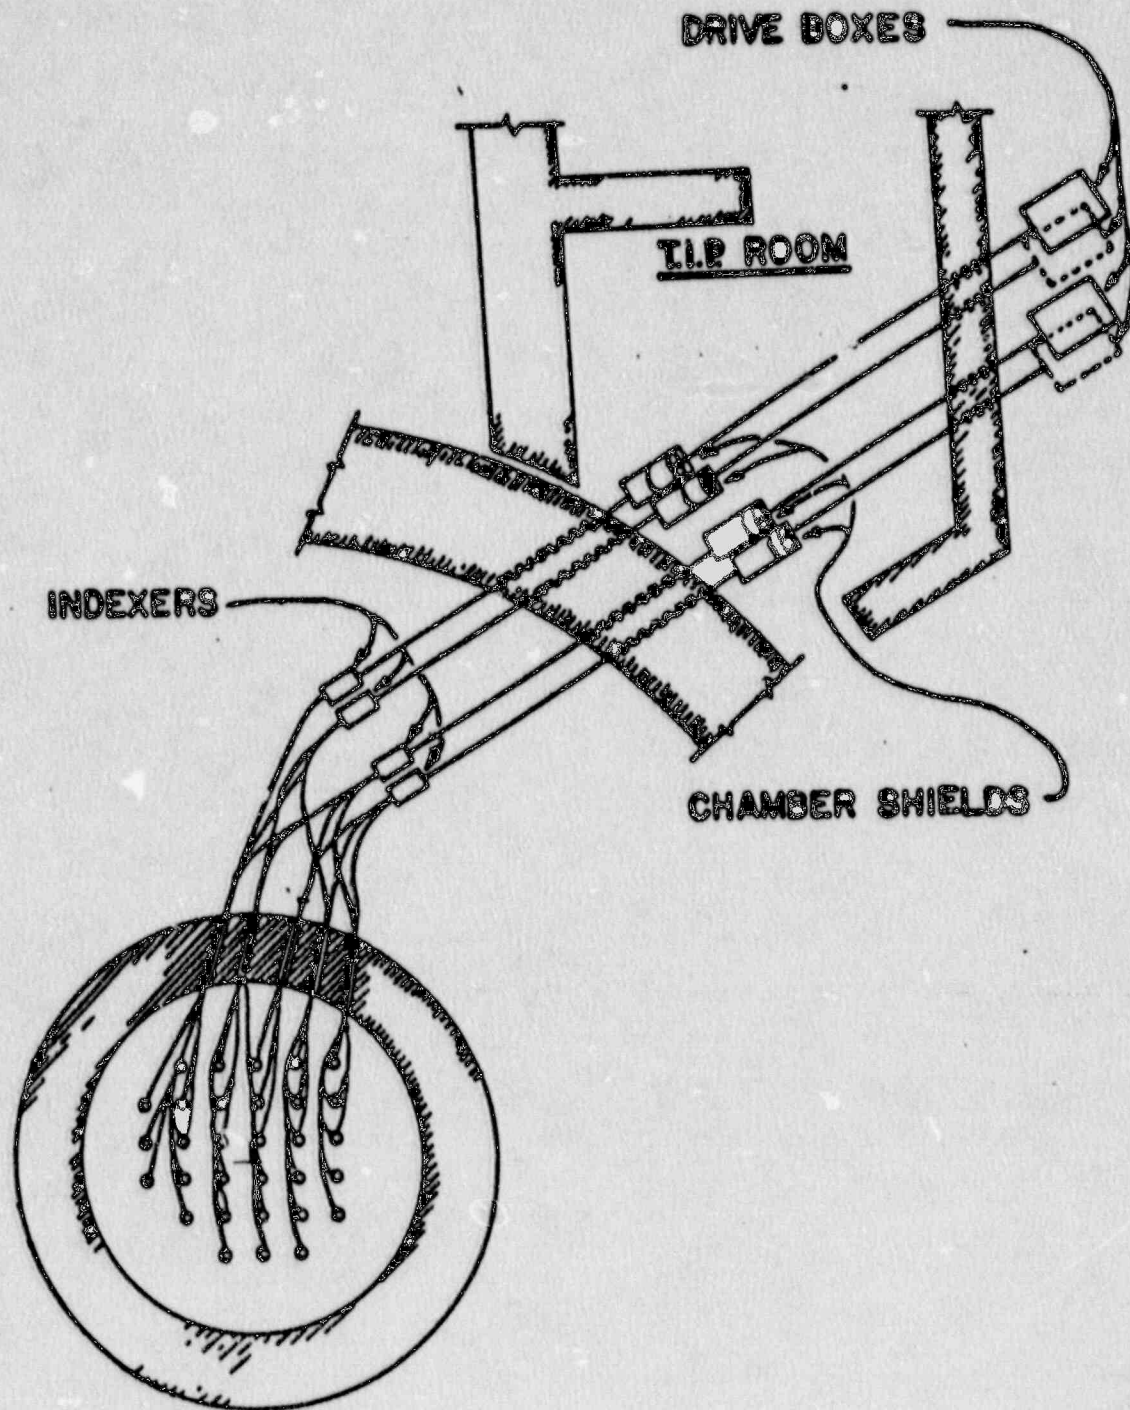
- MEASURES AXIAL THERMAL NEUTRON FLUX PROFILE
IN THE REACTOR CORE.

- USED TO CALIBRATE THE LOCAL POWER RANGE
MONITORING DETECTORS.
