U. S. NUCLEAR REGULATORY COMMISSION
REGION I

Docket/Report No. 50-289/90-13
50-320/90-06

Facility: Three Mile Island Nuclear Station, Units 1 and 2

Inspection Summary for Combined for Inspection Report Nos. 50-289/13 and 50-320/06

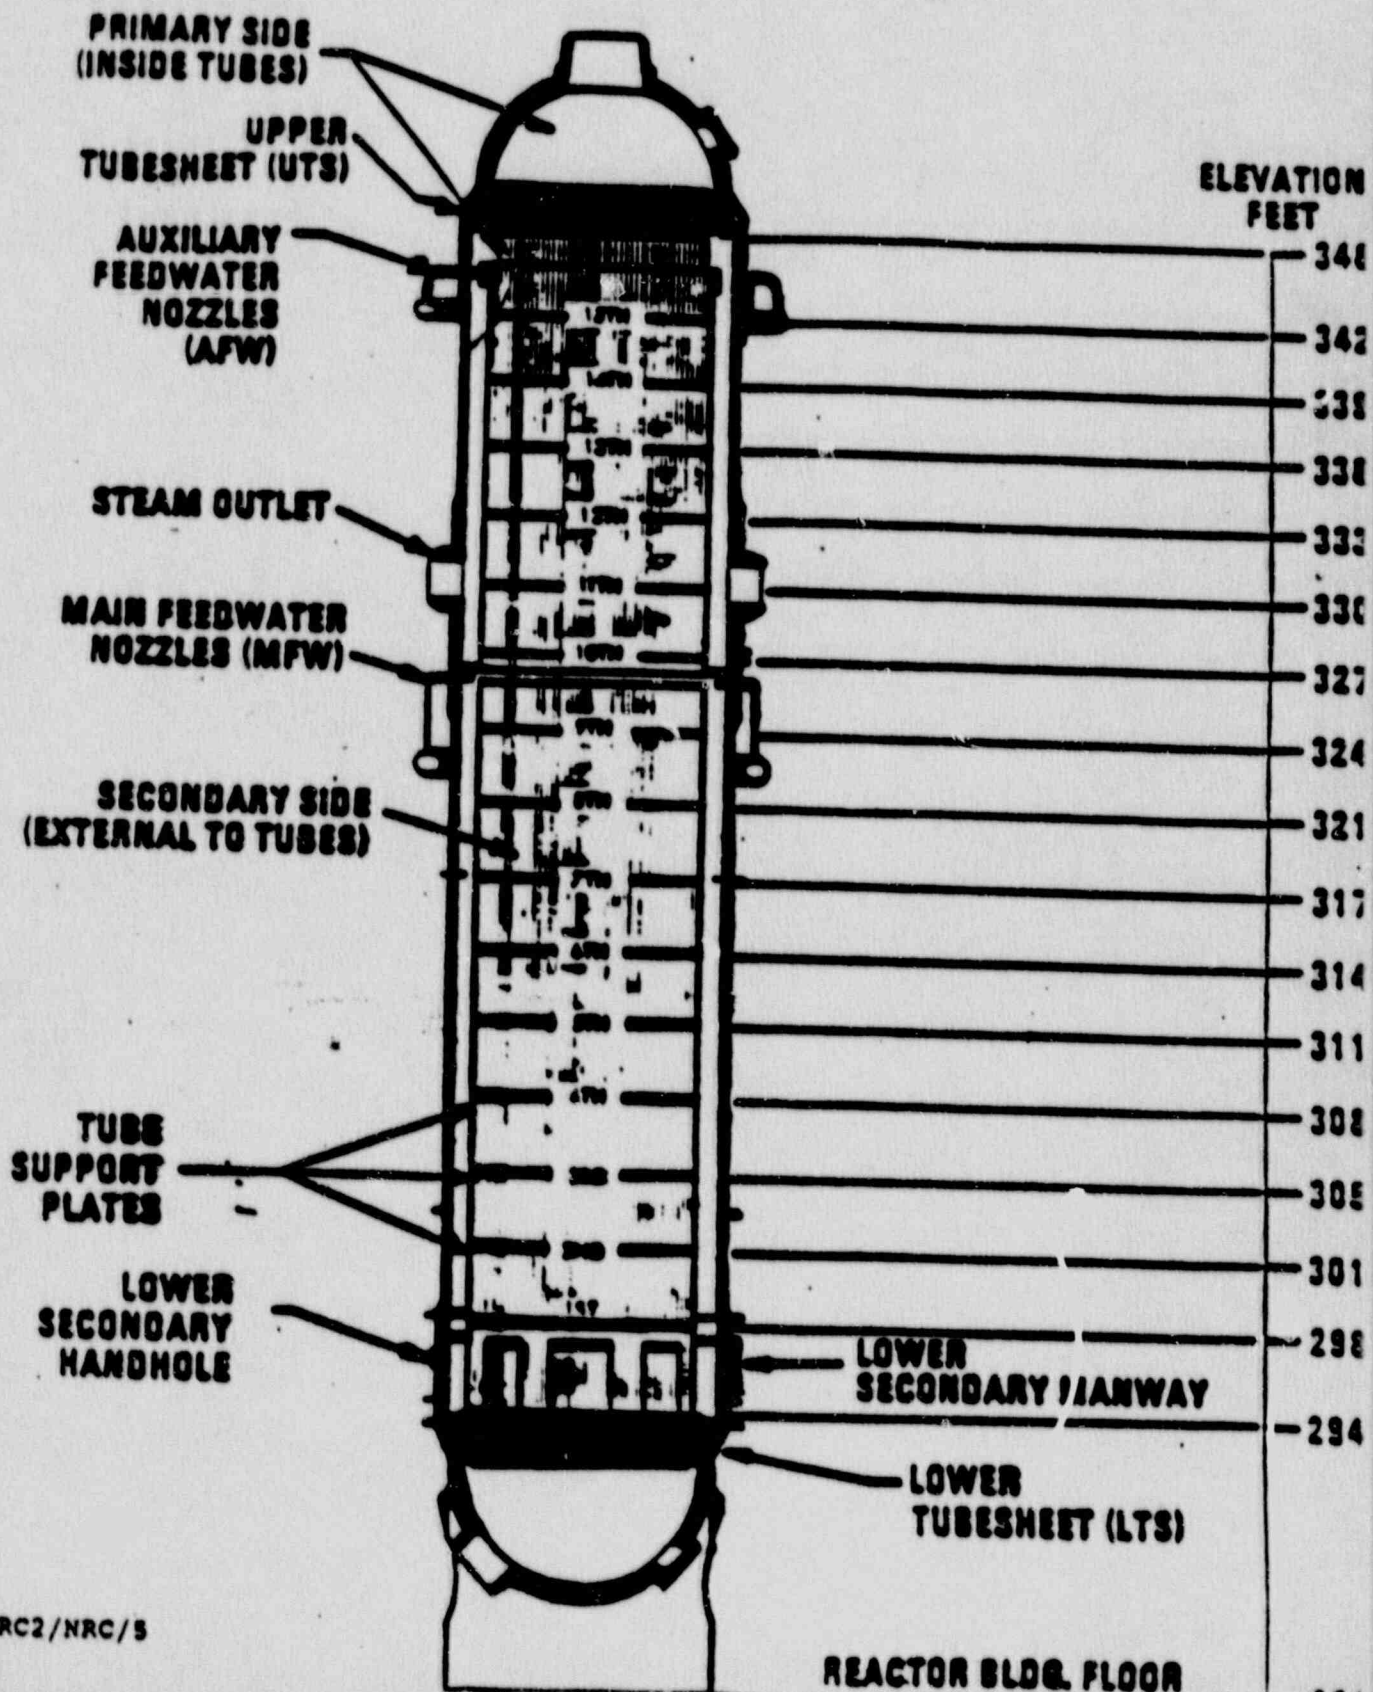
OTSG Longitudinal Section Elevations (Typ.)

- IRON AND DISSOLVED SOLIDS ARE GENERATED IN THE TURBINE CYCLE PIPING AND COMPONENTS AND THE OTSG
- IRON IS TRANSPORTED TO AND DEPOSITED IN OTSG
- DEPOSITS FORM ON THE SUPPORT PLATES AND ON THE TUBES
- TEMPERATURE CHANGES CAUSE DEPOSITS ON TUBES TO SPALL (FLAKE) OFF
- THE BROACHED HOLE OPENING REDUCED BY SUPPORT PLATE FOULING AND FLAKE BLOCKAGE
- INCREASED FLOW PATH RESISTANCE NECESSITATES HIGHER DRIVING FORCES (DOWNCOMER LEVEL)

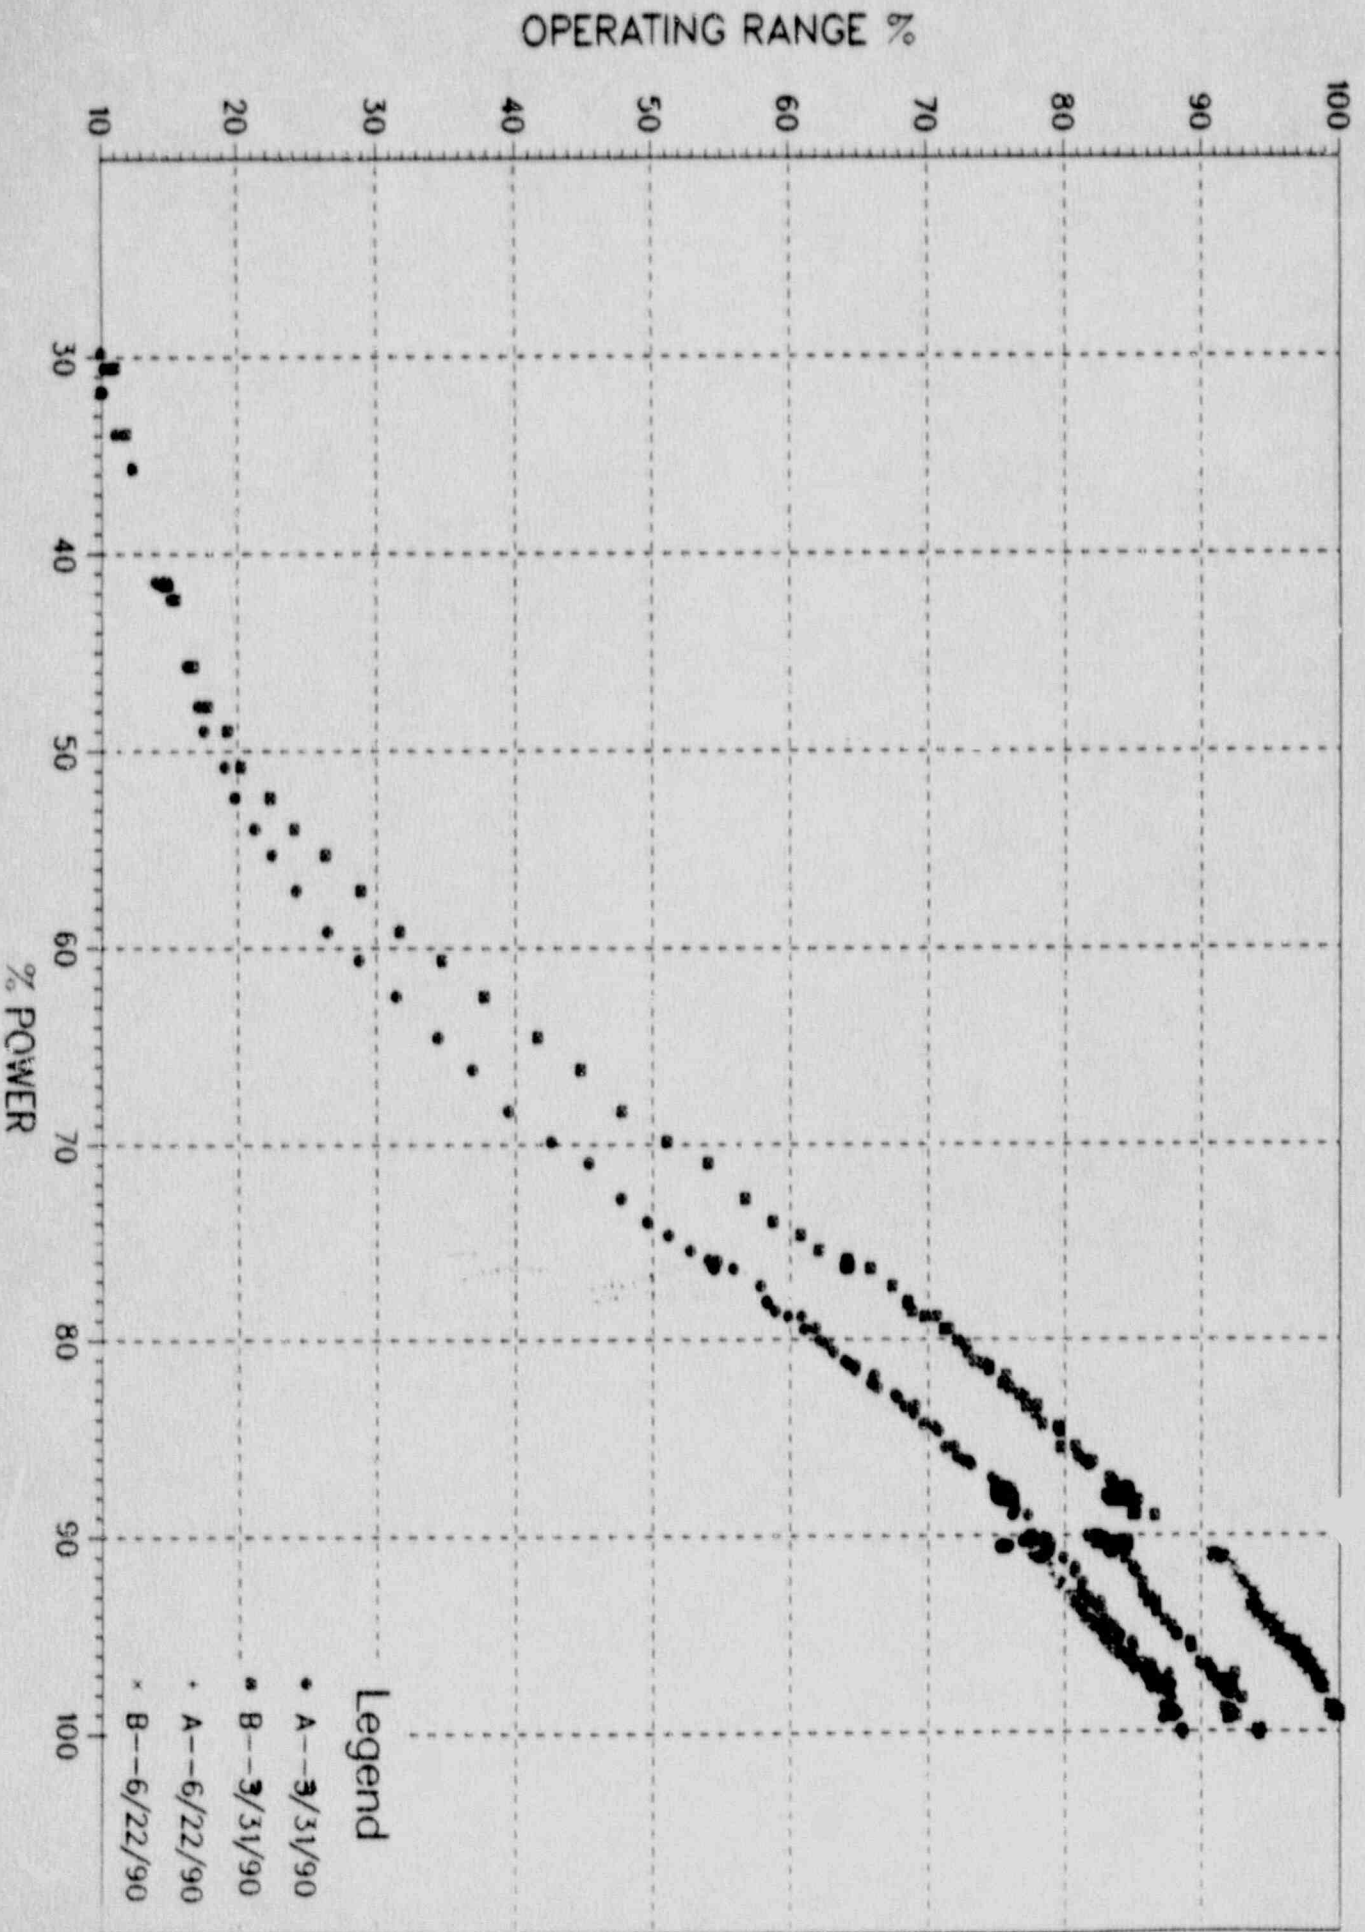
TMI-1 STEAM GENERATOR LEVELS - CYCLE 8

Steam Generator
High level test
