LABORELEC RODESTRAAT 125 B-1630 LINKEBEEK	Tel 02/38.20.211 Telex 22297 Fax 02/38.20.241
---	---

HEADING	STEAM GENERATOR PWSCC IN SERVICE LEAKAGE EXPERIENCE IN BELGIUM	21 pages
SUMMARY	<p>Belgium has a large experience of operating steam generators with PWSCC through-wall axial defects in the tube roll transitions.</p> <p>The service behaviour has nevertheless been very good, with a rather low primary to secondary leakage.</p> <p>This report documents the available data and investigates the reasons for the observed leakrate variability and discrepancy with respect to theoretical models and laboratory experiments.</p>	
ANNEXES

REFERENCES LABORELEC	
Document	M00-90-022/R-PH/SD
Task/Beneficiary	M00/00339/ELNUC

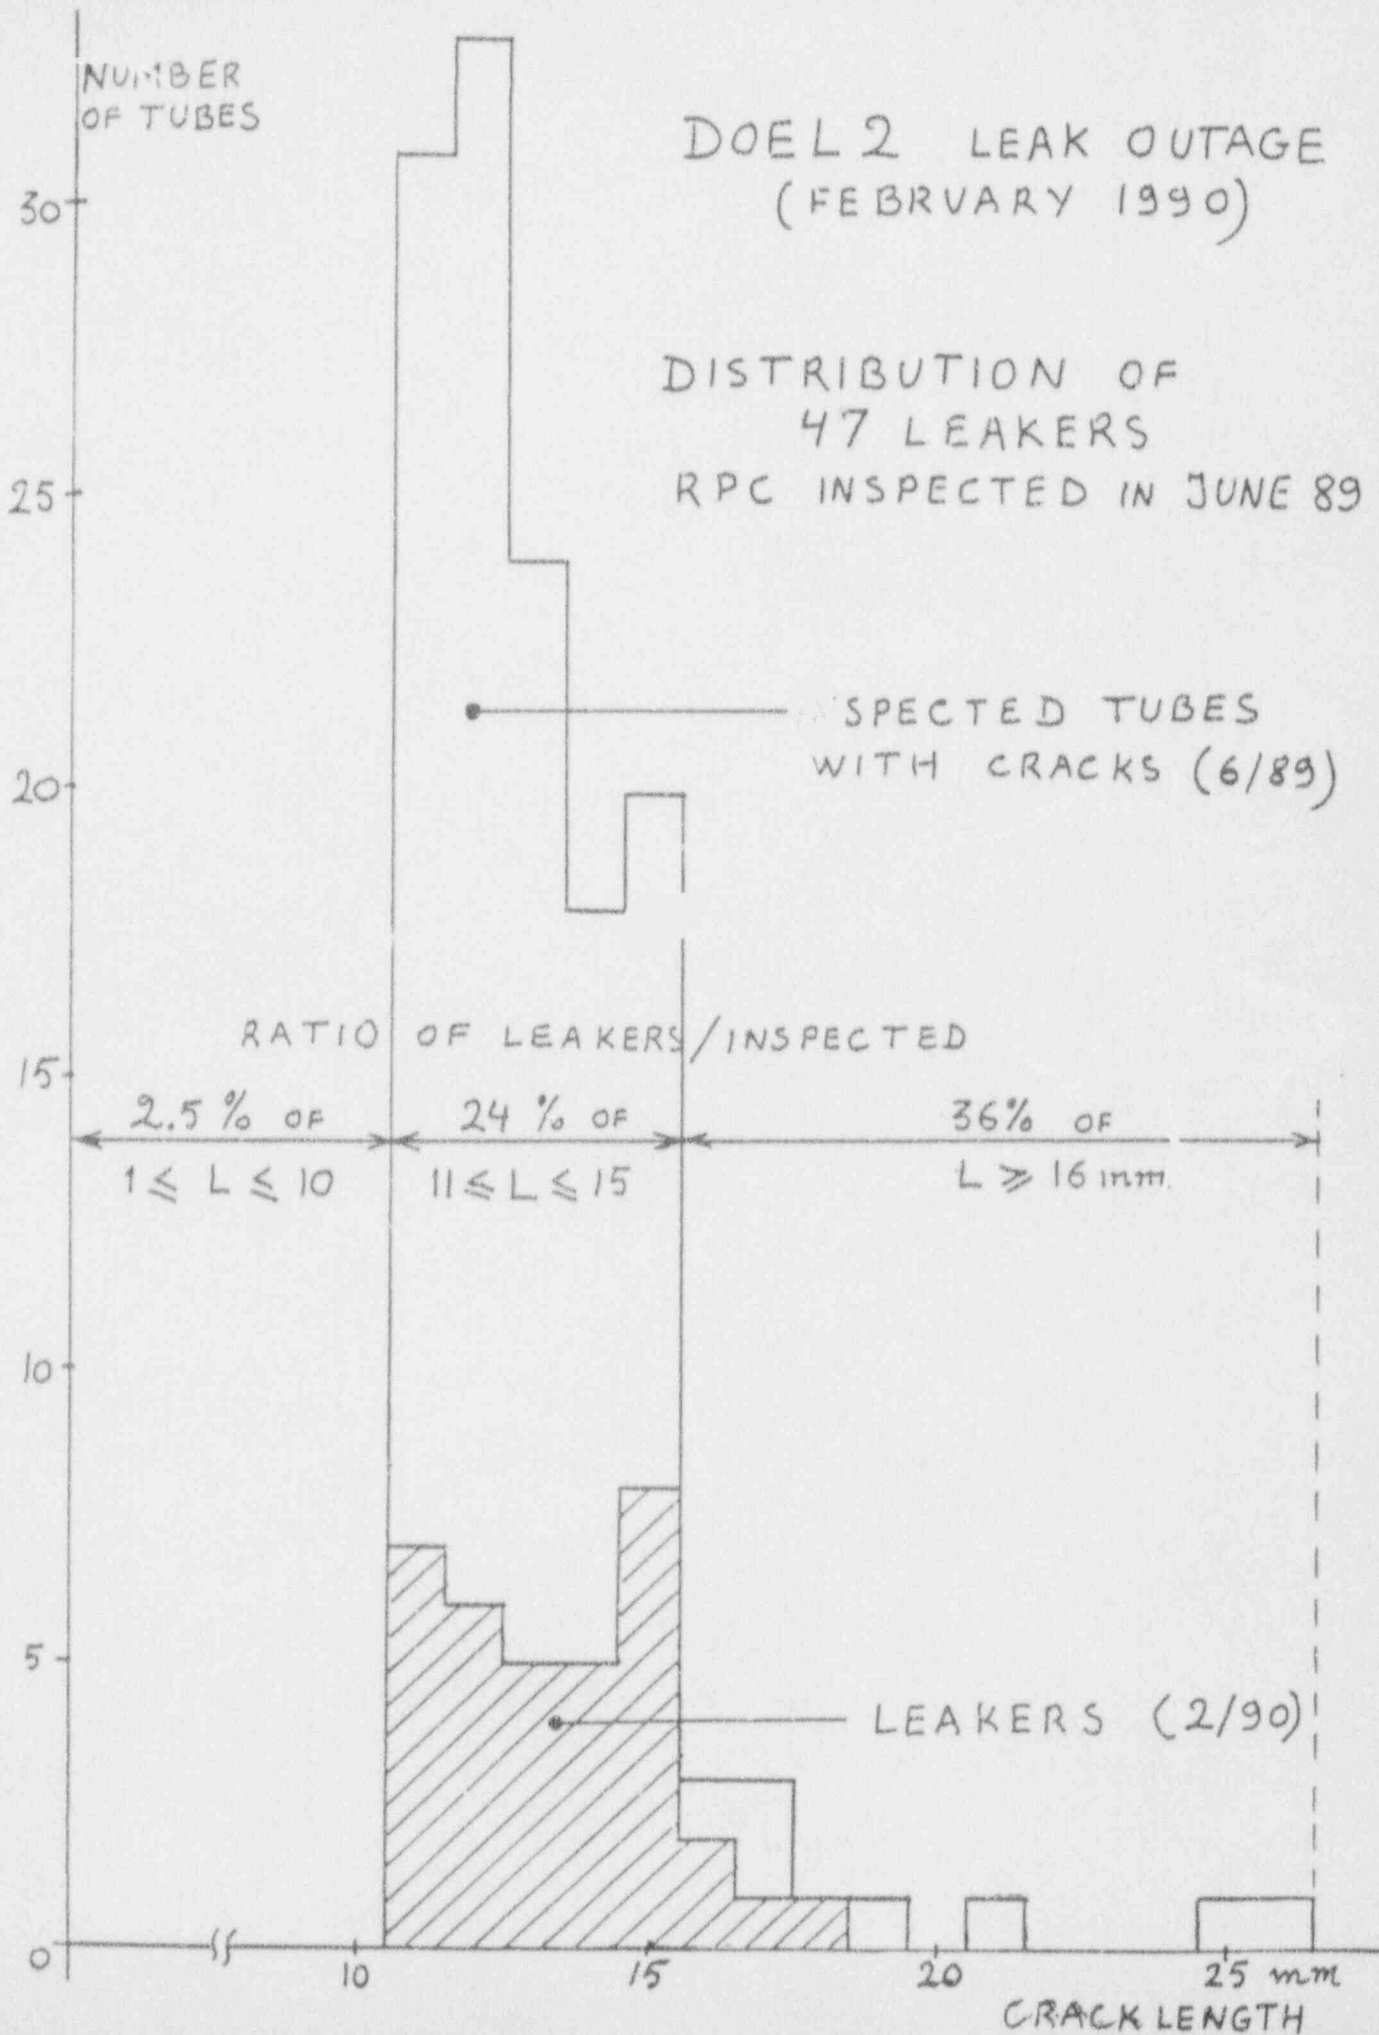
FIGURE 5

- the behaviour of the actual leakers does not support this assumption,
 - . the denting at the top of the tubesheet acting as a leaktight barrier ; this is apparent from the tubesheet map where the 135 inspected leakers are mostly outside the sludge/dent area (see figure 5),
