50-151

214 Nuclear Engineering Laboratory
103 South Goodwin Avenue
Urbana, IL 61801-2984

March 9, 1994

Final Report on Delay Tank Leak
at the
UIUC Nuclear Reactor Laboratory

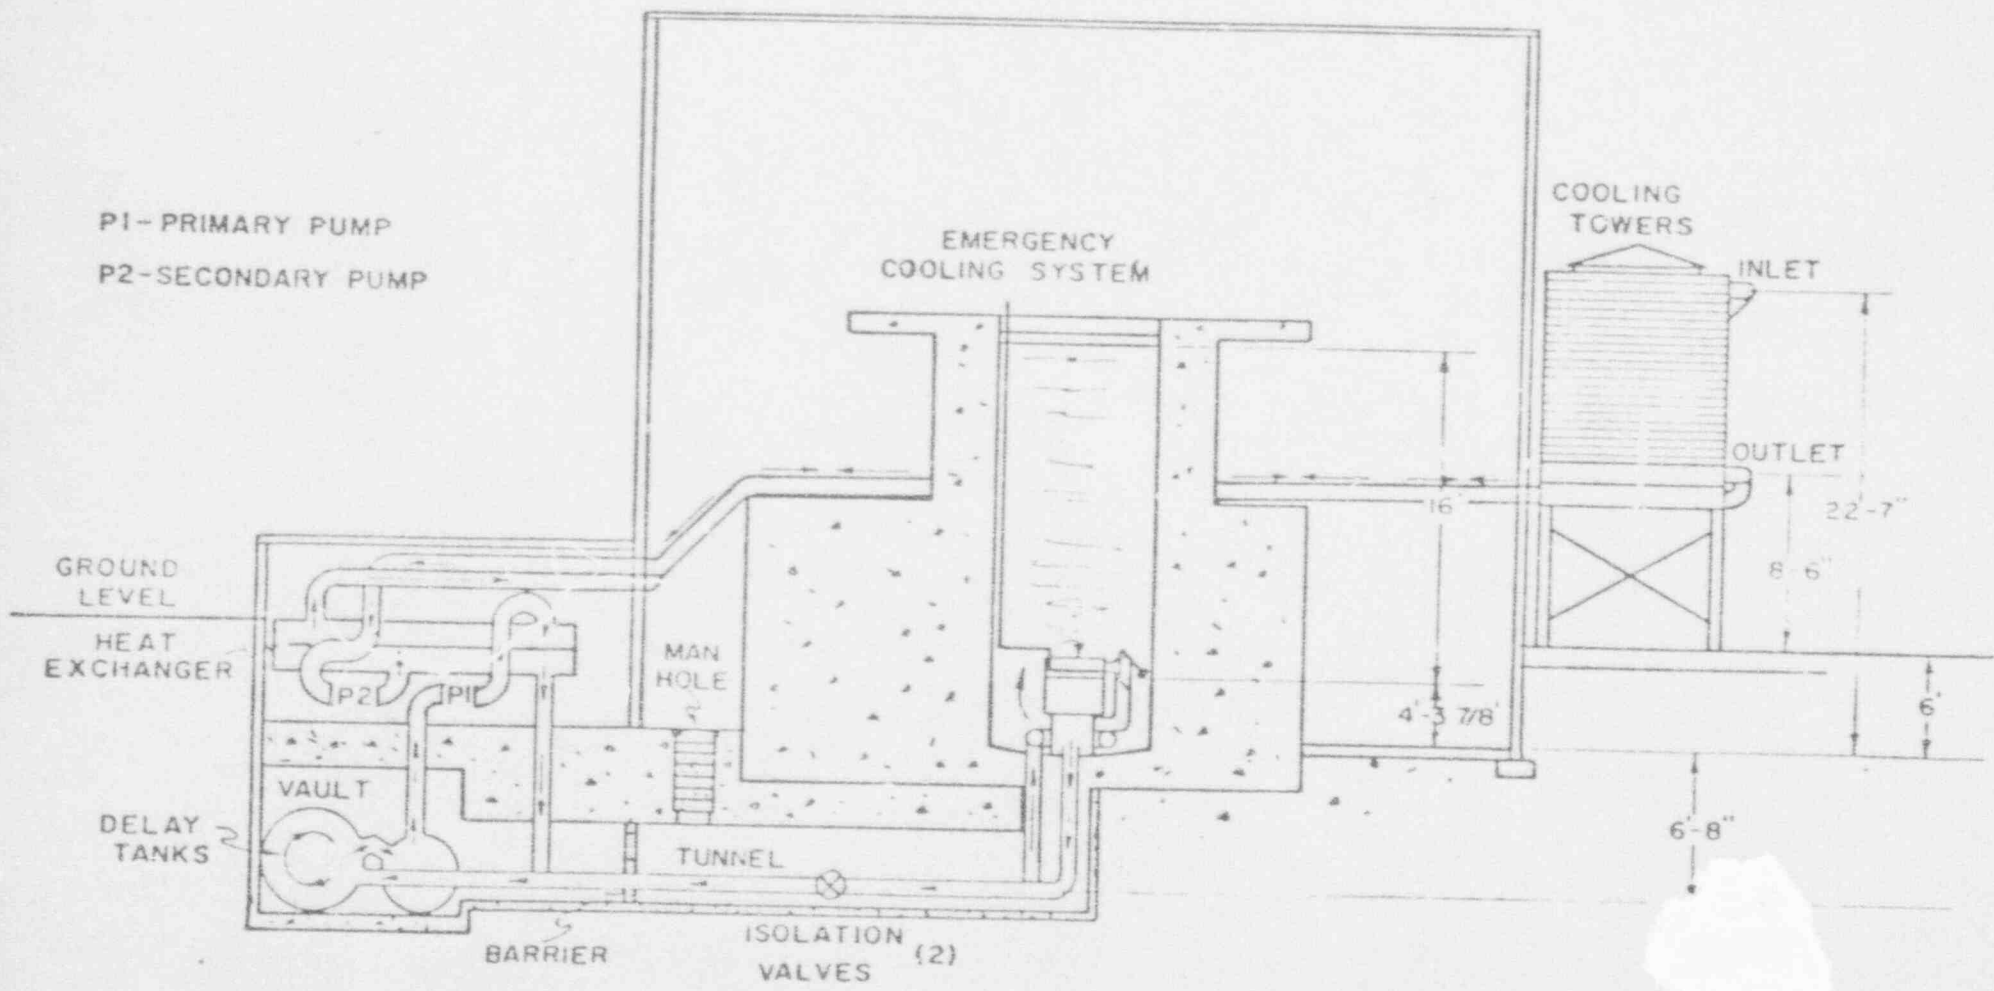
FIG. IV-6 PRIMARY FLOW COMPONENTS IN THE VAULT

The stress caused by this situation apparently caused a fracture in one of the circumferential weld seams in the large delay tank [see Fig. IV - 6]. The 3 gpm makeup valve operated sporadically during Tuesday afternoon, but that was attributed to the fact that the controller got wet when the tank overflowed. The next day the reactor and primary system were operated and it was noticed that the 3 gpm makeup valve was operating fairly frequently and the operator decided to shutdown the reactor. It was found that there was a vault sump alarm and the vault was opened. Approximately 1400 gallons of water were found in the vault and the leak was immediately evident as it was relatively close to the manway. A physical inspection was

- A welder, qualified in aluminum welding, and employed by the University of Illinois repaired the weld in the delay tank on Monday morning, January 10, 1994. *[It was later determined that the welder was not 'certified' for welding on an ASME qualified tank. This situation developed due to miscommunication on the part of the Reactor Supervisor and the Operations and Maintenance Division of the University of Illinois. The Reactor Supervisor did not specify correctly to O & M what was required.]* It was noted that the crack was very evidently due to the stress placed on the weld and not due to corrosive forces. It was also noted that the area of the original weld where the crack occurred had been ground down. This presents the possibility that a stress zone may have been introduced at that time that failed during the transient. The vast majority of the weldment on the tanks still retained the weld cap material, i.e., no grinding had taken place.

- DNV Industries, Inc. of Des Plaines, IL was engaged to perform an NDE inspection of the weld repair and all other accessible weldment. DNV is certified to inspect aluminum tank welds. Dye penetrant and ultrasonic testing of the weld repair and all other accessible weld material on the delay tanks and the sections of the primary piping were tested. No further cracking was evident on any of the weld seams.
