UNITED STATES  
NUCLEAR REGULATORY COMMISSION  
WASHINGTON, D. C. 20555

AEOD/E119

SUBJECT: LOSS OF RESIDUAL HEAT REMOVAL (RHR) CAPABILITY AT BRUNSWICK  
UNITS 1 AND 2

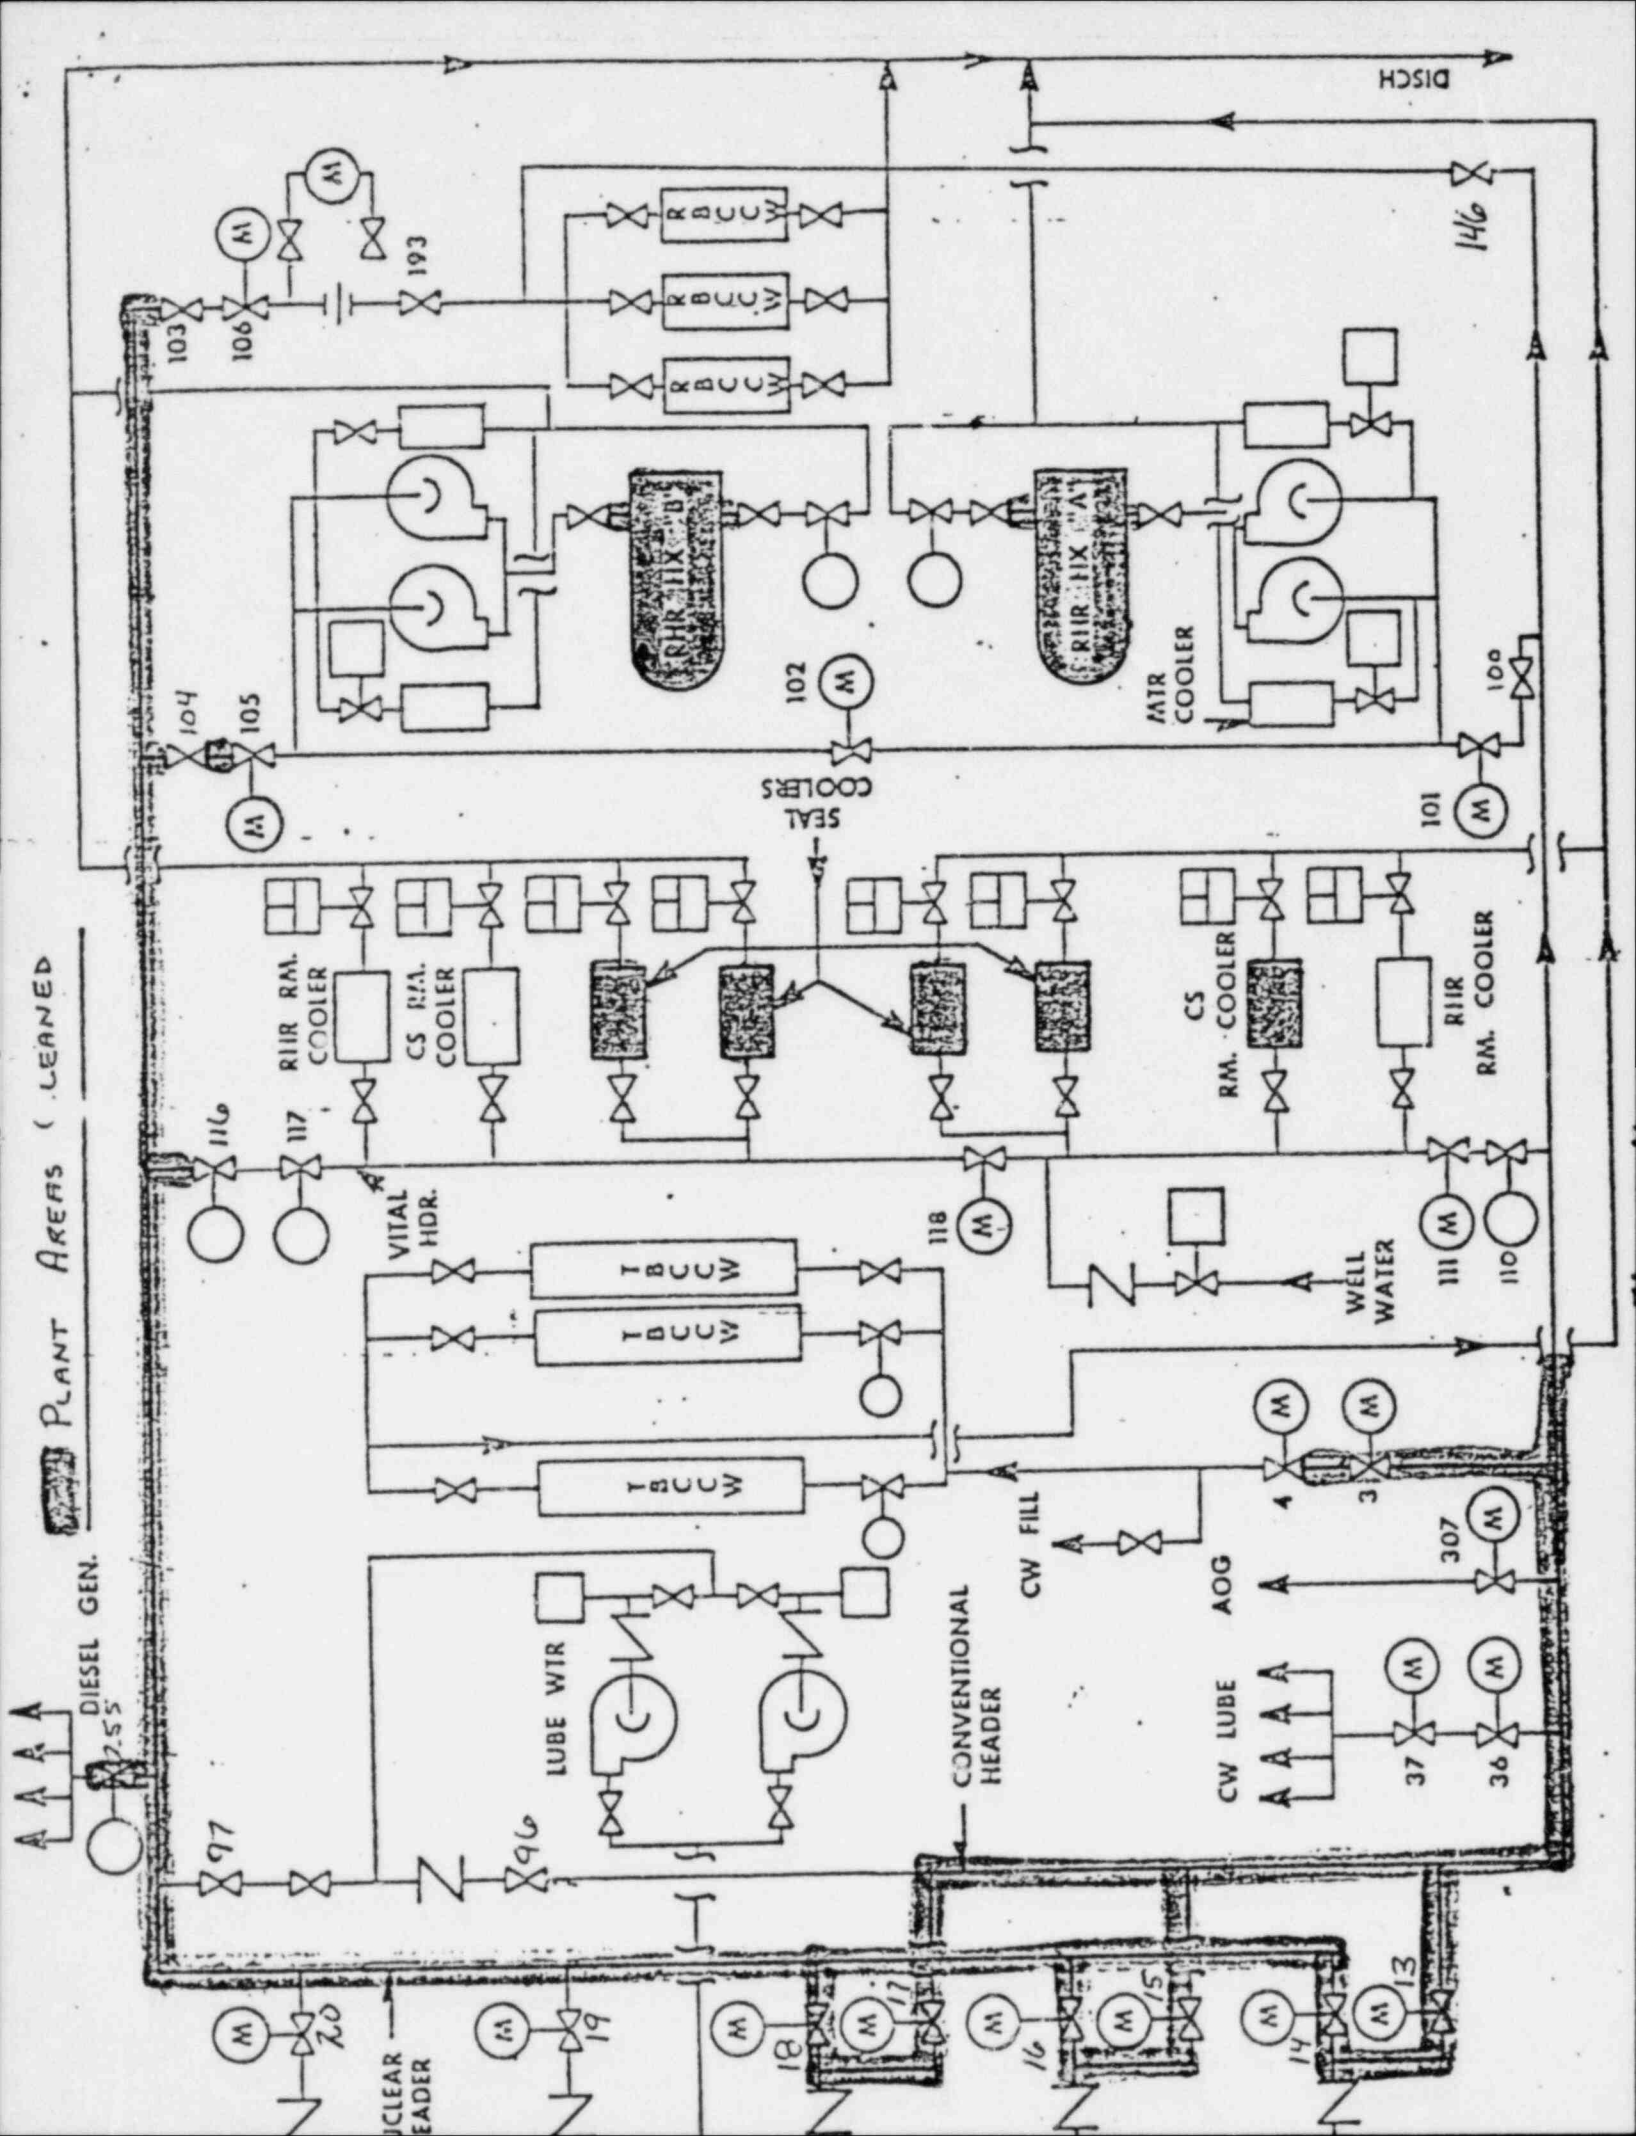
Figure 2

non-calcareous organisms were hydrozoans and polychaete worms. The most common species encountered was the American oyster. These organisms formed a layer approximately one-inch thick on the bottom of the pipe tapering off to 1/2 inch on the top. As was expected, more organisms were found in the larger diameter pipes, where flow rates are lower (about 3.36 fps in the 30 inch header with one service water pump running) than in the smaller diameter pipes with higher flow rates. Settlement of marine fouling larvae is dependent on flow velocity and larvae have difficulty attaching if the flow velocity is above four fps. It was also noted that the accumulation of organisms decreased proportionately with the distance from the intake structure. This may be due to the existence of an unfavorable temperature gradient or a depletion of the food supply. Pipes which are normally isolated were, for the most part, found to be clean. Isolated portions of the system including the RHRHXs are generally layed-up with well water. Detailed information on the location and extent of marine growth is shown in Figure 2.
