AEOD/C104

REPORT ON THE
MILLSTONE UNIT 2 LOSS OF 125 V DC BUS
EVENT ON JANUARY 2, 1981

OFFICE FOR ANALYSIS AND EVALUATION
OF OPERATIONAL DATA

November 1981

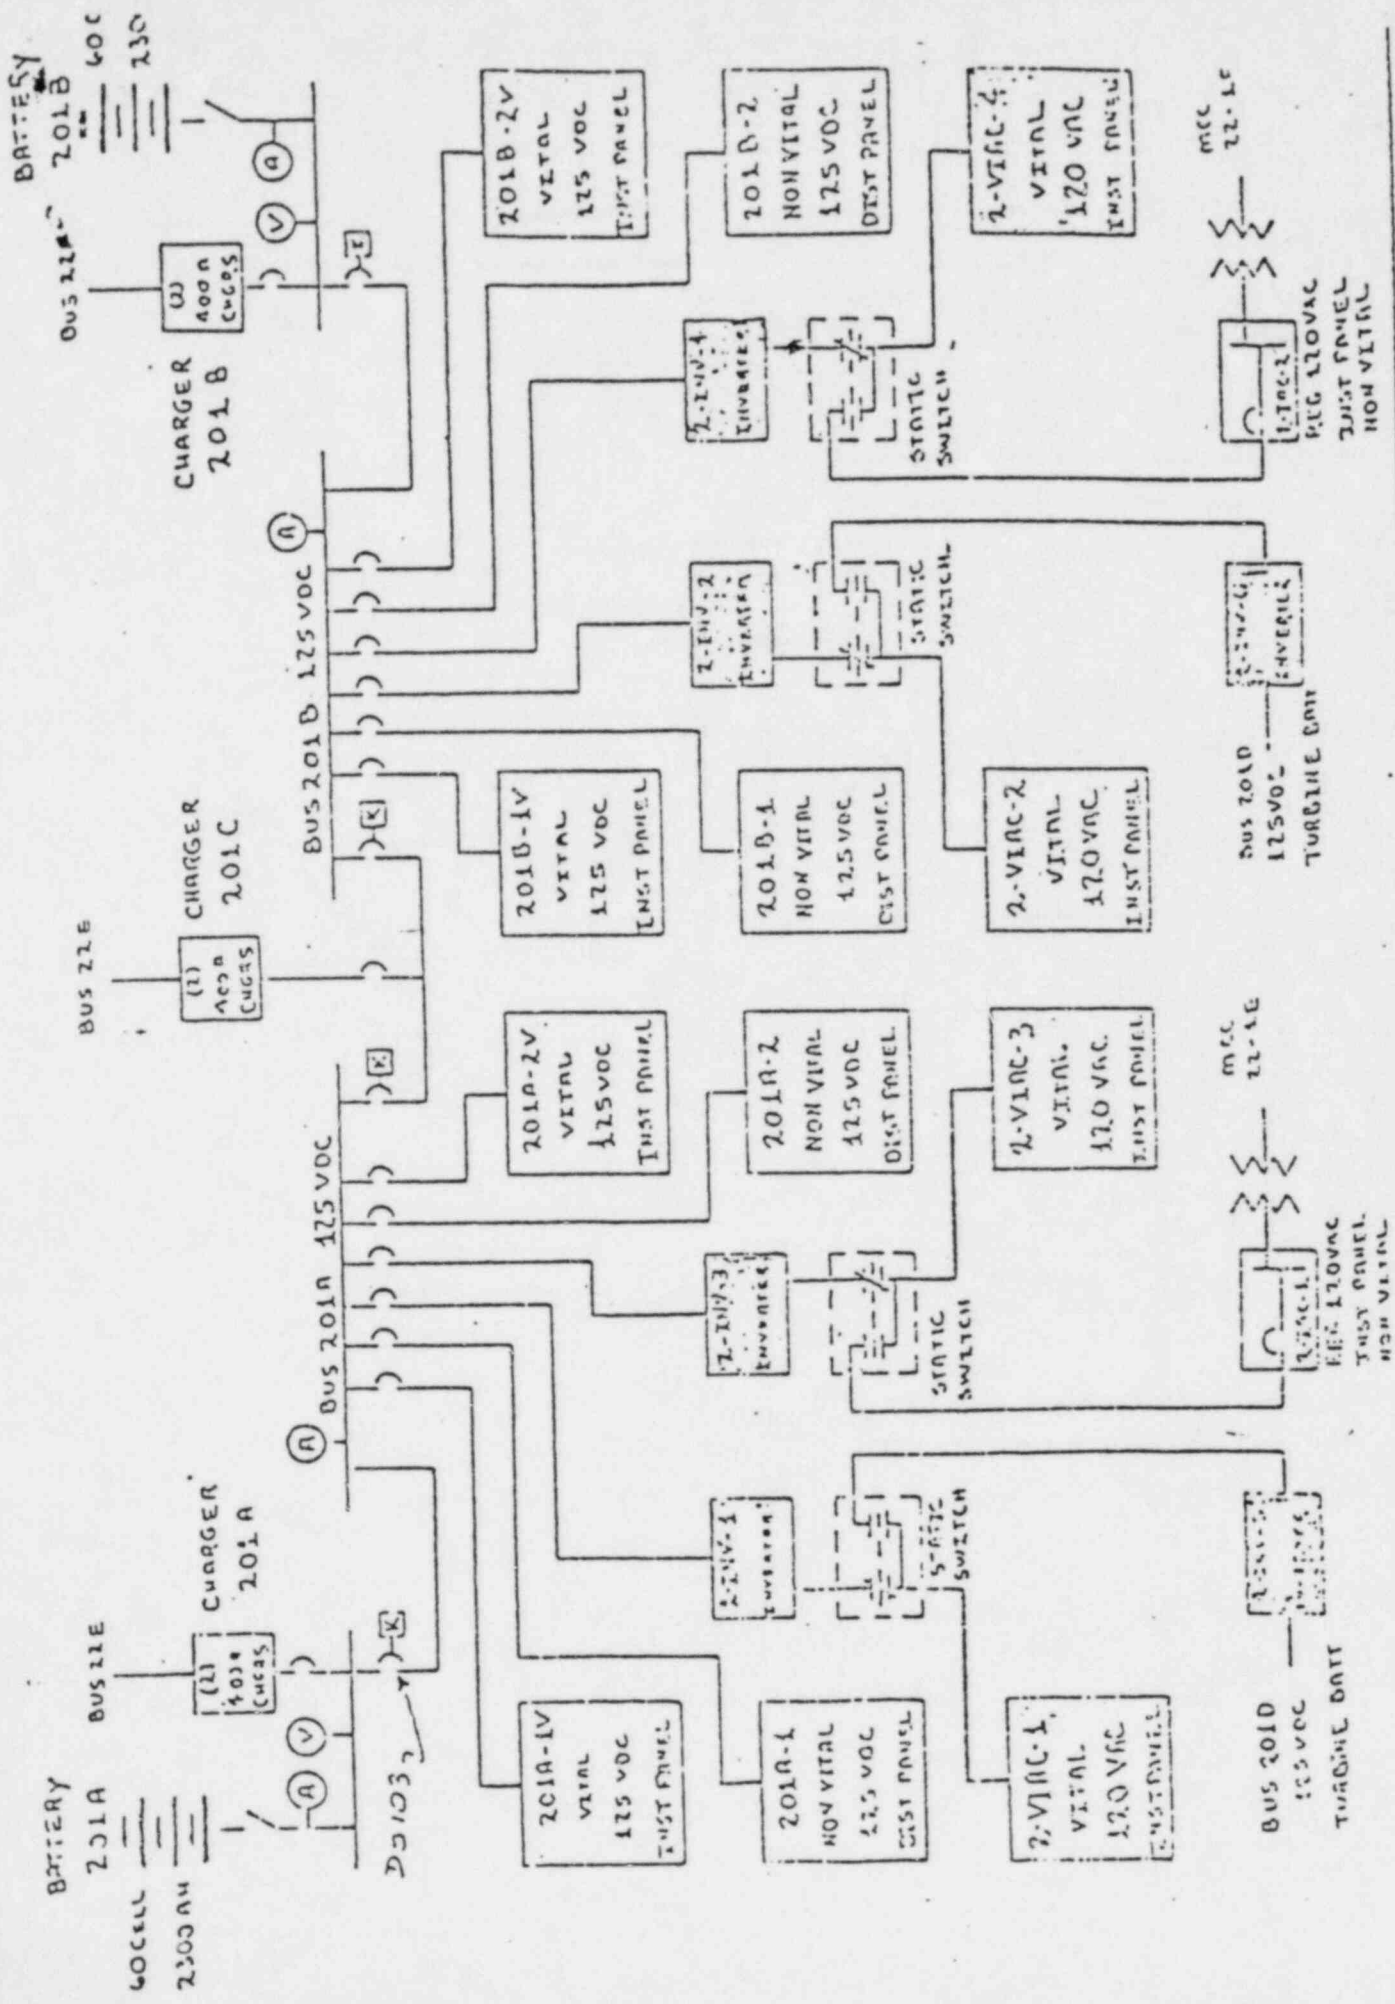
FIGURE 1

The event was initiated by a plant equipment operator while performing his shift duties. Instead of operating a 125 V dc system ground detector switch, he mistakenly used the adjacent control switch and opened breaker D0103 which de-energized the "A" facility 125 V dc bus 201A (see Figure 1). Loss of the dc bus caused the opening of four (of a total eight) reactor trip circuit breakers (TCBs) which tripped the reactor. The loss of the dc bus also caused complete loss of all control room annunciators and started the "A" facility diesel generator. The operators noticed the trip by observing CEA inward motion (the four TCBs that opened were without indication because of loss of dc voltage, and the other four were indicated closed).
