GPU Nuclear	TDR NO. <u>341</u>	REVISION NO. <u>0</u>
	BUDGET ACTIVITY NO. <u>120010</u>	PAGE _____ OF _____

PROJECT: TMI-1	DEPARTMENT/SECTION <u>OTSG Failure Analysis</u>
RELEASE DATE _____ REVISION DATE _____

DOCUMENT TITLE: TMI-1 OTSG Failure Analysis Report

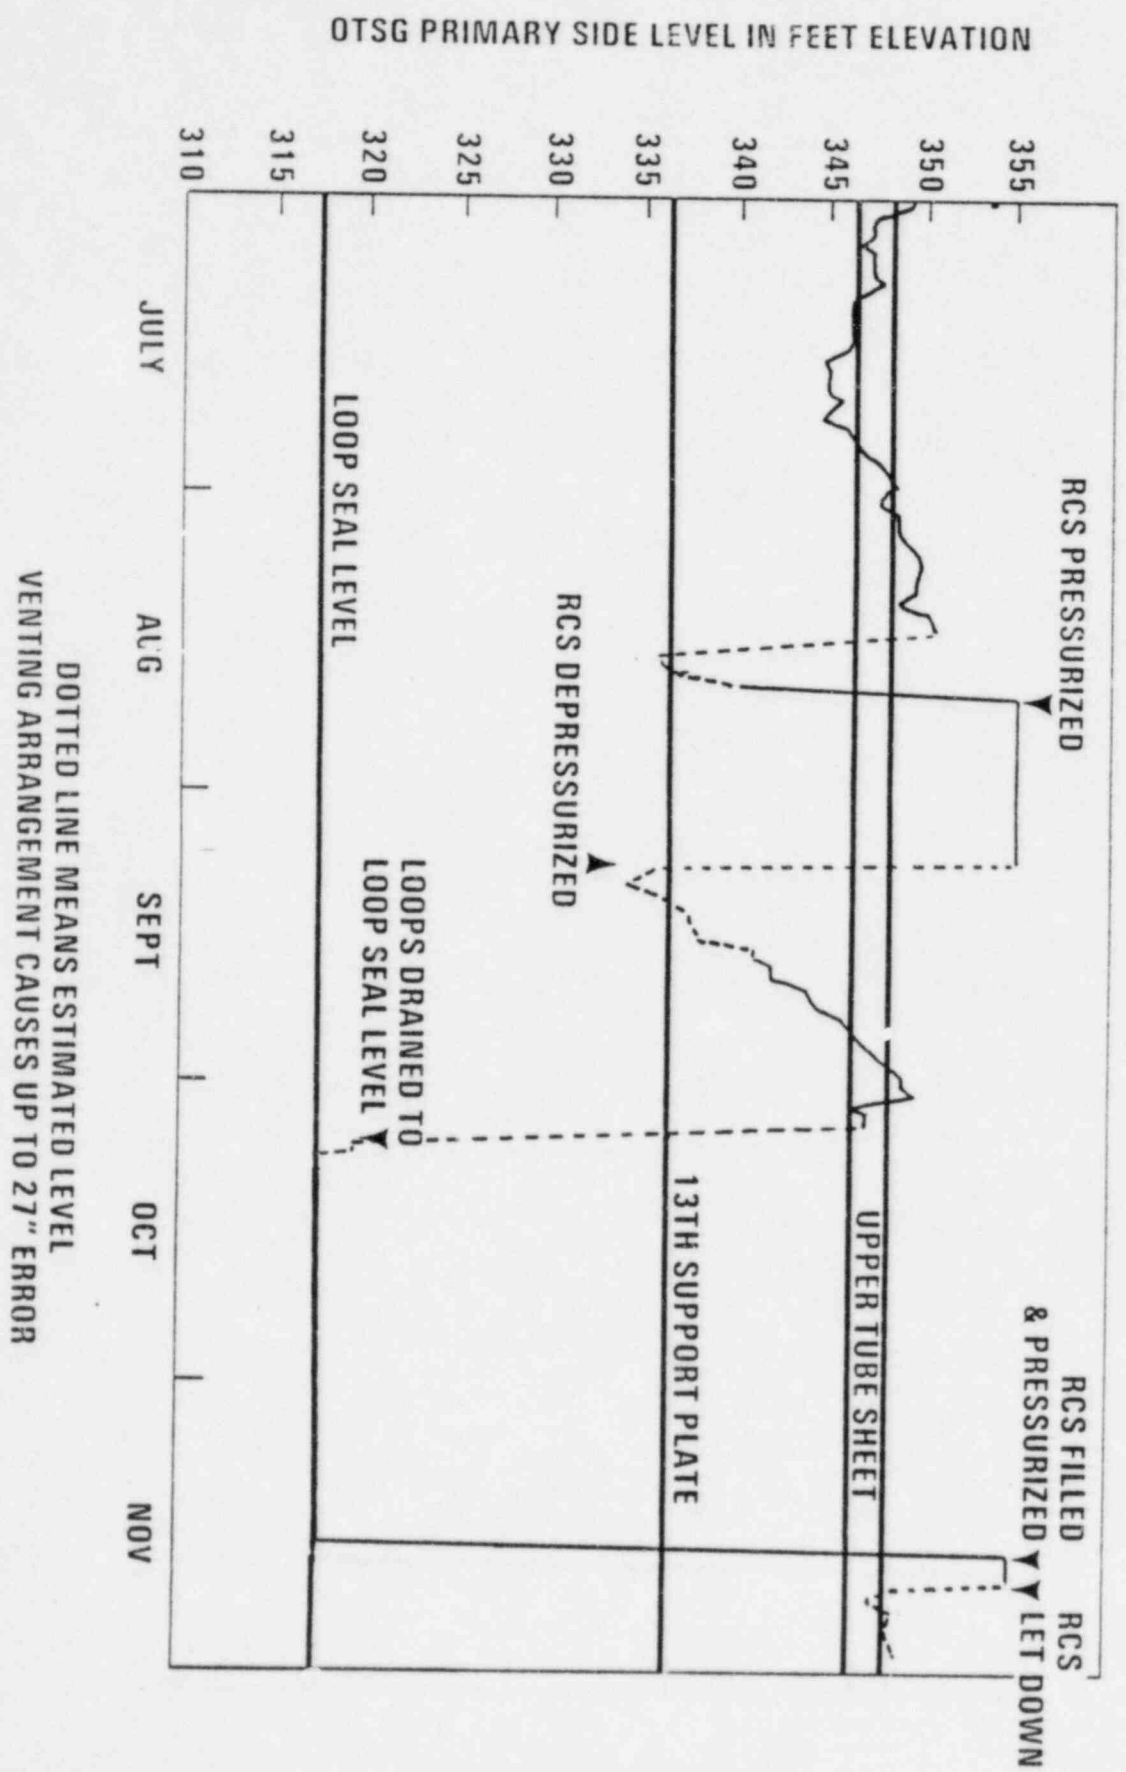
FIGURE I-1

OTSG Level July 1981 — November 1981

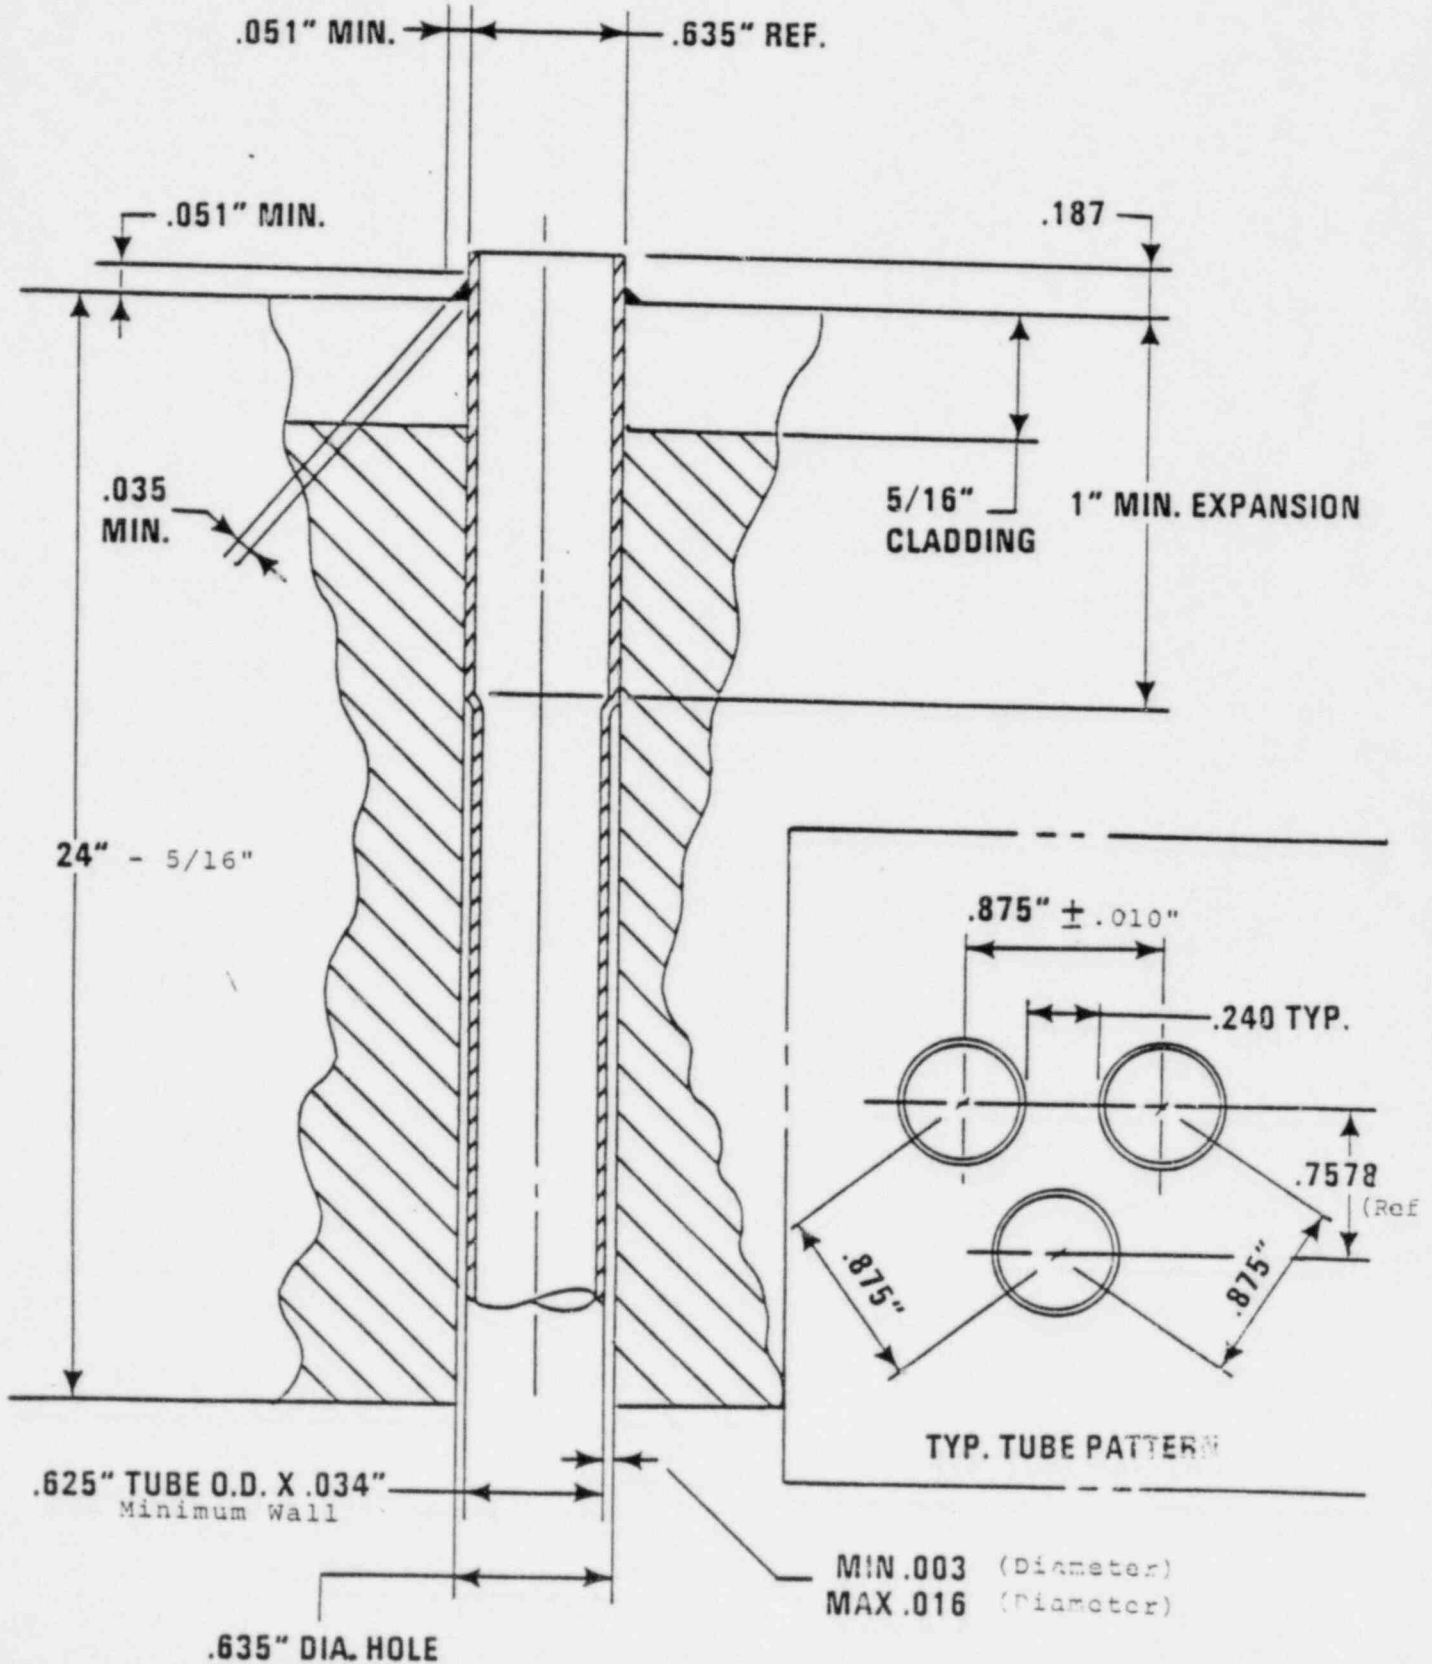
F I G U R E I I - 5

In-situ eddy-current results exhibits tube wall defect indications at varied rates distributed both axially and radially in both OTSG 'A' and 'B' tube bundles. The majority of the defect indications are in the upper tubesheet (UTS) region and particularly confined in the tube roll transition zone. Ninety-five (95) percent of all tubes with defect indications are contained in the top seven (7) inches of UTS with less than 200 tubes containing defect indications below the UTS (80 percent of those defects are above the top support plate). Radial distribution of tubes with defect indications in 'A' OTSG shows a high percentage in the UTS periphery with the defect rate decreasing rapidly as you move toward the center of the bundle. In the 'B' OTSG, however, half of the UTS exhibits an approximate 20 percent defect rate with defect rates to 90 percent in a broader peripheral area of the other half. Reference 9 documents defect rates in detail.

TMI-L OTSG Upper Tubesheet Detail (Typ)

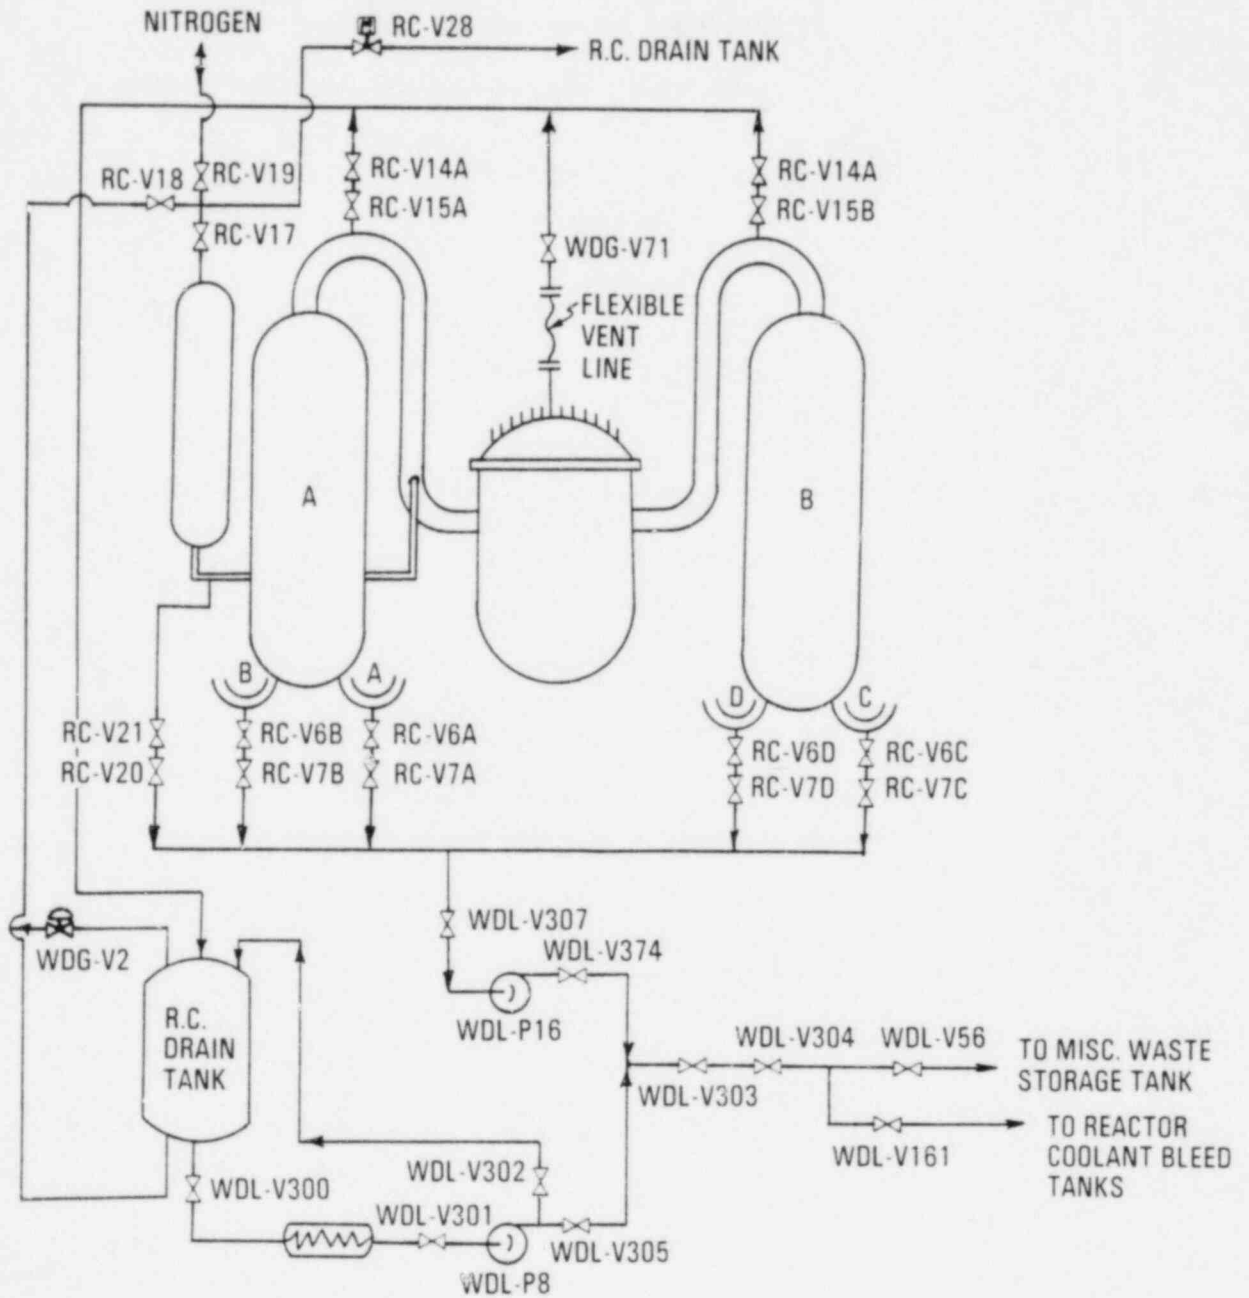
Figure III-1
R.C. System Drain Arrangement

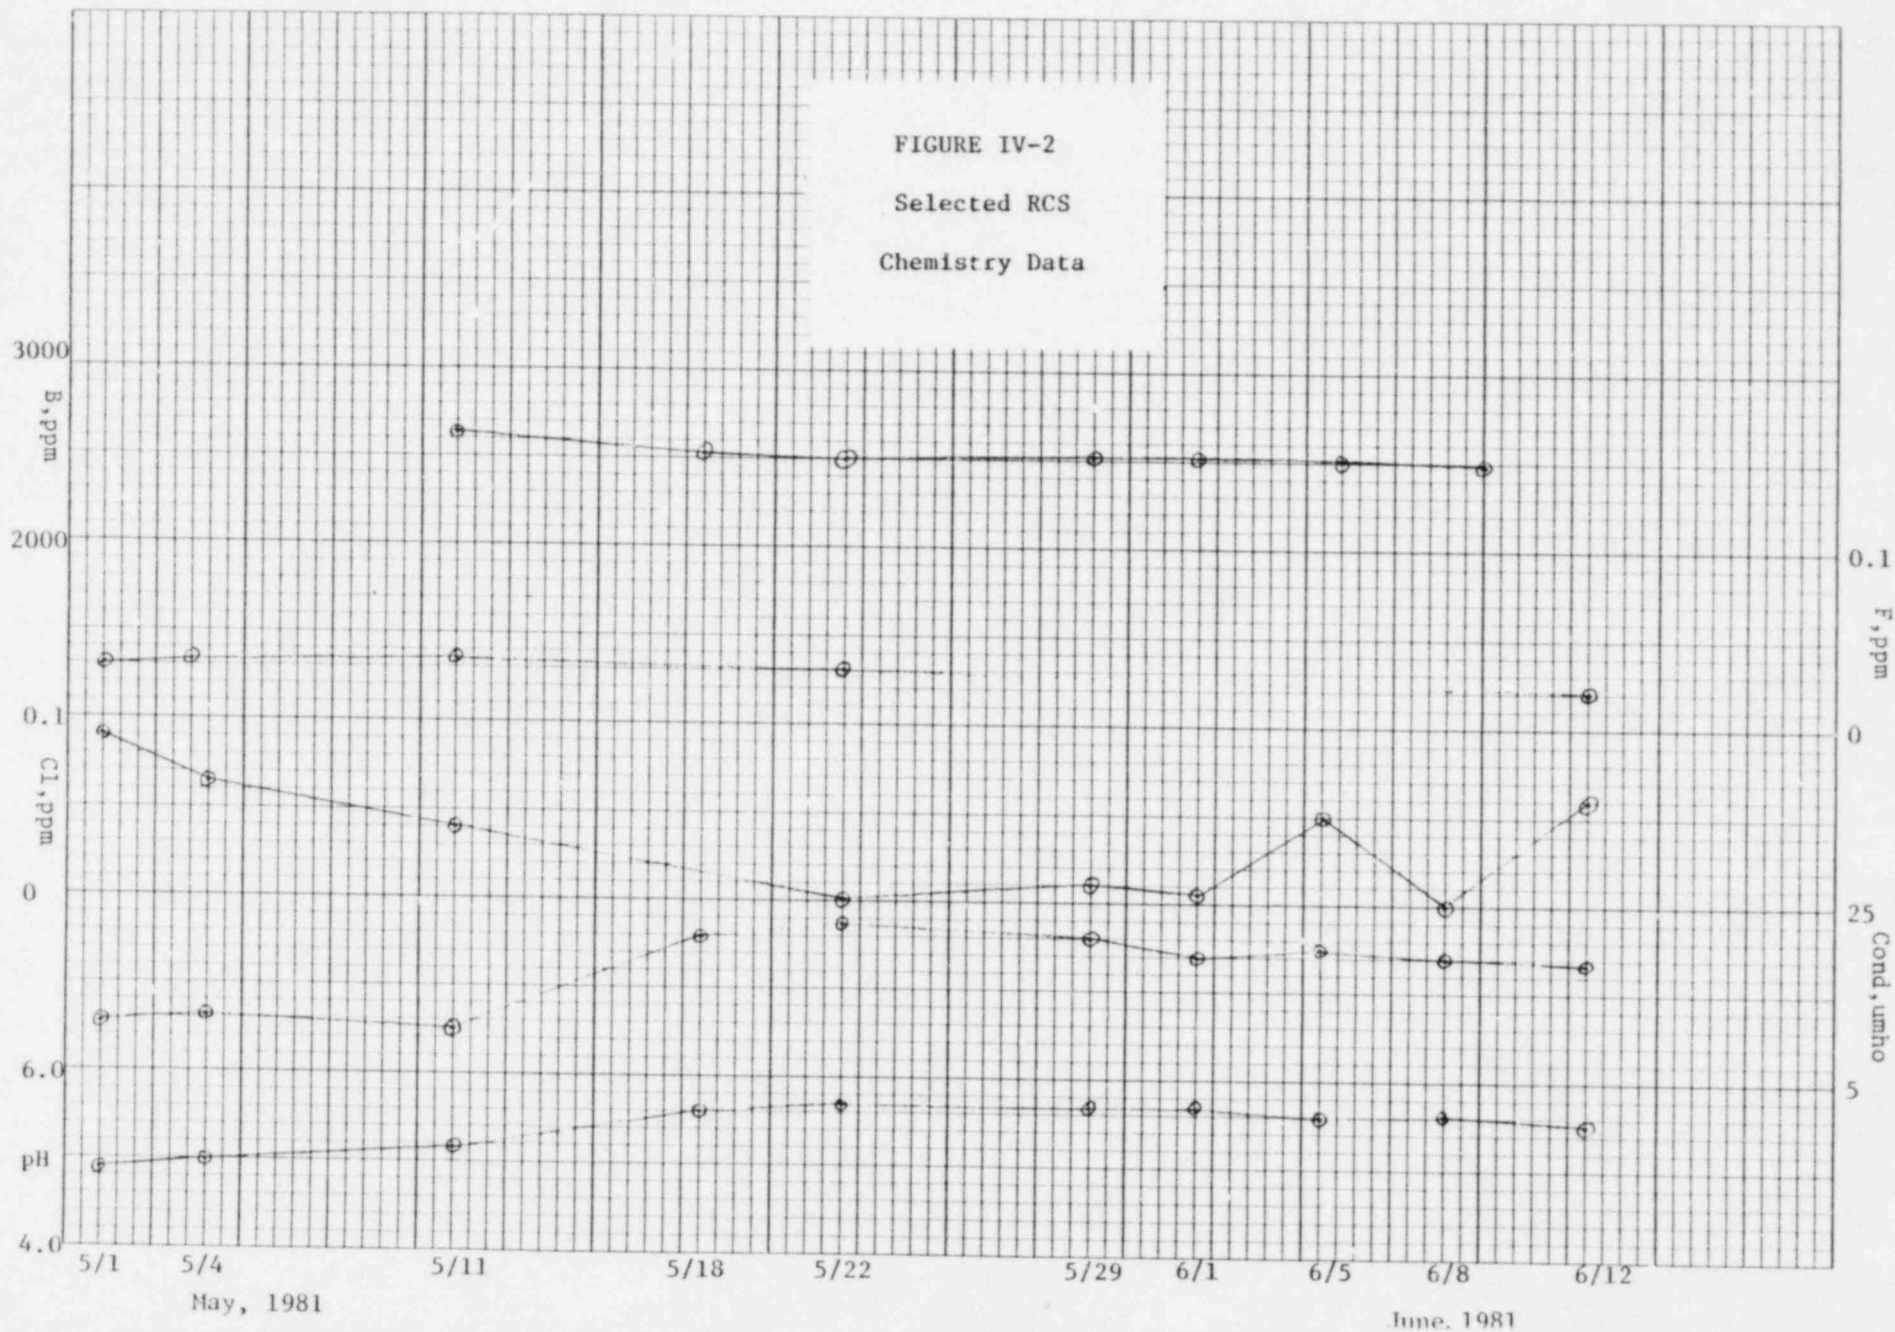
Review of the RCS chemistry for this period indicates a significant change in pH and conductivity with essentially no change in boron concentration. Calculations were performed to estimate the volume of acid necessary to cause the change in pH. The volume of acid was relatively small, being approximately 0.4 liters of the concentrated acid.

FIGURE IV-2
Selected RCS
Chemistry Data

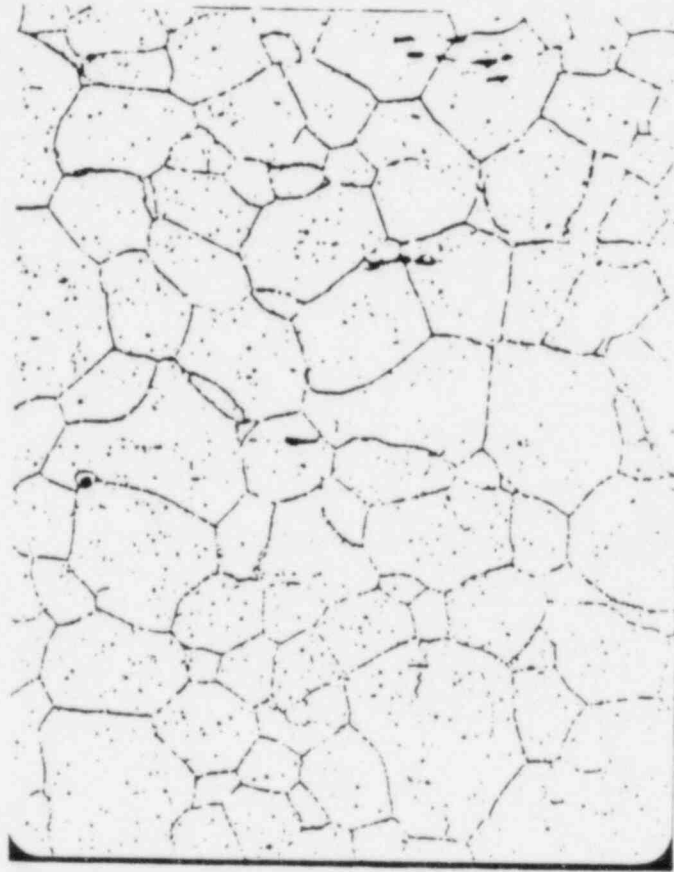
FIGURE VI - 2

b) 100% through-wall crack continuing to grow.

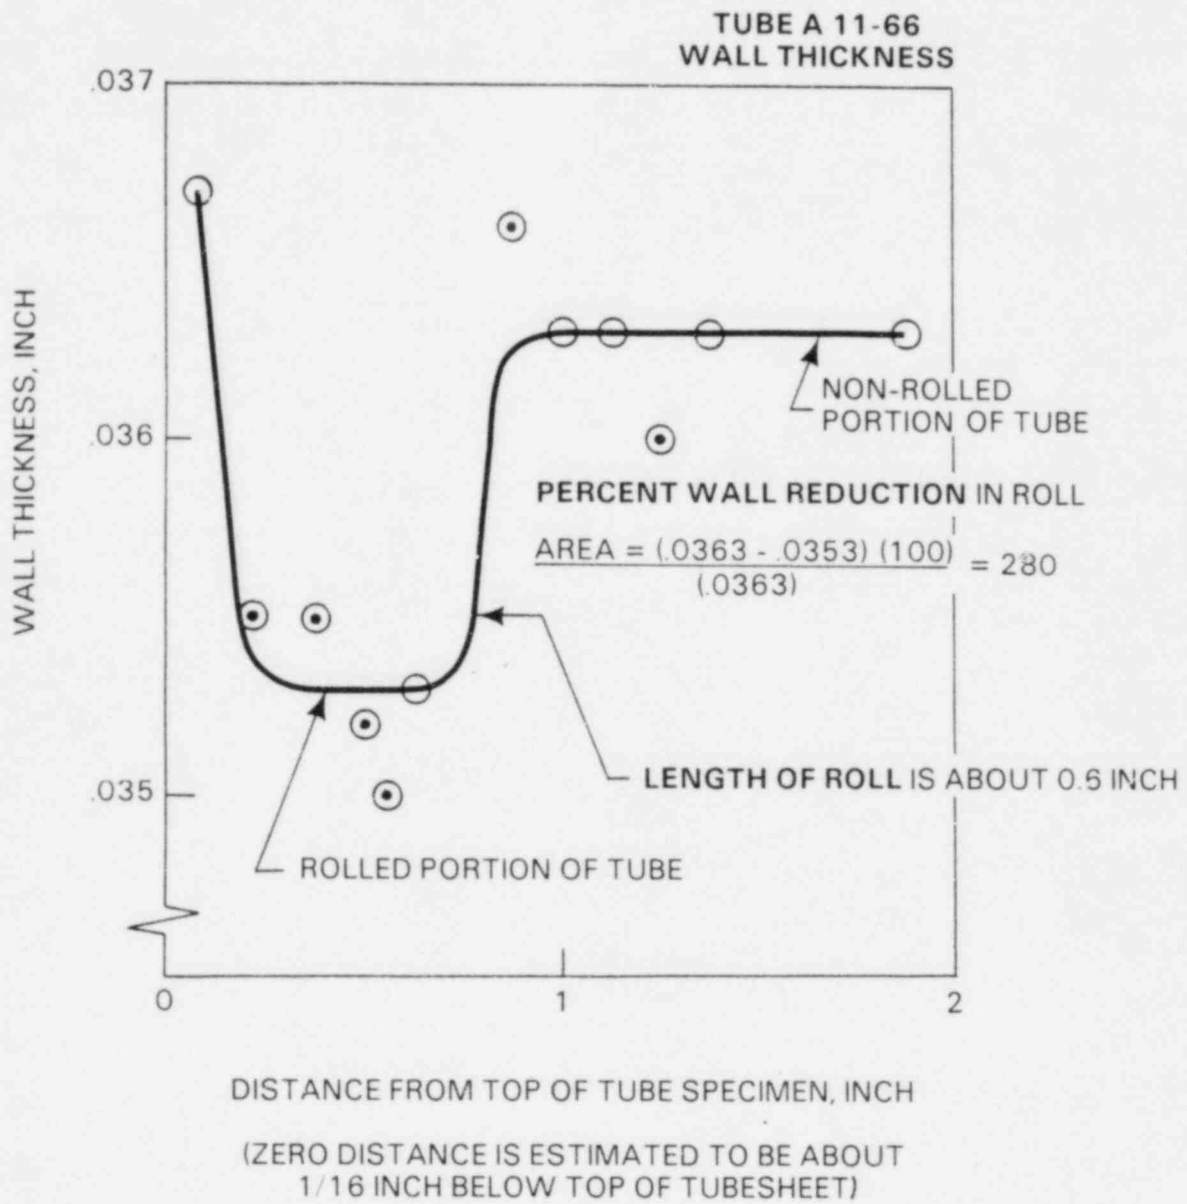
FIGURE VIII-1

- (1) Axial stresses include estimated preload stresses of 3,000 psi for a center tube and 6,000 psi for an outer tube because of elasticity of the tubesheets.
- (2) Axial stresses in the roll area are based on the assumption that the initial residual compressive stresses have been relieved and changed to tensile stresses due to preload and applied loads as a result of some sliding of the rolled joint.
- (3) Tube stresses between tubesheets are primarily due to the tube straightening manufacturing process and may vary considerably depending on the location within the tube.

TUBE/TUBESHEET ROLLED/WELDED JOINT
ESTIMATED DISTRIBUTION OF TUBE RESIDUAL STRESSES

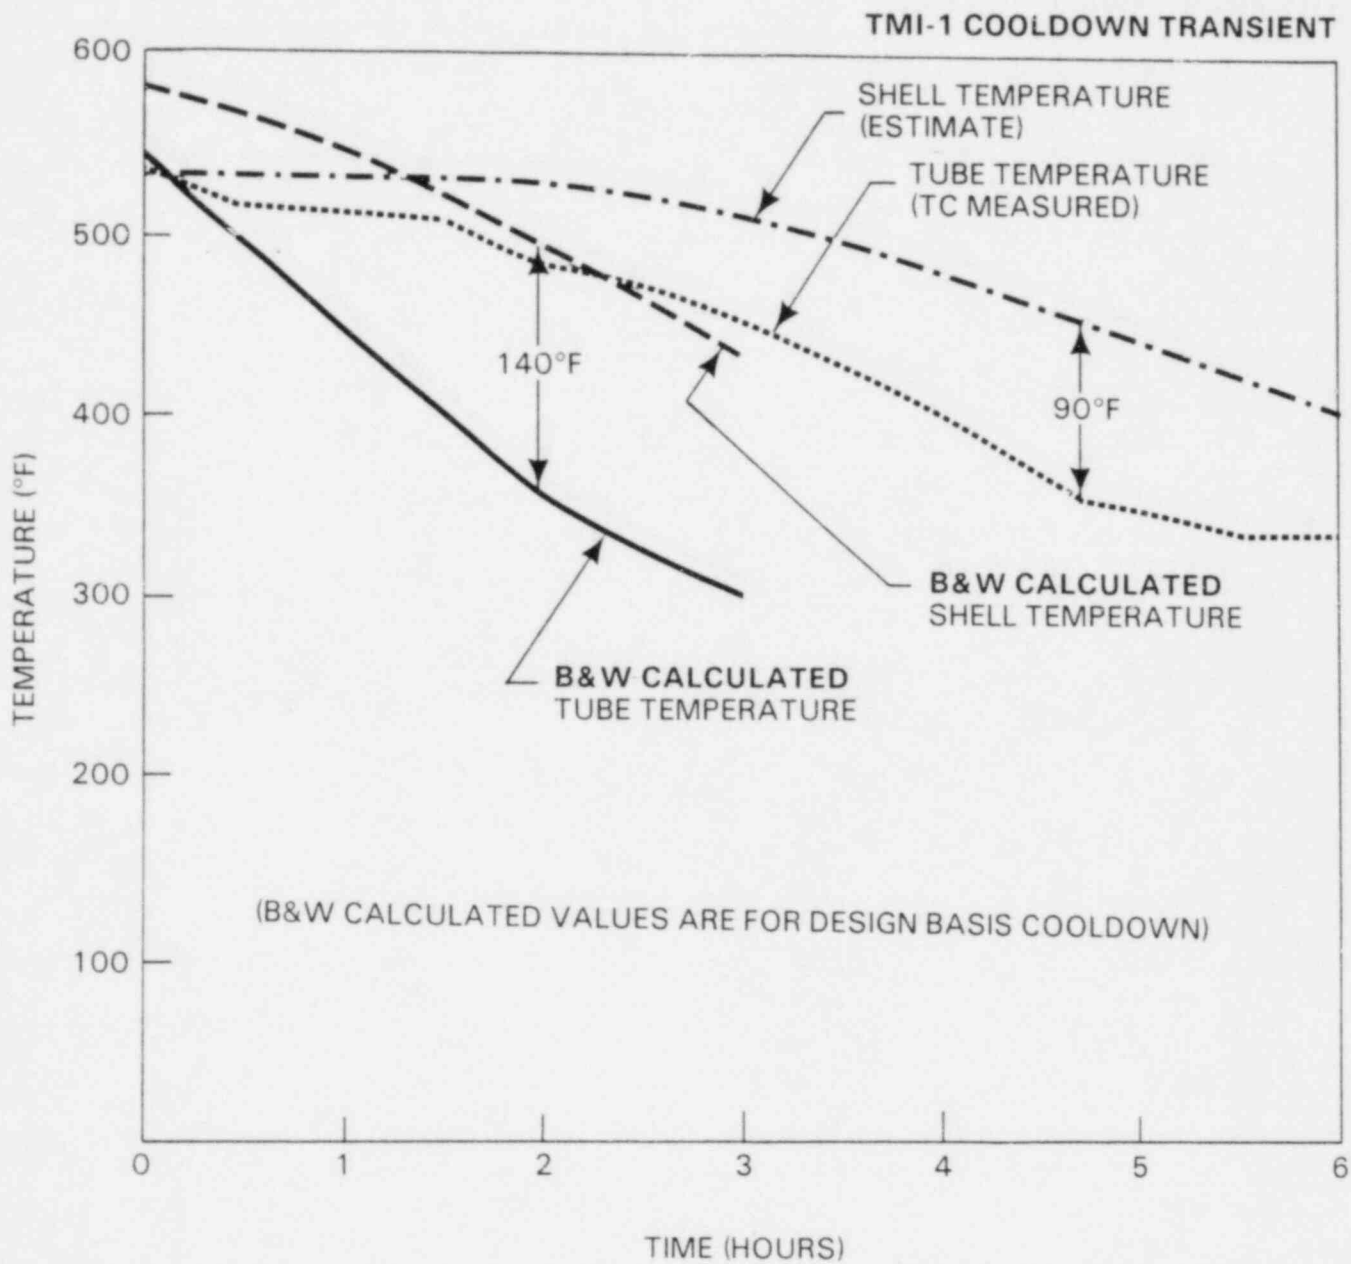
FIGURE VIII-5

The time of the OTSG tube failures may be bracketed based on operational considerations. During hot functional testing on 9/4/81 at 0637, the leak rate of the RCS at full pressure was measured and found to be within specifications at 0.5 gallons per minute. On 11/21/81 with the RCS at about 40 PSI pressure leakage through the OTSG tubes were observed.

**TMI-1 STEAM GENERATOR TEMPERATURES
DURING COOLDOWN TRANSIENT OF 9/6/81**
