Subject: Main Feedwater System

MAINE YANKEE ATOMIC POWER STATION FEEDWATER EVENT

On January 25, 1983, Maine Yankee experienced a feedwater line steam-water hammer event that caused the feedwater line adjacent to a steam generator to crack through and leak. This report describes the plant systems and components related to the event, its causes and consequences, the repairs and modifications that were made or planned, and provides a justification for continued power operation. Most of the material contained herein was presented to the NRC at a meeting held at their offices on February 9, 1983. It has been supplemented by commentary reflecting some of the technical comments made during the oral presentation.

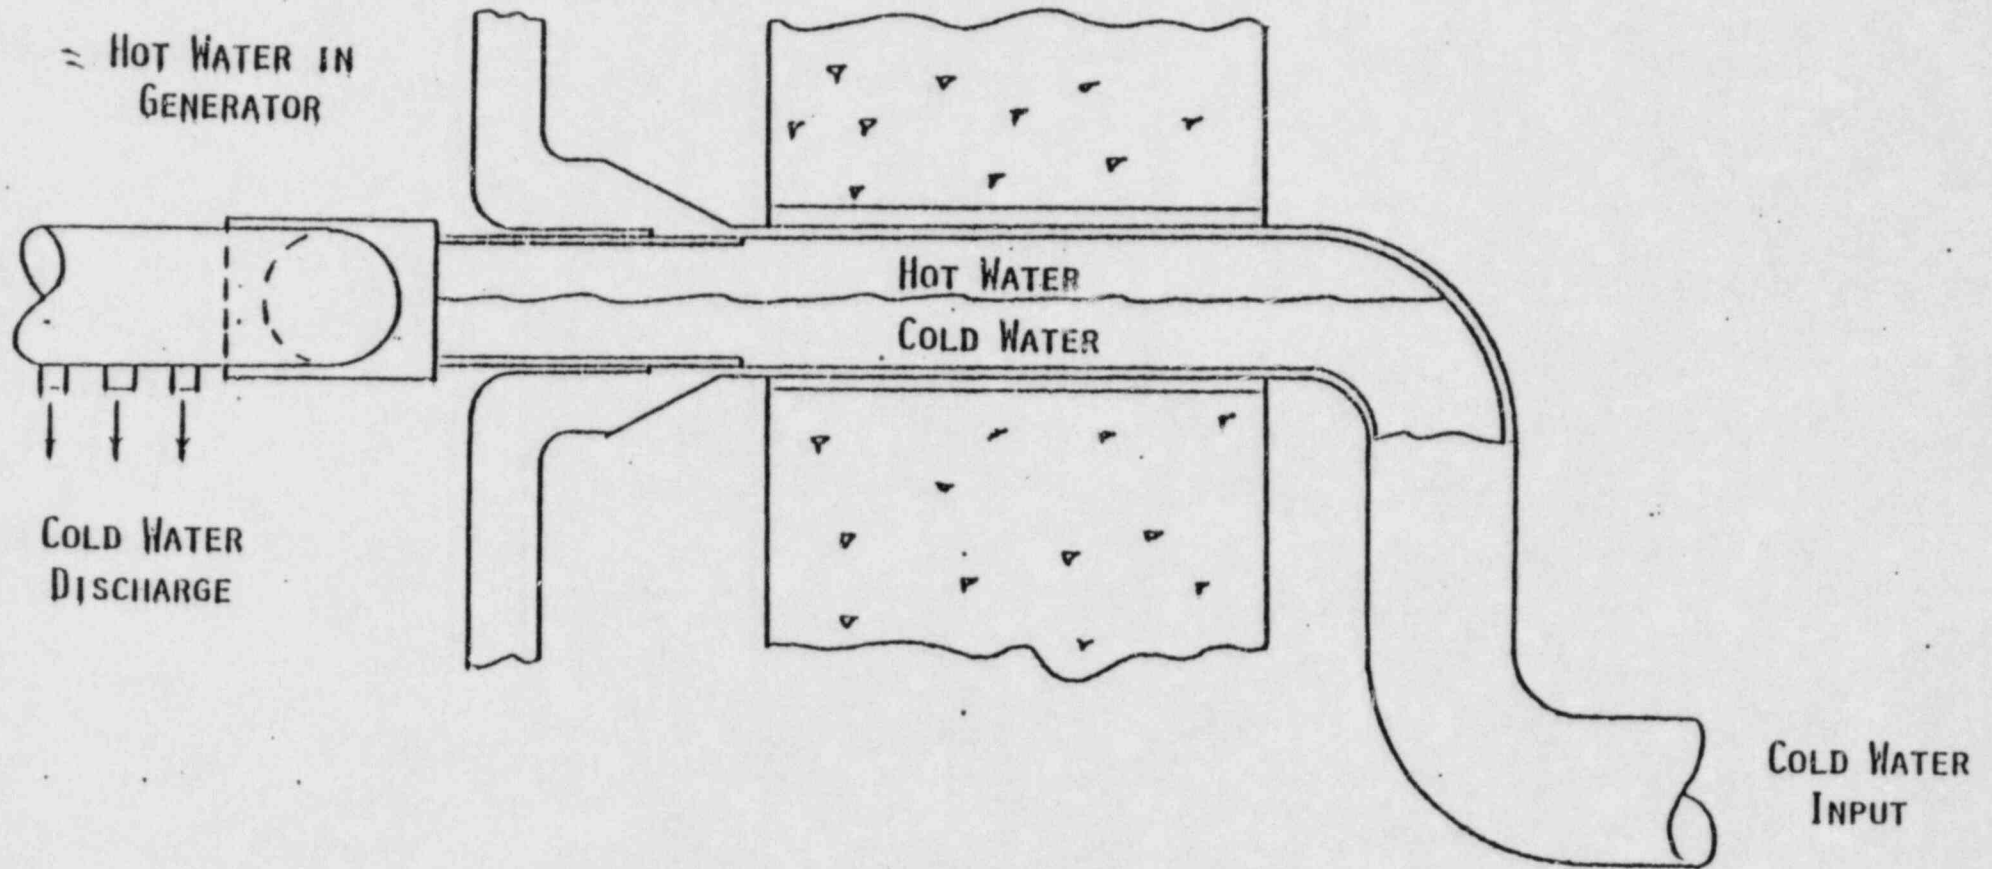
STRATIFICATION IN FEEDWATER PIPE

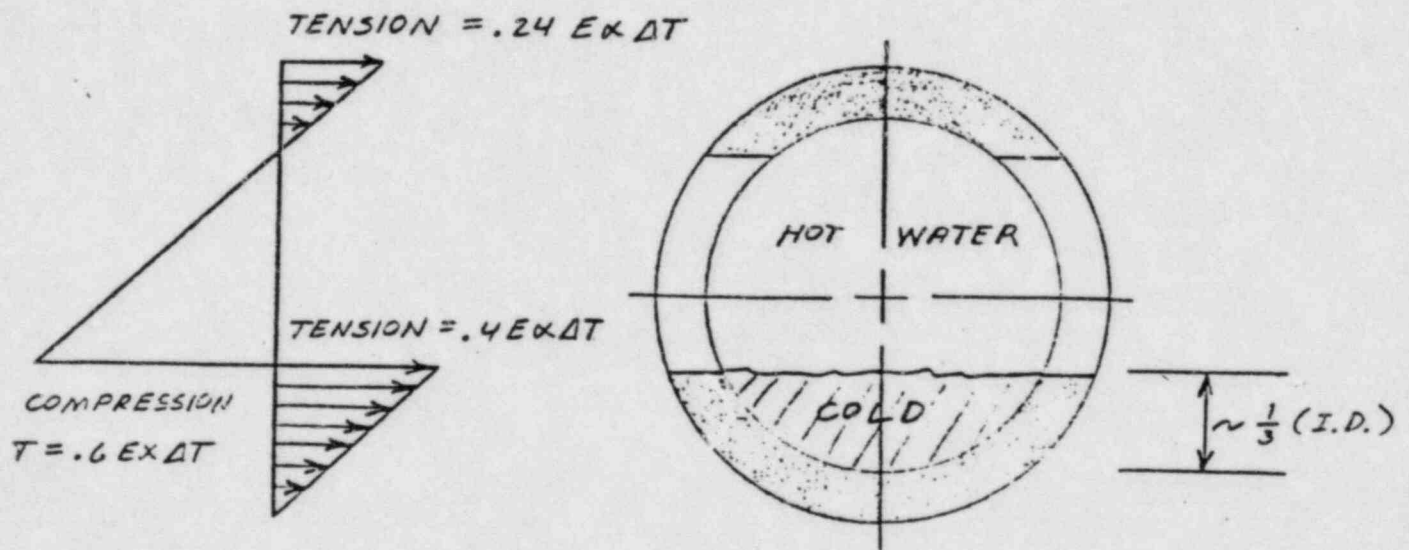
MAINE YANKEE FEEDWATER PIPE
POTENTIAL STRESS DISTRIBUTION

AREAS OF TENSILE STRESS HAVE THE CAPACITY TO
PROPAGATE INITIATED CRACKS

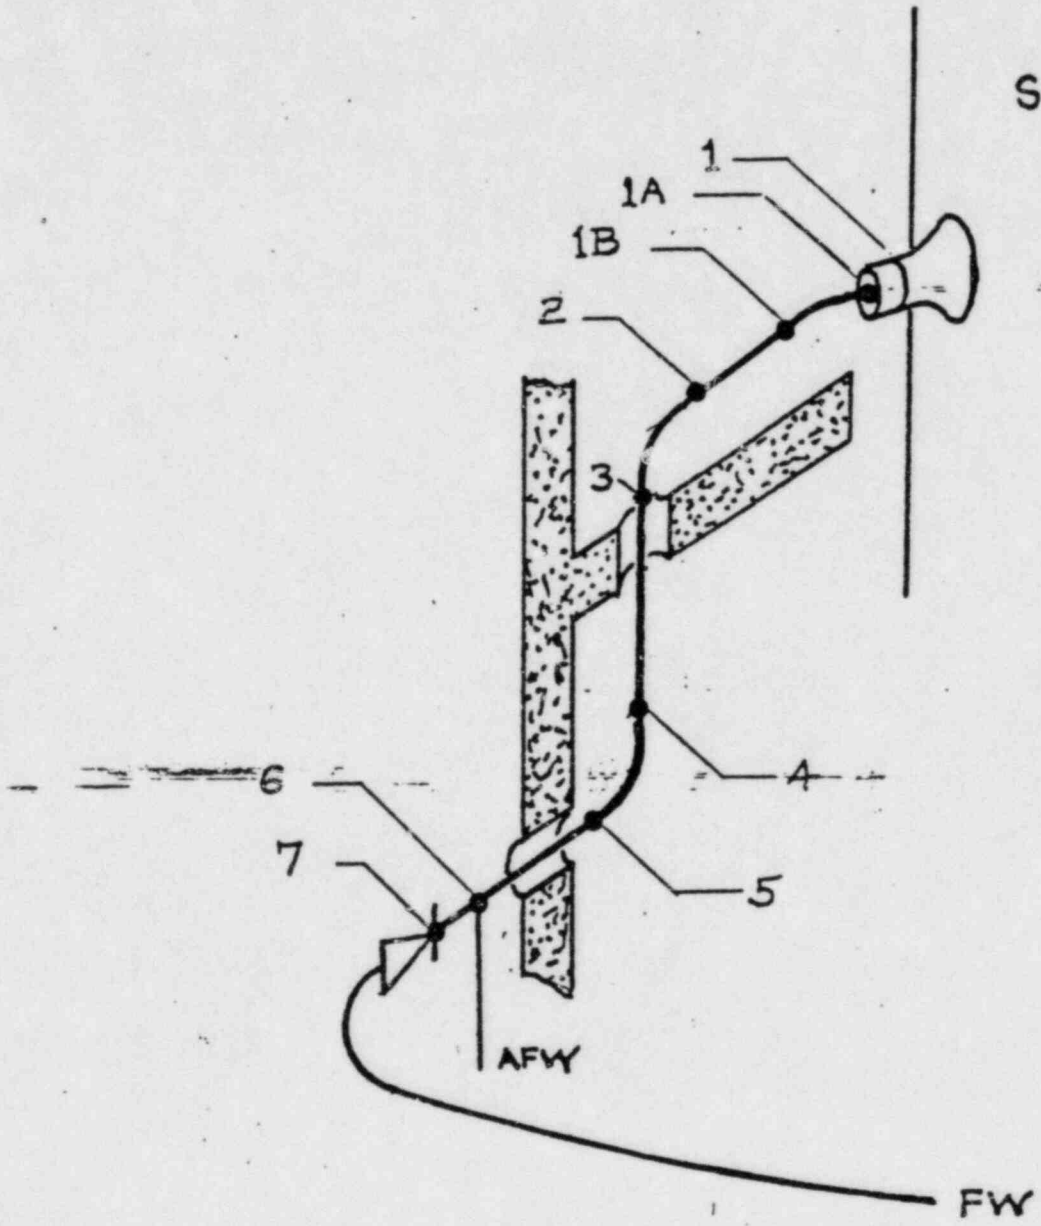
SG-3

#6 MP ONLY

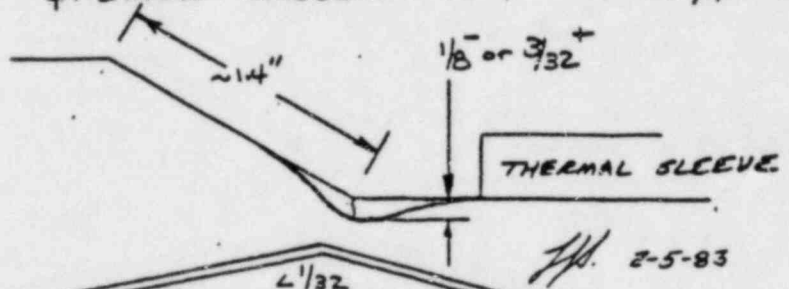
1. NO APPRECIABLE METAL REMOVAL FROM 9:00-3:00
2. POROSITY PER ATTACHED SHEET
3. APPEARS DEEPEST BETWEEN 6:30 & 7:30. GROOVE BLENDED & FLAPPER WHEELED. DEEPEST PART $\approx 1/4"$ RAD.

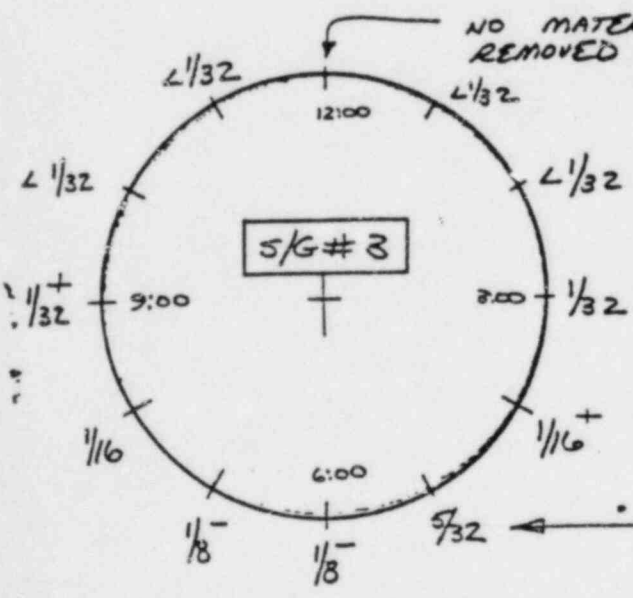
NO MATERIAL REMOVED

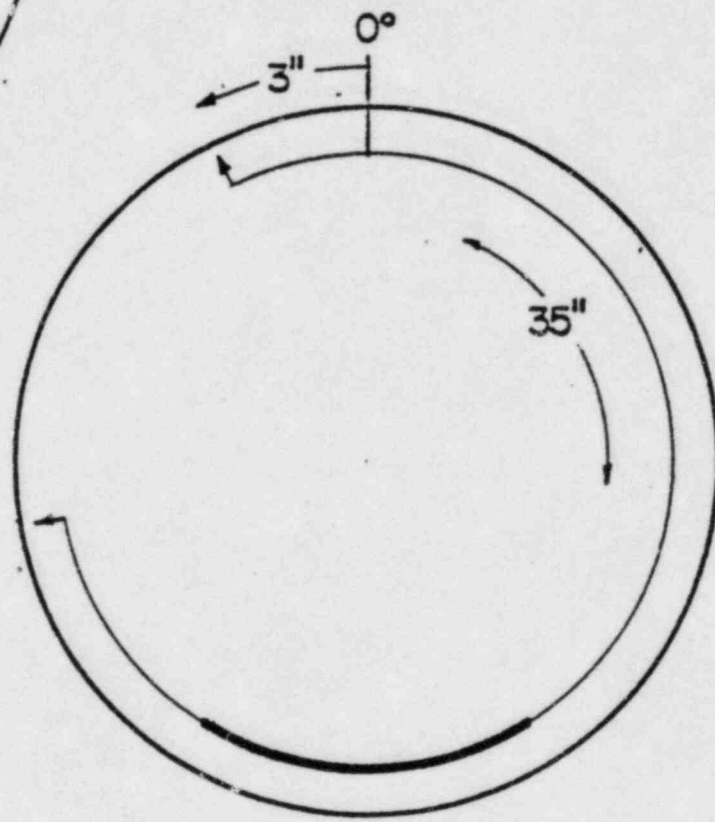
2 EL

HEAVIEST
INDICATION

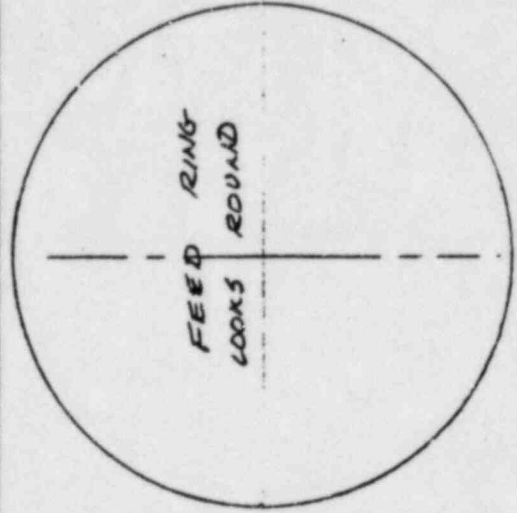
VIEW FROM
NUT SIDE

SLEEVE LOOKS NORMAL
THIS PAD NOT IN
CONTACT WITH NOZZLE
(GAP GREATER THAN .015")

LOWER 2 PADS IN
CONTACT WITH
NOZZLE

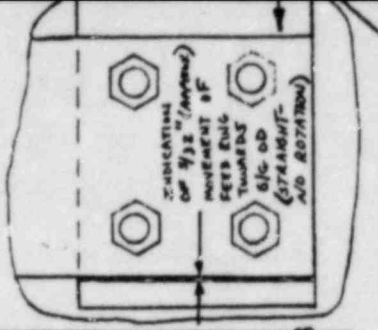
2 TACK WELDS PER
BOLT HEAD & 2 PER NUT

BOLT HEAD
THIS SIDE

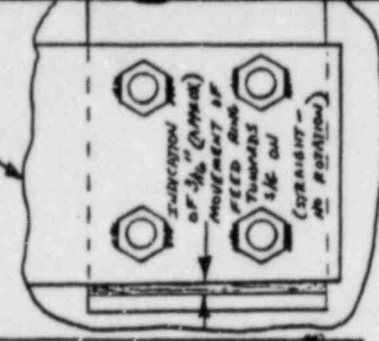
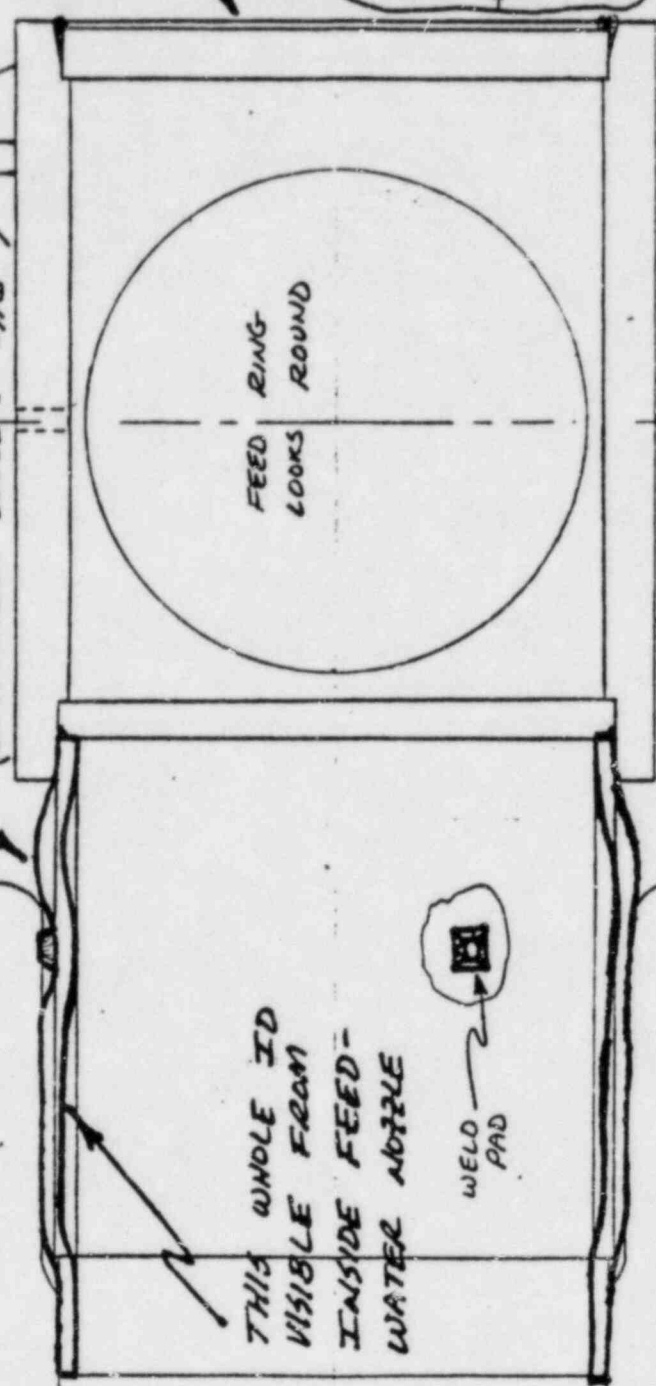
FIGURE 3

THIS PLATE NOT VISIBLY BULGED

VIEW FROM NUT SIDE

2 TACK WELDS PER BOLT HEAD & 2 PER NUT

BOLT HEAD THIS SIDE

THESE 2 TACK WELDS CRACKED

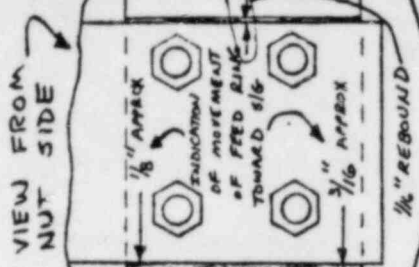
(SLIGHT DIMPLE ON
INSIDE OD OF RING
ABOUT $1/2$ WAY ALONG
ONE RING $1/2$ PROB.
FROM FABRICATION.)

WELD
PAD

THIS BOLT BROKEN AT
UNDERSIDE OF NUT. NUT
HELD BY PART OF 1 TACK
BOTH PIECES REMOVED

NOTE: MANY TACK WELDS BROKEN

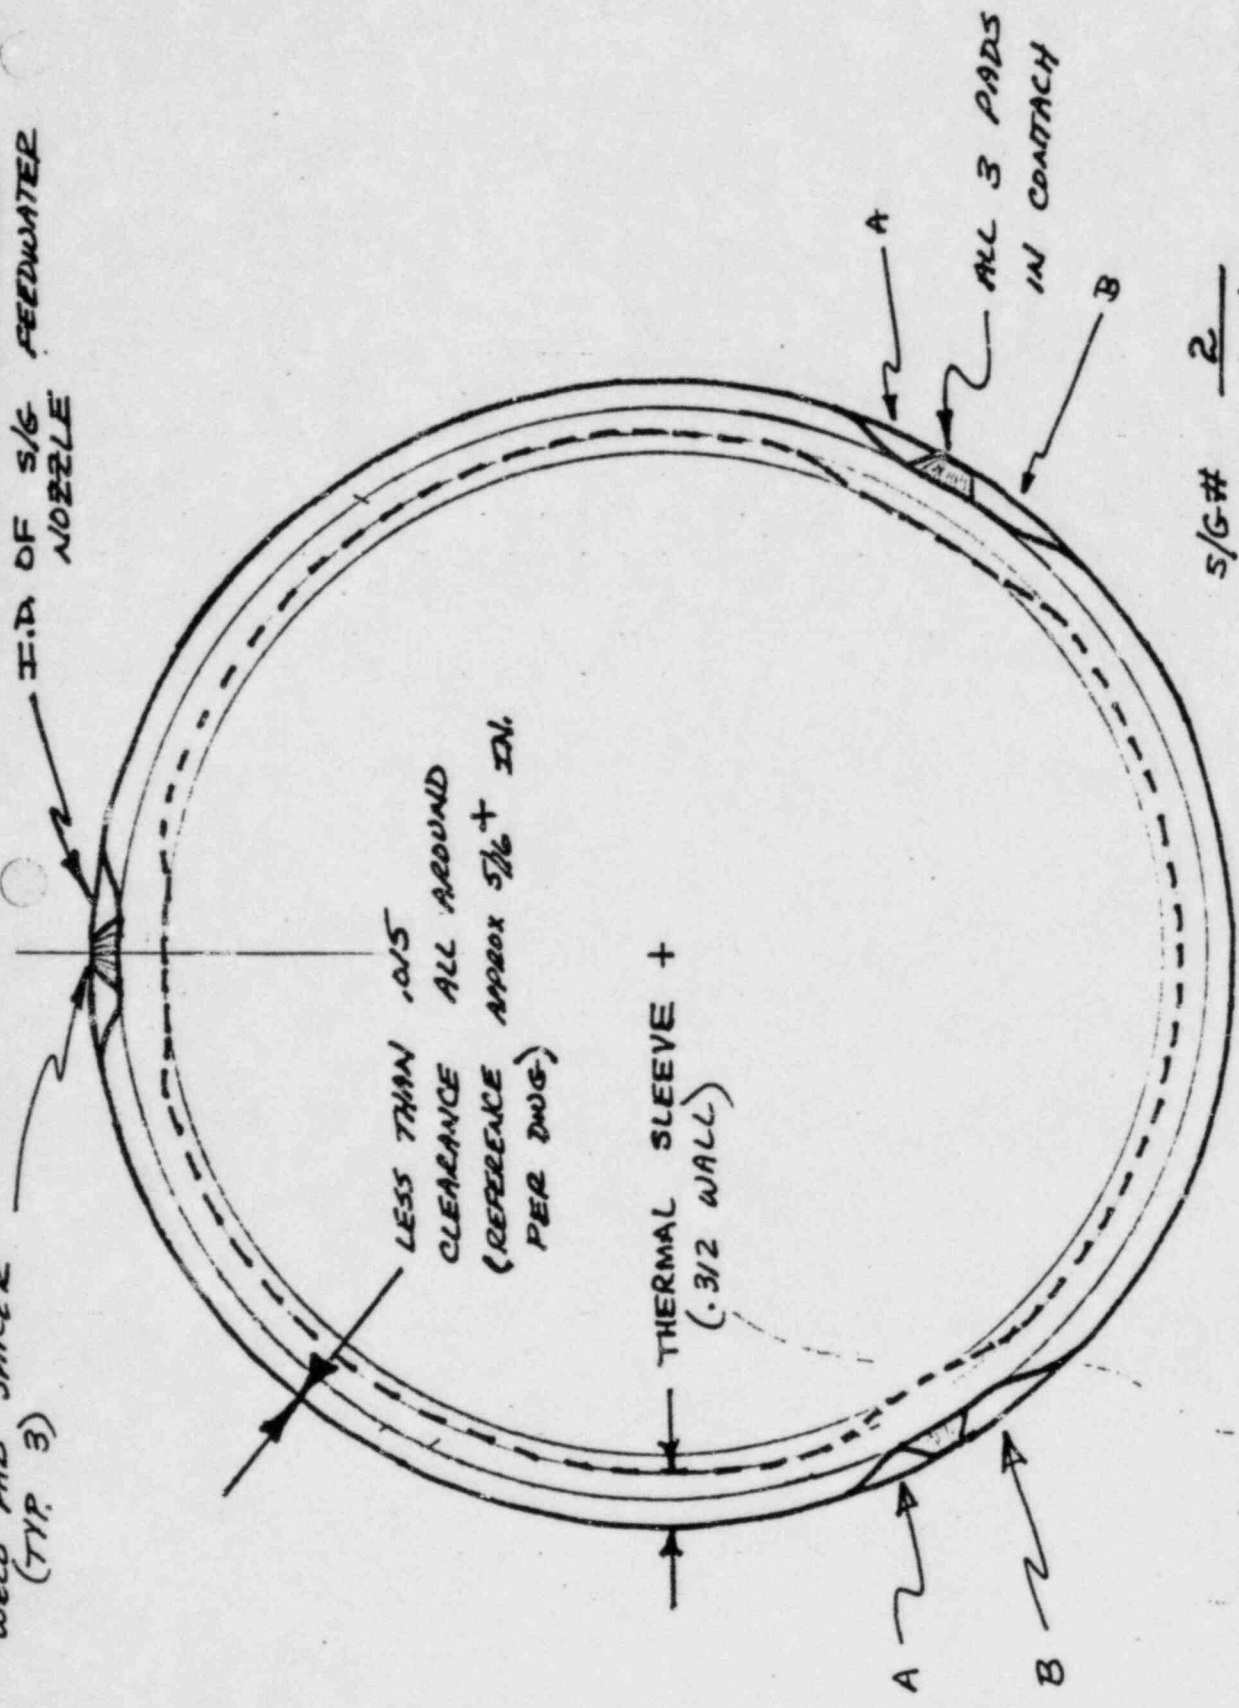
WELD PAD SPACER (TYP 3) I.D. OF S/G FEEDWATER NOZZLE

S/G# 2
 DATE 1/28/83 (~1450)
 BY W. MARTEL
 CF

THE THERMAL SLEEVE SECTION THROUGH WELD PADS

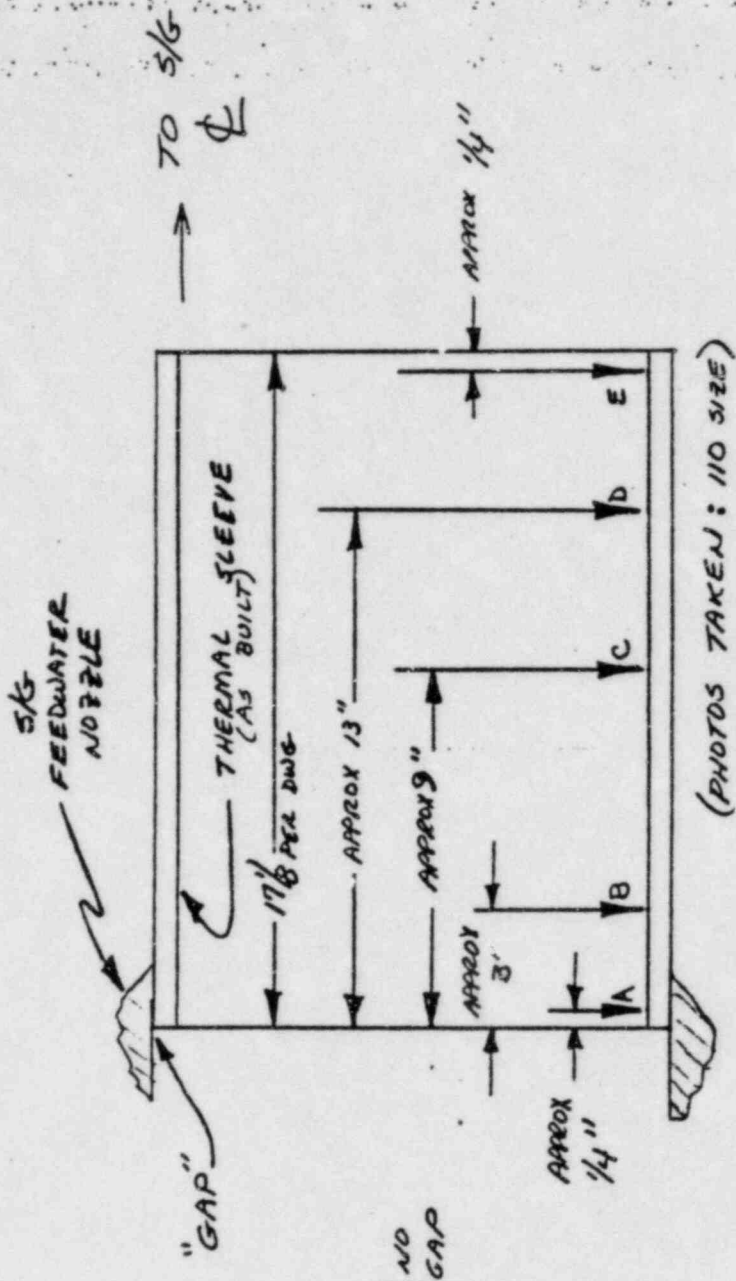
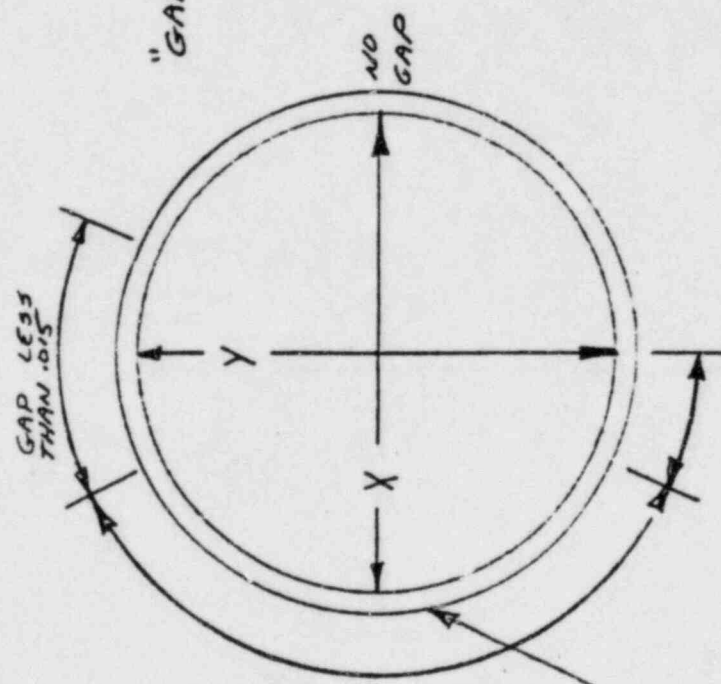
FIGURE 8

GAP MORE THAN .015 ABOUT 2+ IN. DEEP

GAP ABOUT .025\" (ESTIMATED)

NOTE:
 THE MOUNDS CAUSED BY EACH WELD PAD ARE CLEARLY VISIBLE ON SLEEVE I.D.

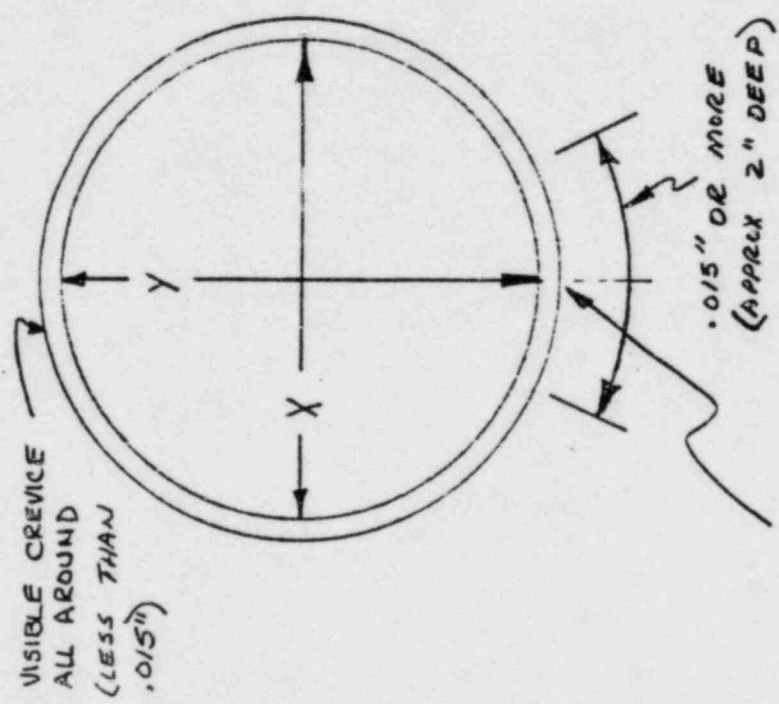
GREATER THAN .015" (MORE THAN 9" DEEP - MAX LENGTH OF FEELER GAGE)

* This dimension taken from 11:00 to 5:00 vs. exactly vertical due to the weld pad bulge at the 12:00 position.
 ** This dimension approx. (and minimum) was beyond capacity of I.D. mic. Est. range 14.275 - 14.050

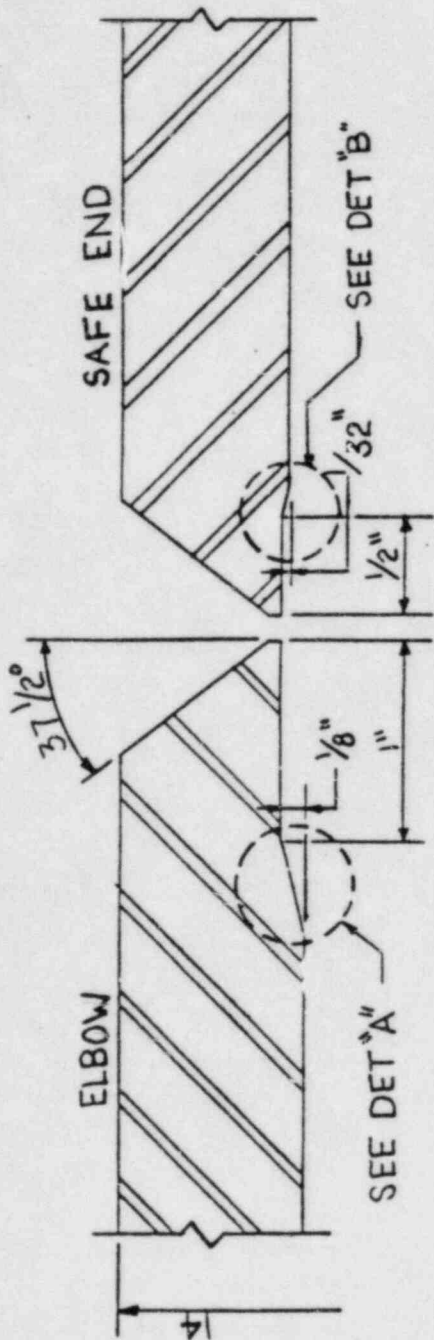
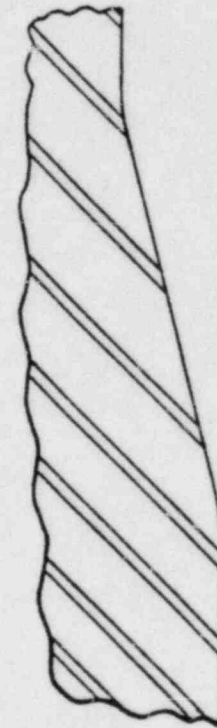
SKETCH #2

AS-LEFT CONDITION

- BLENDING TO REMOVE STRESS RISERS
- J VENTS
- OPERATIONAL GUIDANCE

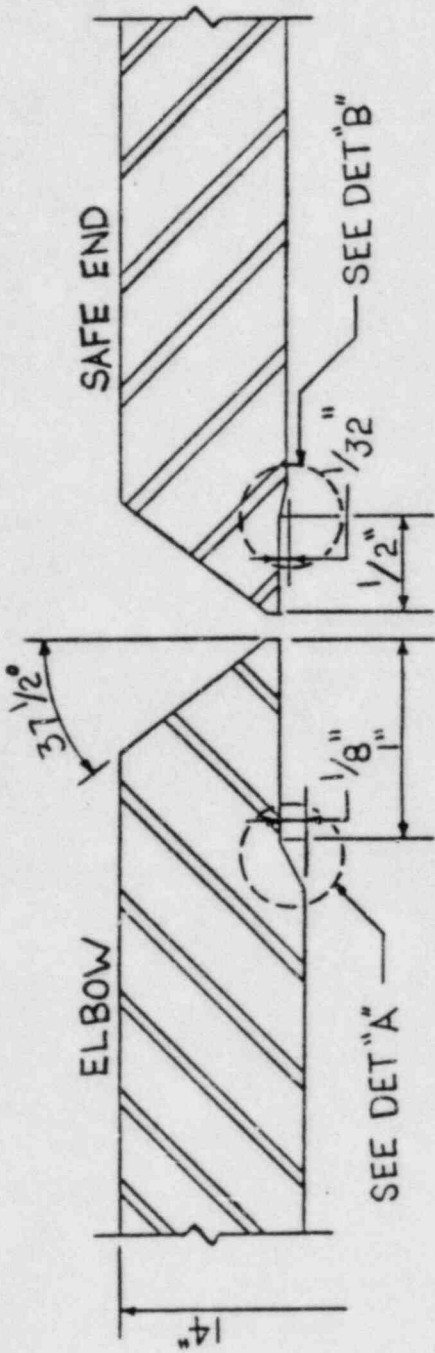
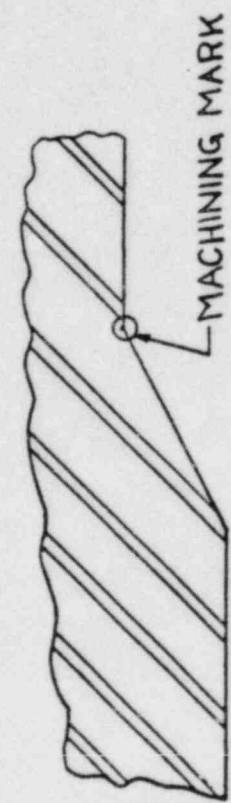
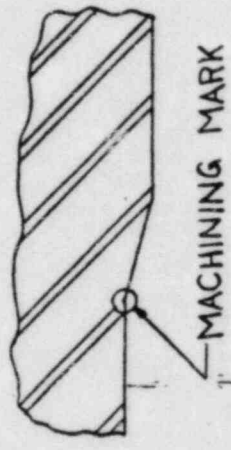
SKETCH # 1

AS-FOUND CONDITION
