**COLORADO ENGINEERING
EXPERIMENT STATION INC.**

**Air Blast Destructive Testing
of NUKON® Insulation
Simulation of a Pipe Break LOCA**

Tests 1,2,3,4,7 and 8
Final Report

October 22, 1993

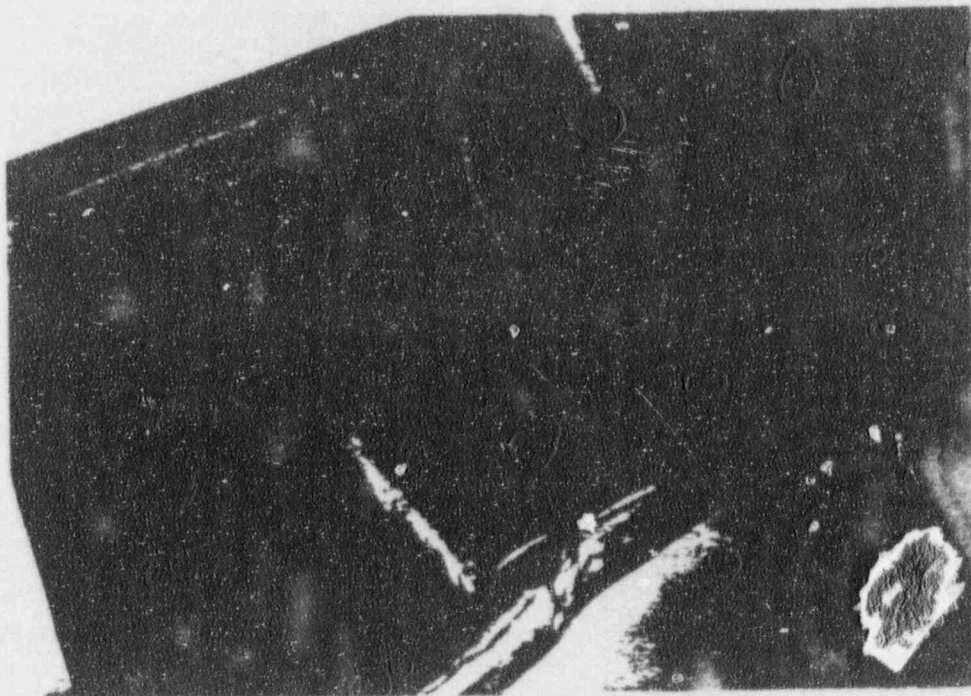
Figure 5: Typical NUKON Blankets

Test blankets were received from the Owens Corning Science and Technology Center. At Owens Corning the blankets were exposed to a 550 °F surface for a period of at least 24 hours. All the blankets exhibited a dark coloration on the inner surface that would indicate the application of heat. Typical blankets are shown in Figure 5. Copies of certification forms from Owens Corning are contained in Appendix A.

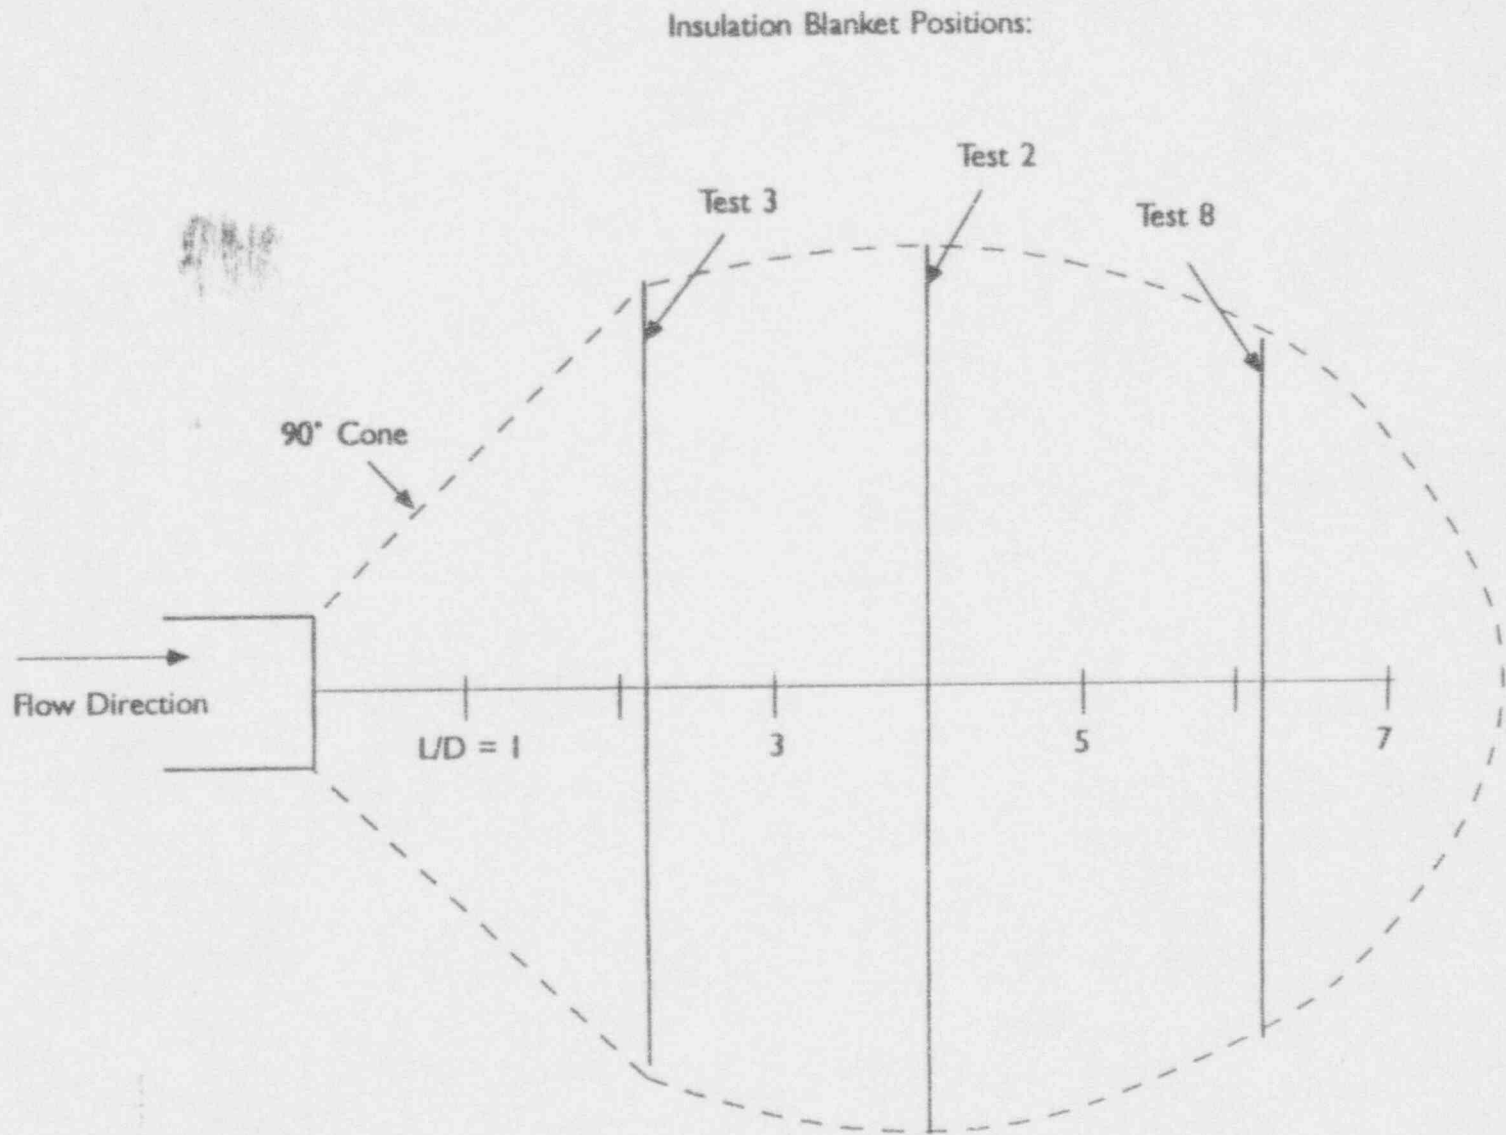
Figure 34: Proposed Shape of Zone of Destruction

1. The angle between nozzle and the sharp deformation edge in Figure 33 is approximately 90 degrees. This would indicate that the region of higher destruction follows a 90 degree cone.

2. In Figure 33 the deformation edge corresponds to the 1 bar isobar. In Figure 32 it lies between the 1 bar and 2.5 bar isobars. This difference is attributed to the fact that in Figure 32 the jacket surface is not perpendicular to the flow direction.

Based on these results a zone of destruction with a different shape is proposed, it is shown in Figure 34.
