U. S. NUCLEAR REGULATORY COMMISSION

Report No. 50-320/82-08

Facility Name: Three Mile Island Nuclear Station, Unit 2

Inspection Conducted: July 6 - August 7, 1982

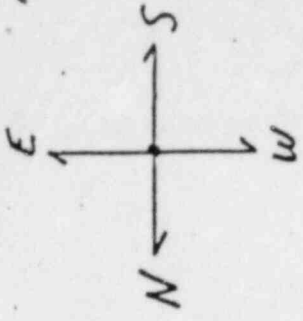
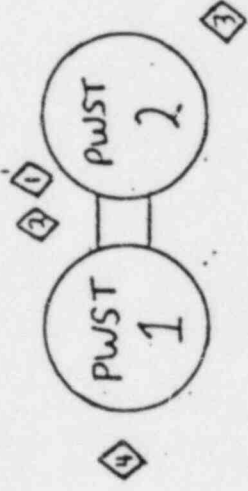
FIGURE 2 -7-

4. Special NRC Sample Program. During March and April 1982, the NRC sampled various onsite locations (Figure 2) to assess BWST leakage/cleanup, and the licensee monitoring program. Soil and liquid samples were tested by the Analytical Chemistry Laboratory, Idaho Operations Office, DOE. The results of these analyses are reported in the following table.
