TRANSIENT ASSESSMENT REPORT

RANCHO SECO REACTOR TRIP

AUGUST 7, 1981

TRANSIENT REPORT NO. 53

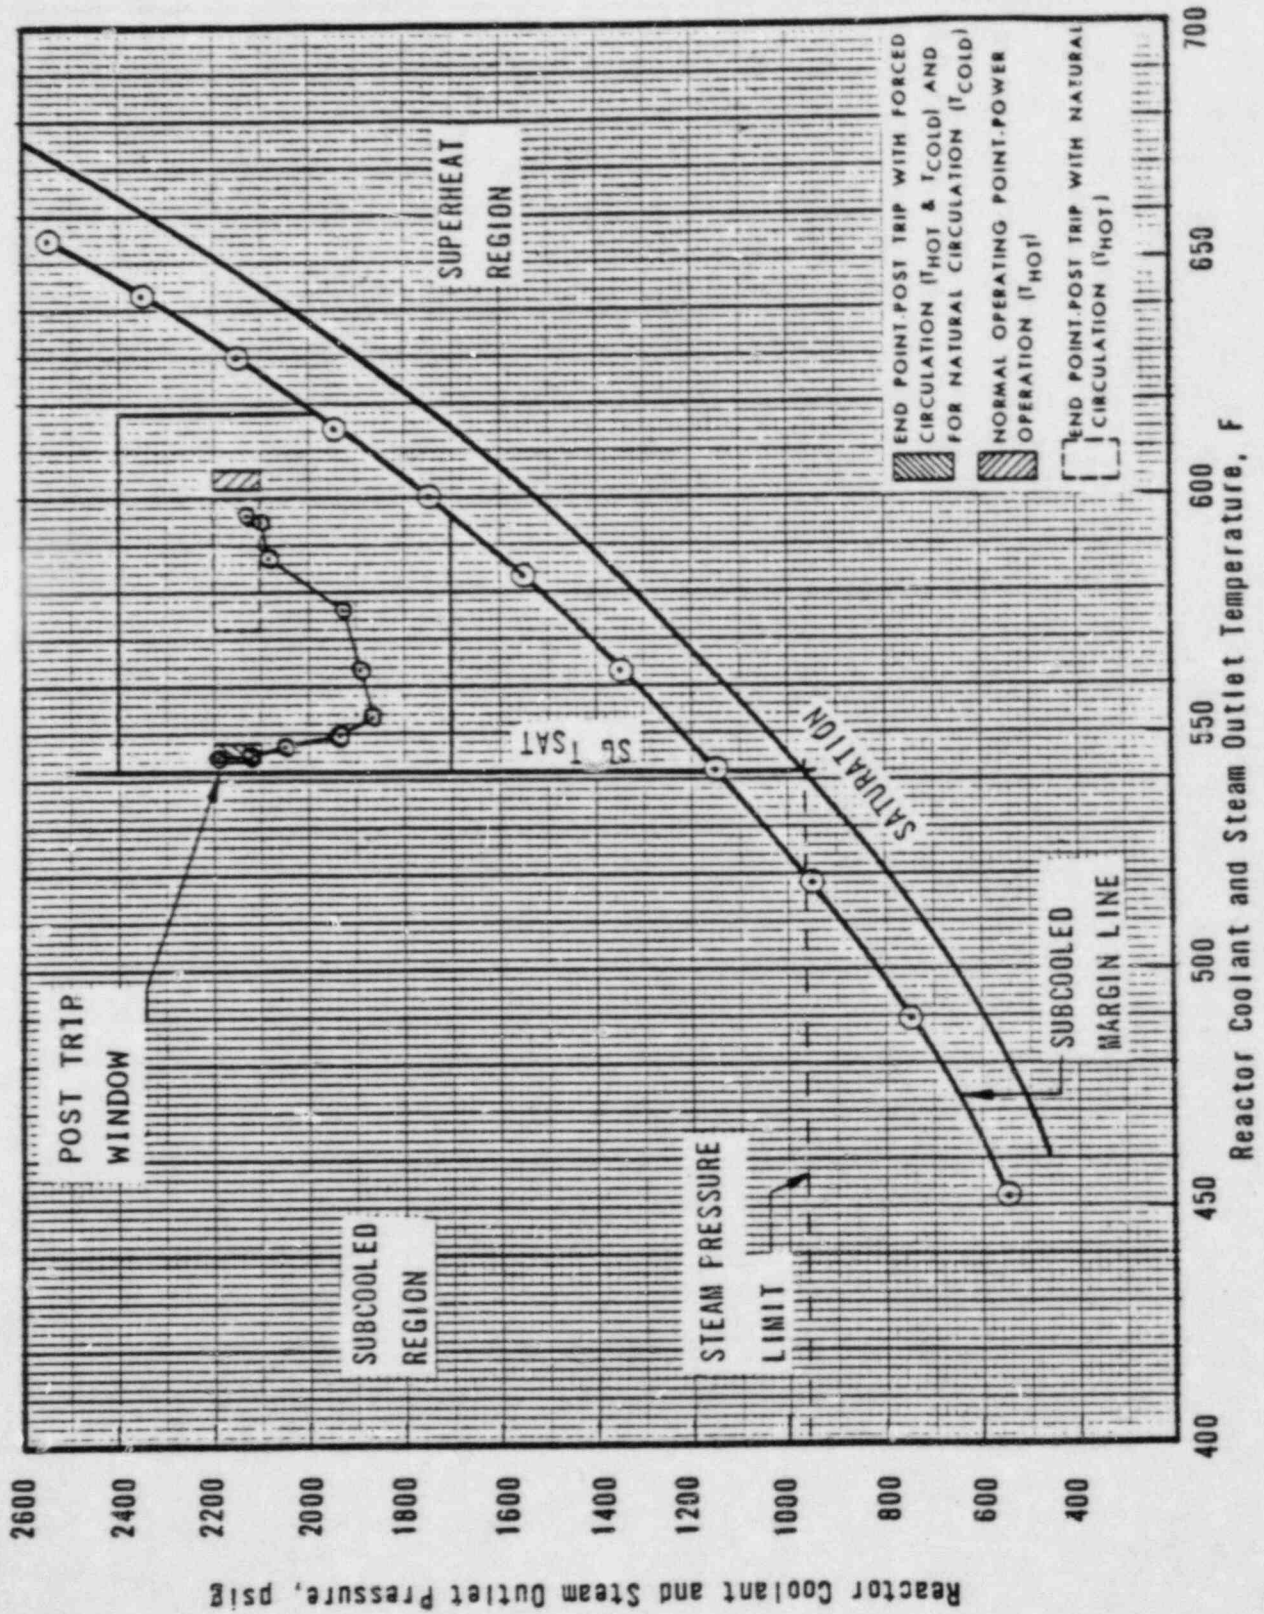
$T_{HOT}$  VS PRESSURE FIGURE 2

Post-trip response of the RCS is represented in Figures 2 through 17. Pertinent parameter limits obtained from the Plant Computer Memory Trip Review are listed in Table 1.
