U.S. NUCLEAR REGULATORY COMMISSION
REGION I

Docket/
Report No. 50-213/94-03

Facility: Haddam Neck Plant

EXECUTIVE SUMMARY
HADDAM NECK PLANT INSPECTION 50-213/94-03

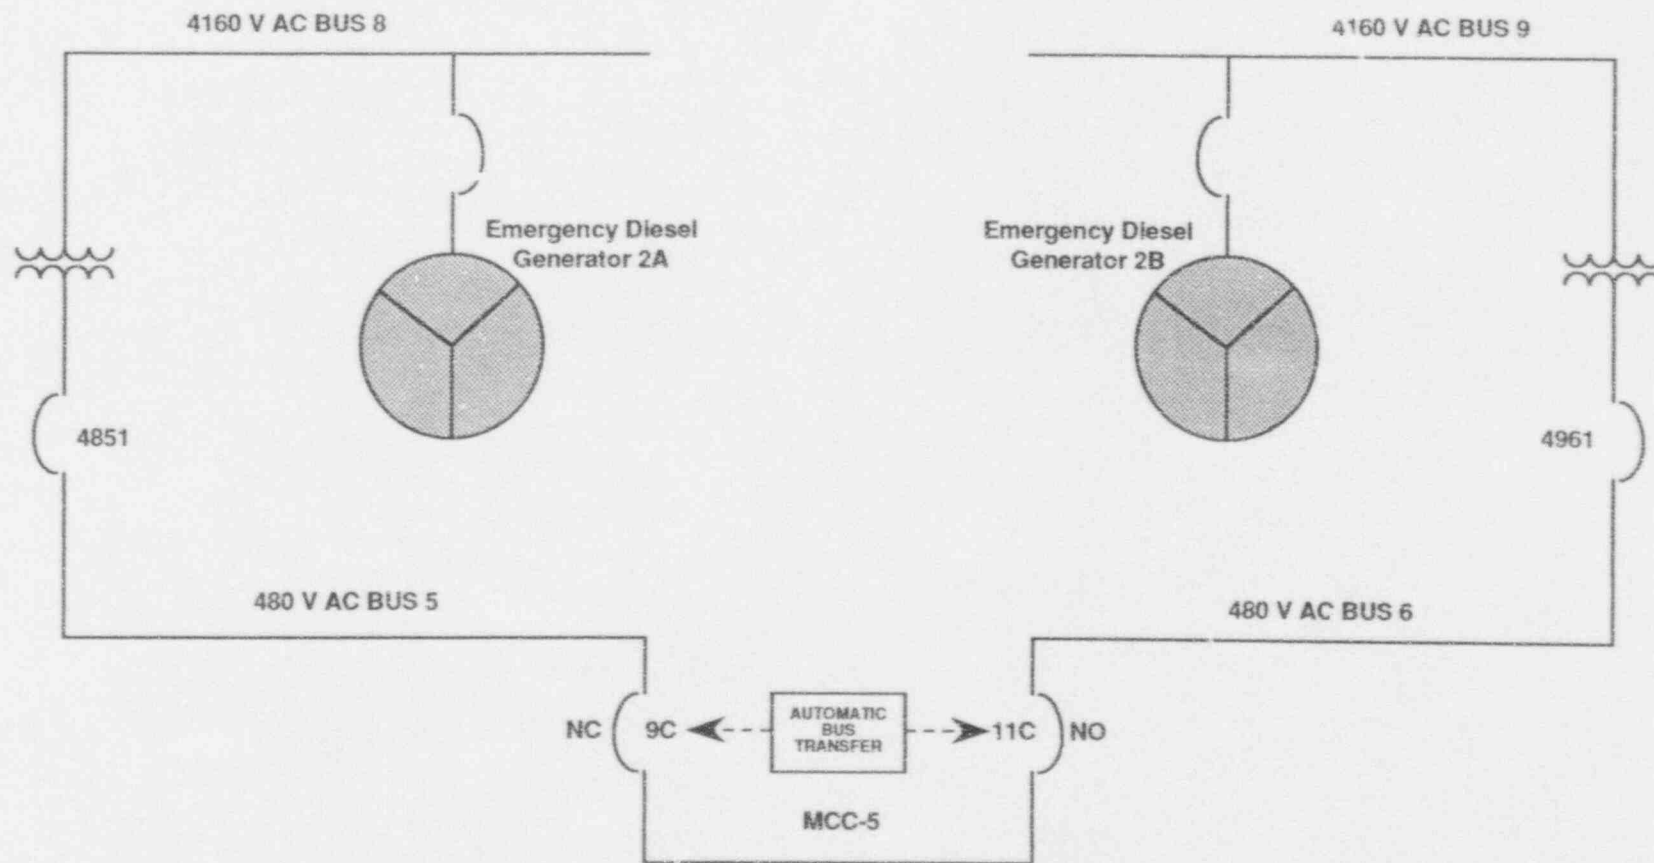
MCC-5 SIMPLIFIED DIAGRAM
FIGURE 1

The test of the ABT on November 10 was successful and was repeated periodically with the plant operating at power. The last successful test at power was performed on January 28. The purpose of the test was to assure continued operability of the ABT by de-energizing the 52X relay in the Westinghouse AK-25 breaker supplying power to MCC-5. A schematic of the MCC-5 bus and the ABT logic diagram are enclosed with this report as Figures 1 and 2, respectively. For the tests at power, the normal supply was from 480 volt Bus 5, which fed MCC-5 via breakers 9C on Bus 5. The test plan was to de-energize control power to breaker 9C to drop the 125 Vdc supply to the associated 52X relay. The 125 Vdc power was removed by opening the knife switch in the Bus 5 control power supply cabinet. Once control power was

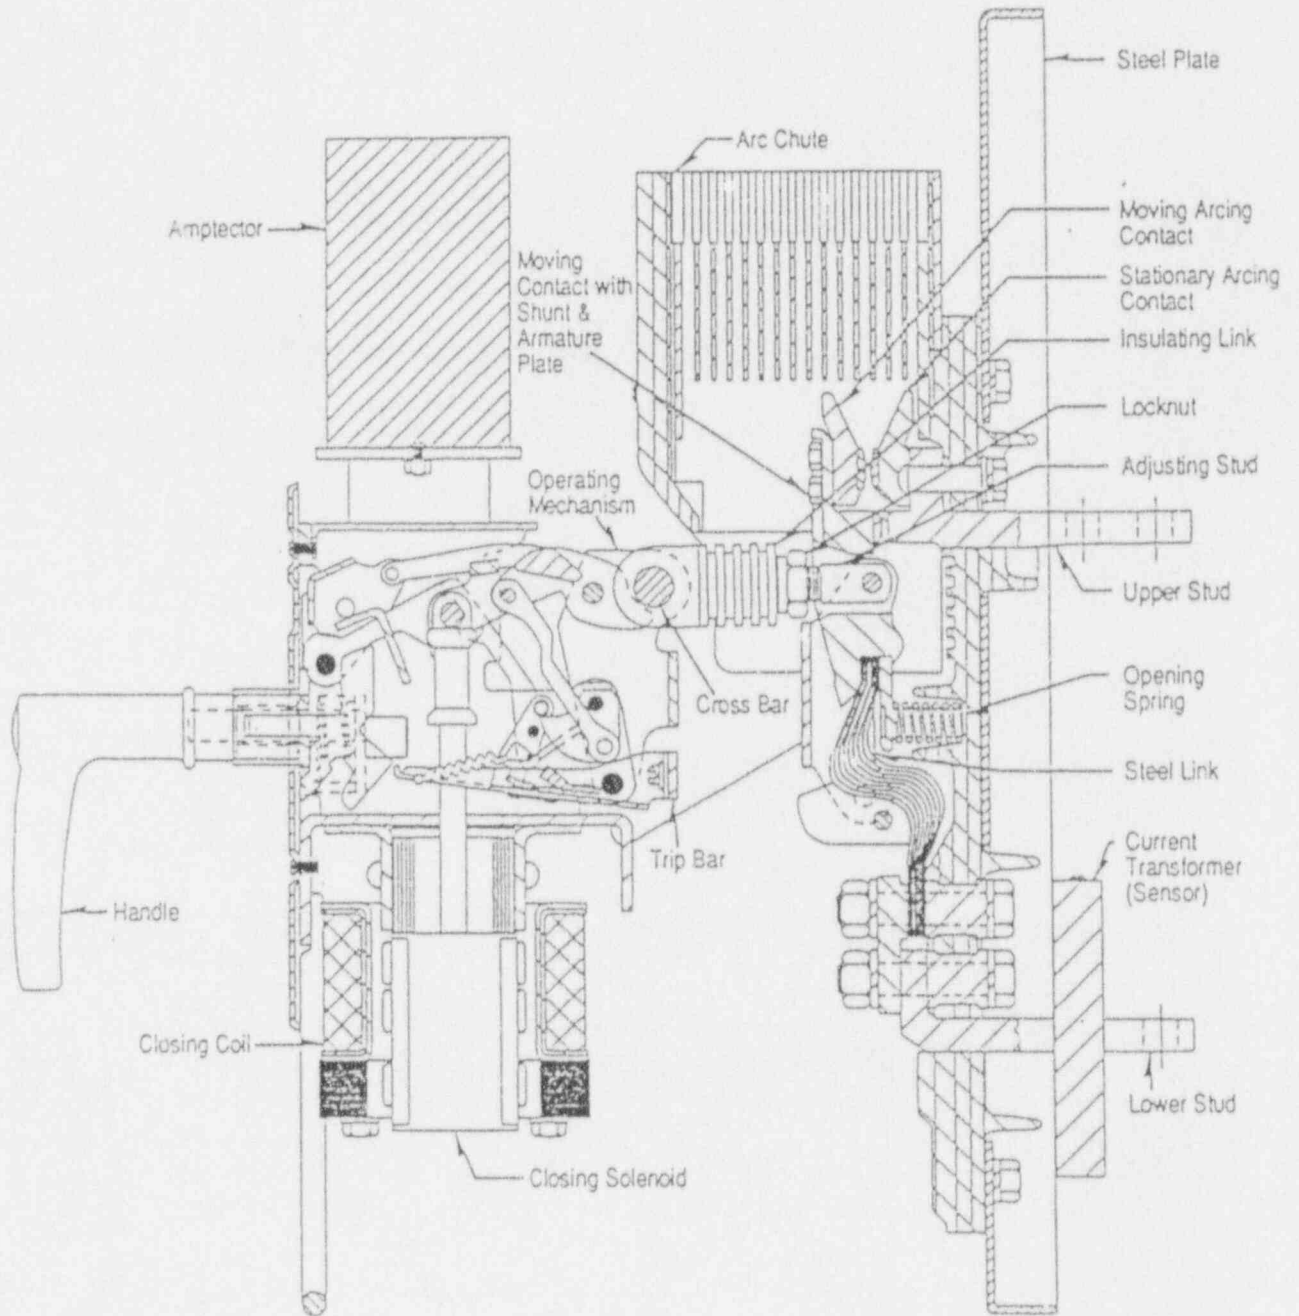
FIGURE 5
DB-25 BREAKER OPERATING MECHANISM

Breakers 9C and 11C are Westinghouse Model DB-25 air circuit breakers. Figures 3 through 5 show the relevant features of the DB-25 design details. The licensee conducted visual inspections of the breaker 11C components on February 19. Covers to the auxiliary switches were removed and the auxiliary switch wiring and contacts were visually inspected. No abnormalities were identified during the visual examination of the auxiliary switches. The amptector (overcurrent device) and the cover to the closing/trip linkage was removed. During a visual inspection of the linkage, the licensee identified that the snap ring on the manual closing linkage was not properly located in the snap ring slot (see Figure 5). The snap ring was back away from the slot, toward the manual closing handle, approximately 1 to 1 1/2 inches. This allowed the manual breaker closing linkage to protrude into the closing/trip linkage.
