Duke Power Company
Oconee Nuclear Station
Unit 1

Report Number: RO-269/81-11, Supplement 1

Identification of Occurrence: Core Barrel Assembly Thermal Shield Bolts Broken

Subject: Broken Thermal Shield Bolts at Oconee Unit 1

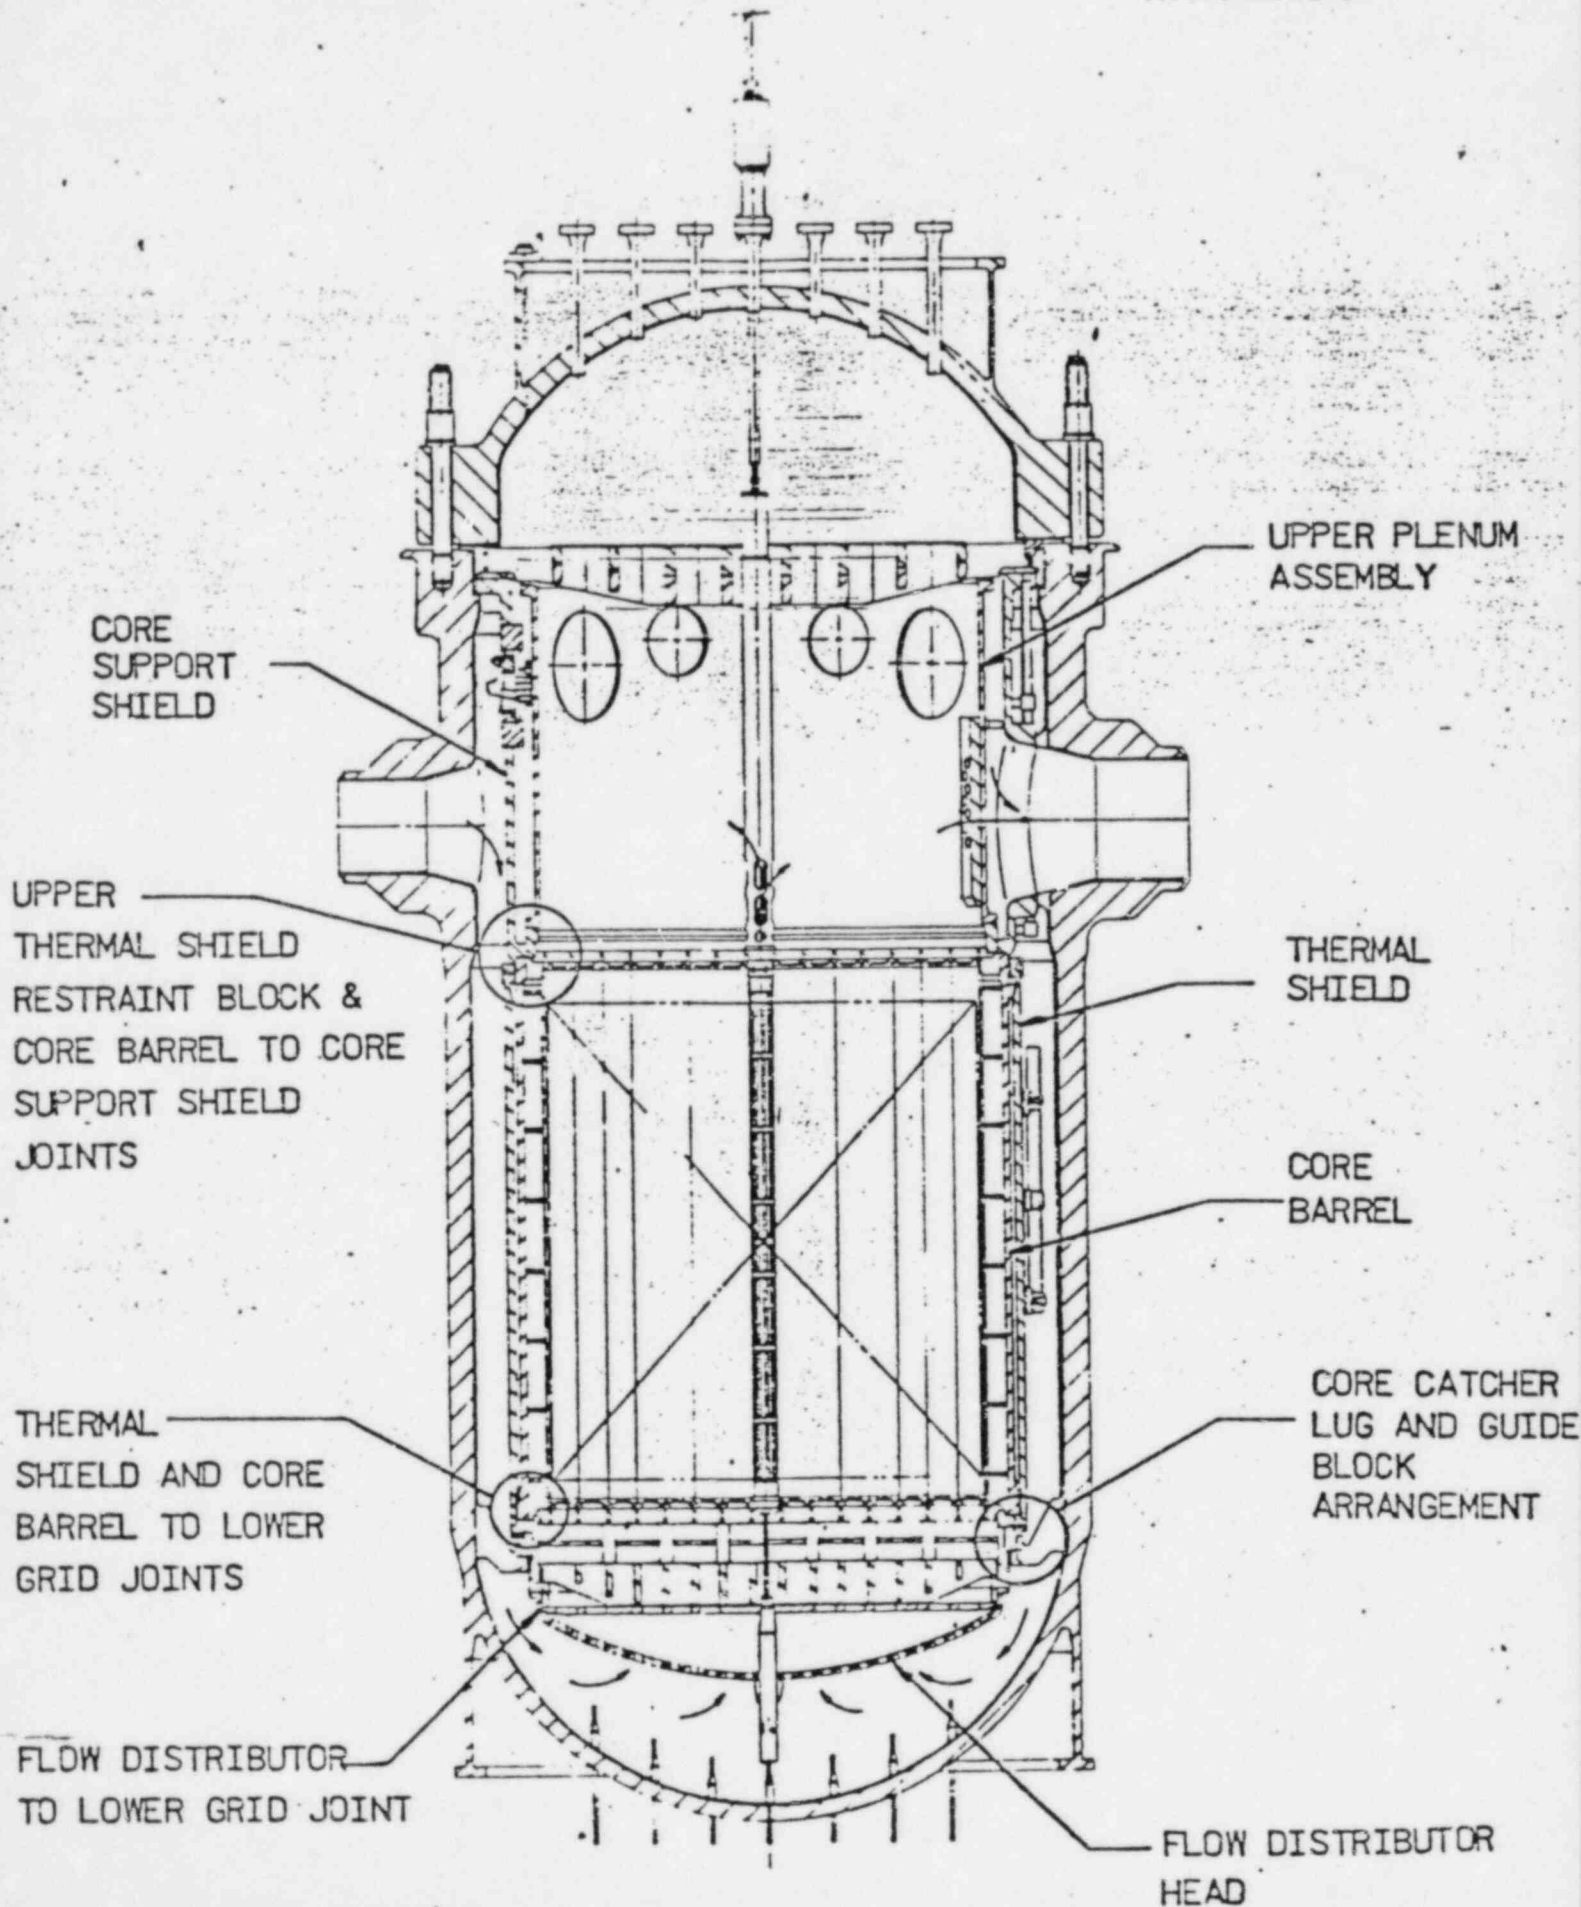
THERMAL SHIELD LOWER SUPPORT

The fracture surface covering most of the bolt cross section was found to be intergranular with grain boundary corrosion attack and branch cracking evident. A smaller central region was found to be transgranular with some fatigue evident. No evidence of shear lips or ductile tearing associated with overload was found. The failure mechanism identified from this examination was determined to be a corrosion fatigue mechanism with low stress levels involved.

Due to the nature of these findings, a review has been initiated in regard to other A-286 (SA 453 GR 660) bolt applications in the reactor internals. Bolts of different size but similar material are used in the Core Barrel to Core Support Shield, Core Barrel to Lower Grid, Upper Thermal Shield Restraint Blocks, and Flow Distributor to Lower Grid Joints. These joints have been carefully scanned with remote video equipment. The joints appear to be tight and no abnormal conditions have been observed. As a precautionary measure, plans are being made to remove one or more bolts from these joints for detailed examination.
