UNITED STATES  
NUCLEAR REGULATORY COMMISSION

SUBJECT: MARCH 16, 1994, MANAGEMENT MEETINGS

# South Texas Project Standby Diesel Generator Presentation To NRC Region IV Management

## Damaged Piston Photograph Legend

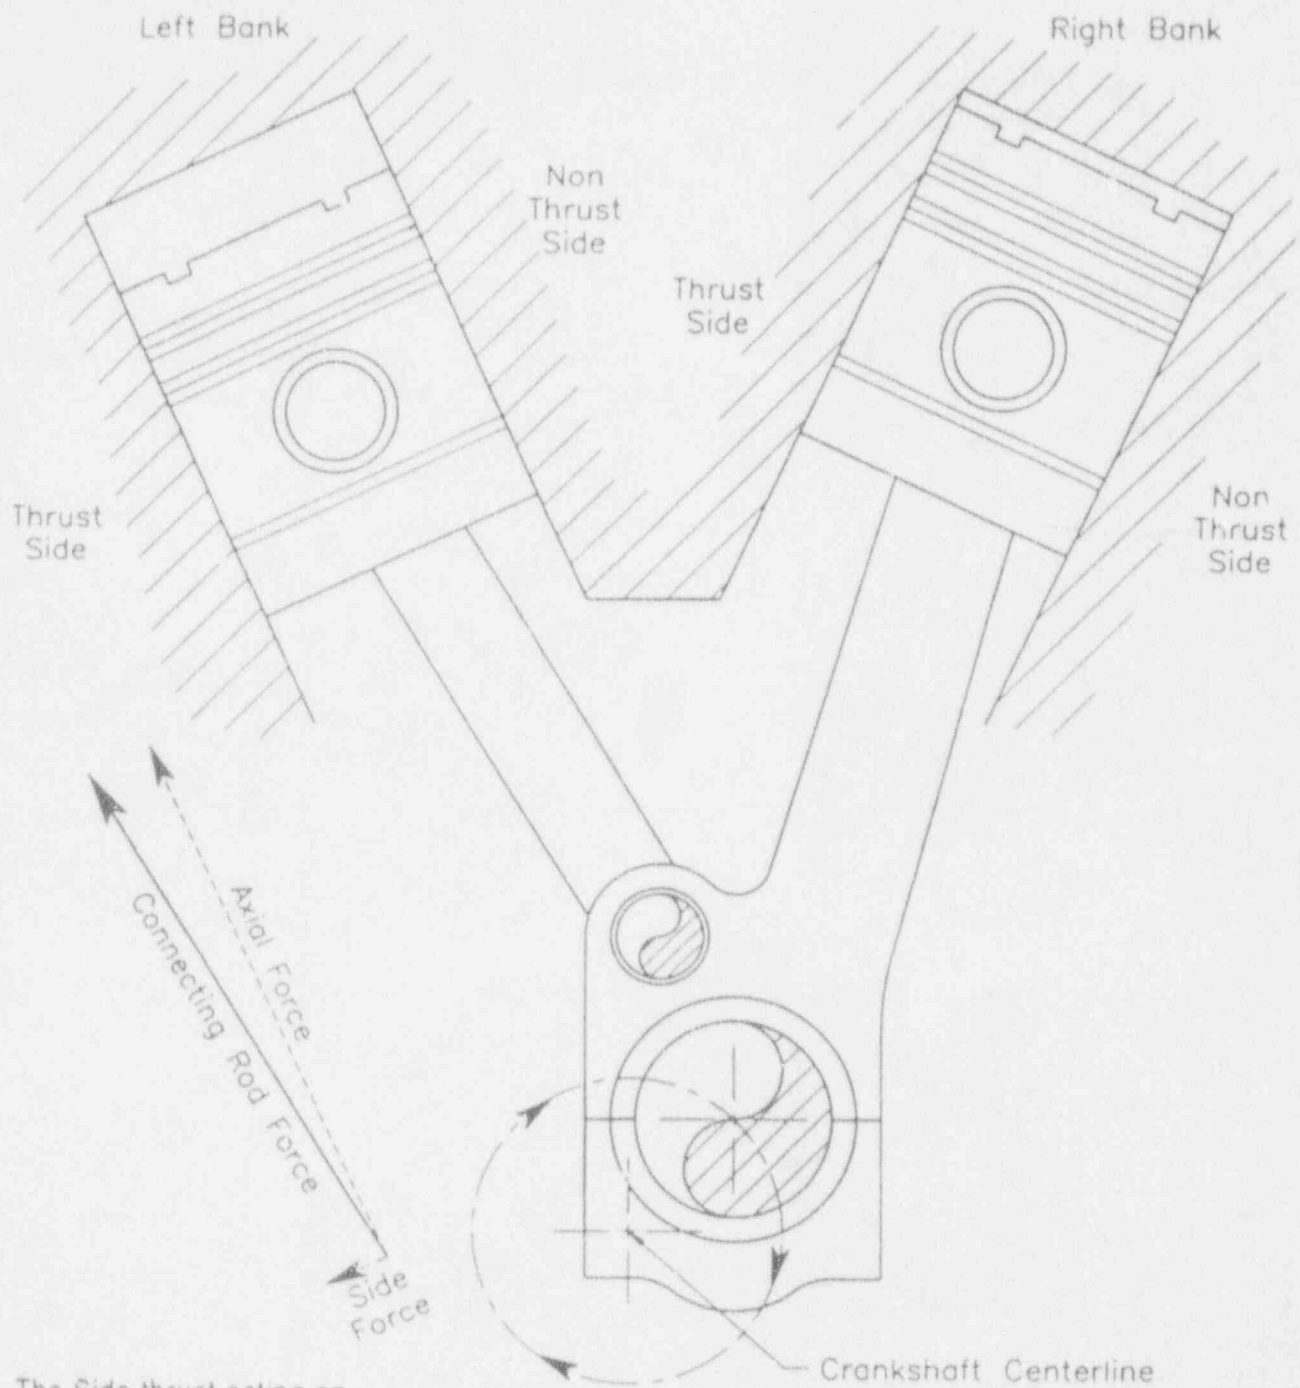
Piston and Cylinder Linear Thrust and Non-Thrust Sides

- SCUFF ORIGINATED ON LOWER SKIRT - THRUST SIDE
- TIN EMBEDDED IN LINER FROM SCUFF REDUCED LUBRICATION ON THRUST SIDE OF LINER
- REDUCED LUBRICATION CAUSED CONTINUED SCUFF/LOSS OF MORE TIN
- HIGH FORCES ON THRUST SIDE RESULTED IN HIGH SECTIONAL HEATING AND MECHANICAL FORCES
- HIGH TEMPERATURES CAUSED REDUCED MATERIAL STRENGTH, THERMAL GROWTH AND THERMAL STRESSES
- REDUCED MATERIAL STRENGTH RESULTED IN THRUST SIDE FAILURE
- NON-THRUST SIDE TIN TRANSFER DUE TO THERMAL GROWTH
- INITIAL SCUFF CAUSE UNKNOWN BUT COULD BE THE RESULT OF GRIT, DIRT, PISTON/LINER IRREGULARITY OR POTENTIAL IMPACTS FROM THE 1989 EVENT

The Side thrust acting on the piston pin is transferred to the piston and is reacted by an equal and opposite force from the cylinder.

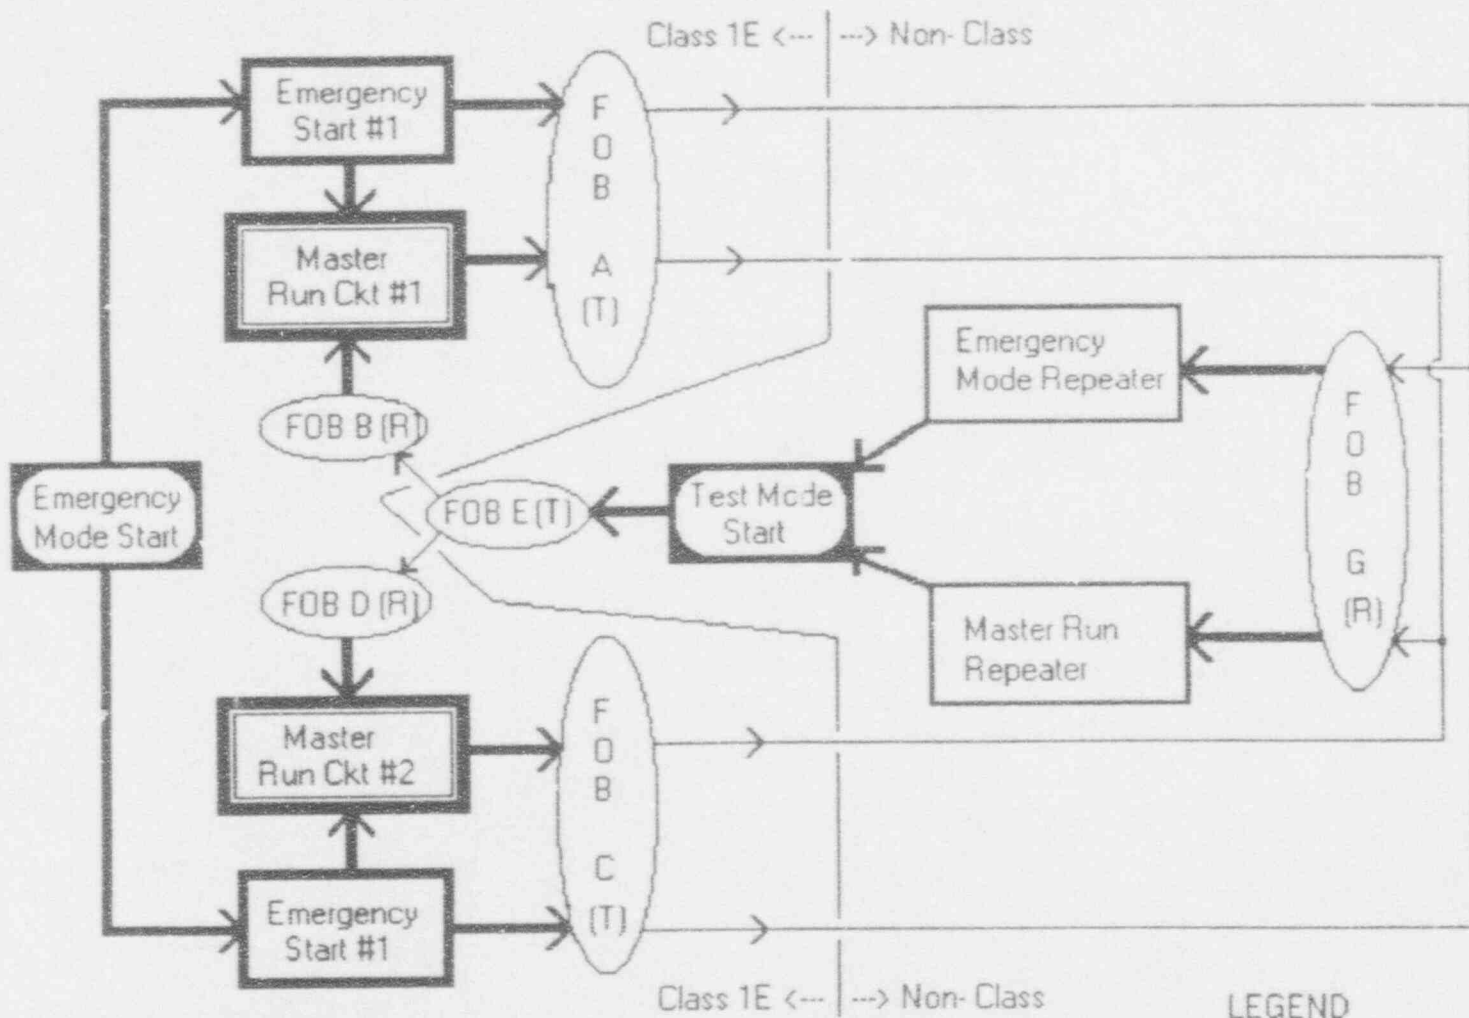
**Fiber Optic Board  
Starting Circuit Interface  
Block Diagram**

- 03/01/94 EVENT ANALYSIS
  - FAILURE SIMILAR TO 1E FIBER OPTIC BOARDS (VARISTORS/TRANSISTORS)
  - SCOPE OF EXPOSURE FROM FAILED FIBER OPTIC BOARDS EXPANDED TO COVER NON-1E FIBER OPTIC BOARDS

- 03/05/94 EVENT ANALYSIS
  - ROOT CAUSE ELUSIVE
  - ILLUSTRATED REQUIRED CONTROLS TO PANEL ACCESS

- REMEDIAL
  - FIBER OPTIC BOARD G REPLACED
  - DEFECTIVE FIBER OPTIC CABLE REPLACED

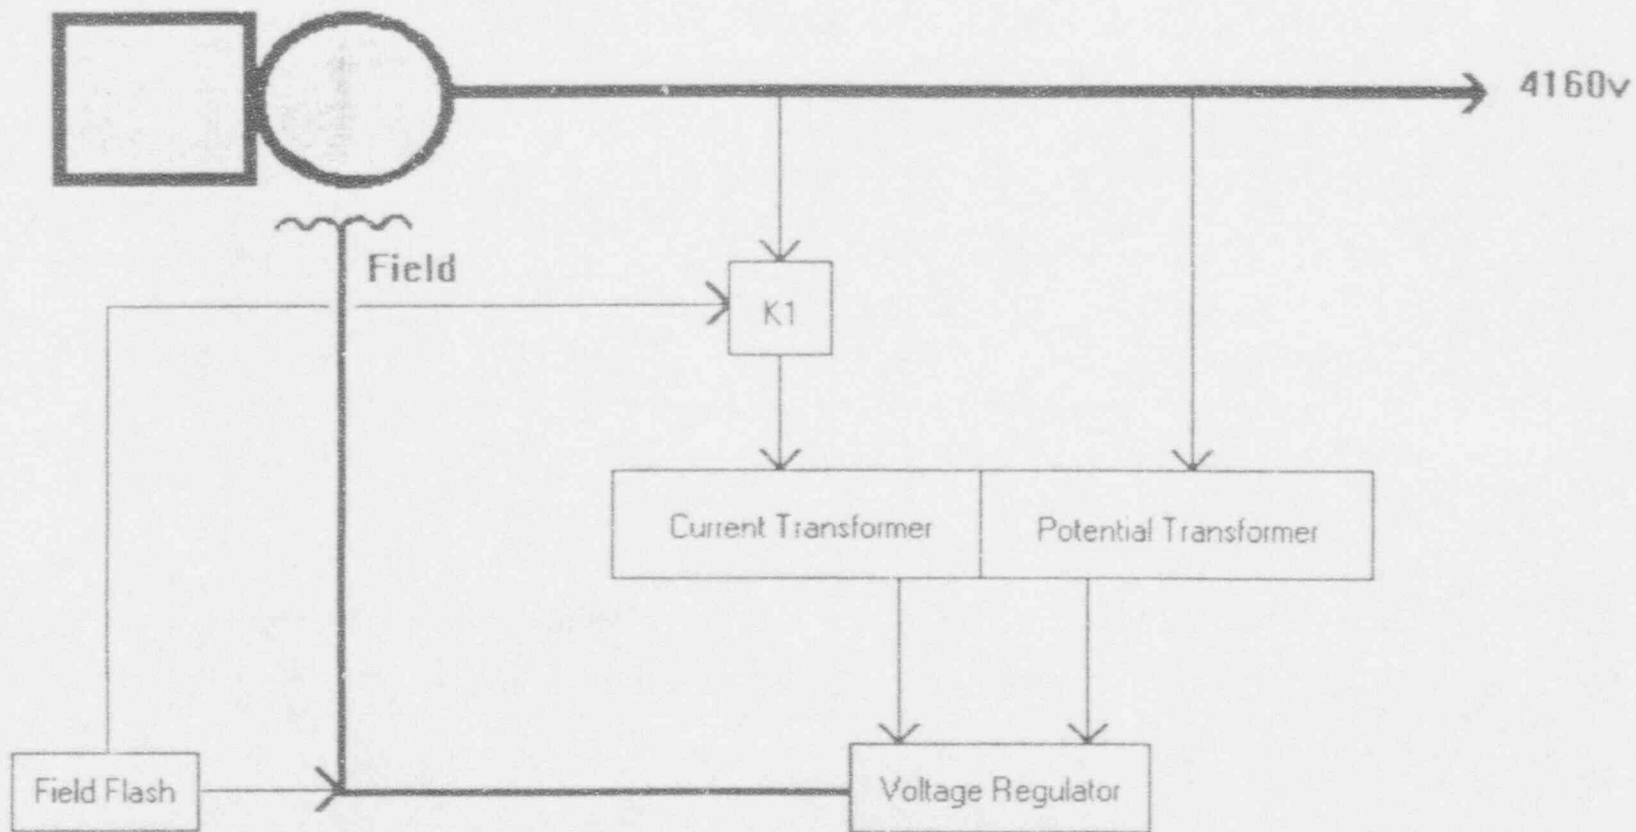
**Standby Diesel Generator  
Voltage Regulator / Field Flash Block Diagram**

- SDG NO. 11 FAILED TO DEVELOP REQUIRED VOLTAGE DURING TEST
  - 02/03/94
  - 03/01/94
- ENGINE RUN, COOLDOWN, AND SHUTDOWN OTHERWISE NORMAL
- TEST FAILED, DECLARED VALID FAILURE
