NORTH ANNA UNIT 1
STEAM GENERATOR IMPACTED TUBE ENDS
RECOVERY EVALUATION

OCTOBER 1982

WESTINGHOUSE ELECTRIC CORPORATION
NUCLEAR SERVICE INTEGRATION DIVISION
P.O. BOX 2728
PITTSBURGH, PA 15230

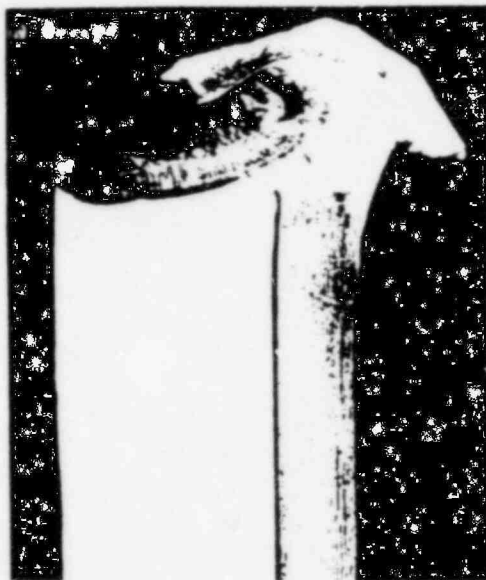
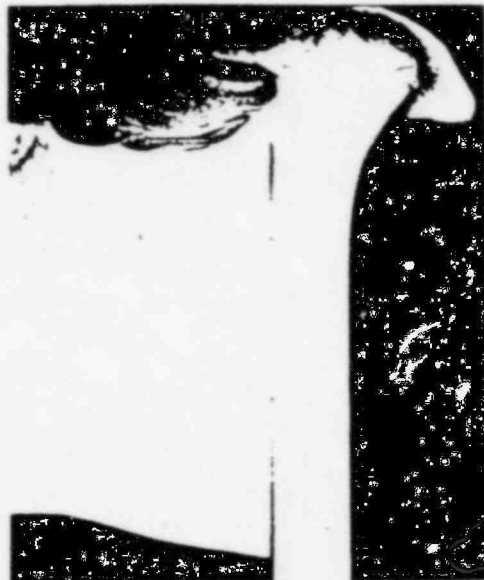
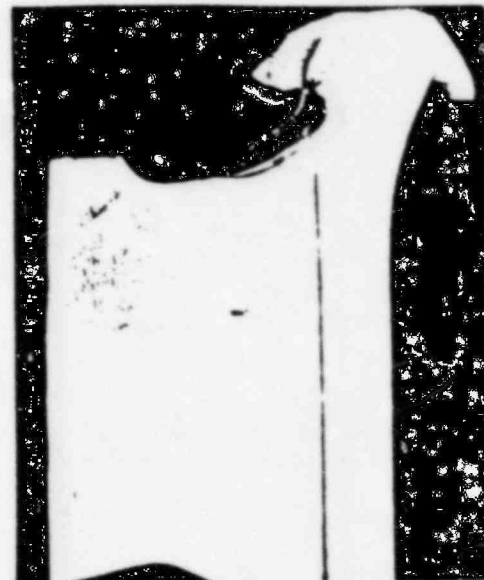
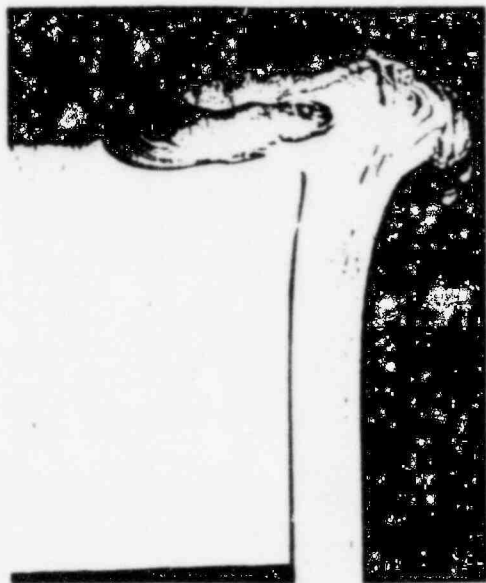
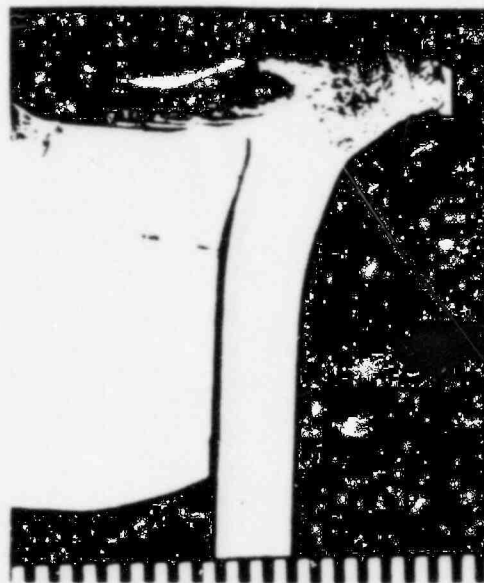
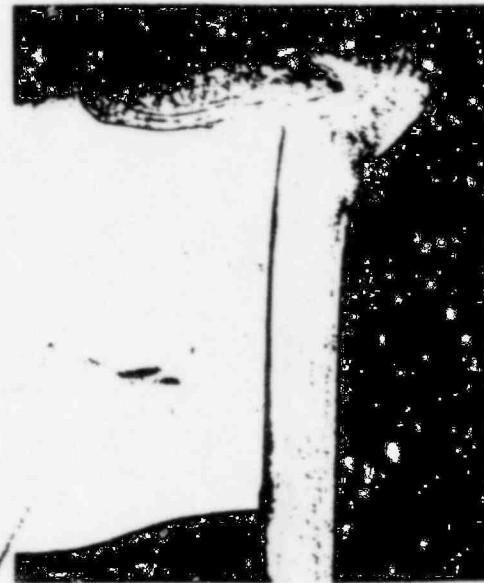
tional photographs were taken of the test block. Figure 12, the test block at a magnification of 1X, shows nine tube ends before impactation and nine tube ends after impactation. Figure 13 shows four of the more heavily affected tube ends at a magnification of 3X. The three worse impacted tube ends were selected for metallurgical examination. These tube ends, include heavy peening and cracking (type b.), peening (type c.) and peening on the weld area (type e.). Figure 14, 15 and 16 show representative macrographs, at 7X, of tube and tubesheet mockup axial sections.

Fig. 14 Macrographs of Sections Through the Tube and Tubesheet Mockup, Row 1, Column 1 (See Figures 12, 13) -7X Magnification

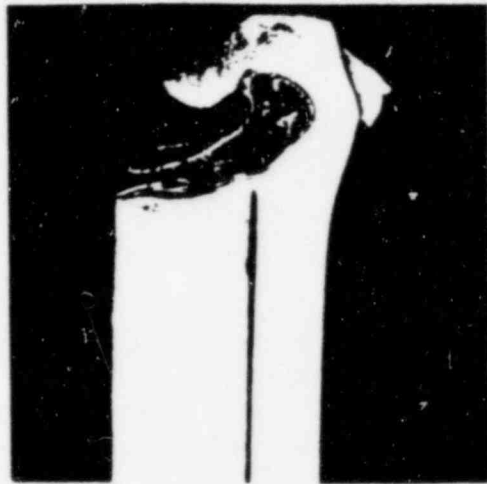
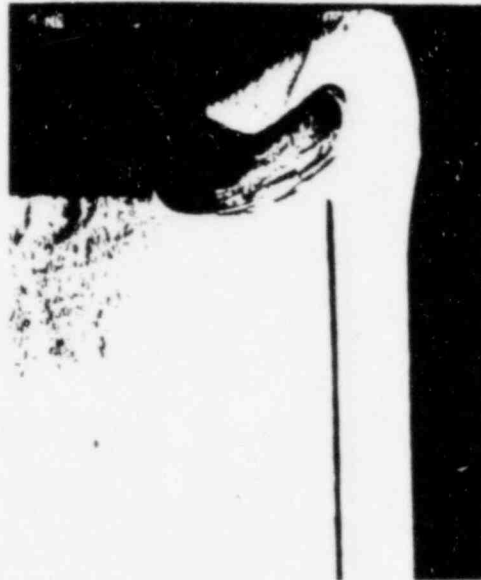
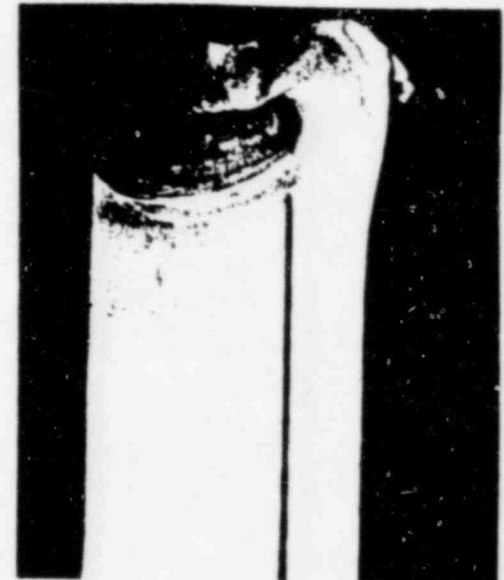
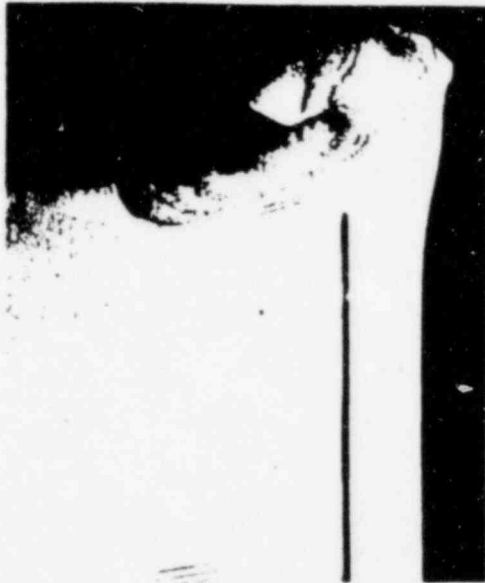
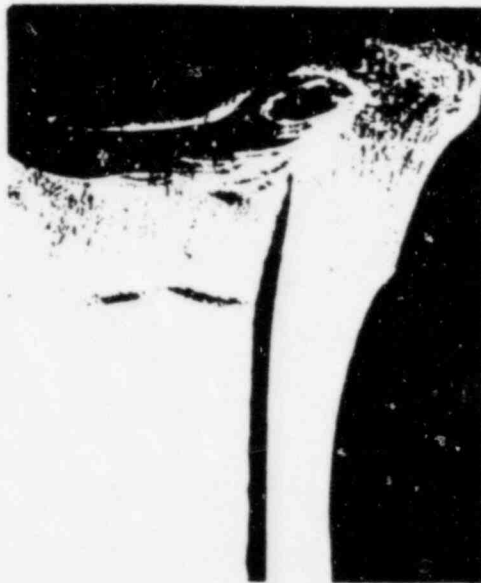
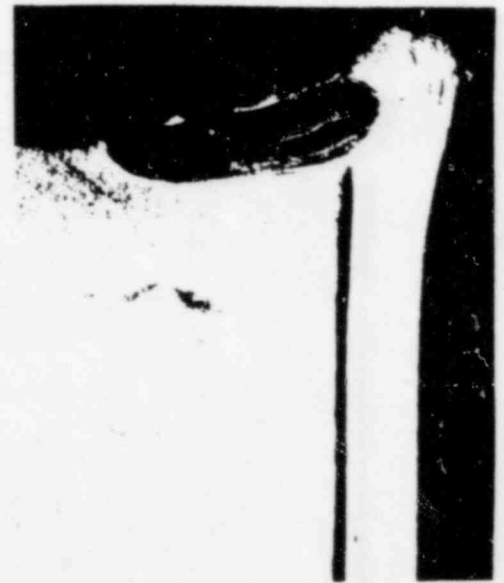
Fig. 15 Macrographs of Sections Through the Tube and Tubesheet Mockup, Row 2, Column 1, (See Figures 12, 13) -7X Magnification

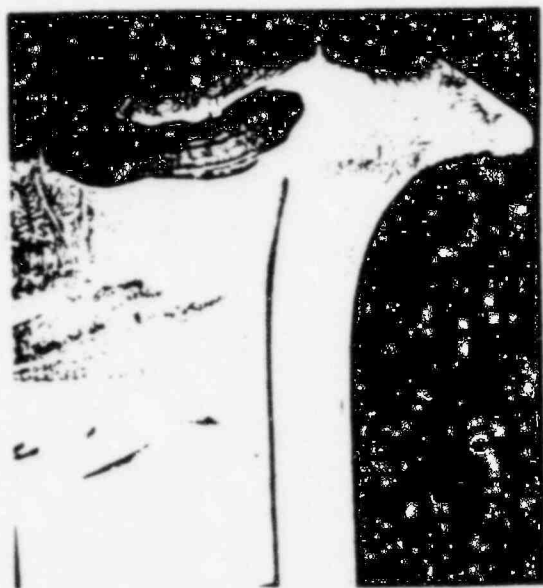
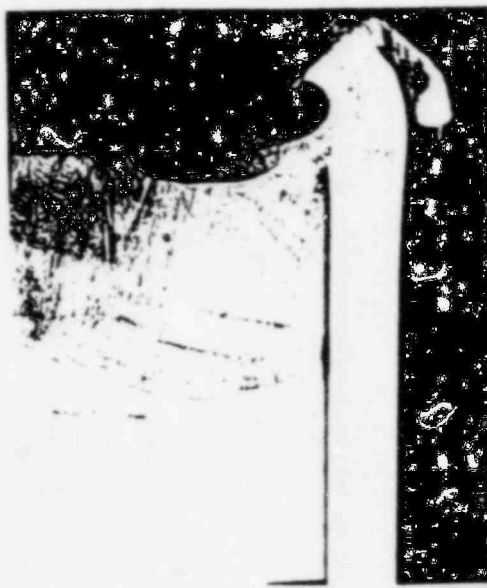
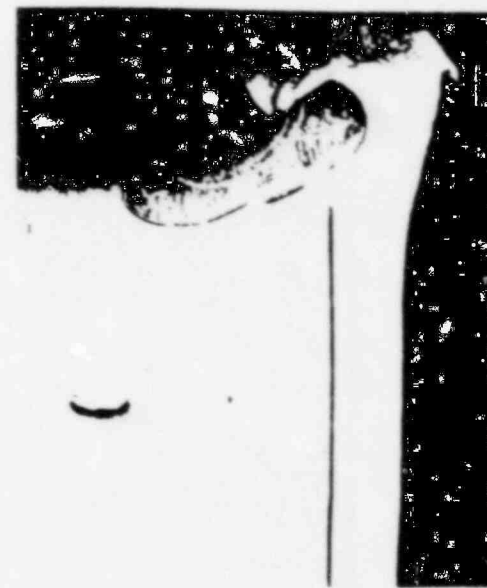
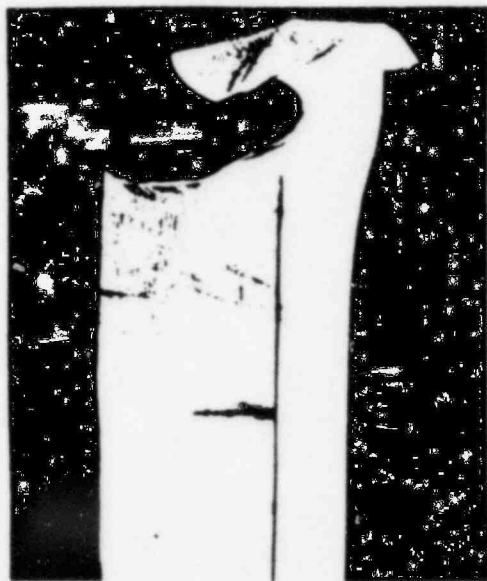
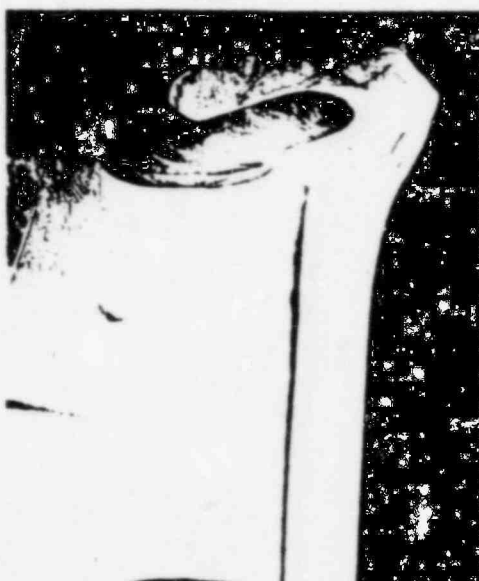
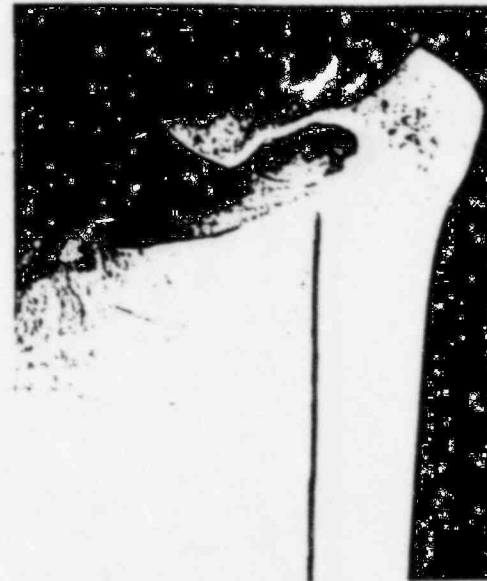
Fig. 16 Macrographs of Sections Through the Tube and Tubesheet Mockup, Row 2, Column 2 (See Figure 12, 13) -7X Magnification

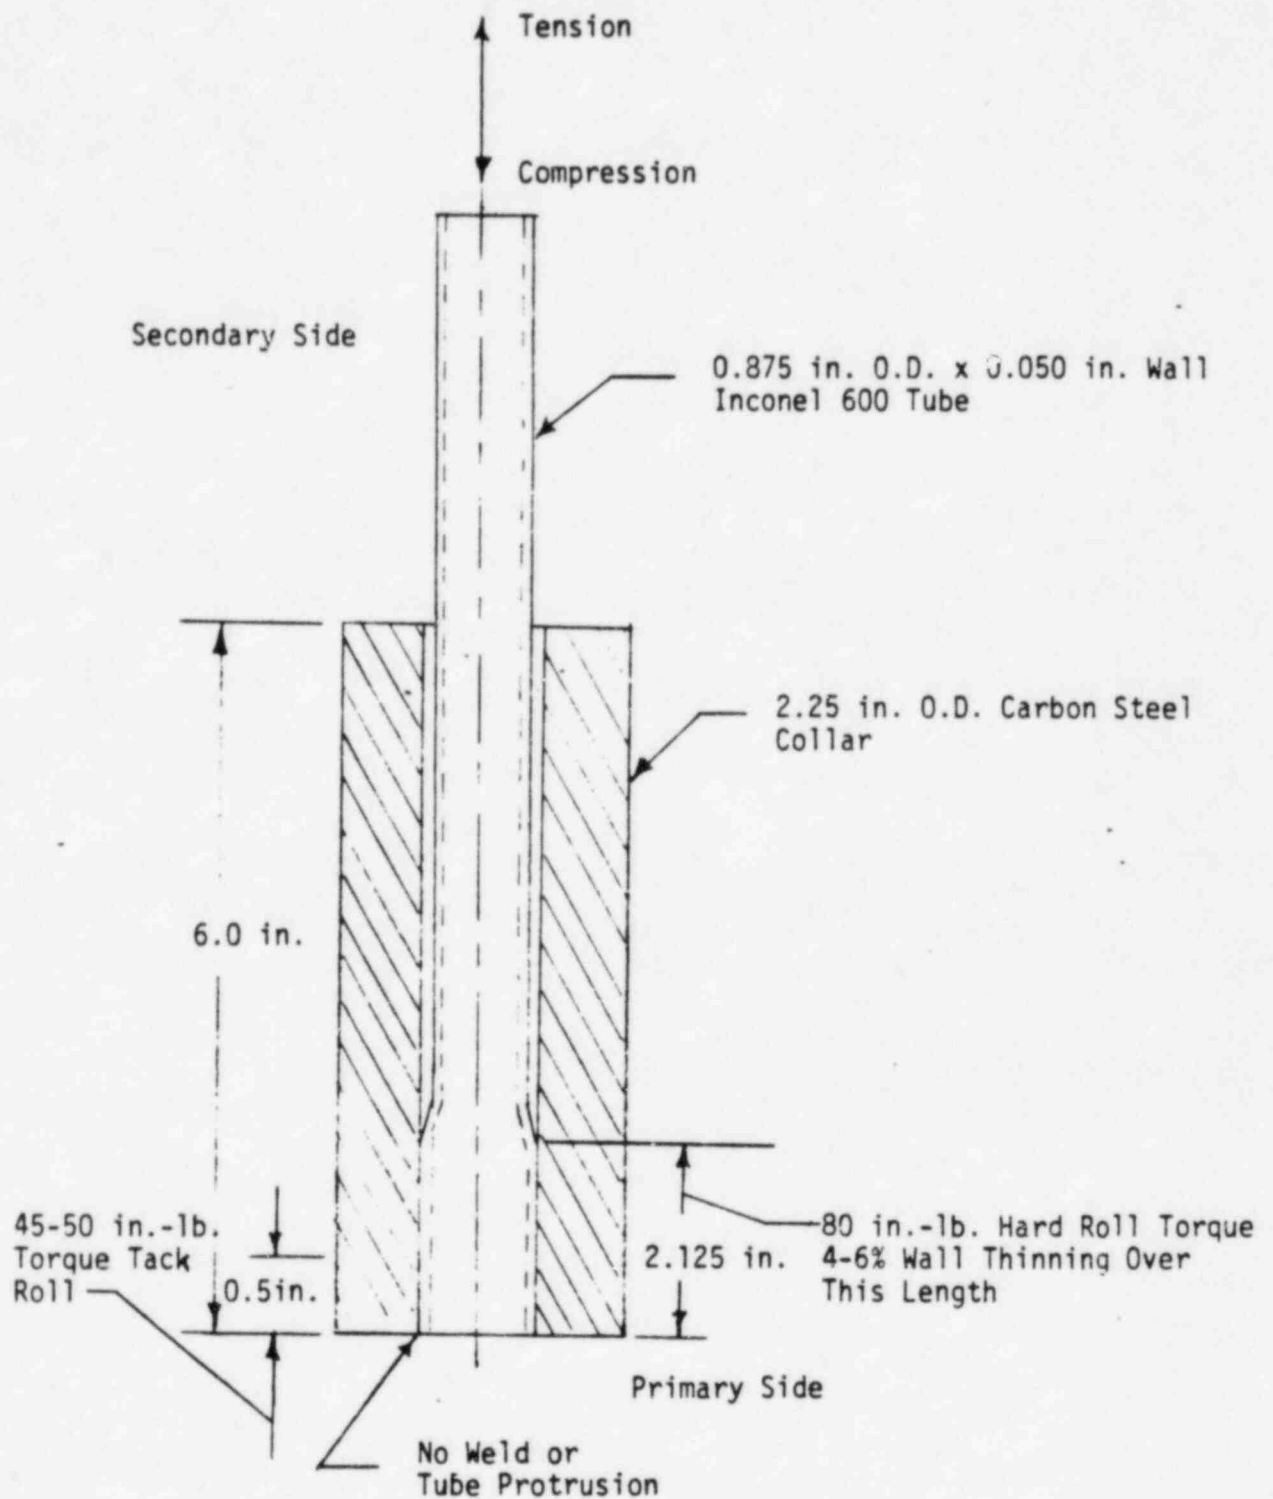
It was determined that the tubes in the steam generator were first tack rolled over a length of 0.5 in. above the tubesheet bottom surface and then hard rolled to a length of 2.25 in. above the tubesheet bottom surface (after welding). The tube end protrusion of 0.219 in. does not provide any holding strength so this was not included. The effective strength of the rolled joint will result from the effective 2 1/4 in. long roll depth of the tube to the tubesheet. This was simulated as shown in Figure 17. The physical properties of the tube material, actual rolling torque, percent wall thinning etc. were recorded for each sample. After the samples were prepared, the strengths of the joints were established experimentally.

Figure 17 Specimen for Hard Roll Joint Strength Test

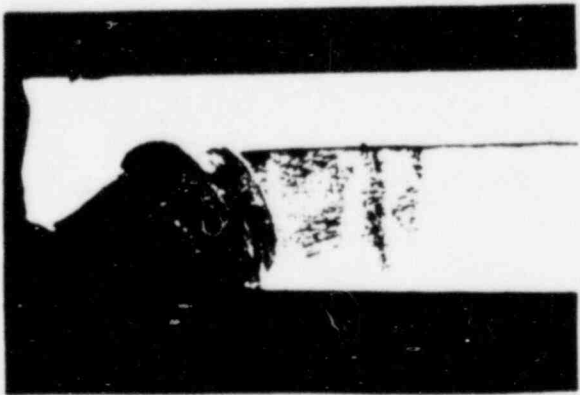
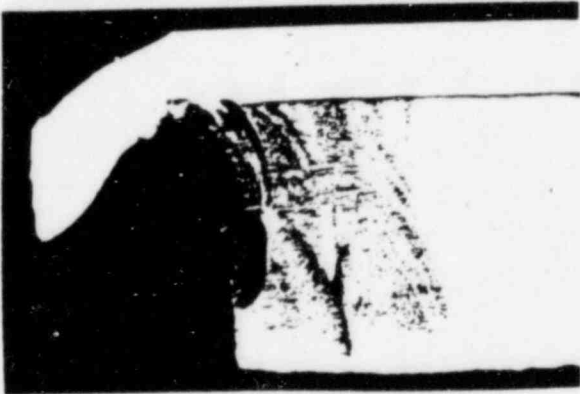
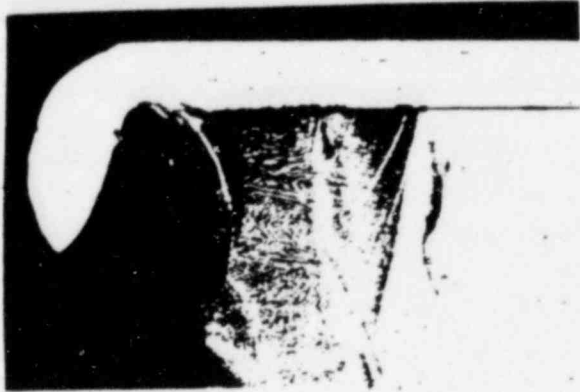
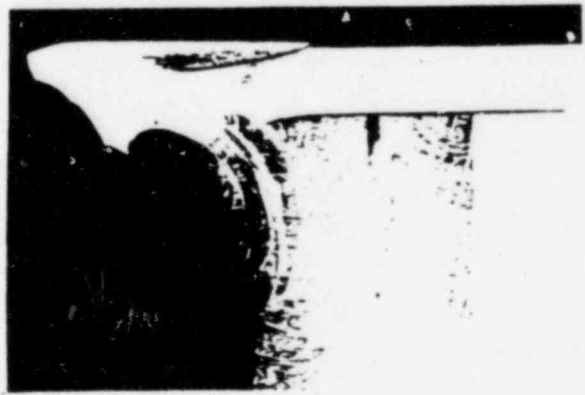
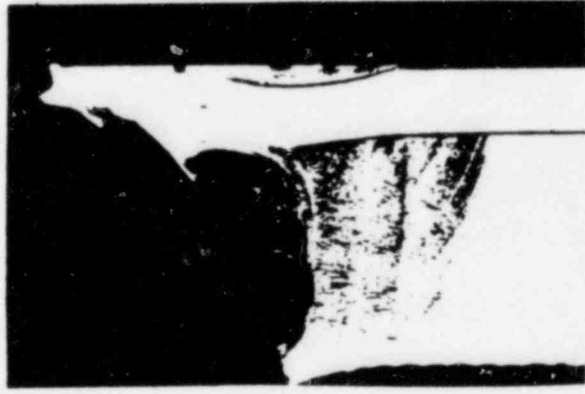
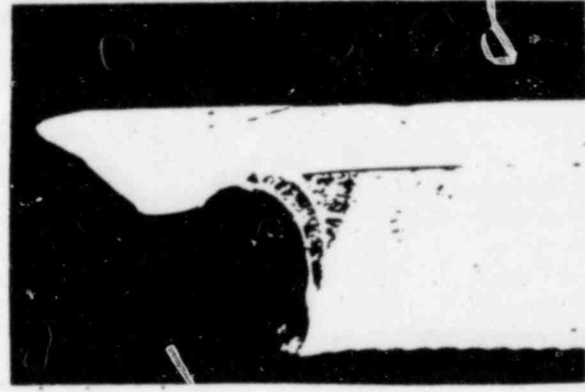
deformation. Figure 23 shows a tube end section that had not been deformed significantly out over the weld. It had, apparently, been deformed inward and, when repaired, part of the tube lip folded over and formed the imbedded sliver that is apparent. In Figure 24, the tube end had apparently been deformed both inward and outward, as evidenced by the tube wall thickening above the weld in some sections and the formation of an imbedded sliver. In Figure 25, the tube end was deformed sharply outward over the weld in one sector.

FIGURE 24 MACROGRAPHS OF SECTIONS THROUGH INTENTIONALLY DIFORMED AND REPAIRED TUBE AND TUBESHEET MOCK-UP, R1, C4, - 7X MAGNIFICATION

Optical metallography was performed on three tube ends in the test block after the deformation has been repaired by hard rolling. Figure 23, 24 and 25 show macrographs (at 7X magnification) of axial sections through the tube, test blocks and weld. These are representative of different degrees of tube end

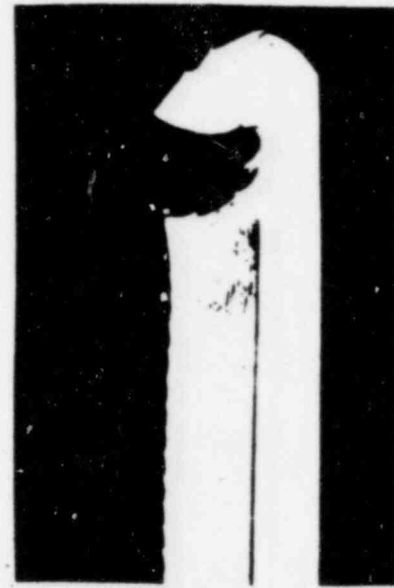
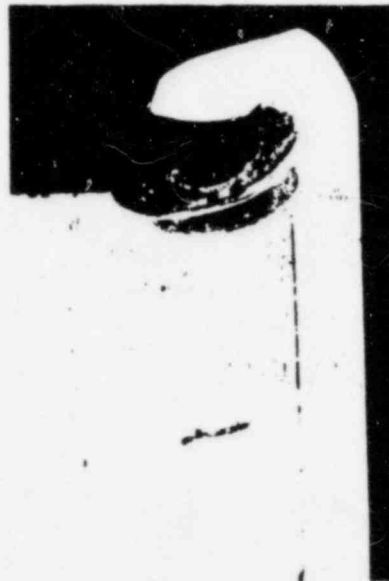
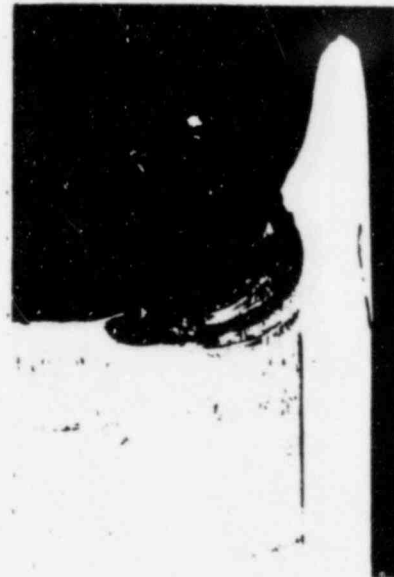
FIGURE 25 MACROGRAPHS OF SECTIONS THROUGH INTENTIONALLY DEFORMED AND REPAIRED TUBE AND TUBESHEET MOCK-UP, R2, C4, - 7X MAGNIFICATION

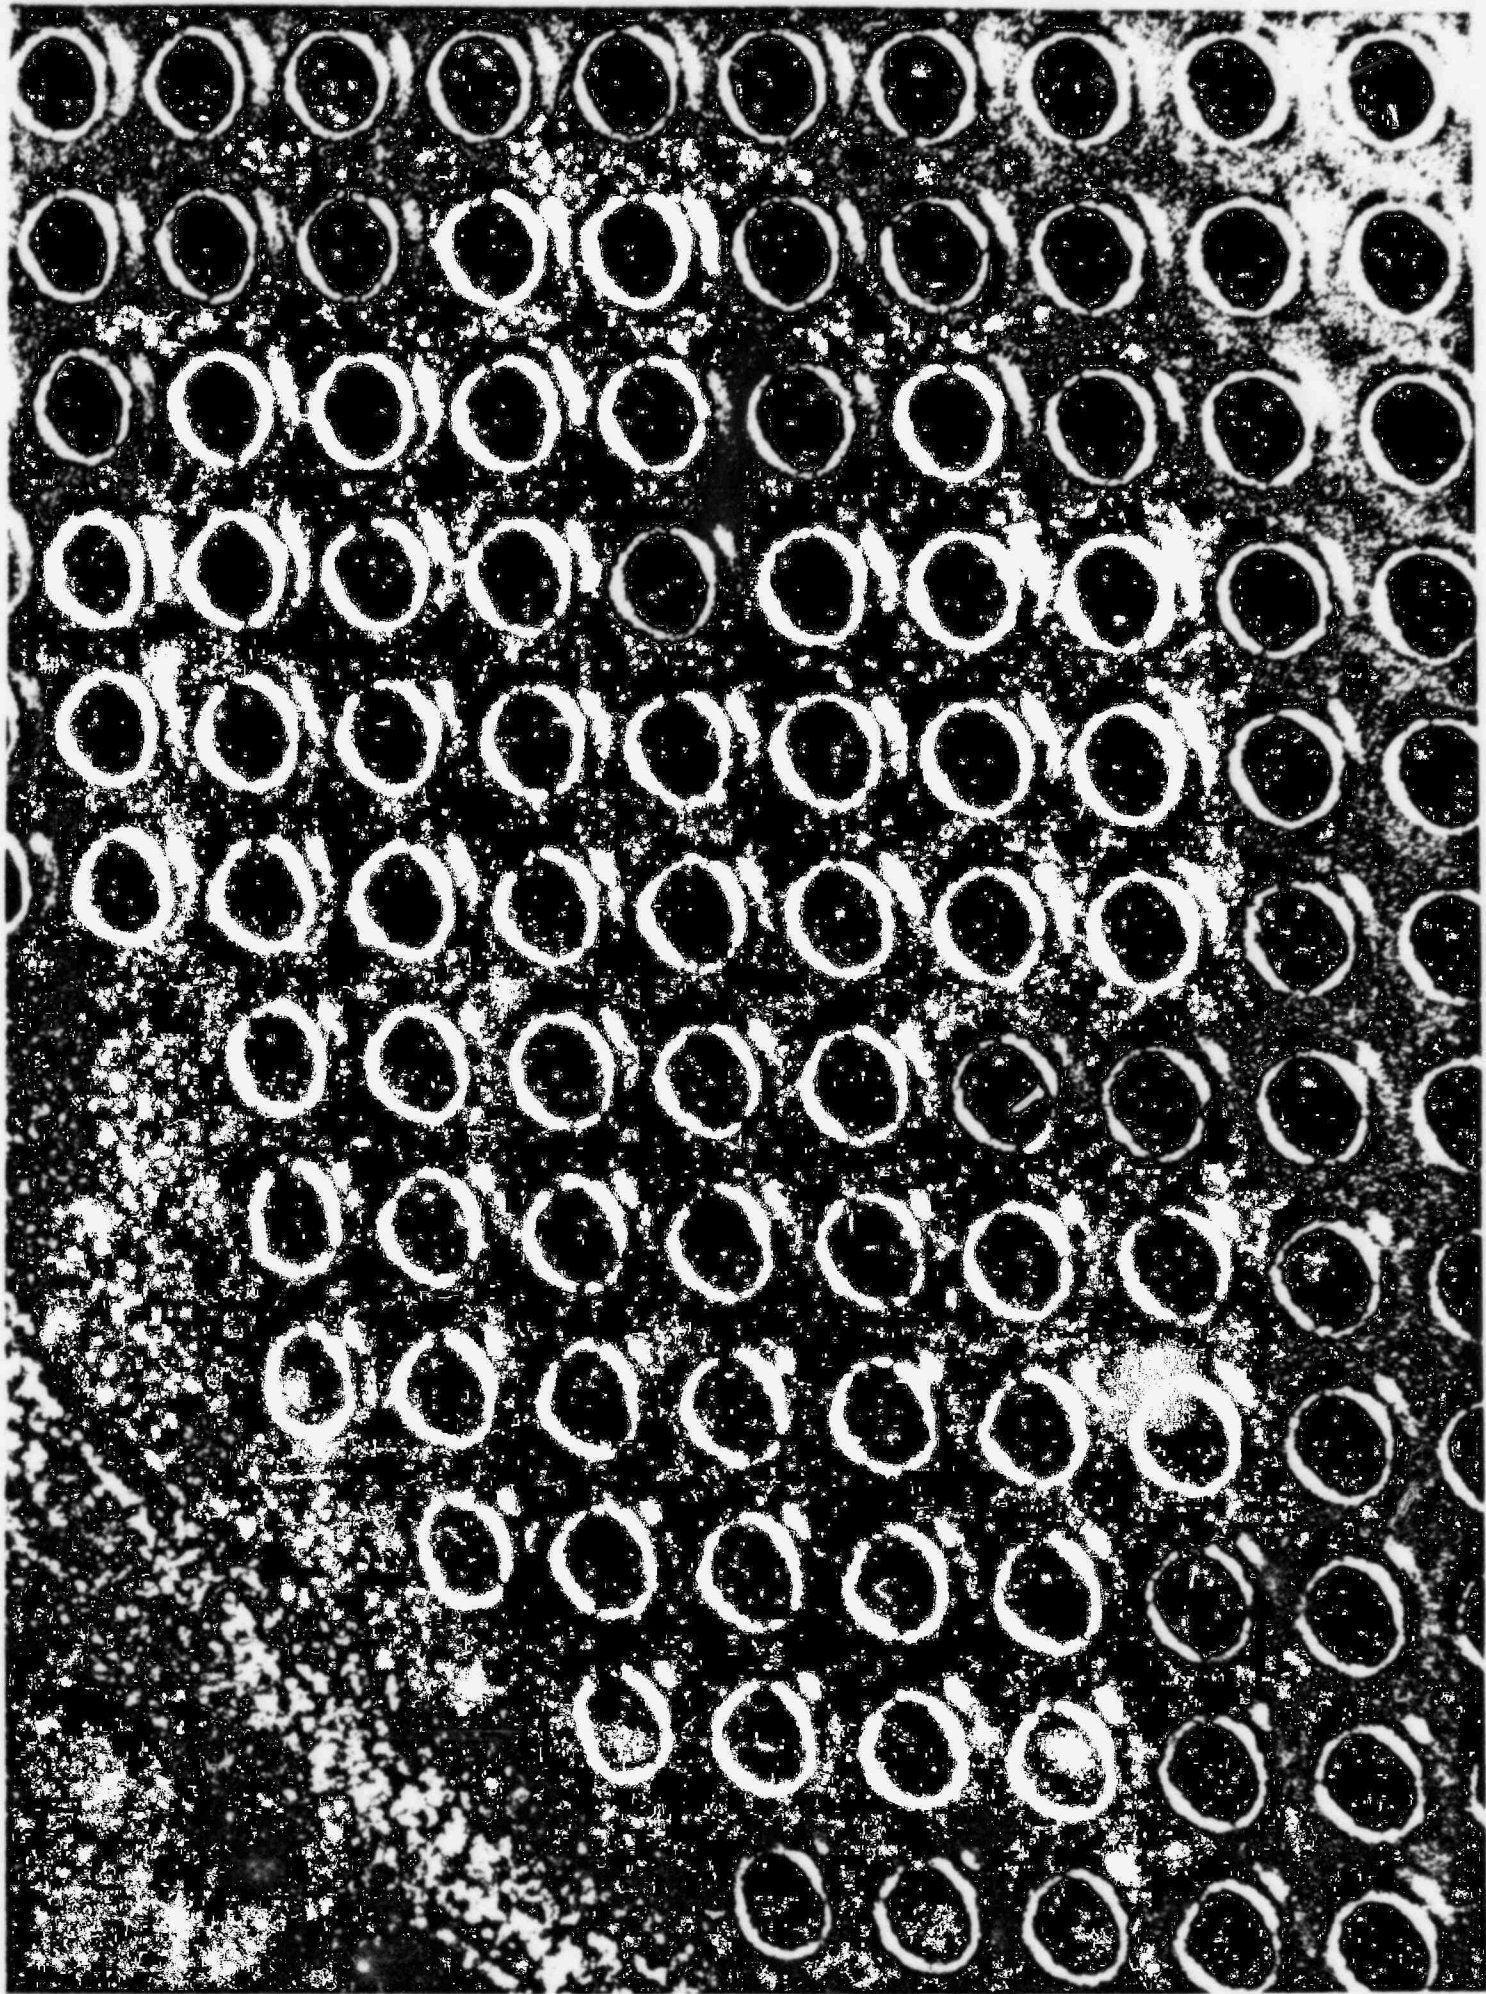
PHOTOGRAPH #2

<u>PHOTO NUMBER</u>	<u>DESCRIPTION</u>
1	General view of tube sheet (inlet side) of steam generator "A"
2	Enlargement of area "B" as indicated in photograph #1
3	General view of tube sheet (inlet side) of steam generator "C"
4	Enlargement of area "A" as indicated in photograph #3

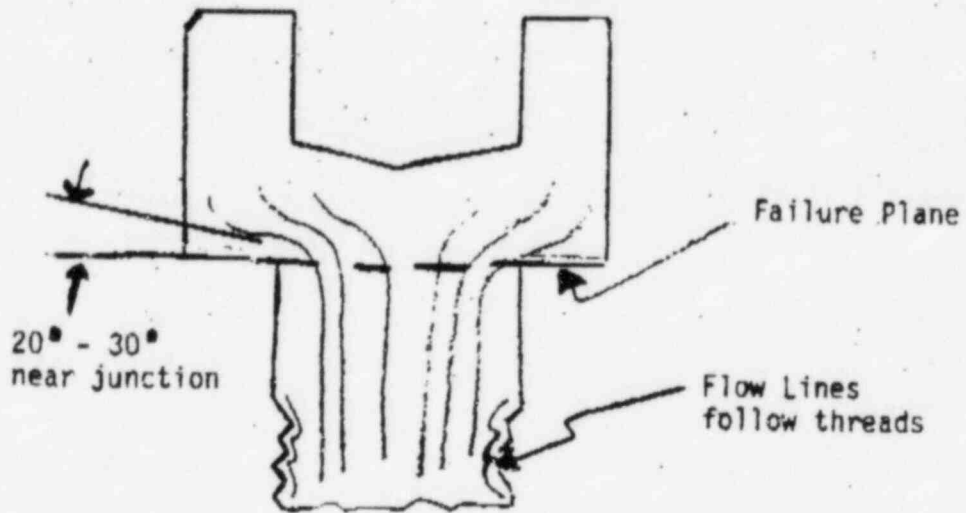
FIGURE 1.

4. The bolt material is 303 stainless steel, resulfurized with .32% sulfur. Sulfur stringers are evident in the material along the axis of the shank.
5. The sulfur stringers are turned in a direction nearly parallel to the head of the bolt in the area of the head/shank junction. (see Figure 1). The bolts were apparently hot-headed.

Composite of photographs and descriptions
of sulphur stringers in failed socket head
cap screws.

Westinghouse has used the SA-453 Grade 660 stainless steel for more than 10 yrs. on RCP Turning Vane bolts, in both domestic and foreign plants. These turning vane bolts experienced higher stresses than the diffuser adapter bolts, in an otherwise similar RCS environment. To date, no inspection has revealed any abnormality attributable to either fatigue or stress corrosion. Based on this operational history, and the fact that the SA-453 Grade 660 has a higher yield strength than the original bolt material W believes that the new material is an excellent choice for diffuser adapter bolts.
