NUREG/CR-5280
BNL-NUREG-52178
Vol. 2

Age-Related Degradation of Westinghouse 480-Volt Circuit Breakers

Mechanical Cycling of a DS-416 Breaker
Test Results

Brookhaven National Laboratory

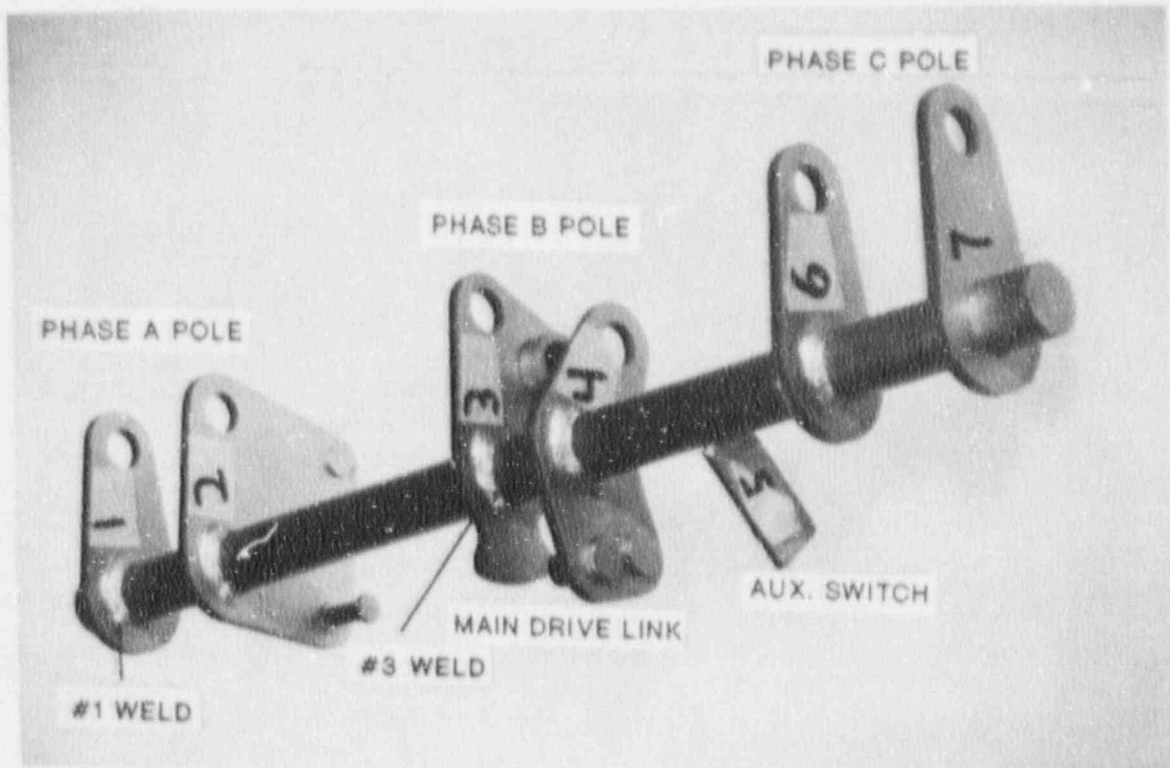
Figure 3-1. Pole Shaft with Seven Levers Welded on to it

The pole shaft is constructed of a round steel shaft and seven levers welded on to it. With exception to the levers 4 and 5 (see Figure 3.1), the other five levers are connected to the moving contact assemblies for the three poles. The #3 and #4 levers are also connected to the main drive link which, in turn, is connected to the operating mechanism via the main roller and cam assembly. The #5 lever is for the auxiliary switch drive link. Thus, when the breaker is closed, or tripped, the stored energy in the closing and/or opening springs rotates the pole shaft to the appropriate positions. Therefore, the welds on the shaft are subjected to torsional forces; weld #3 being the only lever connected to the charging mechanism and the pole, has the worst stress.

The first shaft with a 60 degree weld at the center pole lever (#3 in Figure 3.1) had a life of 3000 mechanical operating cycles. At the end of the test, the pole lever was completely detached from the shaft, as shown in Figure 4.8. A crack was first noted at one end of the weld where the weld material was taken out for experimental purposes. At that time the breaker had undergone 1000 operating cycles. Up until 2500 cycles, the effect of this crack was not noticed; at this point the pole shaft was bent. From then, until the end of the test, several problems associated with the

The second pole shaft with a 120 degree weld size lasted for 13,593 cycles. Two cracks appeared at the levers #1 and #3 welds (see Figure 3.1) simultaneously after the shaft had undergone 8,970 operating cycles. Both cracks grew at almost same rate and reached to sizes of 2.5mm - 3.5mm before the misalignment between the five levers shown in Figures 4.9 and 4.10 caused the end of the shaft life. The event occurred when this pole shaft experienced 12,941 cycles. Problems associated with this misalignment caused the phase A pole pin to break. In between the period when the first cracks were noticed and the misalignment (8,970 to 12,941 pole shaft cycles), the first operating mechanism failed to operate and the motor burned out. In evaluating the data, we attributed these problems to the aging in the operating mechanism rather than to the two cracks on the shaft. These cracks never grew big enough to suggest that there was any change in the torque on the shaft, as was the case in the first shaft, nor did they induce problems with other components attached to the shaft. However, the misalignment caused by the shaft finally fractured the pin.

The No. 3 weld (60 degrees weld) shown in Fig. 3.1 in the main text failed causing the No. 3 lever to loose after 3000 test cycles. EDAX analysis of the weld shows that it is carbon steel.

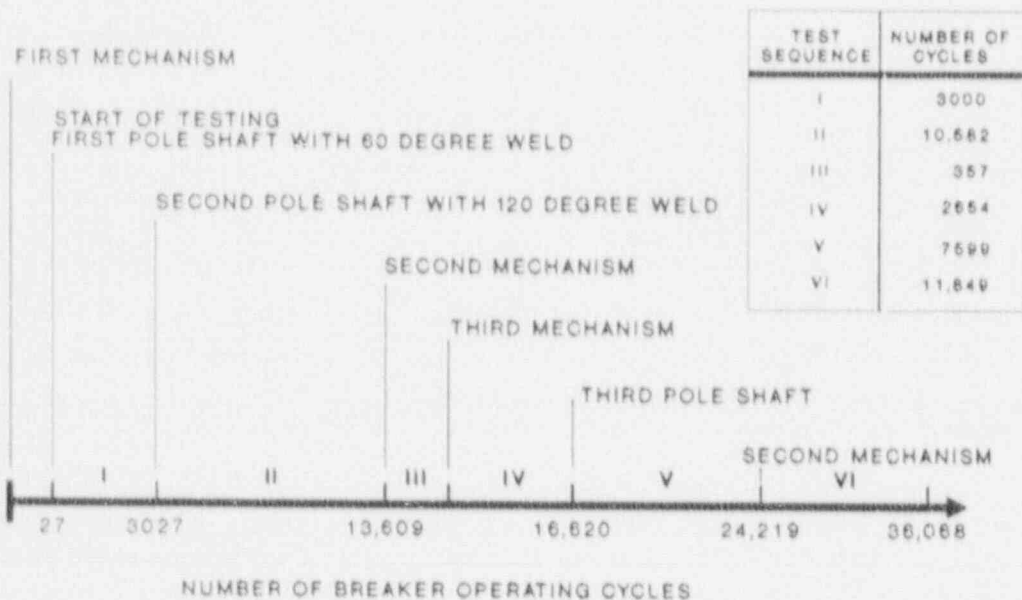
Figure 4-1. Sequence of Major Events in the Breaker Testing

Figure 4.1 illustrates the sequence of major events that took place during the nine months of the test. The first 27 cycles occurred during the pre-testing period with the first operating mechanism in place. Next, the first shaft with the 60 degree weld was installed on the third pole lever; the test then started with automatic cycling. The shaft failed after 3000 cycles of operation when the center pole lever was completely separated from the shaft; this period was designated as Test Sequence I. The test resumed with the second shaft with a 120 degree weld, but the operating mechanism remained the same. After 10,582 cycles (Test Sequence II) the operating mechanism failed. The second mechanism was installed and the test was resumed. Because of a burr on the crank shaft due to poor quality assurance during manufacture, the mechanism failed

after only 357 cycles (Test Sequence III). It was then replaced with the third mechanism for next 2654 cycles (Test Sequence IV). The defective unit was repaired and was kept for later use. At the end of this period, the second pole shaft was inoperable. In this case, the pole levers never separated from the shaft; however, cracks in the first and third welds had extended to 4mm in lengths causing misalignment between the five levers on the shaft. The second shaft was then replaced with a third unit containing a set of good welds and the test continued for another 7599 cycles (Test Sequence V), when the third operating mechanism failed. In the final Test Sequence VI the second mechanism was reinstalled and the test was continued for 11,849 cycles with the third shaft until the mechanism failed at 36,068 cycles. Table 4.1 lists the events that occurred during each Test Sequences.

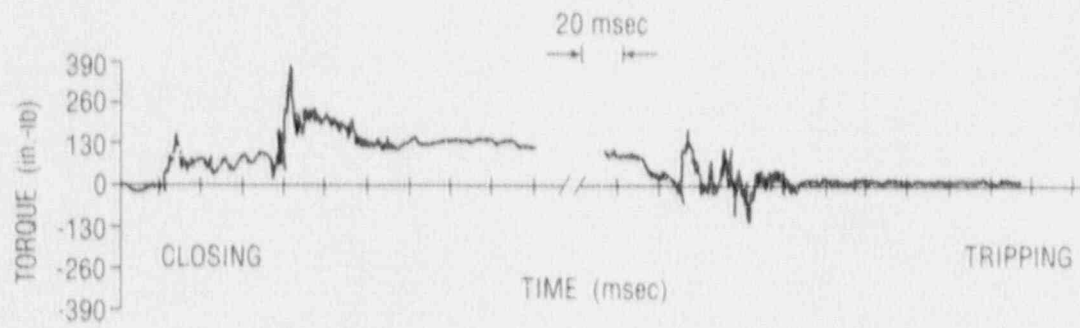
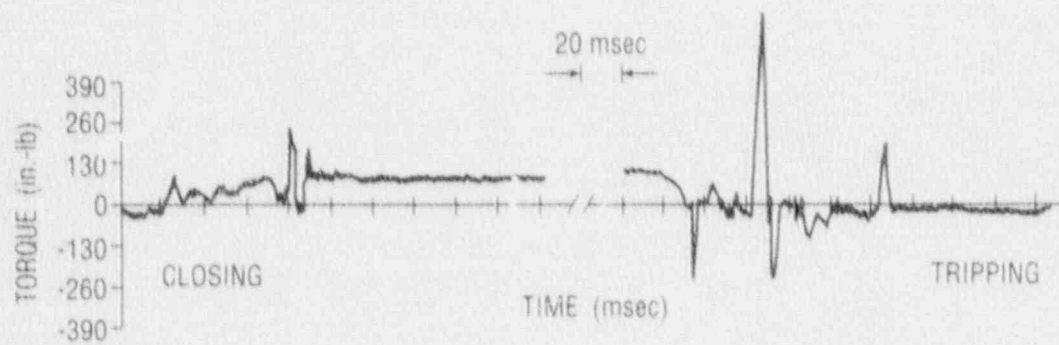
Table 4.2 summarizes torques on the first pole shaft for the beginning and before failure cycles of the test breaker. The average closing torque range remained almost unchanged at 340 to 373 inch-lbs in the later part of the shaft life, while the opening torque range averaged more than doubled from 400 to 840 inch-lbs. This change in the tripping torque occurred at about 2000 cycles on the shaft and the crack in the weld separation had grown to 3.18mm in circumference. Figures 4.2 and 4.3 illustrate the strain gage signatures for the torque on the shaft representing the beginning and final part of its life, respectively. Comparing these two figures, a change in

Figure 4-2. First Pole Shaft Torque Signature at 287 Test Cycles (Sequence I – Beginning)

Figure 4-3. First Pole Shaft Torque Signature at 2854 Test Cycles (Sequence I – End)

The failure of the pole shaft weld, which recently received a great deal of attention, is analysed separately. The strain-gage plots shown in Figures 4.2 through 4.7 suggest that the peak torques experienced by the pole shaft and the tripping time spans change with the age of the breaker. These torque signatures are influenced both by the pole lever weld cracks and aging of various parts within the operating mechanism assembly. Analysing the test results for the three test shafts, the following two failure modes are associated with pole shaft failures:

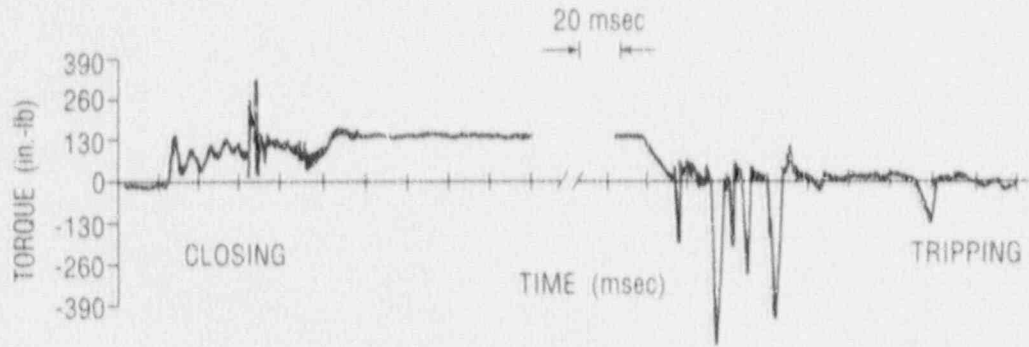
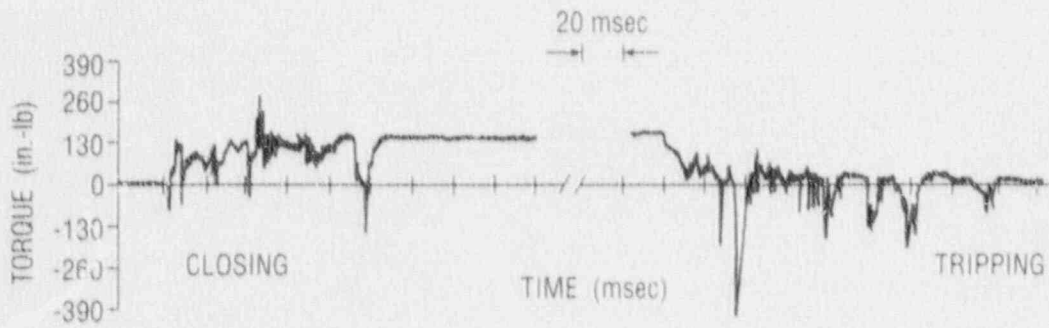
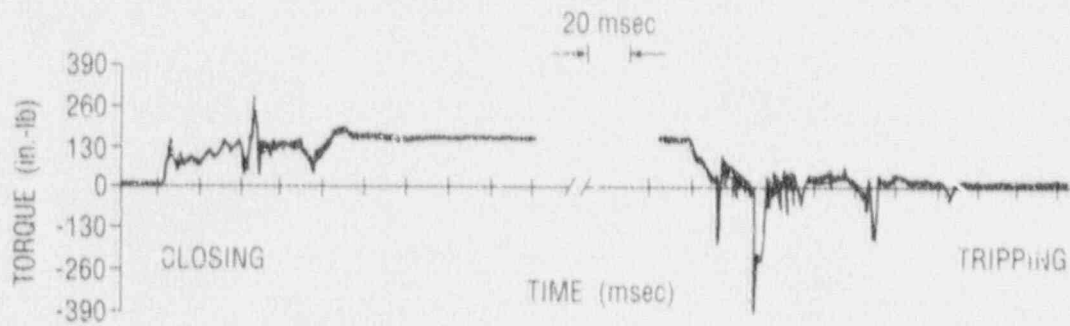
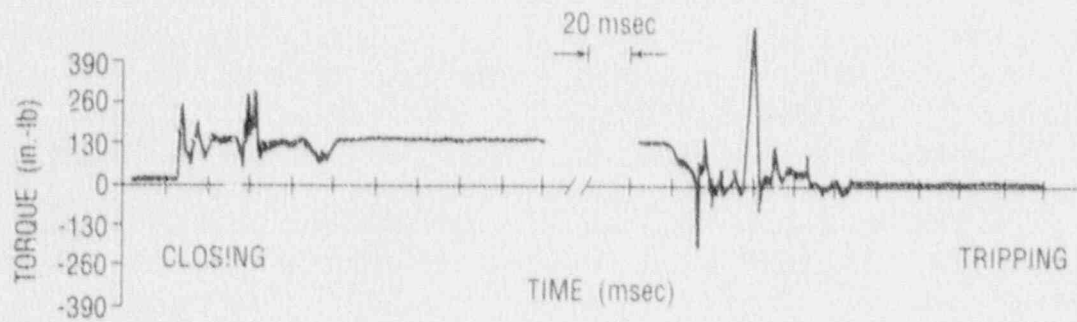
Figure 4-4. Second Pole Shaft Torque Signature at 3027 Test Cycles (Sequence II - Beginning)

Figure 4-5. Second Pole Shaft Torque Signature at 13,500 Test Cycles (Sequence II - End)

Figure 4-6. Pole Shaft Torque Signature at 13,966 Test Cycles (Sequence IV - Beginning)

Figure 4-7. Pole Shaft Torque Signature at 15,968 Test Cycles (Sequence IV - End)

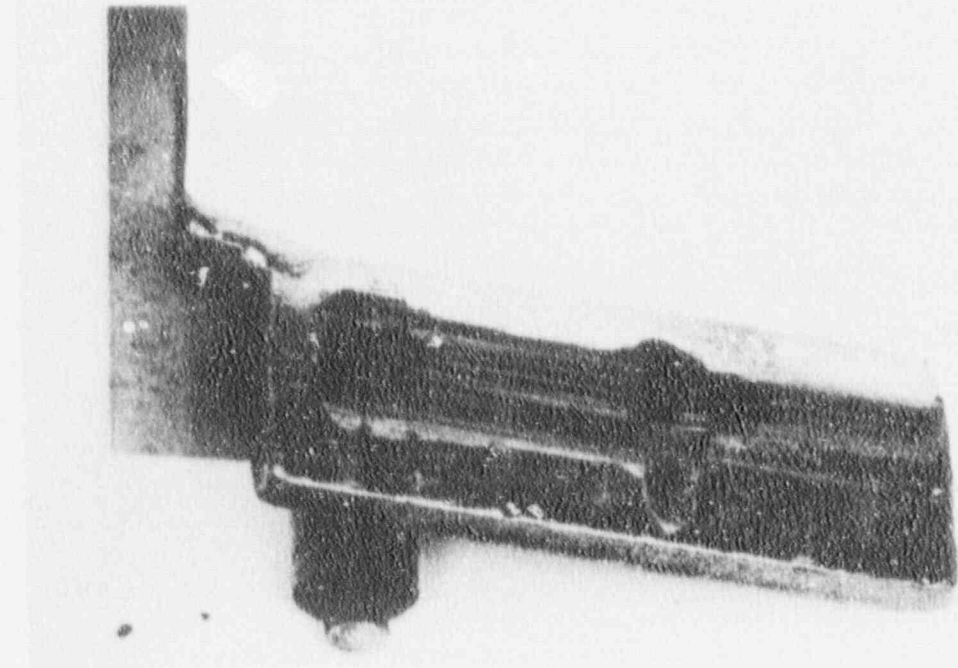
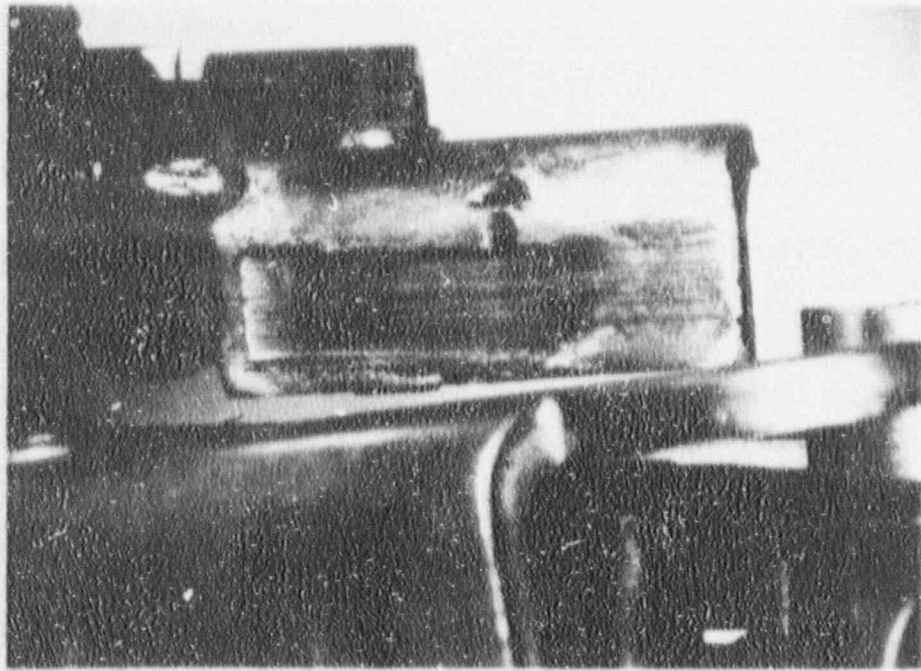
Figure 4-16. Wear on Oscillator Surface

First Mechanism
(End of 13,609 Cycles)

Third Mechanism
(End of 10,253 Cycles)

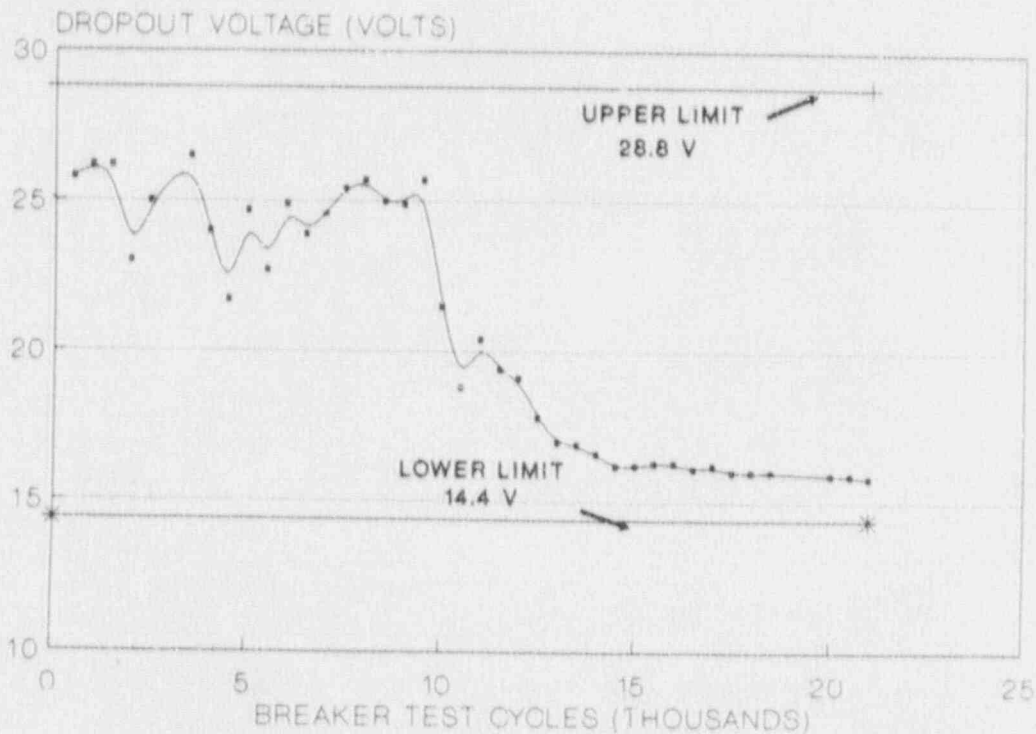
Figure 4-18. Dropout Voltage for the UVTA

Finally, the test results of the dropout voltage of the UVTA coil were examined. Figure 4.18 shows the trend of this parameter with the breaker test cycles. Each data point represents the average of three measurements performed according to the maintenance procedure. The upper and lower limits for a successful operation of this device are also illustrated. It is interesting to note that for the entire life of this device all the measured values remained within these limits; for the first 10,000 cycles it was closer to the upper limit of 28.8 volts, while for the remaining life it was closer to the lower limit of 14.4 volts. The drop in dropout voltage at 10,000 cycles is not understood. However, degradation within the coil insulation by the ohmic heat may be the cause. Again, after this drop the trend remained unchanged for the rest of the coil life.

We conclude that aging in any of these three coils has minimal effects on breaker operation. However, the STA and closing coils are vulnerable to quick burnout due to excessive heat generated by an extended operation, which is primarily caused by the aging of various elements in the operating mechanism and the associated linkages whose binding or sluggish motion caused the coils to burn out instantly.

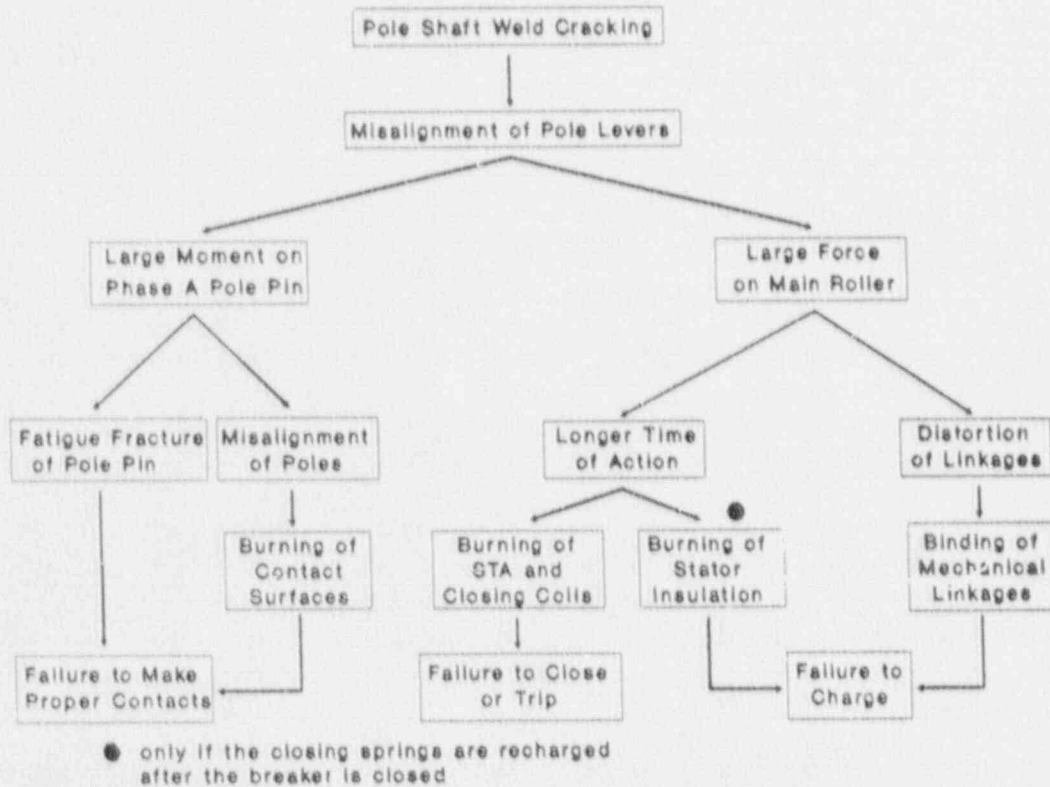
Figure 5-2. Cause and Effect Analysis of Failure of Pole Shaft Weld

- (1) If the quality of the weld in the lever #3 is very bad (i.e. an effective weld size less than 90 degree, or the presence of cleavages or slugs in the weld), complete separation of the lever will occur.

- (2) If the quality of the weld in the lever #3 is normal (i.e. an effective weld size is at least 90 degree with some level of imperfection such as porosity), cracks in the #1 and #3 welds will develop.

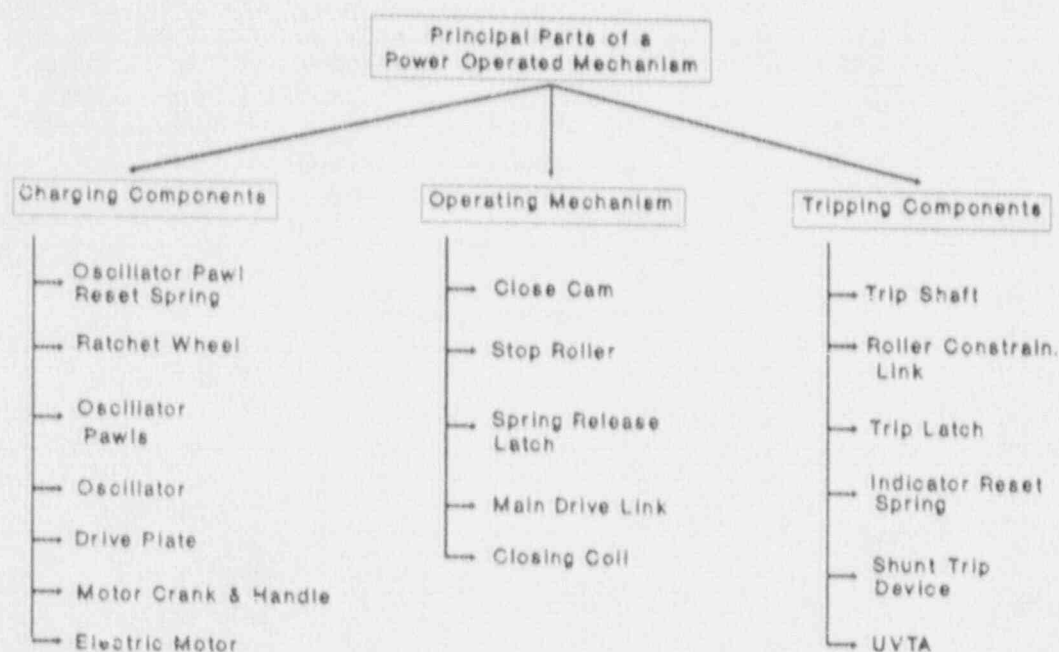
Figure 5-3. Principal Parts of a Power Operated Mechanism Vulnerable to Aging

The principal parts of a power-operated mechanism assembly, that have shown some aging due to mechanical cycling, are listed in three groups (Figure 5.3). Others, not included in this list, such as the closing and opening springs, crank shaft performed their design functions throughout the test. Group 1 components are responsible for charging the unit while the closing springs store the potential energy for closing the contacts, group 3 components are responsible for tripping the breaker, and group 2 components are responsible for closing the contacts and also providing controlled motion for the three operations (i.e. charging, closing, and tripping) of the breaker.

Table 5.2 summarizes the life estimates for the power-operated mechanism assembly. The two predominant modes of failure include the jamming of all linkages and the slipping of the

crank shaft which prevented the breaker from charging. Based on the test results, the average life of this assembly is about 12,000 cycles. However, indications of aging were observed somewhere around 9500 cycles. These indications are presumed to reflect the synergic effects of parts of this assembly and the cracking of the pole shaft welds. Therefore, for the second mechanism where the pole shaft contained good welds, no particular early sign was noted until the final 500 cycles.

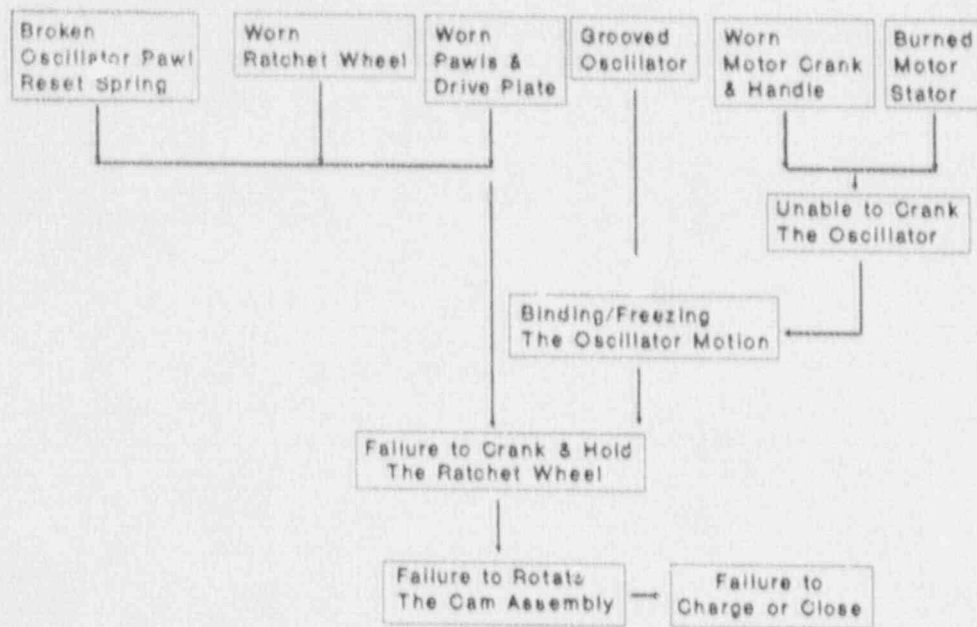
Figure 5-4. Cause and Effect Analysis of Parts Responsible for Charging the Breaker

tions. Figure 5.4 illustrates the root-cause analysis of parts associated with components responsible for charging the breaker.

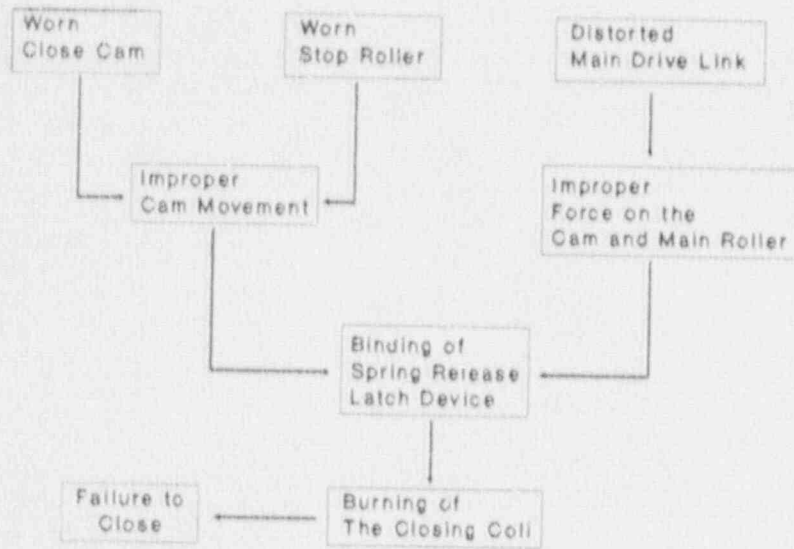
Figure 5-5. Cause and Effect Analysis of Parts in the Operating Mechanism

For the parts within the operating mechanism, wear in the cam assembly and the stop roller reduced the ability of the cam to transfer appropriate control to the main drive link. The constant rolling action of the main roller over the cam surfaces, which can be further accentuated by the redistribution of forces on the main drive link by either failure of the pole shaft weld or misalignment, is primarily responsible for wear on the cam. The main roller attached to the main drive link showed some wear and distortion. Aging in all these components often leads to a binding force on the spring release latch which, in turn, leads to burning of the closing coil. Figure 5.5 shows the cause and effect analysis for this group of components.

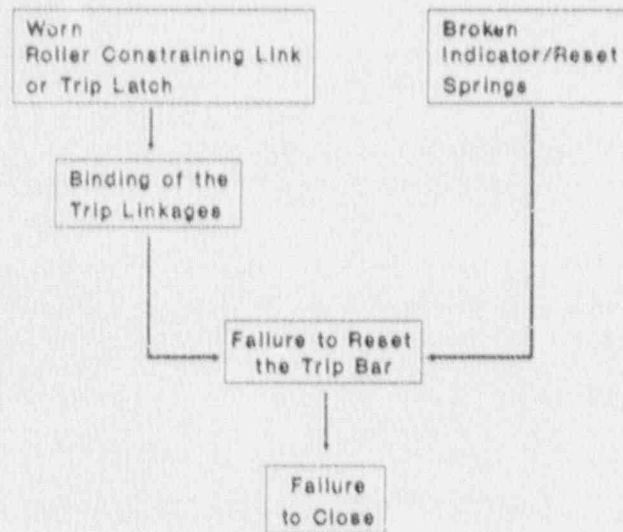
Figure 5-6. Cause and Effect Analysis of Parts in the Tripping Assembly

Finally, among all parts within the tripping assembly, the roller constraining link or the trip latch indicated some wear. In addition, there are two small springs, one attached to the left end of the trip shaft, and the other linked to the 'trip' indicator plate. Both springs are used to reset the trip bar. Metallurgical examination of the fractured surfaces of the broken trip indicator spring revealed that because of the sharp bend at the ends, a high stress probably initiated the crack, which grew under cyclic action of this spring. Under these conditions, the trip shaft failed to reset the breaker. Although this never happened in this test program, dwelling of the trip shaft in one position could lead to burning of the STA coils. Figure 5.6 shows the root cause analysis for this group of breaker components.

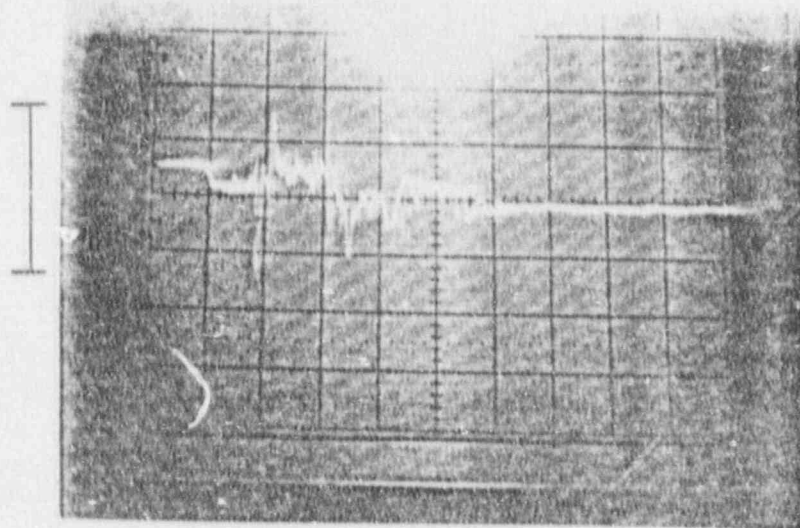
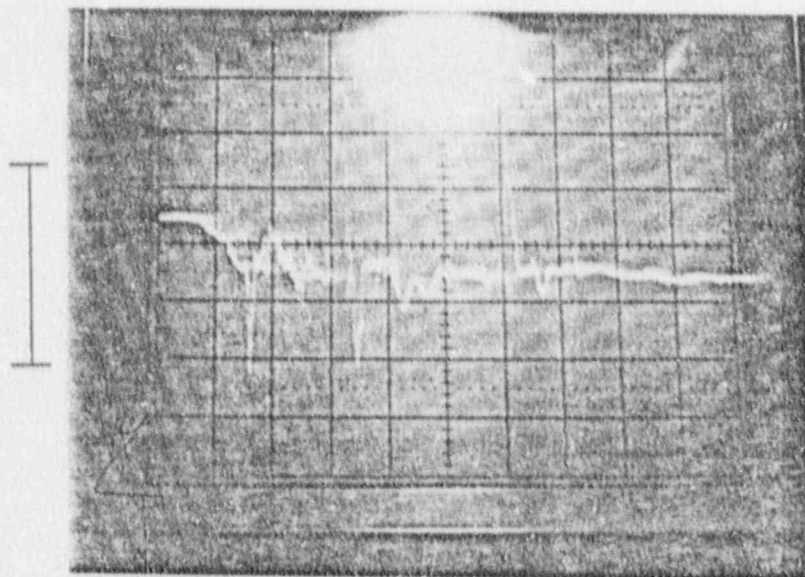
Figure B-3. Tripping Forces - Pole Shaft 1

A characteristic change in the waveform was observed as a function of accumulated opening and closing cycles to the point of failure. The first pole shaft failed at 3027 cycles on July 21, 1989. At 2015 cycles, the oscilloscope photographs indicated a doubling of the "tripping forces" during the opening of the circuit breaker. These higher dynamic torques, in the range of 780 to 910 inch-pounds, remained high until the pole shaft failed.

Figure B-3 shows the tripping forces on June 15, 1989, at 180 cycles; this oscilloscope photograph shows ± 390 inch-pounds of torque and is typical of the results from June 15 to July 10. Figure B-3 also shows a photograph at 2735 cycles on July 19, 1989; the torque is ± 830 inch-pounds which is typical of all photographs taken from July 11, 1989 until failure.

As part of the testing program, dye penetrant readings were made periodically. These tests revealed a 0.125 inch crack on the critical weld at 2000 cycles. This crack reached a length of 0.260 inches at 3000 cycles just before failing.

6/15/89 TRIPPING FORCES = +390 in. lbs

7/19/89 TRIPPING FORCES = +830 in. lbs

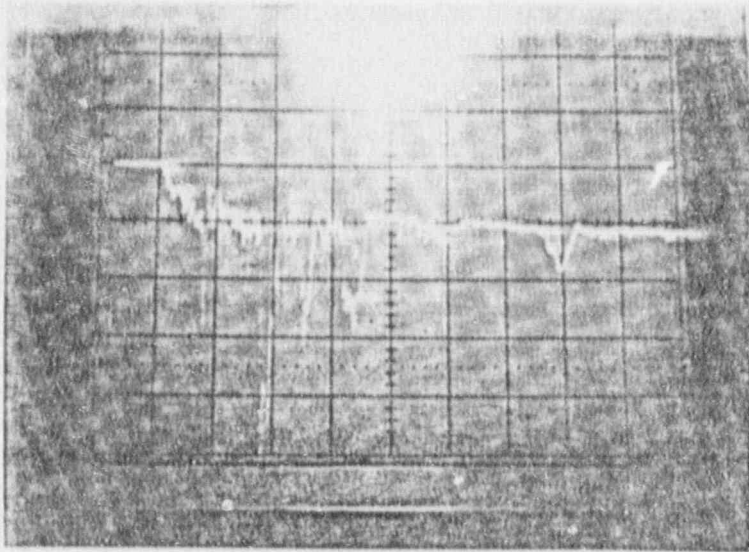
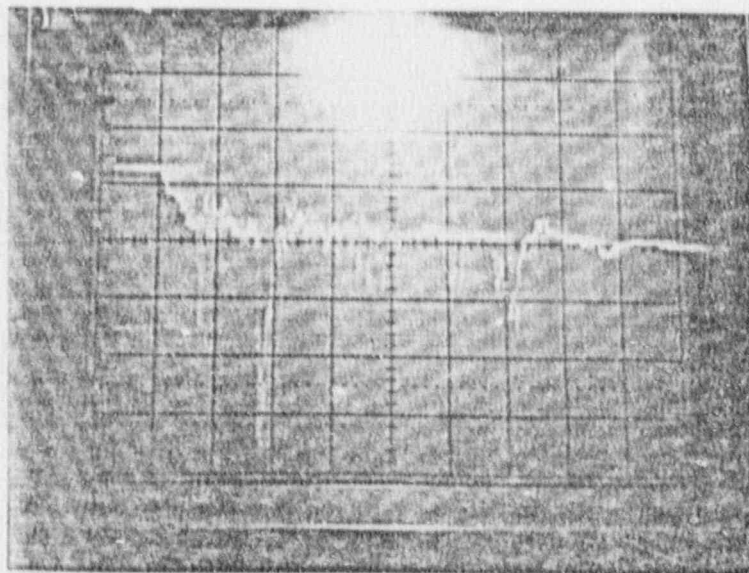
Figure B-4. Tripping Forces – First Mechanism

The first complete failure of the entire first mechanism occurred at 13,609 cycles on November 8, 1989. Before failure, dramatic changes occurred in the pole shaft torque as shown in the oscilloscope photographs. Figure B-4 shows a typical photograph of the torque prior to

TYPICAL WAVE FORM - 10/31/89 - 12, 289 CYCLES

WAVE FORM - 11/8/89 - 13, 227 CYCLES

November 8, 1989. The end of the circuit breaker closing indicates a relatively stable torque waveform. The lower photograph shows a more ragged wave shape, typical of the pattern leading to failure.

We need a more detailed understanding of the entire waveshape and its changes as a function of cycle life. However, it can be safely said that there are progressive indications of wear, measured by changes in amplitude and frequency, that suggest impending failure.

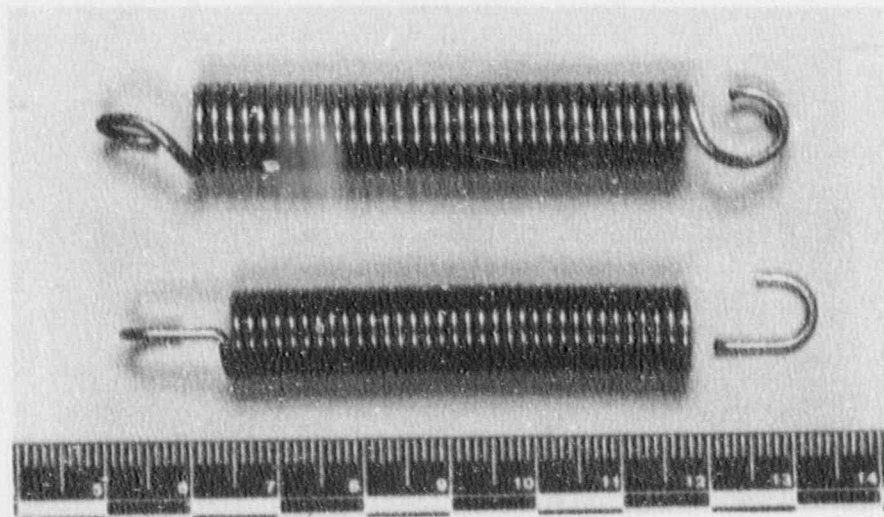
Figure C-5. Oscillator pawl reset springs

The function of this spring is to reset the oscillator pawl after each cycle of testing. It should be noted that this spring experiences a large number of vibrations in the process of resetting. One oscillator pawl reset spring failed after 2,286 test cycles, while the other spring did not fail even after 13,000 cycles. Both springs are shown in Fig. C-5.

EDAX analysis showed that this spring is made of carbon steel, and is plated with chromium and zinc. Because of the plating, the outside surface is relatively free of surface defects. Figure C-6 shows that the steel wire was cold worked (drawn and wound), and then was plated.

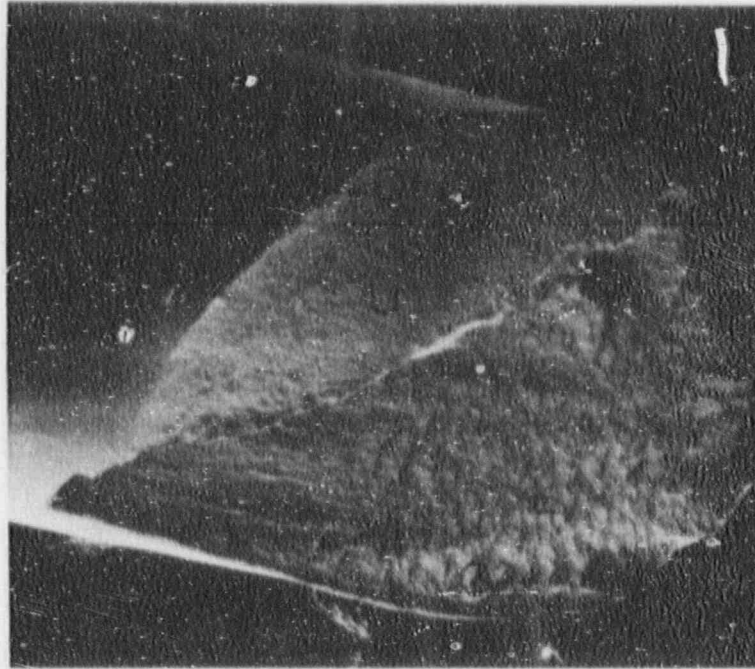
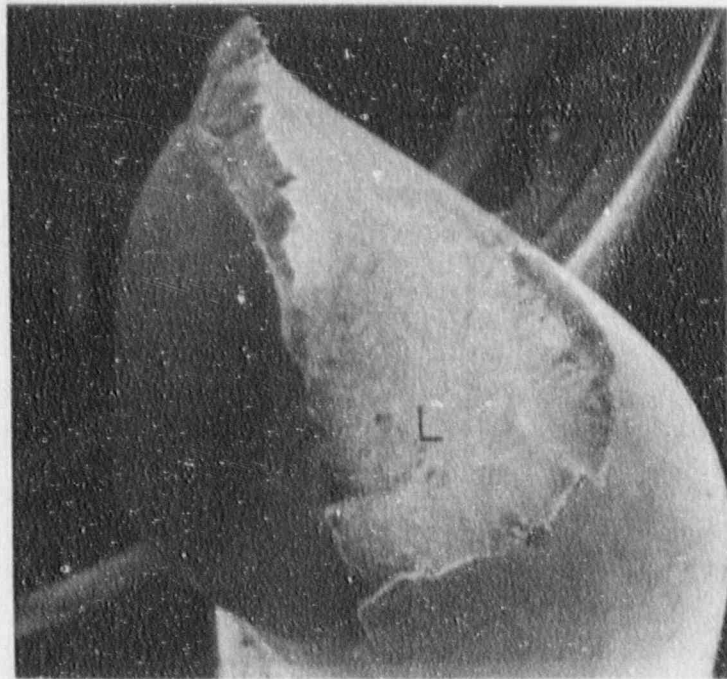
Figure C-7. SEM micrograph of the matching fracture surfaces Mag.: a) 50x b) 43x.

It is known that reverse-bending fractures have two origins or two groups of origins, lying opposite to one another in cross-section [Naumann, 1969]. Thus, it is believed that two cracks started, one at 01 in Fig. C-7 b) and the other at 02 in the same figure, due to the reversed bending stresses. However, the crack initiated at 01 grew much faster than the one at 02 probably due to much higher tensile stresses experienced by the inside surface of the bend when the spring was loaded.

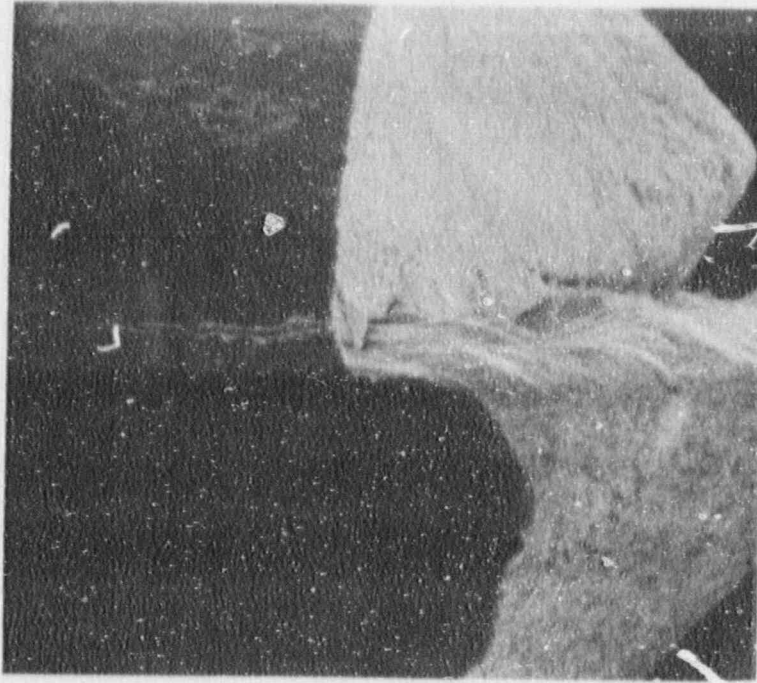
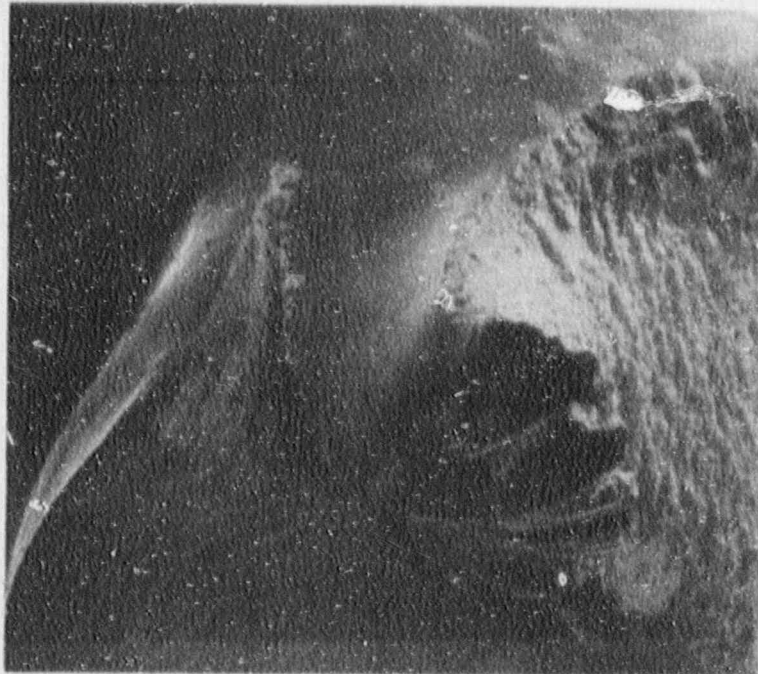
Figure C-10. SEM micrograph show longitudinal, splitting crack. Mag.: 100x.

Figures C-10 a) and b) show a longitudinal (axial), splitting crack initiating at the front of the fatigue crack when the crack had propagated to a length as large as half the wire cross-
