Preliminary Evaluation of the Steam
Generator Localized Tube Diameter Reduction
Phenomenon and its Safety Impact

December, 1975

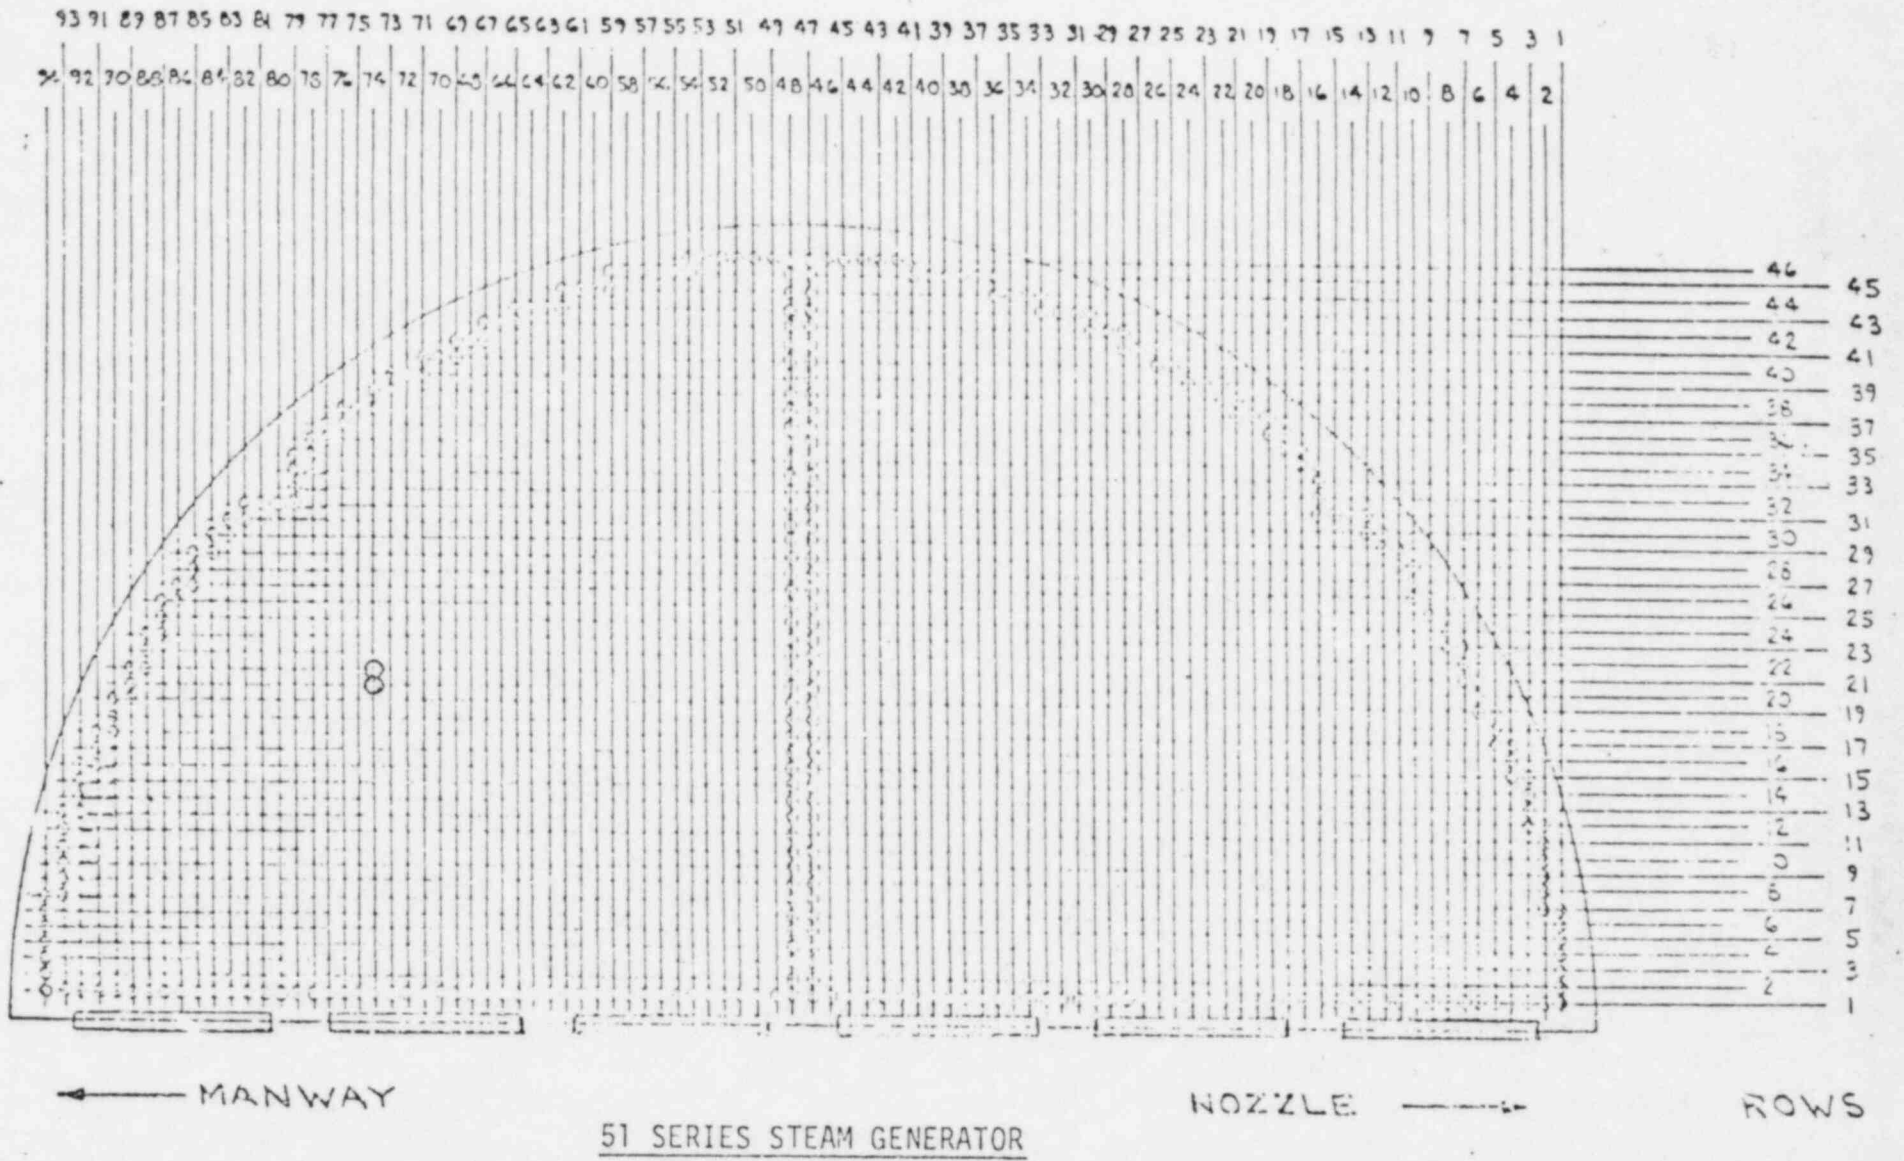
FIGURE 6

On September 23, 1975, a 125-150 gpd primary to secondary leak was detected in steam generator A of Surry Unit 1. The plant was shutdown 3 days later with the leakage rate holding steady at 125 gpd. Three leaking tubes were identified in Row 2 (one row away from and parallel to the divider lane) on the hot leg side. The leaking tubes (R2C31, R2C47, R2C63) were all in the area of the solid webs between the flow slots in the tube support plate. (See Figure 5) The leaks were located in the region of either the sixth or seventh (top) tube support plate. Two non leaking tubes (R20C74, R21C74) on the cold leg side were removed for laboratory examination. (See Figure 6) One was removed to just above the fifth support plate, the other was removed to just above the sixth support plate.

SURRY UNIT 1
 SG A HOT LEG
 X - LEAKING TUBES 9/75

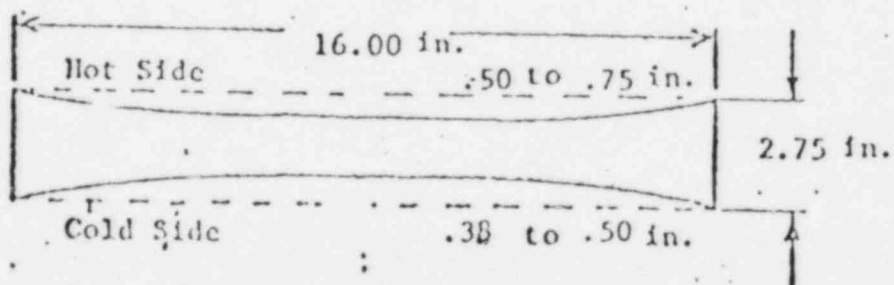
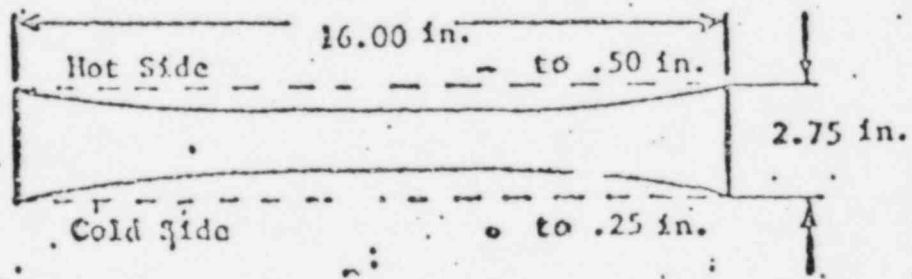
FIGURE 8

Typical Cutout

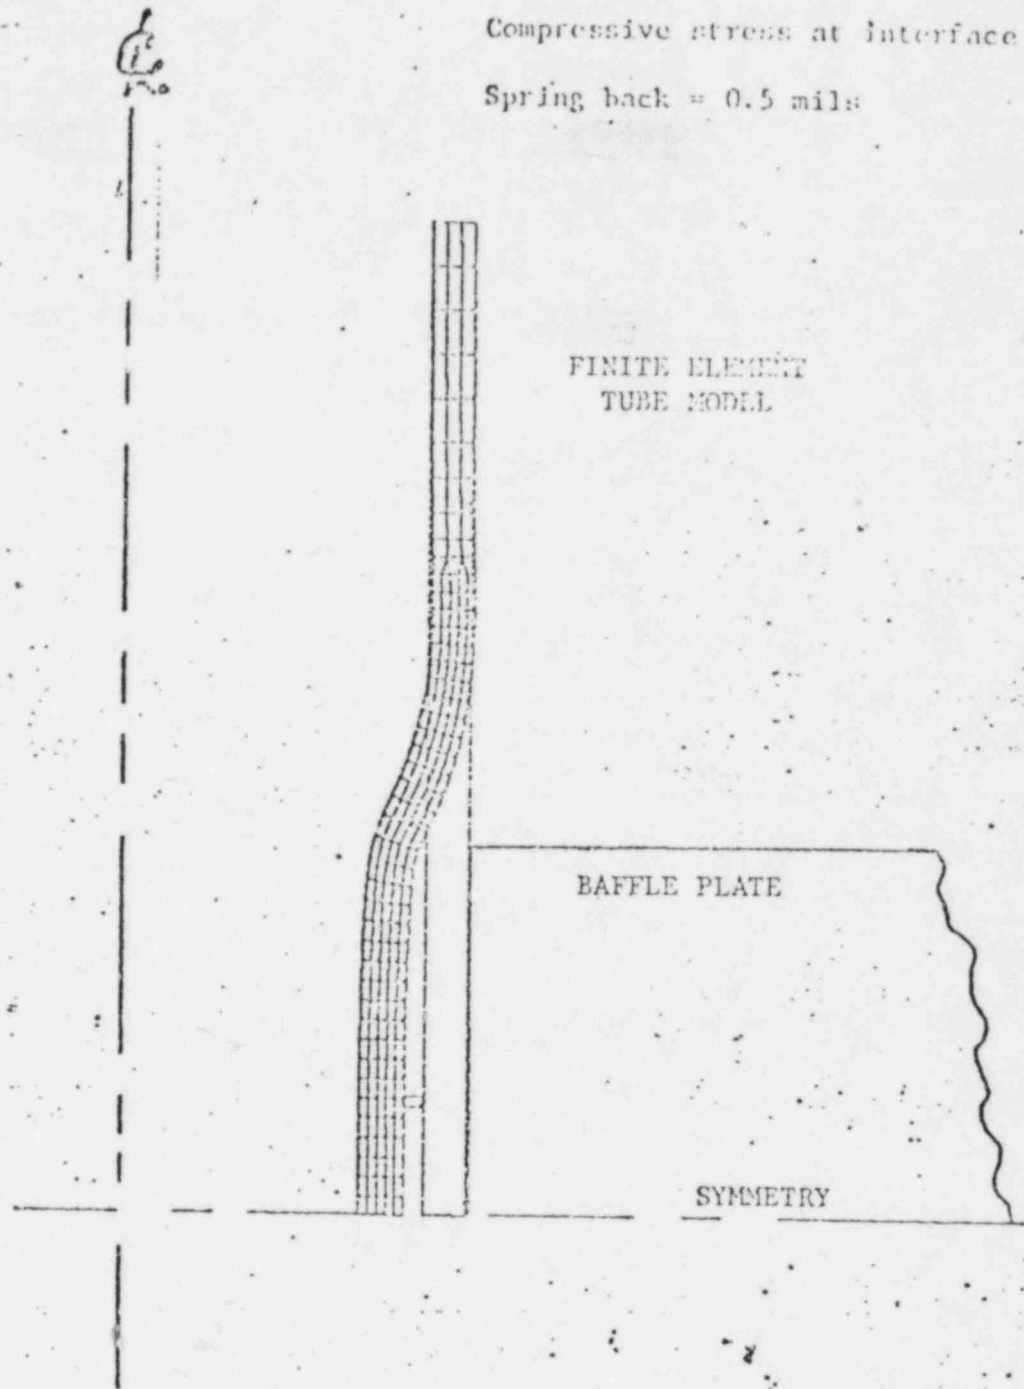
FIGURE 12

Immediately after the discovery of local tube deformations in the area of the tube support plates, an extensive analytical and experimental investigation was started. These analyses were based on several mechanisms, all of which were believed to locally reduce the outside diameter of the tube as shown in Figure 12. Of these mechanisms, the two most probable were thermal ratcheting and crud deposition. The thermal ratcheting was assumed to occur with an internal to external pressure difference of 1500 psi and an alternating tube OD temperature from approximately 590° to 490° (ΔT varies from 0 to 100°F as shown in Figure 13). This mechanism alone, however, was shown not to be credible both experimentally and analytically. The crud deposition model, however, did show credibility in that significant deformation could be obtained

Free radial growth of tube = 2.0 mils
Compressive stress at interface = 5000 psi
Spring back = 0.5 mils

TUBE/BAFFLE INTERACTION CYCLE
FINAL TUBE POSITION AT ROOM TEMPERATURE
- 1 cycle -

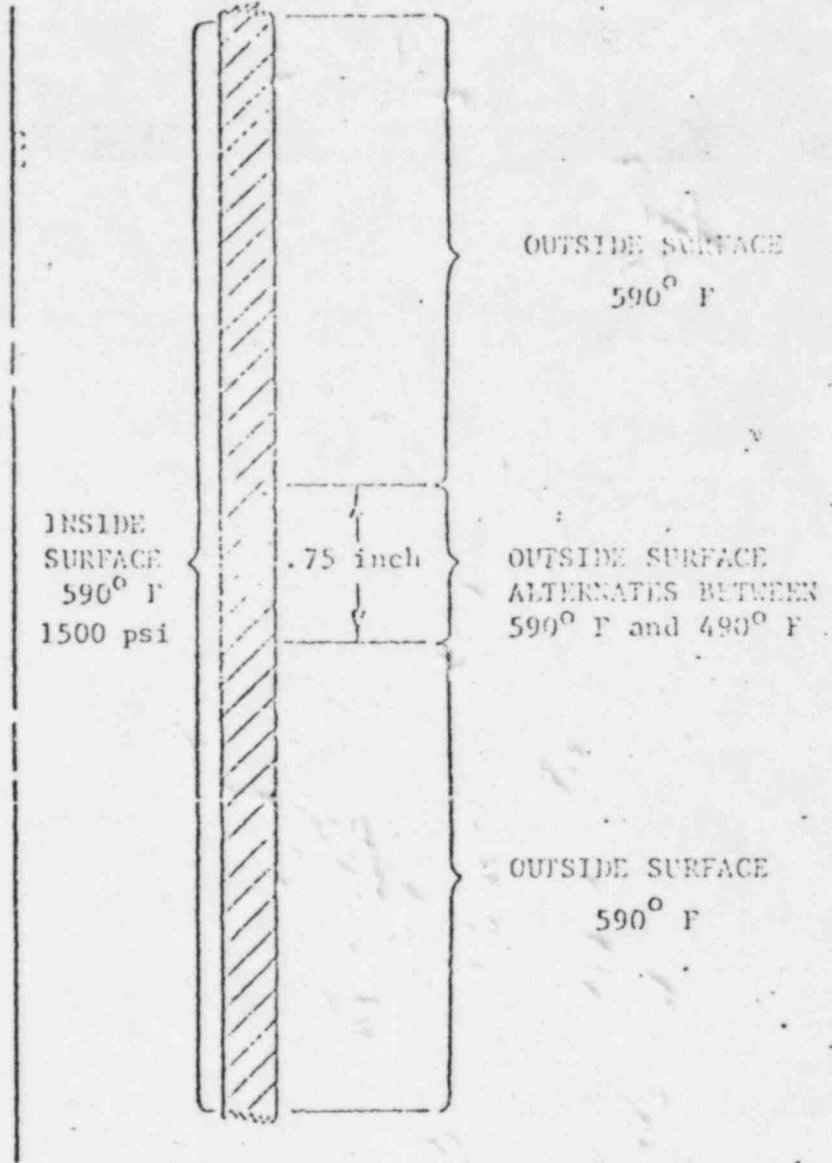
FIGURE 13

Tube Wall Temperature History

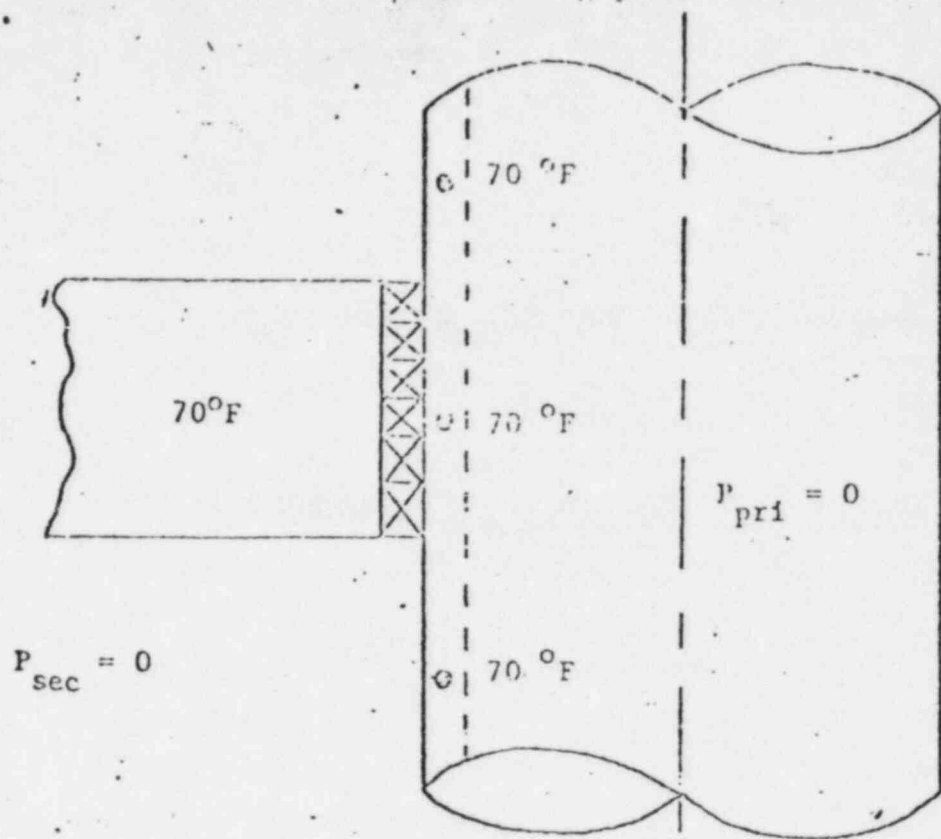
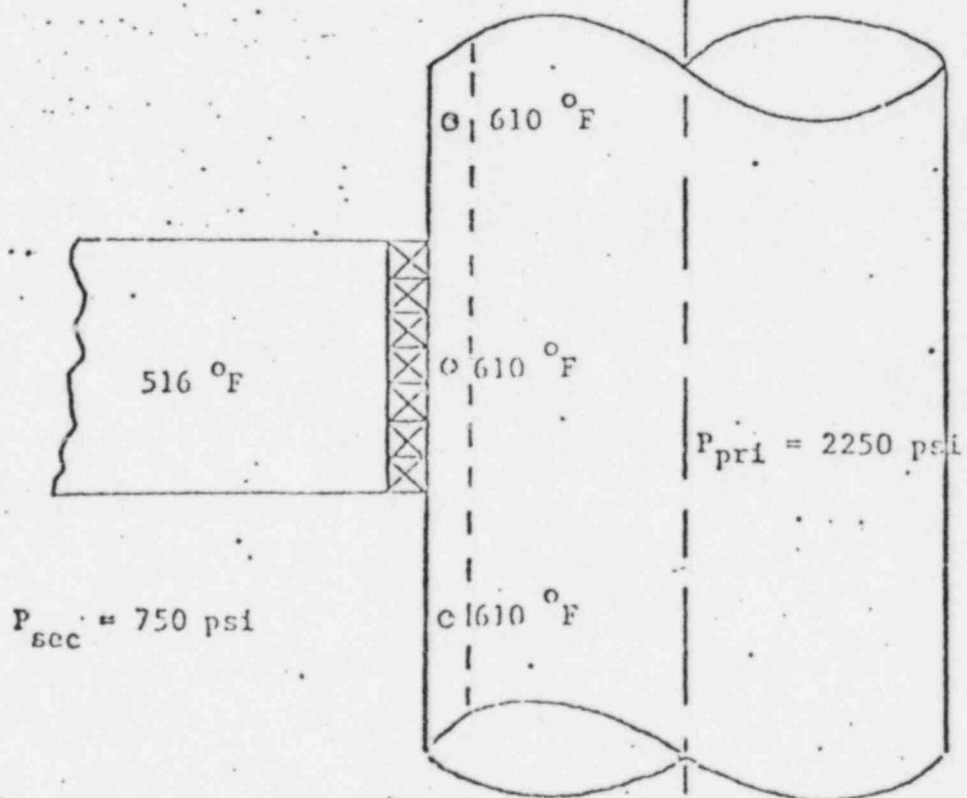
FIGURE 14

in relatively few cycles. The loading condition for one form of this model is presented in Figure 14. The crud deposit in the tube to tube support hole annulus was assumed to be incompressible and with a zero coefficient of thermal expansion would continue to fill the gap after each cycle. The total radial deformation of each cycle was 1.7×10^{-4} inch. This or a similar mechanism will result in a net pressure on the tube outside diameter and the tube hole inside diameter.

TUBE/BAFFLE INTERACTION CYCLE

ASSUMED HOTLEG CONDITIONS

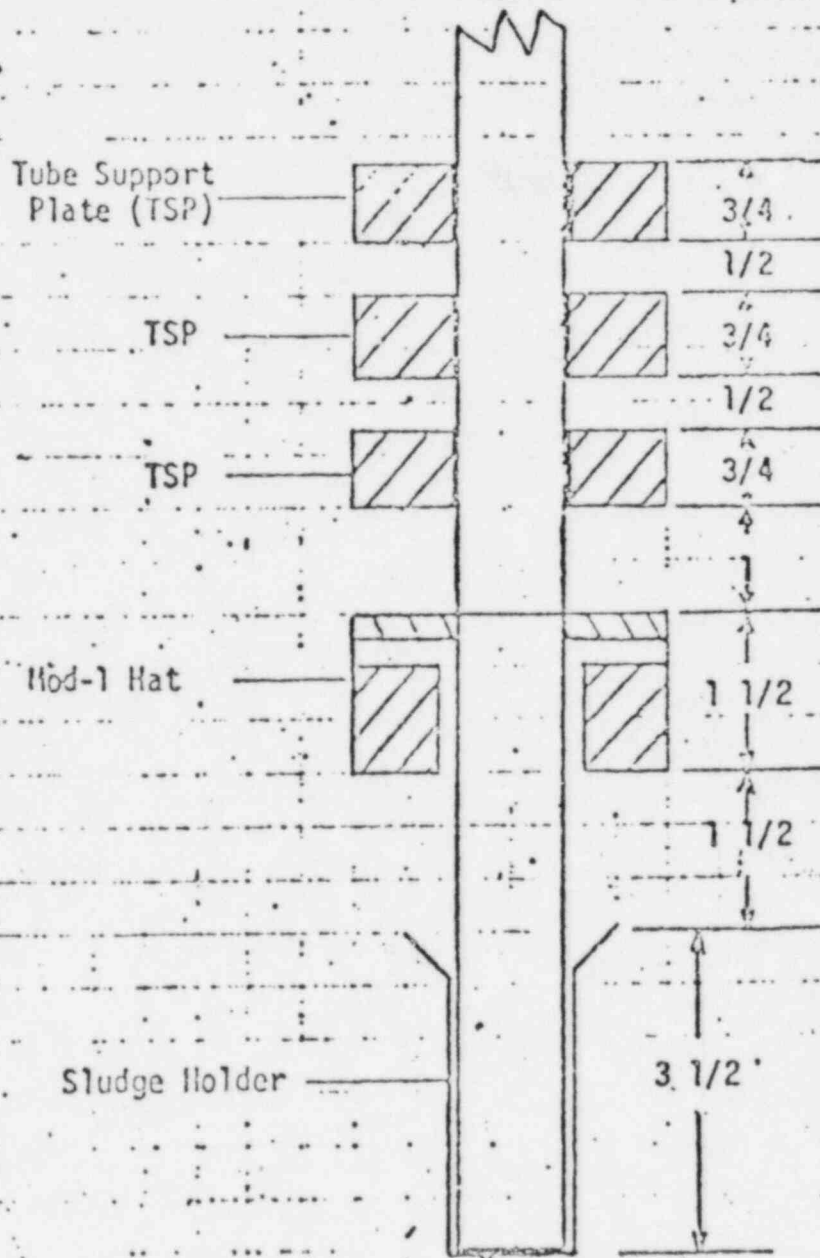
FIGURE 16 Boiler Tube Modification

Another series of tests are planned, and in progress, utilizing the model boiler concept, where the support plate-tube configuration will be used. (See Figure 16). The model boilers will be operated with phosphate chemistry, initially, in an attempt to generate some of the green deposit in the crevice region, as has been found on steam generator tubes. Once having accomplished this, two separate operational paths will be followed: 1) one boiler will be converted to AVT chemistry and the presence and/or progression of diameter reduction followed as a function of operating time, and 2) another boiler will be used for chemical cleaning trials.

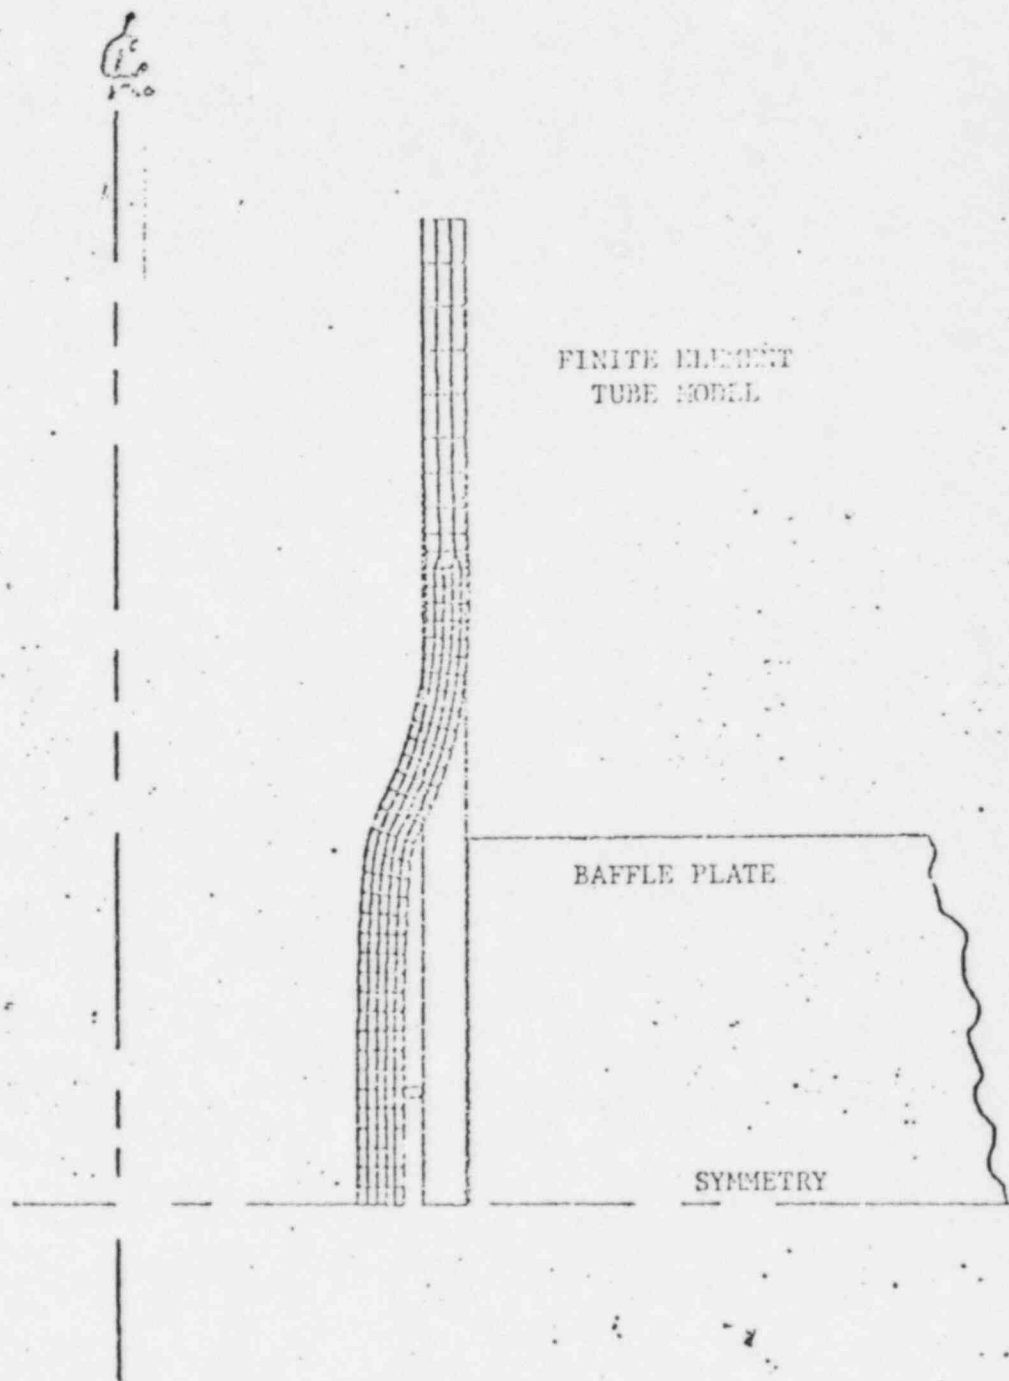
FIGURE 12

TUBE/BAFFLE INTERACTION CYCLE

FINAL TUBE POSITION AT ROOM TEMPERATURE

- 1 cycle -

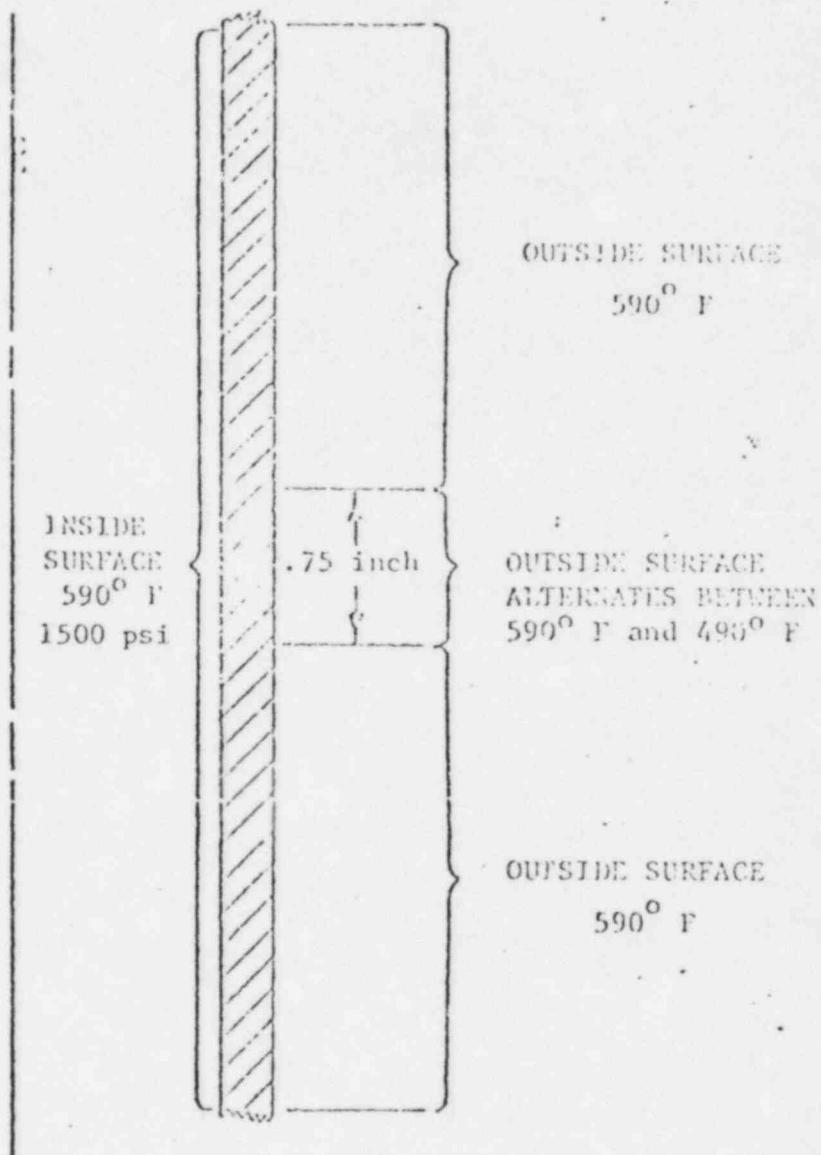
FIGURE 13

Tube Wall Temperature History

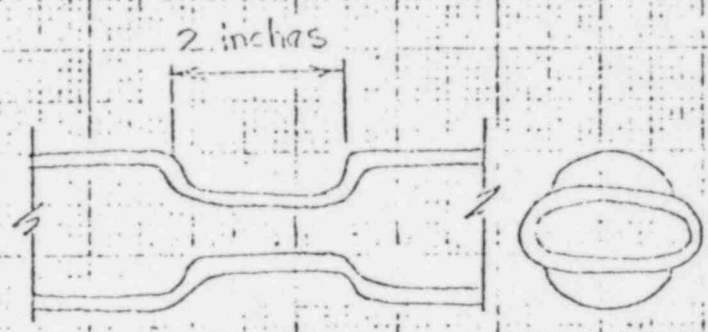
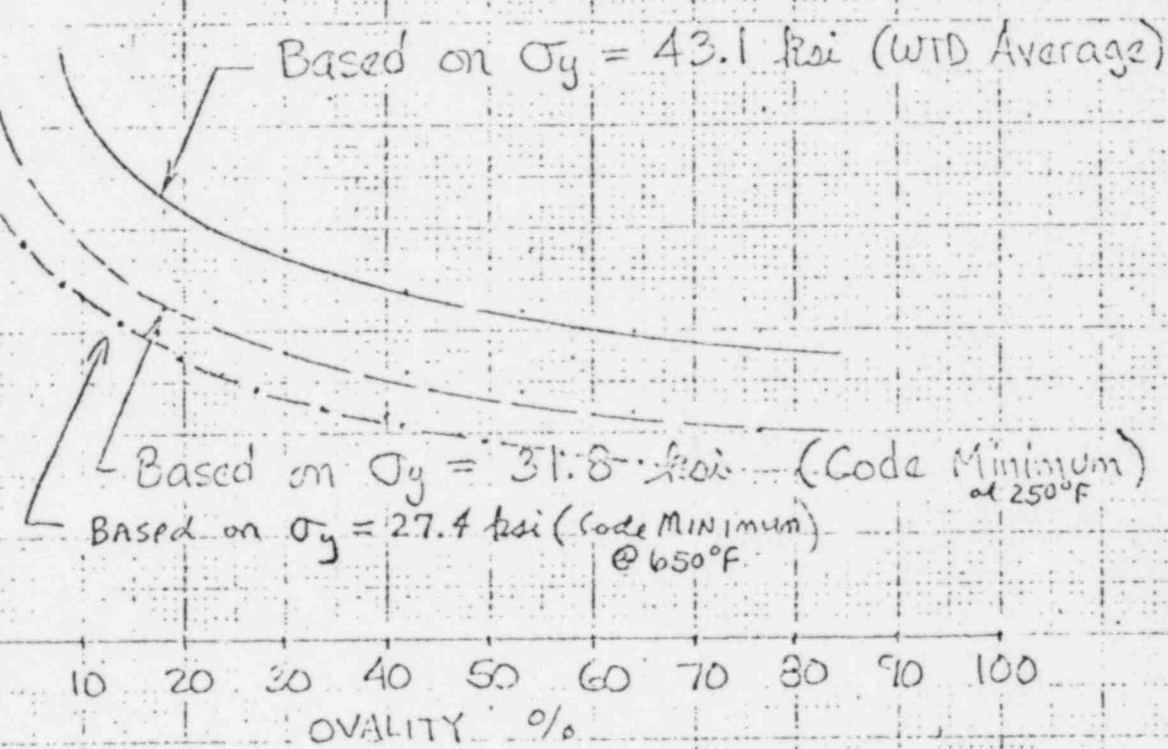
FIGURE 15

Figure 15 is a plot of hydrostatic collapse pressure versus ovality for the illustrated configuration of severe tube deformation. Data was obtained for values of ovality from 4 to 76 per cent. The additional curves in the plot were added for (1) measured average mechanical properties and (2) ASME Code minimum specified properties at 250°F and at 650°F. As shown on Figure 18 at 650°F, even the most severely ovalized tubes tested did withstand greater than 1000 psi. For minimum specified mechanical properties at 650°F, the collapse pressure approached 1000 psi at 40% ovality. Data from materials testing performed at the Tampa manufacturing facility indicated that approximately 92% of the tubes exhibit properties which fit the average curve rather than the minimum specified properties.

Collapse Pressures of Dented $\frac{7}{8}$ " Tubes
