WCAP-12791

Kewaunee Steam Generator

Mid-Cycle Report

December, 1990

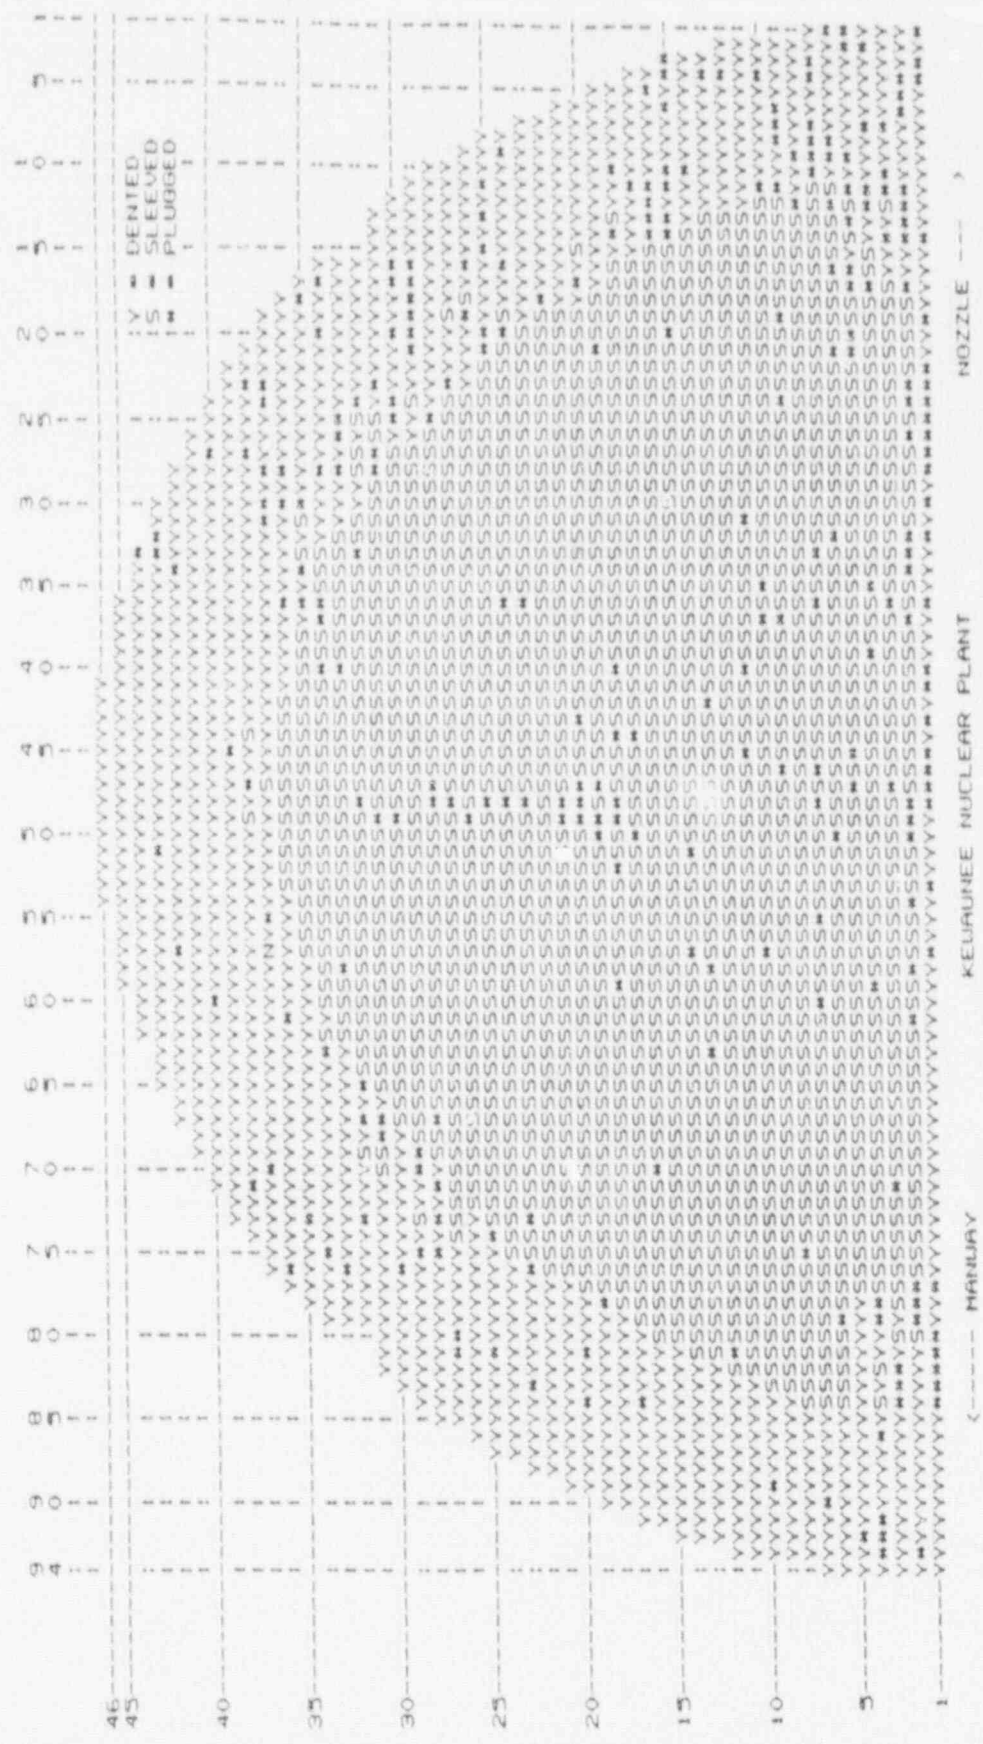
Figure 3-1 S/C "A" Dend Analysis Program

Figures 3-1 and 3-2 provide the tubesheet maps for steam generators A and B showing the tubes sleeved and/or plugged and the result of analysis of the in service tubes. It was determined that all tubes are dented to some degree at the top of the tubesheet. Figure 3-3 shows the distribution of dent voltages (in the 400 kHz/100 kHz mix channel) for the hot legs of the two steam generators. Based on the 1985 bobbin and profilometry data available from the cold leg side of 12 tubes, it is concluded that the denting phenomenon took place sometime prior to the 1985 inspection and that there has been little if any progression since that time.

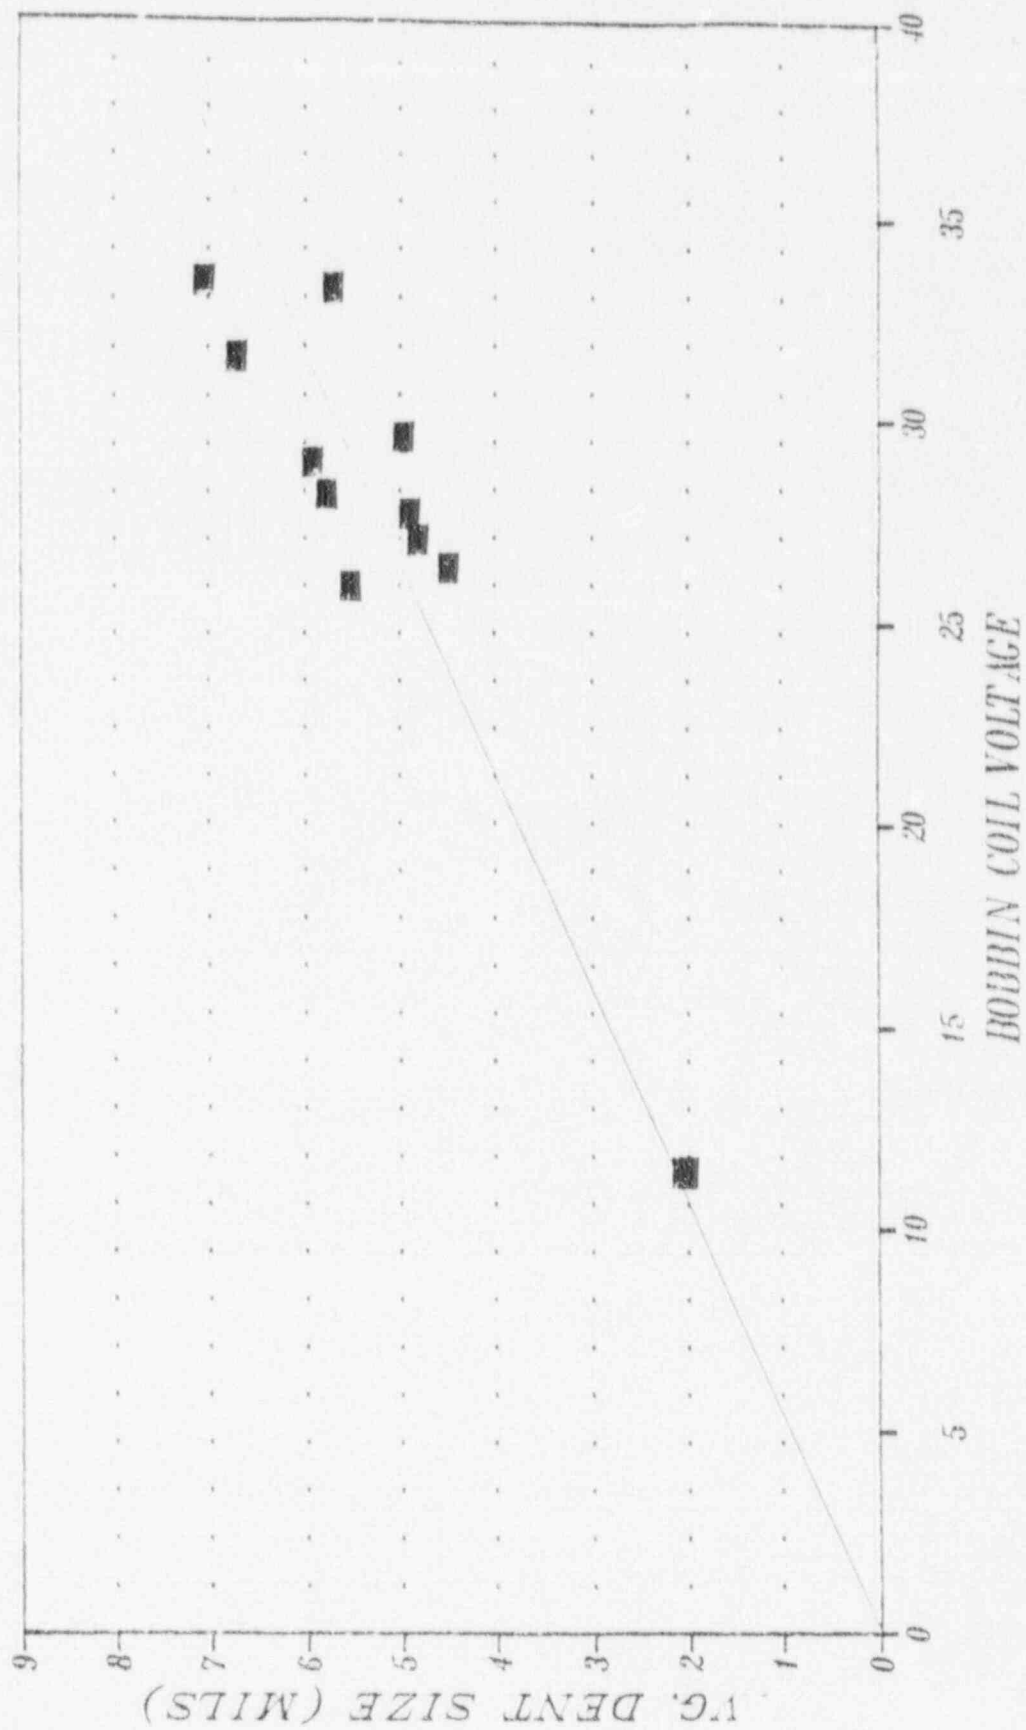
Figure 3-4 Average Dent Size

Profilometry measurements of tube dents in the cold leg of steam generator B were performed in 1985. These results can be used to estimate the dent size associated with the voltage measurements of Figure 3-3. Figure 3-4 shows the maximum dent size from profilometry versus the measured bobbin coil voltages. Based on Figure 3-3 and 3-4, the maximum dent size at the top of the tubesheet is about 1 mil and the most frequently occurring voltage of about 2.0 volts corresponds to a maximum dent size of about 0.4 mils.

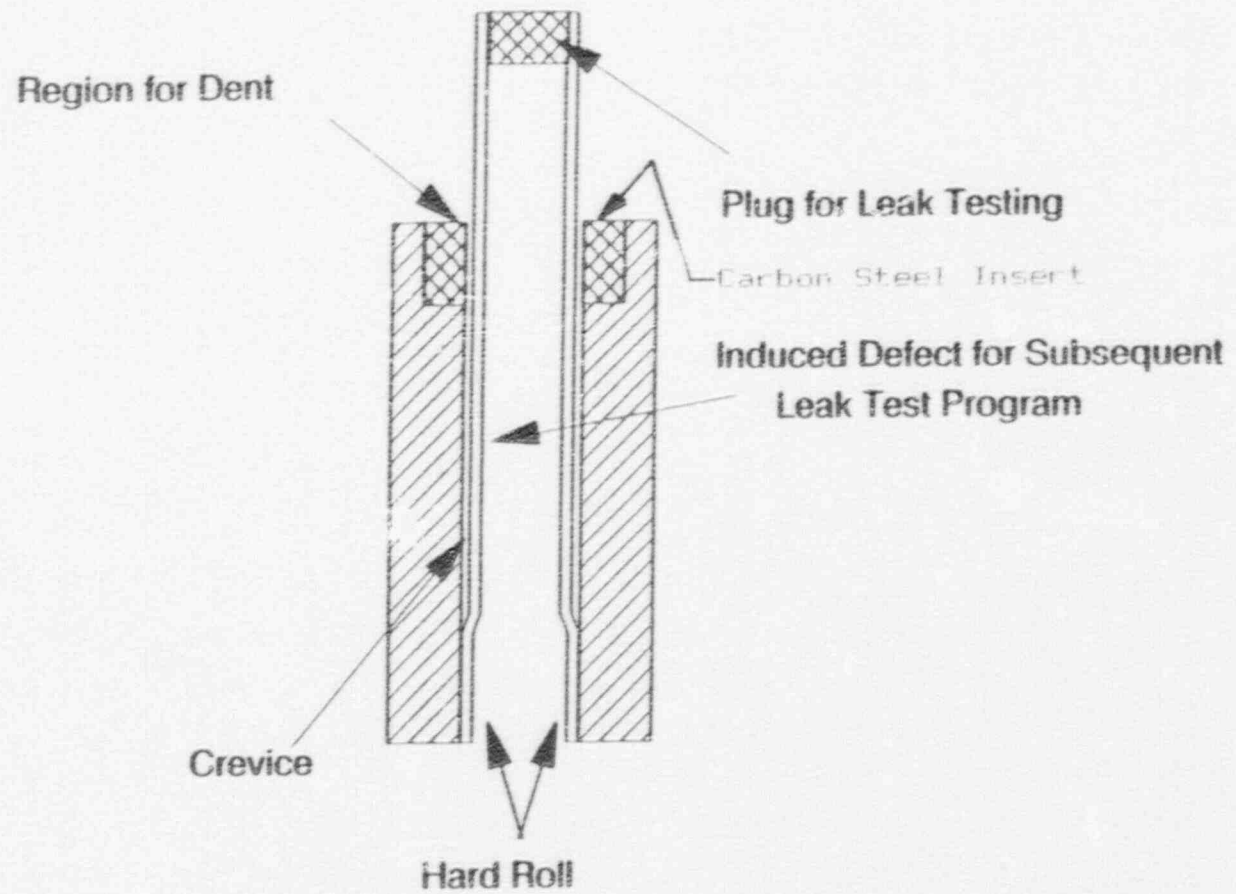
The tubesheet collars (bi-metallic to control the denting) were fabricated from Alloy 600 rod. Refer to Figure 5-1. Following tubesheet collar fabrication, the A285 carbon steel inserts were installed by welding and the welds were pressure tested to certify them leak tight.

The tube samples were prototypical 0.875 inch OD mill annealed Alloy 600 steam generator tubing, 8.0 inches long, and prior to leak testing, each contained a through wall []^{a,b} diameter hole (approximately equivalent to the annular cross-section of the tube-collar crevice) located 2.0 inches from the dent. This placement of the tube perforation was to simulate the location of the eddy current indications in the Kewaunee steam generator tubes which were typically 5 or more inches below the top of the tubesheet. This relatively large flow area upstream of the denting corrosion caused essentially all of the resistance to flow through the specimen to be at the dent. For the samples dented without pressurization, the tube was perforated before denting. For the pressurized samples no hole was drilled before denting, however, a hole was drilled following denting. Refer to Table 5-1, Test Matrix, for sample types, and Figure 5-1 for Test Sample Assembly.

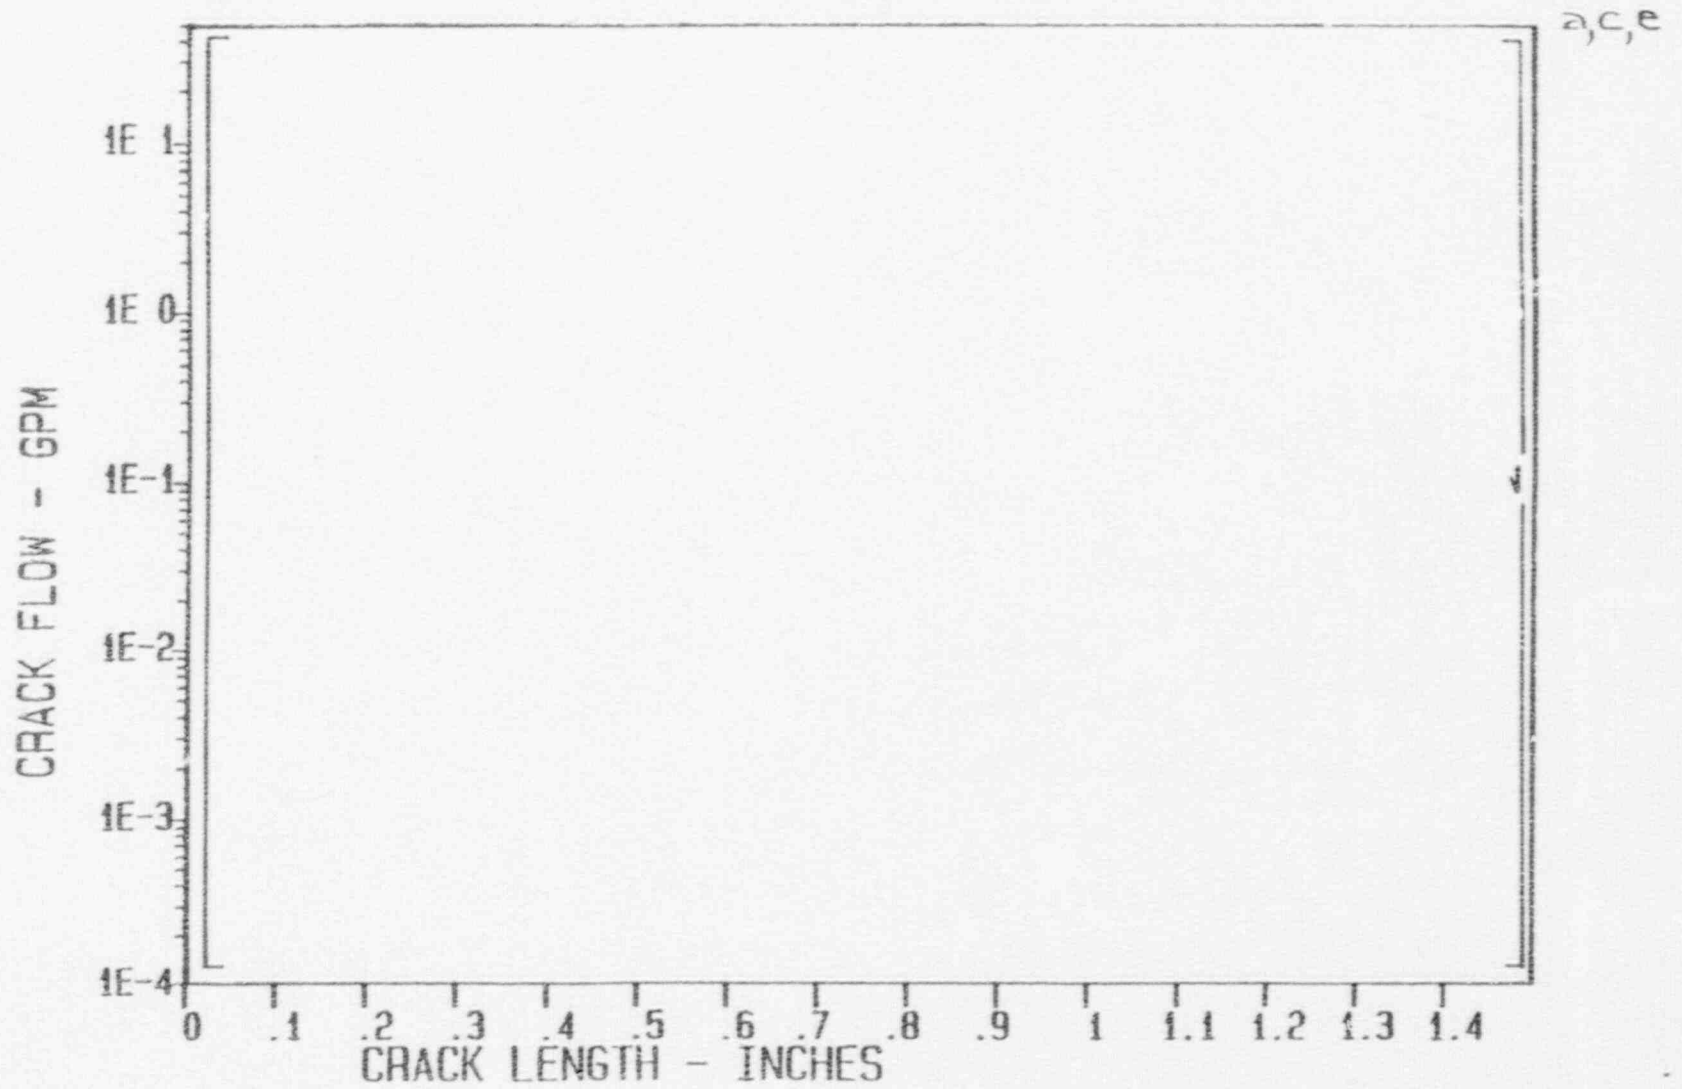
FIGURE 6.3

Figures 6.3 and 6.4 present leak rate versus crack length for normal plant operation and steam line break conditions, respectively. The KD factors shown in Table 6.1 were used to simulate the flow resistance of denting corrosion. For dented tubes, both figures show an asymptotic leak rate as crack length increases above a certain value. For these cracks, the dent restriction is more limiting than the restriction of the flow through the crack. Based on Test No. 5, (Test Nos. correspond to Table 5-1) the asymptotic leak rate is reached for crack lengths greater than []^{b,e}. For KD values characteristic of Test Nos. 3 and 4, dramatic reductions in the leak rate are shown. Moreover, the asymptotic leak rate is reached much sooner []^{b,e} for these tests.
