FACILITY: Maine Yankee Atomic Power Plant

SUBJECT: MEETING WITH MAINE YANKEE ATOMIC POWER COMPANY ON THERMAL SHIELD POSITION PINS.

ATTENDANCE AT
MEETING WITH MAINE YANKEE ON
THERMAL SHIELD POSITION PINS
OCTOBER 27, 1982

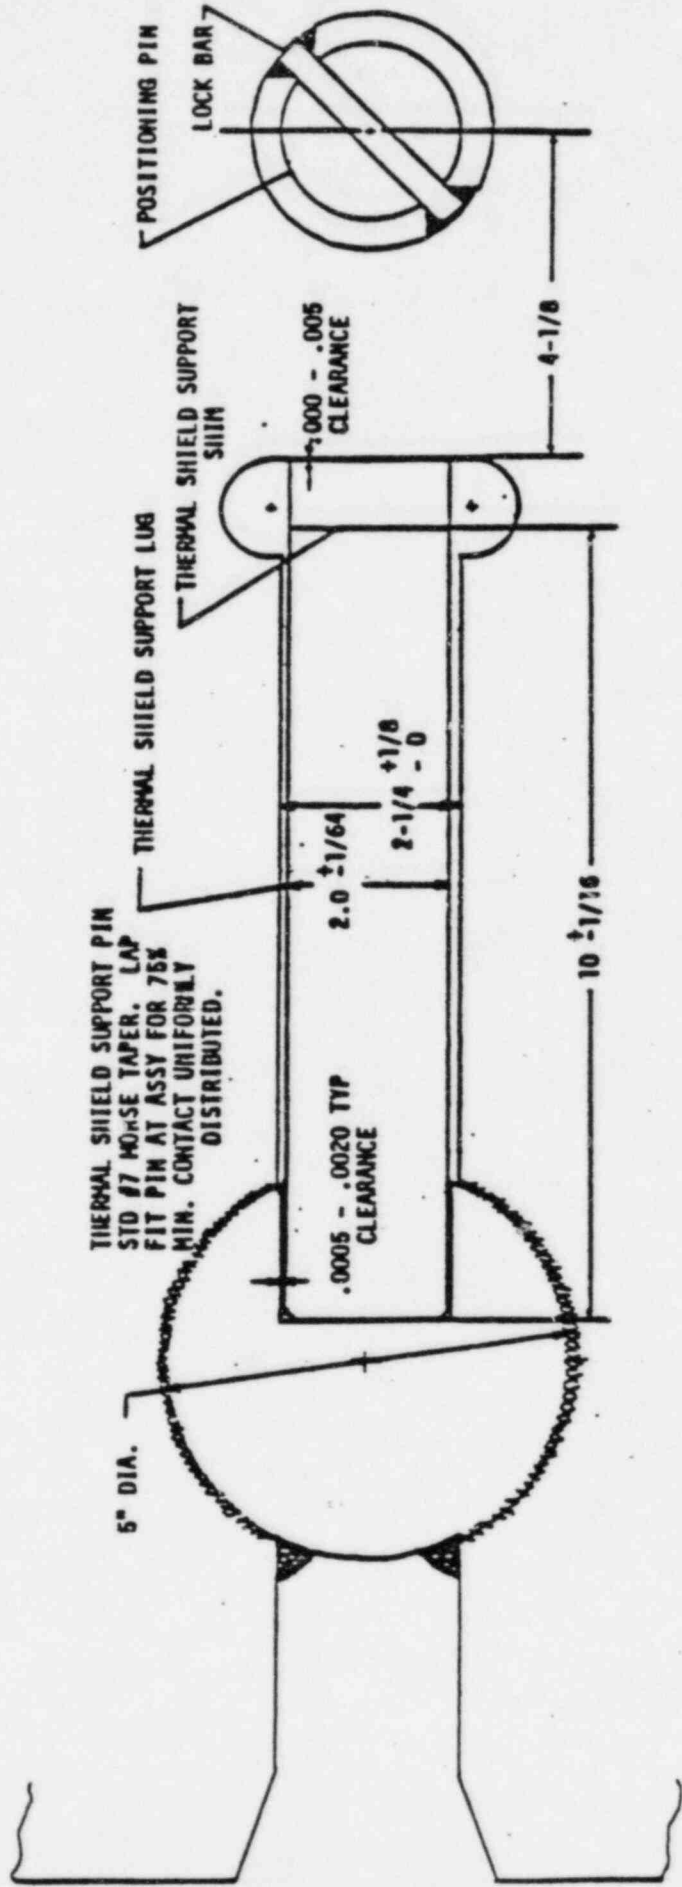
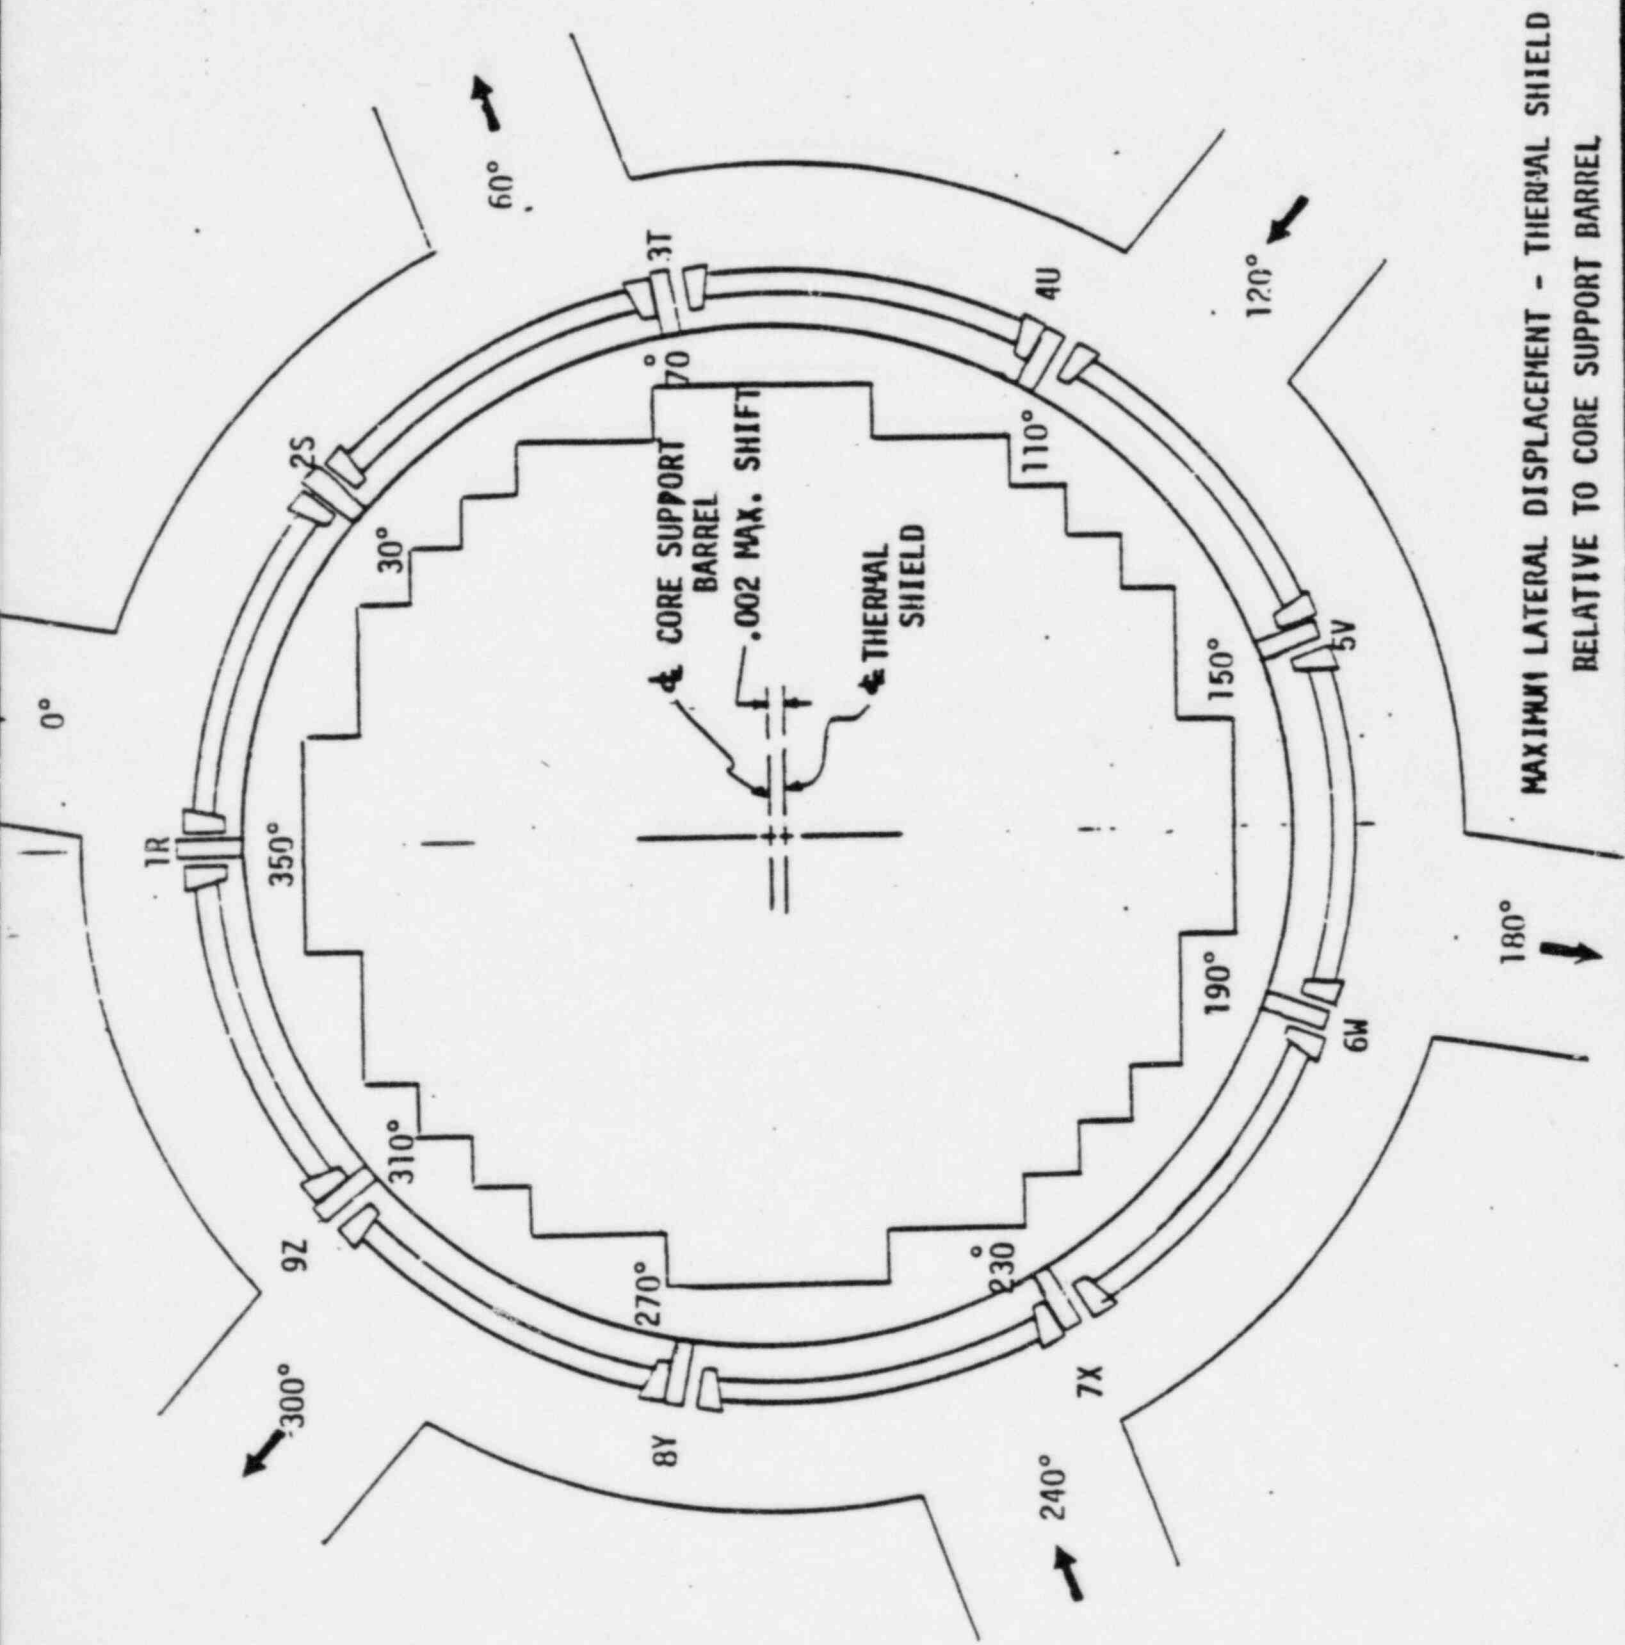
MAXIMUM LATERAL DISPLACEMENT - THERMAL SHIELD
 RELATIVE TO CORE SUPPORT BARREL

CORE SUPPORT BARREL DEFLECTED SHAPE FOLLOWING
POSITIONING PIN INSTALLATION
