CONTAINER ASSESSMENT — CORROSION STUDY OF HLW CONTAINER MATERIALS

QUARTERLY PROGRESS REPORT
JANUARY - MARCH 1982

T.M. Ahn and P. Soo

NUCLEAR WASTE MANAGEMENT DIVISION
DEPARTMENT OF NUCLEAR ENERGY, BROOKHAVEN NATIONAL LABORATORY
UPTON, LONG ISLAND, NEW YORK 11973

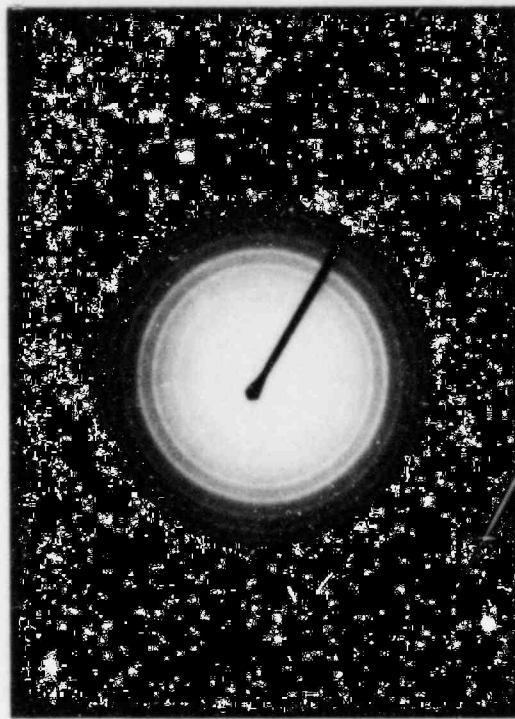
Figure 7a. Electron diffraction pattern from the violet film inside the TiCode-12 crevice.

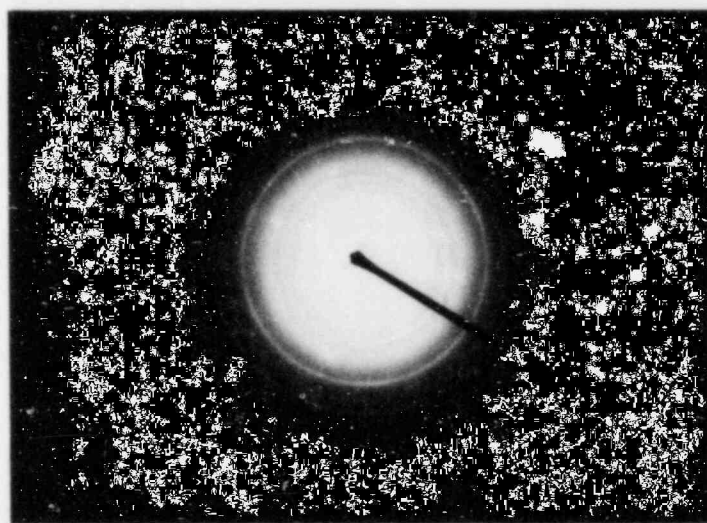
To compare the difference between the oxides present in the crevices and an air-formed oxide, an oxide film was formed in air on CP titanium using a gas flame. Electron diffraction patterns obtained from this film accurately matched those of the rutile form of TiO_2 . The electron diffraction patterns from the crevice corrosion product and the air-formed oxide film are compared in Figures 7a and 7b. The two patterns are distinctly different. It is interesting to note that there was no trace of the rutile form of TiO_2 inside the crevices of CP titanium or TiCode-12 exposed to brine.

Figure 7b. Electron diffraction pattern from the blue film formed on CP titanium by gas flame oxidation in air.
