UNITED STATES
NUCLEAR REGULATORY COMMISSION
WASHINGTON, D.C. 20555

OFFICE OF THE
INSPECTOR GENERAL

As you know, the Office of the Inspector General is conducting an investigation which involves welding issues at Seabrook Nuclear Power Station. On November 1, 1990, Special Agent Frank Forgione of this office spoke with Mr. Neal Pillsbury, New Hampshire Yankee (NHY), Director of Quality Programs. Mr. Forgione has indicated that this conversation concerned the NRC Independent Review Team report NUREG-1425 and the need for additional information from NHY by the Office of the Inspector General (OIG).

In order to more clearly understand the Yankee Atomic Electric Company's (YAEC) 100% review of Pullman Higgins weld radiographs, additional documentation is needed. The table compiled by NHY in NUREG-1425 page 14-2, indicates for the year 1982, 537 film packages were reviewed and two film-quality rejects/discrepancies and three administrative-type rejects/discrepancies were identified. The table provided no reject data for the period from 1979 through 1981 when the table lists 636 film packages were reviewed.

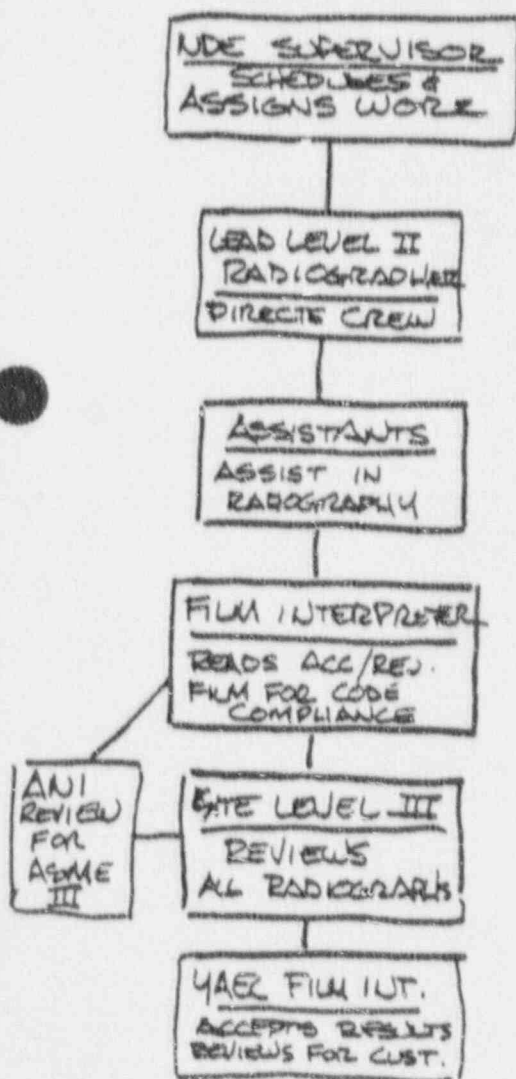
JIM WAS INDIRECTLY INVOLVED WITH THE RADIOGRAPHY OF APPROXIMATELY 473 JOINTS.

THE REASONING BEHIND "INDIRECTLY" CAN BE EXPLAINED BY THE DIAGRAM BELOW.

JIM WAS AN INSIGNIFICANT FACTOR IN THE RADIOGRAPHIC INSPECTION PROCESS FOR THE FOLLOWING REASONS.

1. HIS WORK WAS ASSIGNED & SCHEDULED BY THE NDE SUPERVISOR.
2. IN 374 CASES OF 473 HE WAS FUNCTIONING AS AN ASSISTANT W/ OTHER ASSISTANTS AS PART OF A 3 TO 5 MAN CREW UNDER THE DIRECTION OF A LEVEL II OR III LEAD RADIOGRAPHER.
3. FILM WAS READ AND REPORTS COMPLETED, RESULTS ACCEPTED OR REJECTED BY THE DESIGNATED FILM INTERPRETER.
4. FILM REVIEWED BY SITE LEVEL III
5. FILM REVIEWED BY ANI (ASME III)
6. FILM REVIEWED FOR CUSTOMER BY QAEC FILM INTERPRETER.
