MONTICELLO NUCLEAR GENERATING PLANT
Docket No. 50-263 License No. DPR-22

Response to IE Bulletin 82-03, Revision 1, and
Confirmatory Action Letter dated October 19, 1982
From J. Keppler Regional Administrator, Region III, USNRC

Summary Report of the
Augmented Inservice Inspection of Stainless Steel Pipe Welds
Prepared by: Phillip J. Krumpo

Summary Report
of
Weld Overlay Repairs
of
Recirculation System Piping

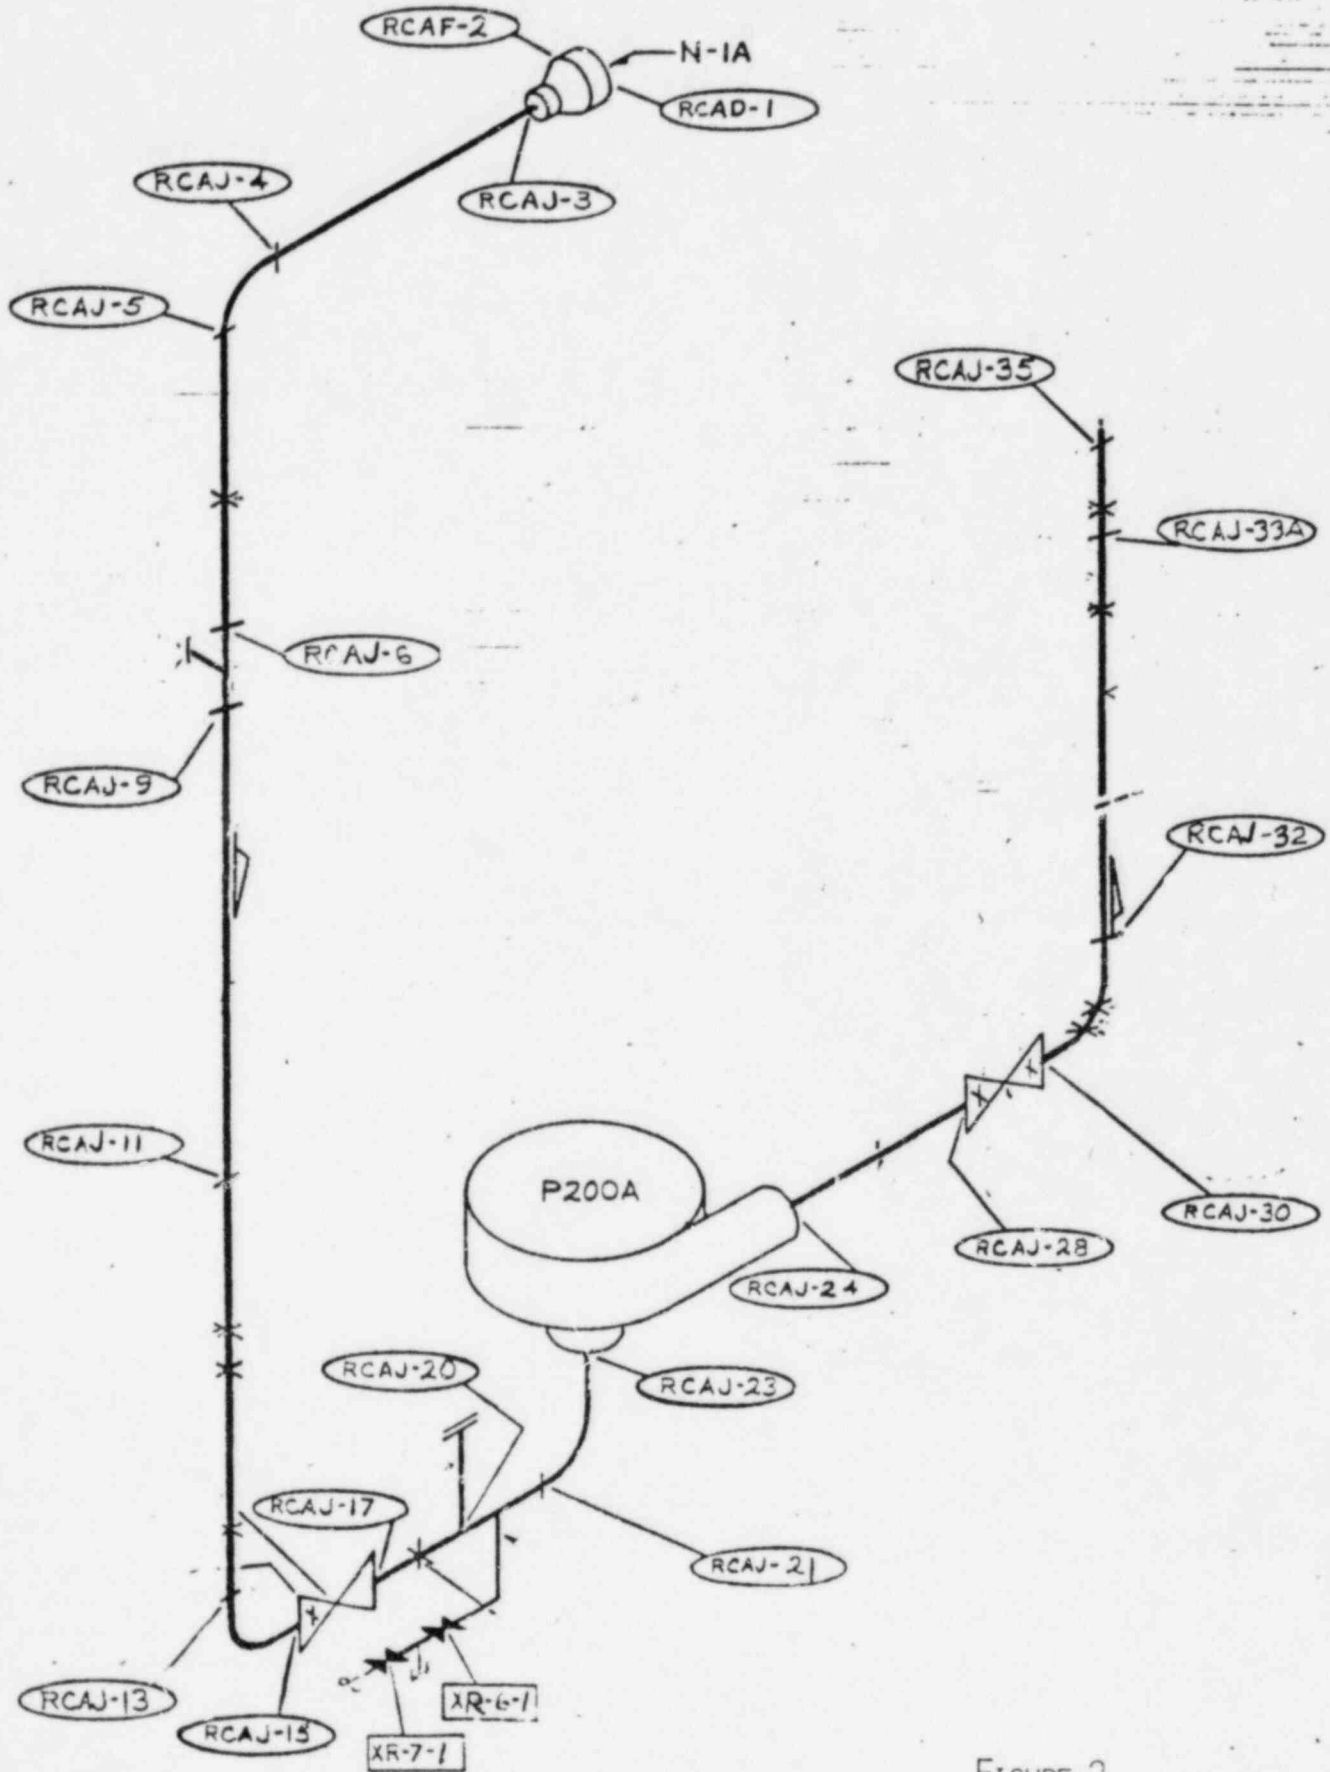
FIGURE 1B

Later in the inspection, four (4) other welds in the 12 inch diameter recirculation riser piping were found to contain IGSCC's. Three welds (RRCJ-3, RREJ-3, and RRFJ-3) were pipe to safe end welds and the fourth weld (RRDJ-5) was pipe to elbow weld. All four welds were in separate risers; refer to Figures 1A and 1B.

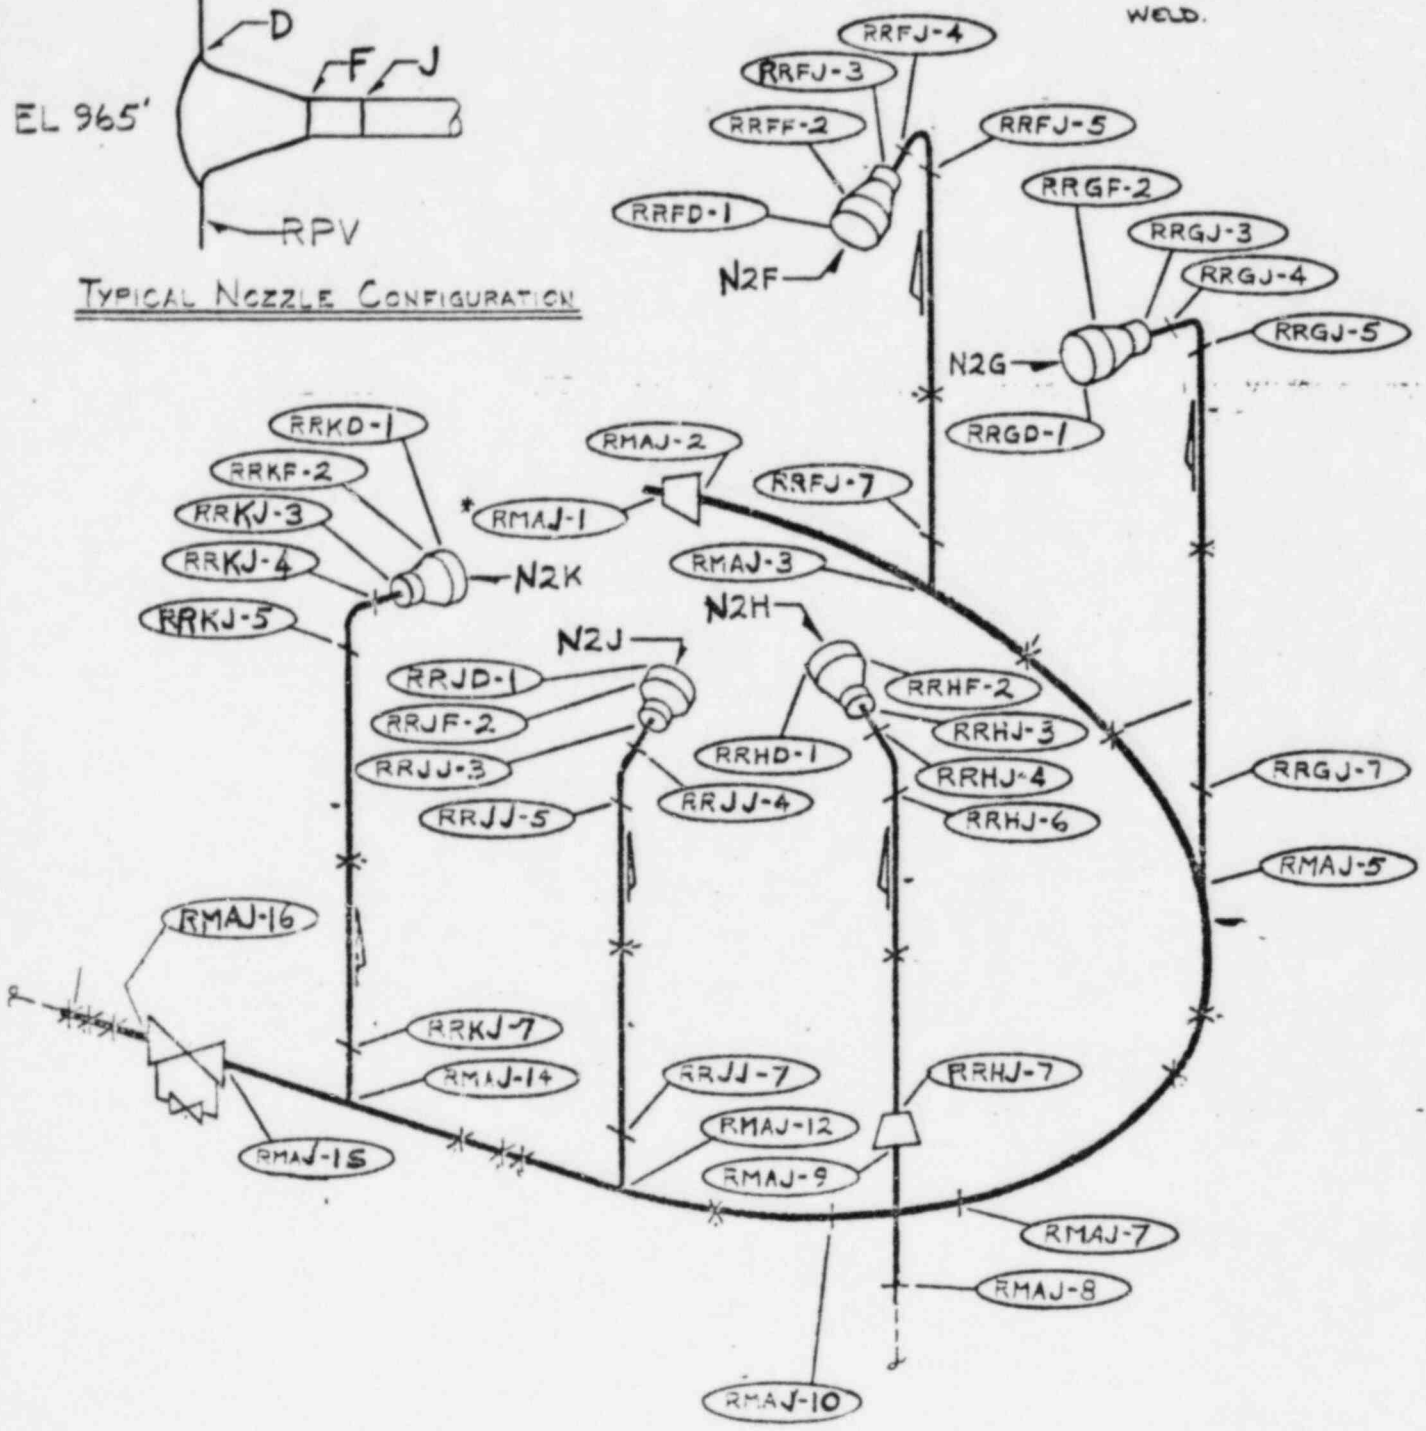
FIGURE 4

SYSTEM	WELD ID	INDICATION DESCRIPTION			
		ORIENTATION	DEPTH	LENGTH	LOCATION
REW 32-22" (MANIFOLD)	RMAJ-2	3-AXIAL	4-11%	1.0" 0.5" 0.5"	12:00-CAP
REW21-12" (RISER)	RRCJ-3	3-RADIAL	>50%	0.41 0.20 0.125	7:30-S.E. 8:00-S.E. 8:30 Pipe(Leak)
		2-CIRC.	3.5%	0.25	ROOT-INCOMPLETE FUSION
REW20-12" (RISER)	RRDJ-5	1-RADIAL	>50%	0.43	3:30-ELBOW
REW19-12" (RISER)	RREJ-3	4-RADIAL	>50%	0.34 0.30 0.28	12:00-PIPE 12:00-PIPE 12:00-S.E.
		1-CIRC.	9%	- 1.06	3:00 S.E.(Leak) 12:00-ROOT
REW14-12" (RISER)	RRFJ-3	2-RADIALS	>50%	0.32	8:00-SE 4:00-SE (Leak)
