LABORATORIES SCIENTIFIC SERVICES & SYSTEMS GROUP

ANALYSIS OF CABLES AND CONNECTORS FOLLOWING
ACCIDENT TEST CONCLUDED ON MARCH 31, 1982
AND
EXTENDED ACCIDENT TEST CONDUCTED
FROM MAY 10 THROUGH 18, 1982
ON
ELECTRICAL PENETRATION ASSEMBLY, TYPE B-M
FOR
DUKE POWER COMPANY

VOLUME II

Test ReportREPORT NO. 45869-1WYLE JOB NO. 45869CUSTOMER P. O. NO. 8828.05-3PMPAGE i OF 89 PAGE REPORTDATE September 10, 1982SPECIFICATION(S) See References,Paragraph 5.0.1.0 CUSTOMER Duke Power CompanyADDRESS 422 Church Street, Charlotte, NC 282422.0 TEST SPECIMEN Electrical Penetration Assembly, Type B-M, Twelve Electrical
Plug Kits3.0 MANUFACTURER D. G. O'Brien

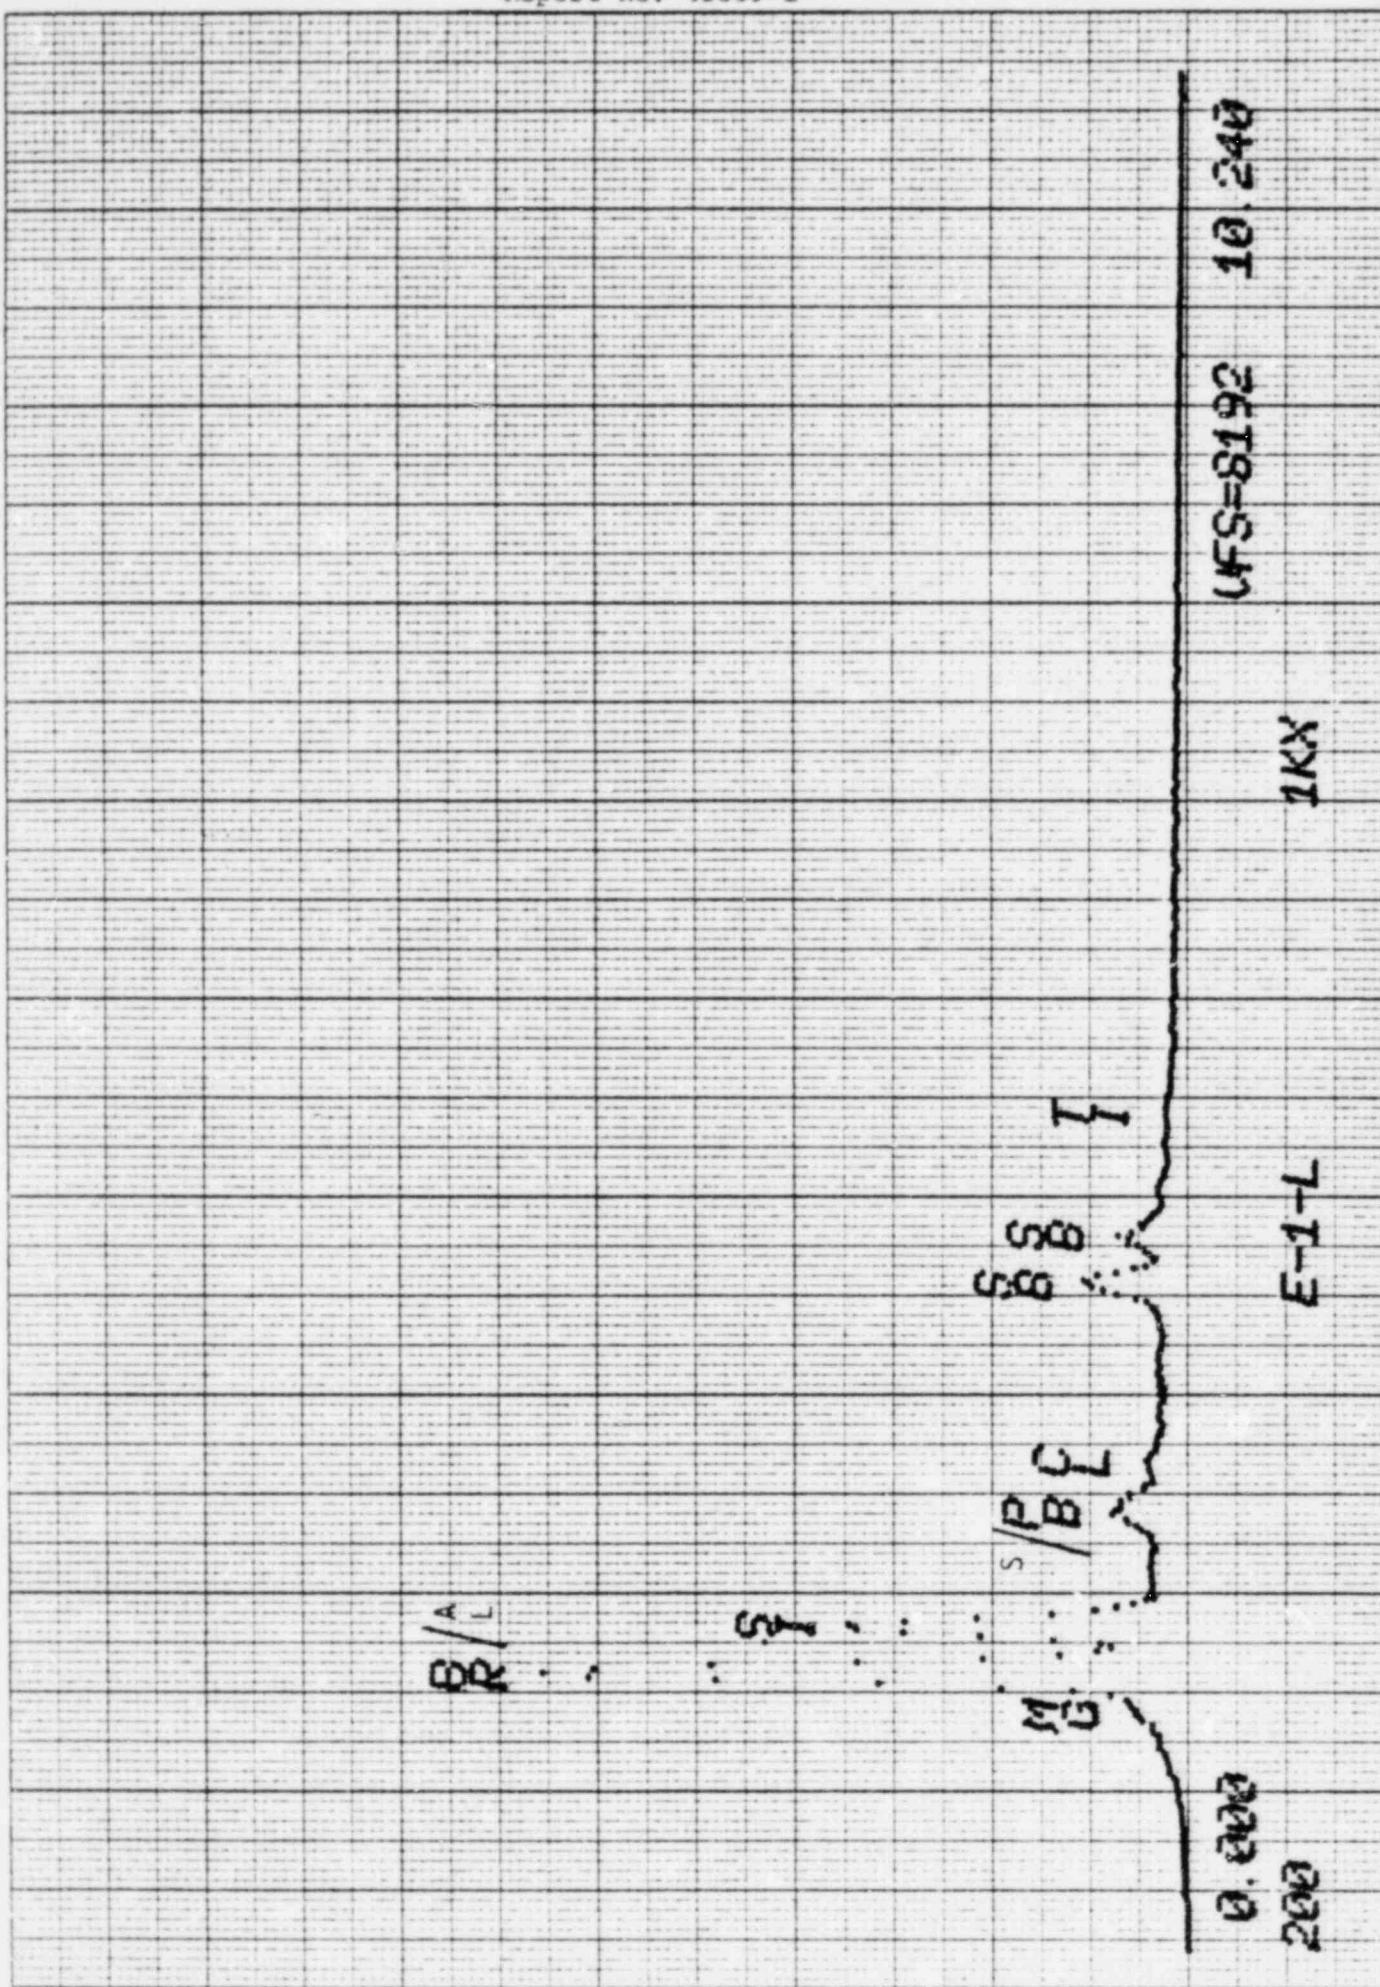
Results: The inner surface of each jacket was examined optically, at 30X magnification, to select an appropriate area for analysis, i.e. an area showing an apparent surface residue. Figure 1 shows scanning electron micrographs of the areas which were examined. Figures 2-3 show EDXA spectra typical of the materials studied; the method is sensitive to elements with atomic number above 8. Note that jacket L-8-L had high chlorine, while E-1-L had little.

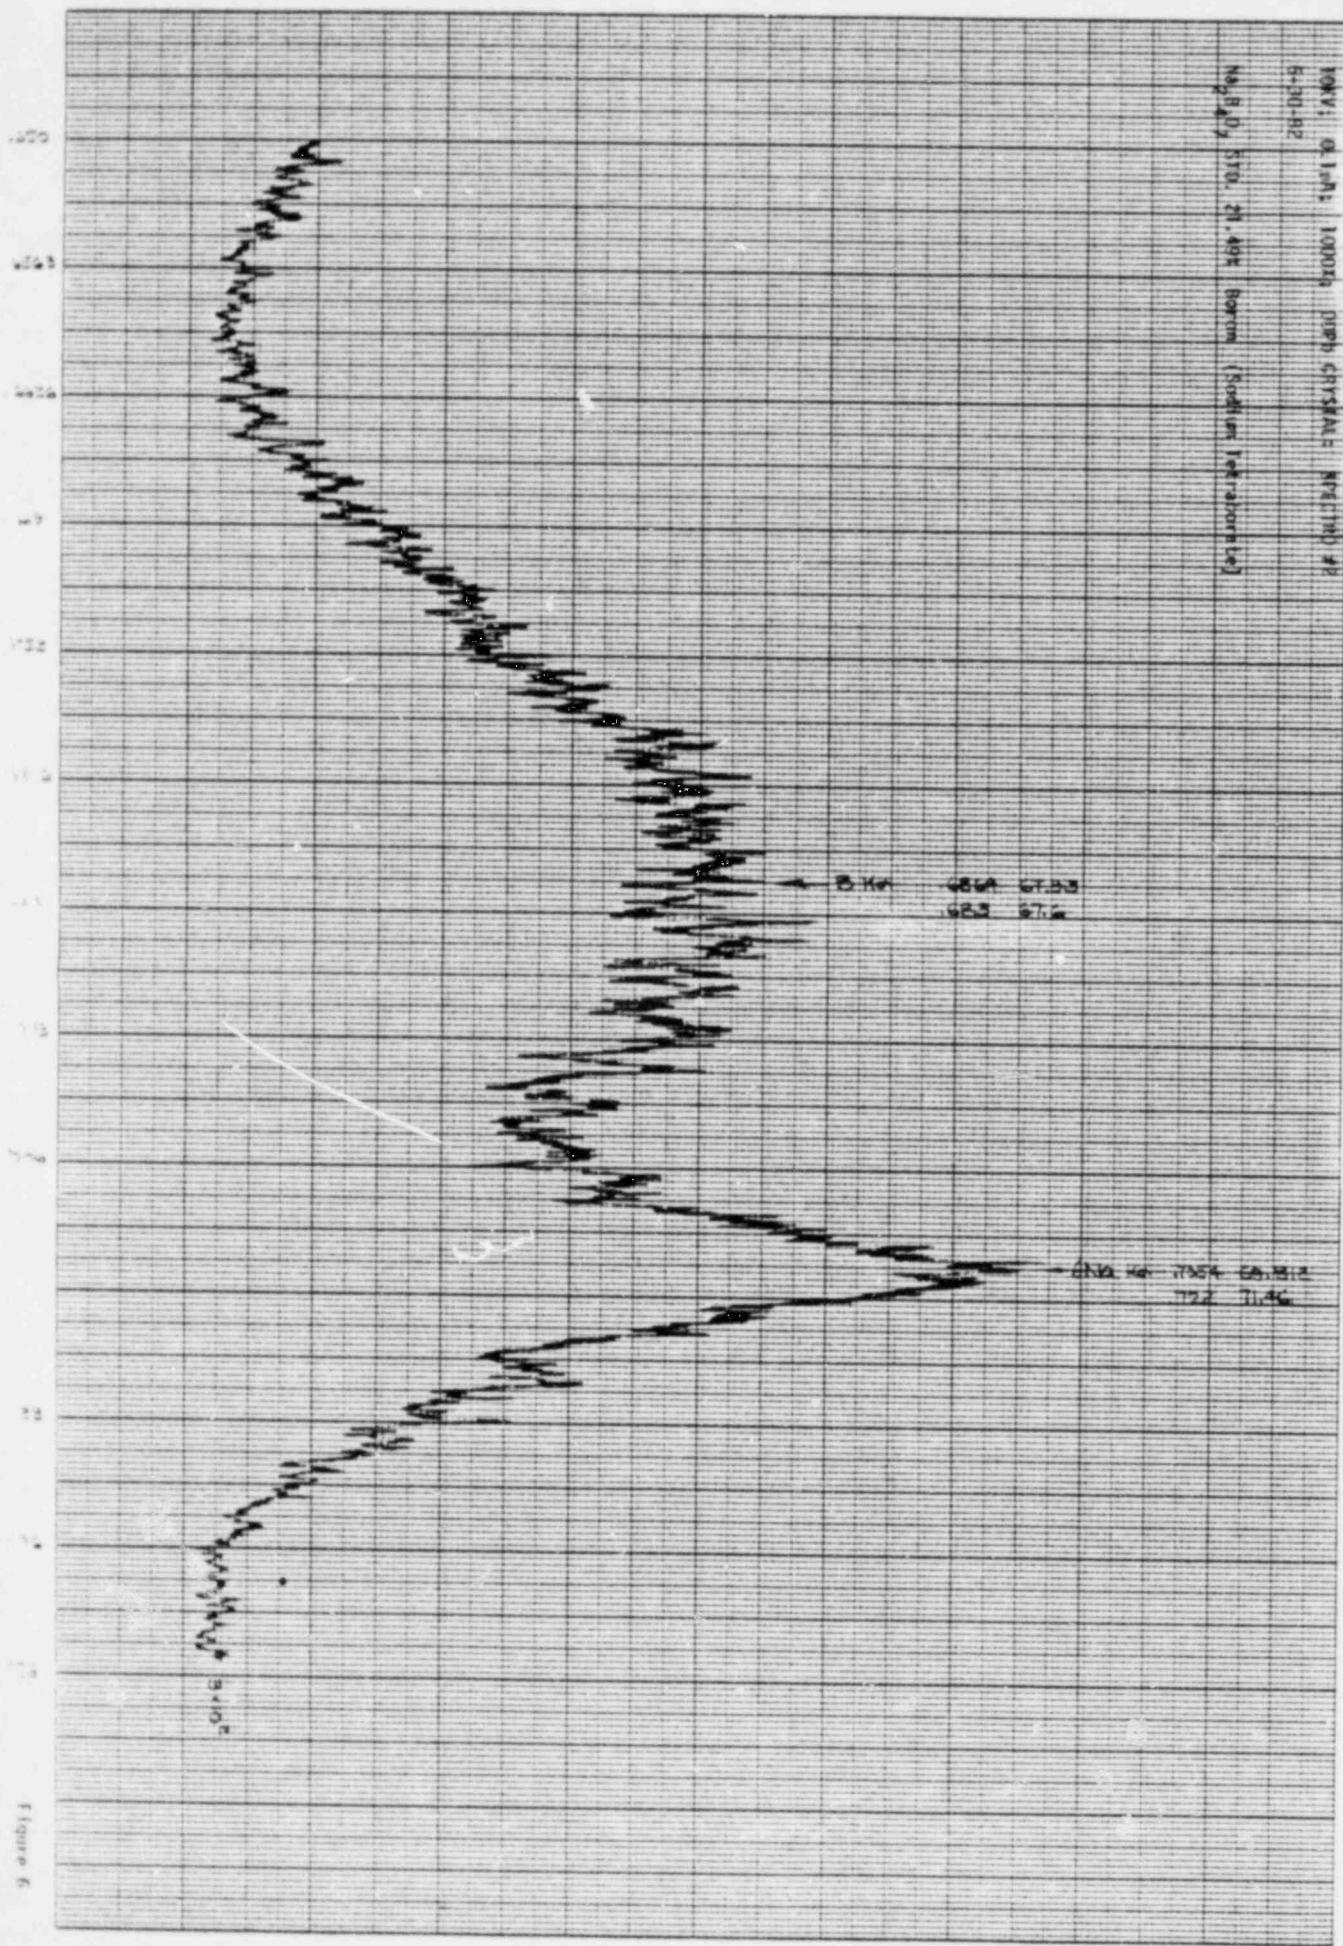
L-8-L and for L-9-L was attributed to chlorine which was high in these samples. The sensitivity for boron is shown by the B $\kappa\alpha$ peak in Figure 6 which was obtained from sodium tetraborate with 21.49 wt.% boron.
