AEOD CASE STUDY C-90-01
OPERATING EXPERIENCE FEEDBACK REPORT
SOLENOID-OPERATED VALVE PROBLEMS
AT U.S. LIGHT WATER REACTORS

December 1990

ABSTRACT

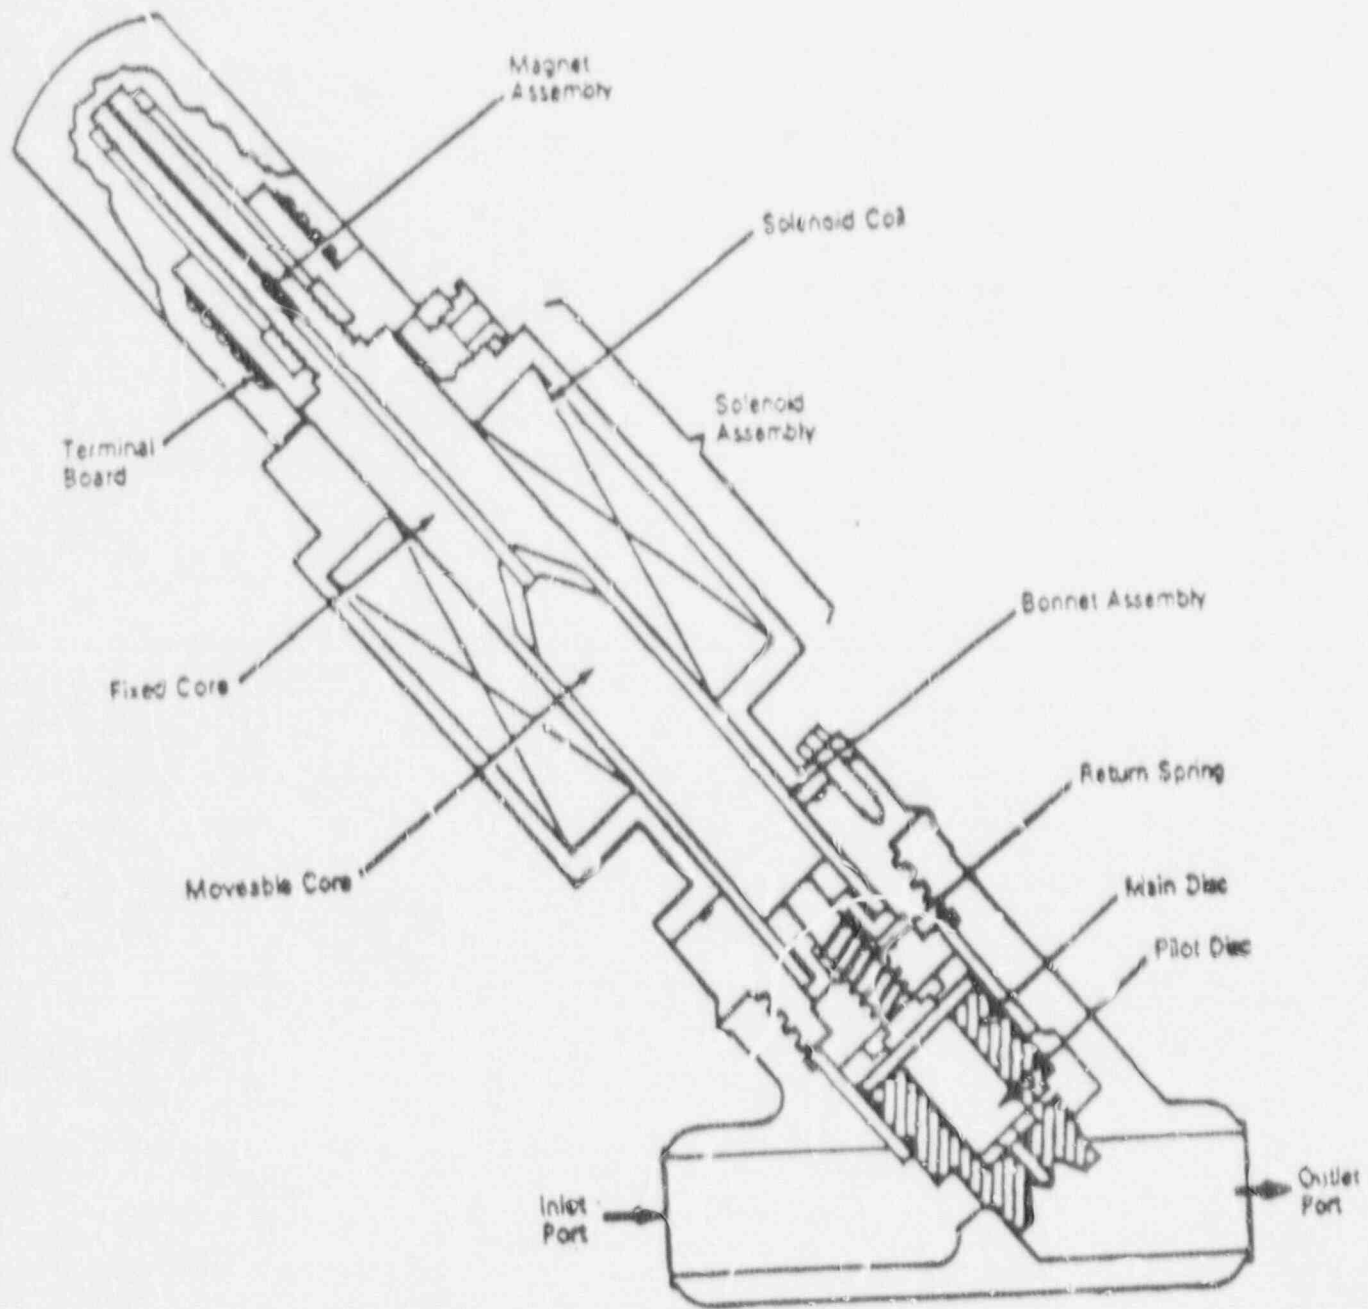
Figure 4 Schematic drawing of a Target Rock pilot-assisted solenoid-operated valve

On the basis of searches of the NRC data bases, at least six plants have observed inadvertent operation of safety-related Target Rock angle-type SOVs as a result of improper valve orientation. As shown in Figure 4, upstream fluid pressure at the inlet port of the angle-type SOV assists valve orientation; upstream fluid pressure at the inlet port of the angle-type SOV assists valve disc seating. However, many licensees also have learned from their own operating experiences and from followup discussions with the SOV manufacturer, that several different models of Target Rock angle-type SOVs used for isolation purposes are "unidirectional." That is, they will experience undesired seat lifting when the backpressure (pressure at the outlet port shown in Figure 4) is only 2 to 5 psi higher than the upstream or inlet pressure. As noted in Target Rock Operation Manual TRP 1571 J (Ref. 42), the manufacturer has been aware of this problem at nuclear plants since 1978. However, in the late 1970's, Target Rock developed an SOV for use as a bidirectional isolation valve (would not open inadvertently as a result of high backpressures). Target Rock considered the inadvertent seat lifting to be an architect engineer/licensee "application problem" - not an SOV problem.* The issue of unidirectional isolation SOVs is addressed in some, but not all, Target Rock SOV users manuals. For example, Reference 43 noted that the unidirectional qualities of the Target Rock angle-type SOVs are described in Target Rock Manual TRP 1571J (Ref. 42), which states that

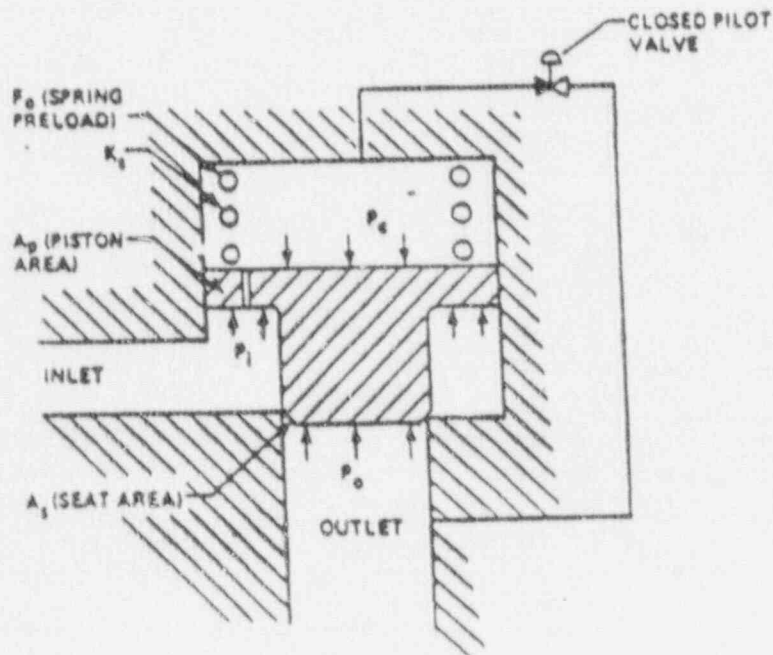
Figure 3. Closed Valve Loadings

Before the analysis can proceed, it is necessary to define what constitutes a severe pressure transient that would be of concern. To do this, we refer to Figure 3, which shows schematically a fully seated hydraulic-assisted, pilot-operated globe valve.

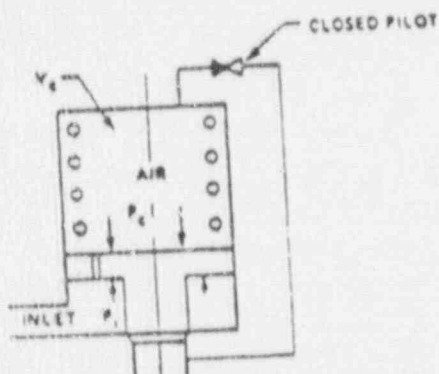
Figure 4a. Valve Closed (Air to Air)

The valve is air-filled and is suddenly exposed to higher pressure air. Figures 4a, 4b and 4c illustrate what would happen if the valve spuriously opens.

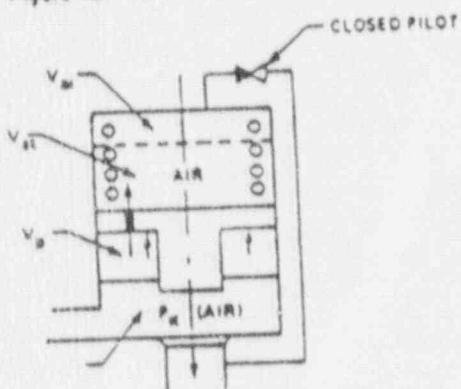
Figure 4b. Valve Opens (Air to Air)

Let V_c be the volume of the control chamber. Therefore, at the force reversal point as shown in Figure 4b,

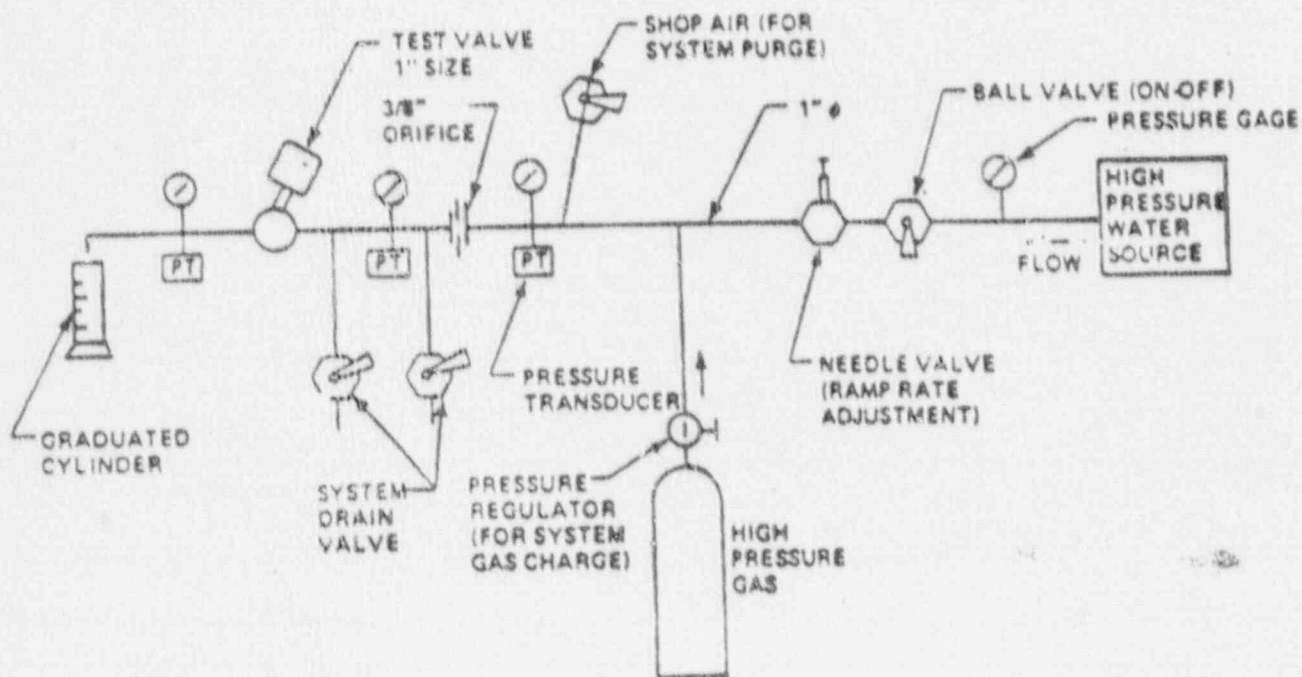
Figure 7. Valve Test Setup

To verify the validity of the analysis, a limited test was conducted to demonstrate the phenomenon. Figure 7 illustrates the test setup. Three tests were conducted to simulate each of the three cases. The results of the tests are summarized in Table 2.
