"Experience in Decontamination
and Repair of Radwaste Concentrator
at Millstone Unit No. 1"

J. Summa Northeast Nuclear Energy Company

K. Kallfisch Unitech Division, Ecodyne Corp.

Presented at the 1978 Annual Winter Meeting of
the American Nuclear Society in Washington, D.C.
(Log Number 00681)

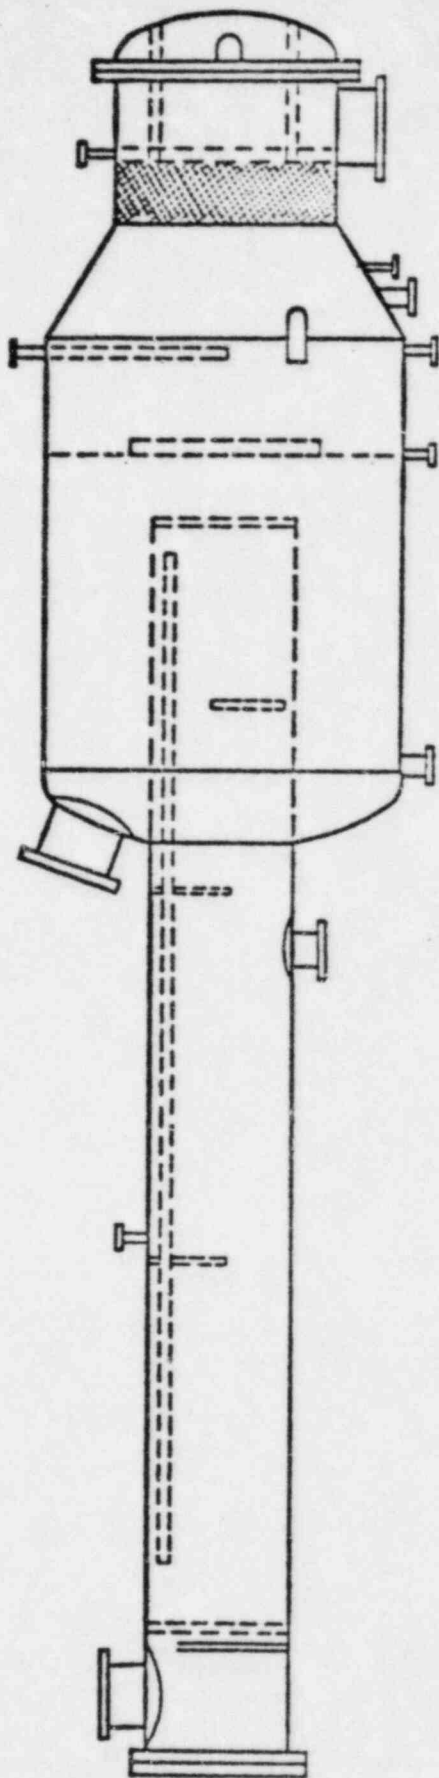
SLIDE IV

Entry, inspection and repair would be carried out through a flanged accessway in the top of the vessel (Slide III). This permitted removal of the mesh pad which was tack welded via support bars to the removable dished head (Slide IV). This would permit visual examination of the vessel prior to entry, which would diminish the man-rem exposure.
